**IRONCLAD (#72)**  
**(MINFILE#105M 063)**

Public Works And Government Services Canada	Travaux publics et Services gouvernementaux Canada	designed by: conçu par:	date:
	Architectural & Engineering Services Western Region		drawn by: dessiné par: C.S.	Nov. / 99
Drawing title: <b>Ironclad Site #72 Site Assessment</b> Yukon Territory		Titre du dessin: révisé par:		project no. no. du projet: 125-12.01
		design no. dessin no.: 1 of 1

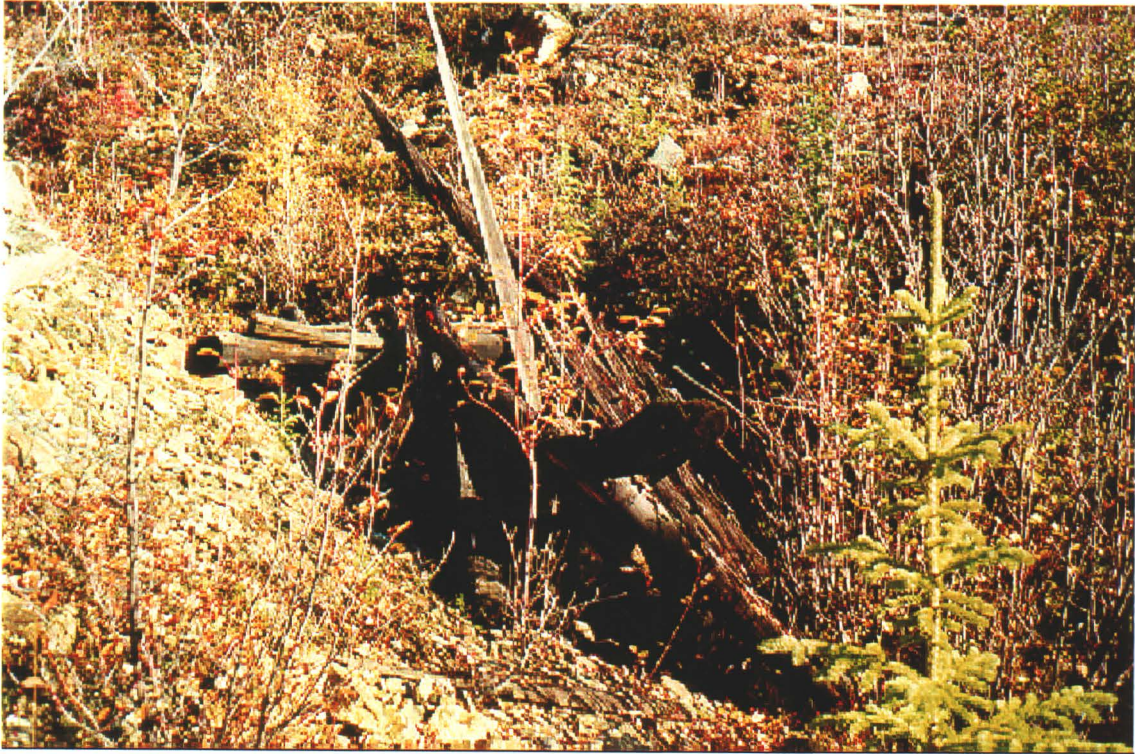
Collapsed adit

Condition: adit is collapsed

Photo 72-1: Collapsed adit Ironclad portal. (Azimuth 000°)

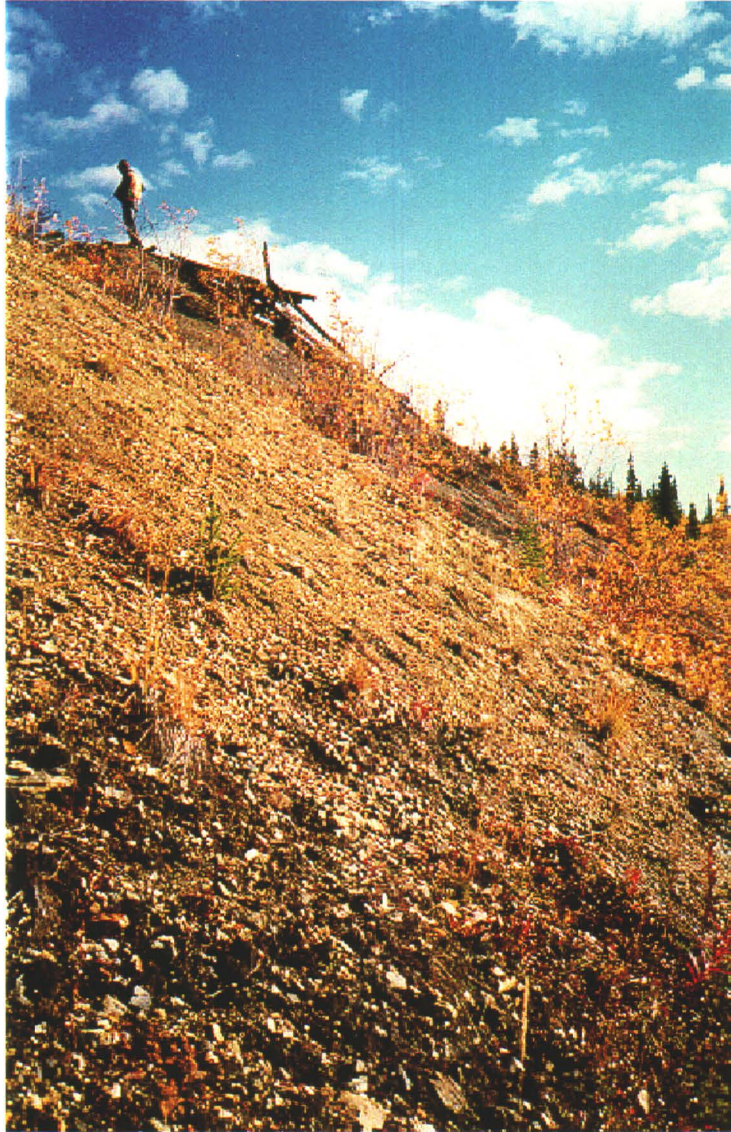
Waste rock pile #1 is located about 30 m south of Adit 1. It lies directly beside Waste rock pile #2 to the west. The pile appears stable at a slope of about 35°. Waste rock pile #1 is primarily fine to

Photo 72-2: Waste Rock pile 72WR01 looking towards treset structure on WR01. (Azimuth 090°)

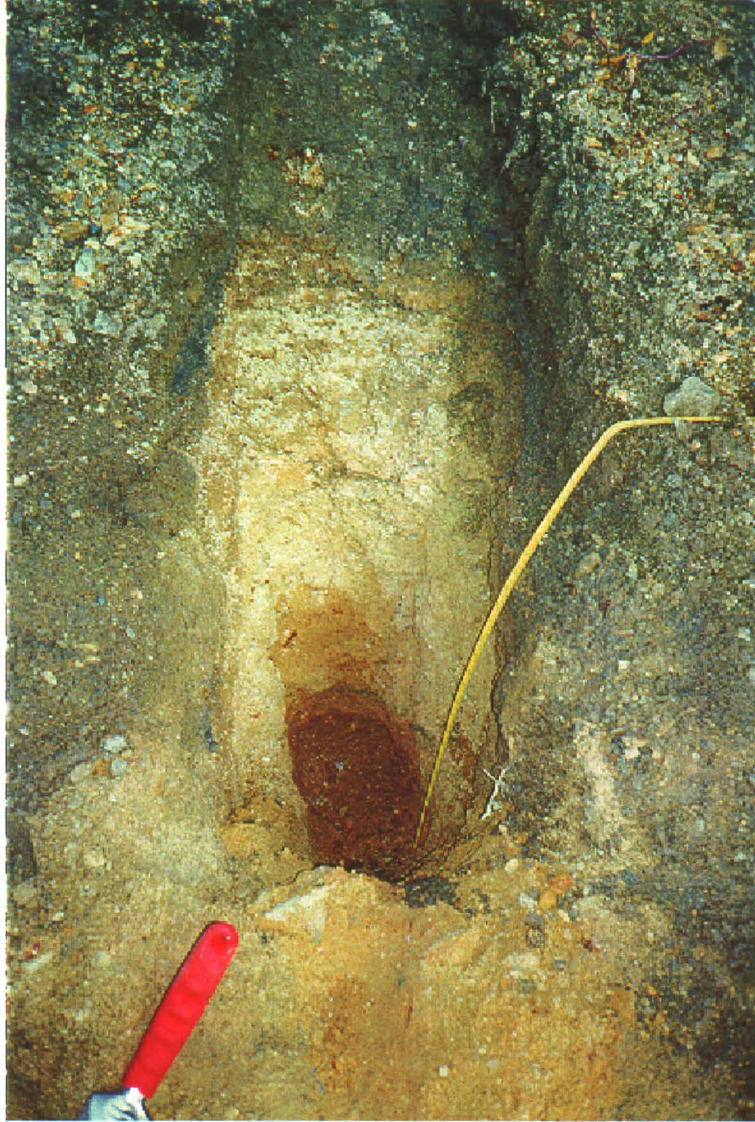
blocky rusty and weathered quartzite. It also consists of about 10% phyllite and 5% quartz vein material. Minor siderite veining and greenstone were also observed in this pile. A 47 cm test pit (Test Pit 72WR01) dug at Waste rock pile #1 revealed four distinct layers of material (photo 72-3). The layers consisted of 8 cm of green yellow to green brown sandy quartzite and quartz veining overlaying 2 cm of dark grey graphitic phyllite, 27 cm of leached pale yellow sandy quartzite and quartz veining, and 10 cm of yellow brown to light brown sandy quartzite and quartzite. Waste rock samples were taken from the pale yellow layer (sample 72WR01-01) and the yellow brown to light brown layer (sample 72WR01-02). The field paste pH and conductivity of sample 72WR01-01 were 7.1 and 10  $\mu\text{S}/\text{cm}$  respectively. The field paste pH and conductivity of sample 72WR01-02 were 7.4 and 20  $\mu\text{S}/\text{cm}$  respectively. Laboratory analysis data is provided in Attachment B.

Photo 72-3: Waste rock sample pit for 72WR01-01 and -02. Note distinct colour change.

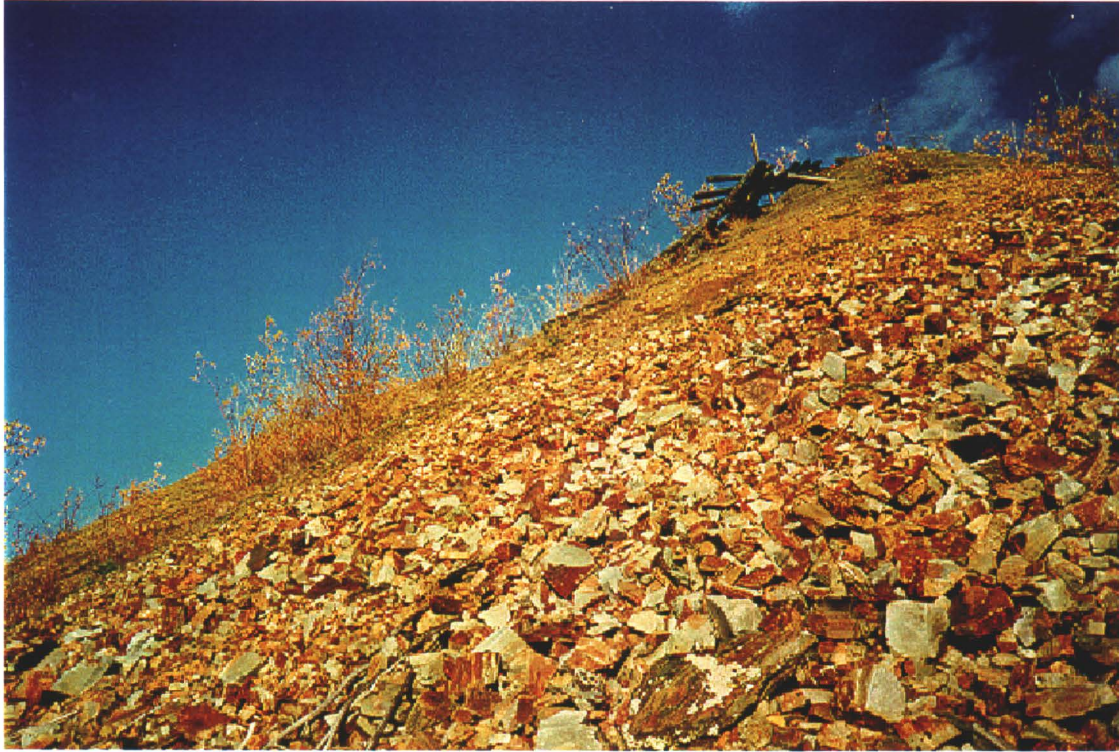
Waste rock pile #2 is located about 30 m south of Adit 1. It lies directly beside Waste rock pile #1 to the east. The pile appears stable at a slope of about 30°. Waste rock pile #2 is primarily fine carbonaceous phyllite with minor graphite. A section of the pile at the southeast edge consists of rusty and weathered blocky quartzite with trace of disseminated pyrite. A 38 cm test pit (Test Pit 72WR02) dug at Waste rock pile #2 revealed a subsurface layer consisting of green brown fine phyllite with some platy and rusty coarse fragments. Waste rock sample 72WR02-01 was taken from the subsurface layer. The field paste pH and conductivity of sample 72WR02-01 were 6.8 and 18  $\mu\text{S}/\text{cm}$  respectively. Laboratory analysis data is provided in Attachment B.

Photo 72-4: Waste rock pile 72WR02. Note rusty quartzite material and collapsed tressel structure.  
(Azimuth 340°)

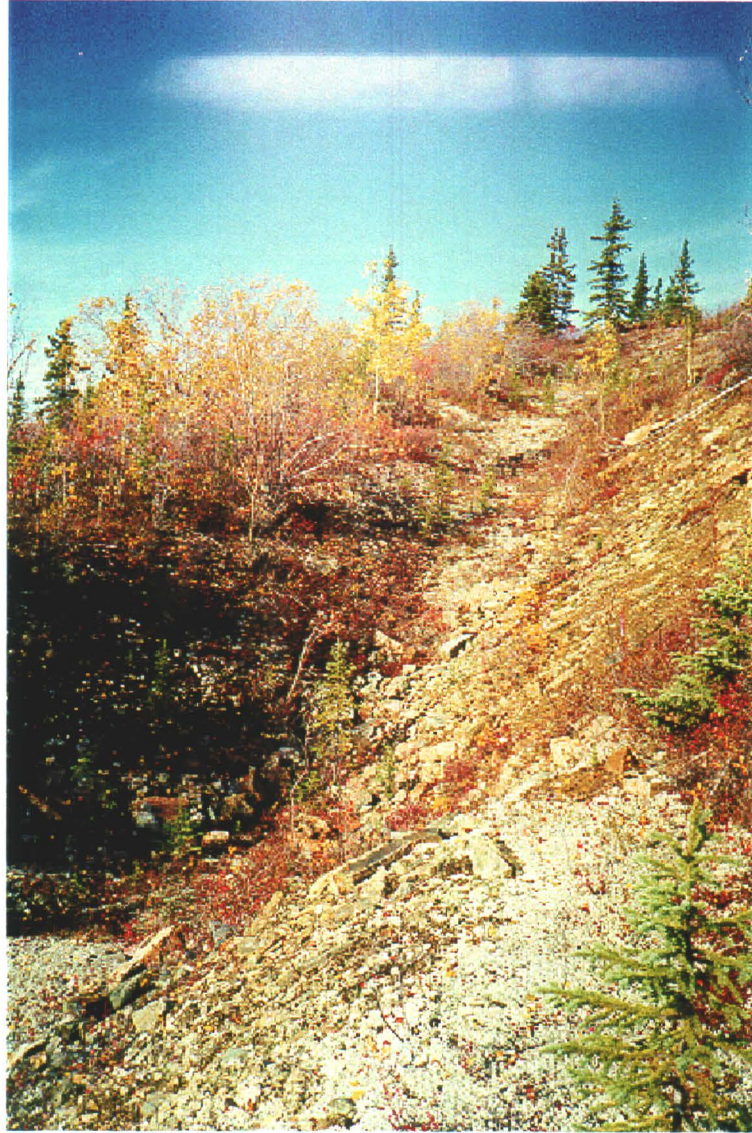
Condition: stable

Photo 72-5: Cat trench TR03 above road. (Azimuth 340°)

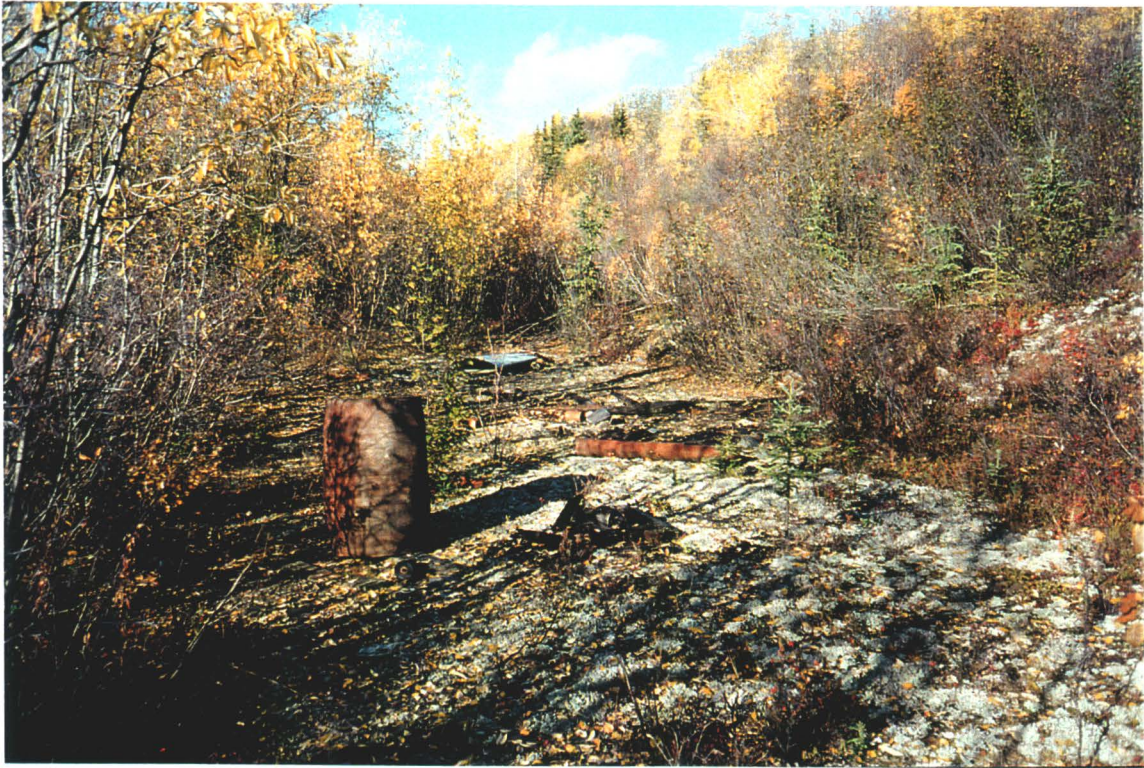
Evidence was found that a building once stood at the Ironclad site. Metal and wood debris are located in an area about 15 m west of Adit 1 (photo 72-6).

Photo 72-6: Levelled mine portal area showing metal and wood debris.
