GAMBLER
SITE #73
MINFILE #105M 069

Public Works And Government Services Canada	Travaux publics et Services gouvernementaux Canada	designed by:	
		concep. par:	
Architectural & Engineering Services Western Region		drawn by:	I.B. Nov. /99
		approved by:	
Drawing title:		revisions:	
Gambler Site #73 Site Assessment Yukon Territory		project no. no. du projet:	125-12.01
		desig. no. desin. no.	1 of 1

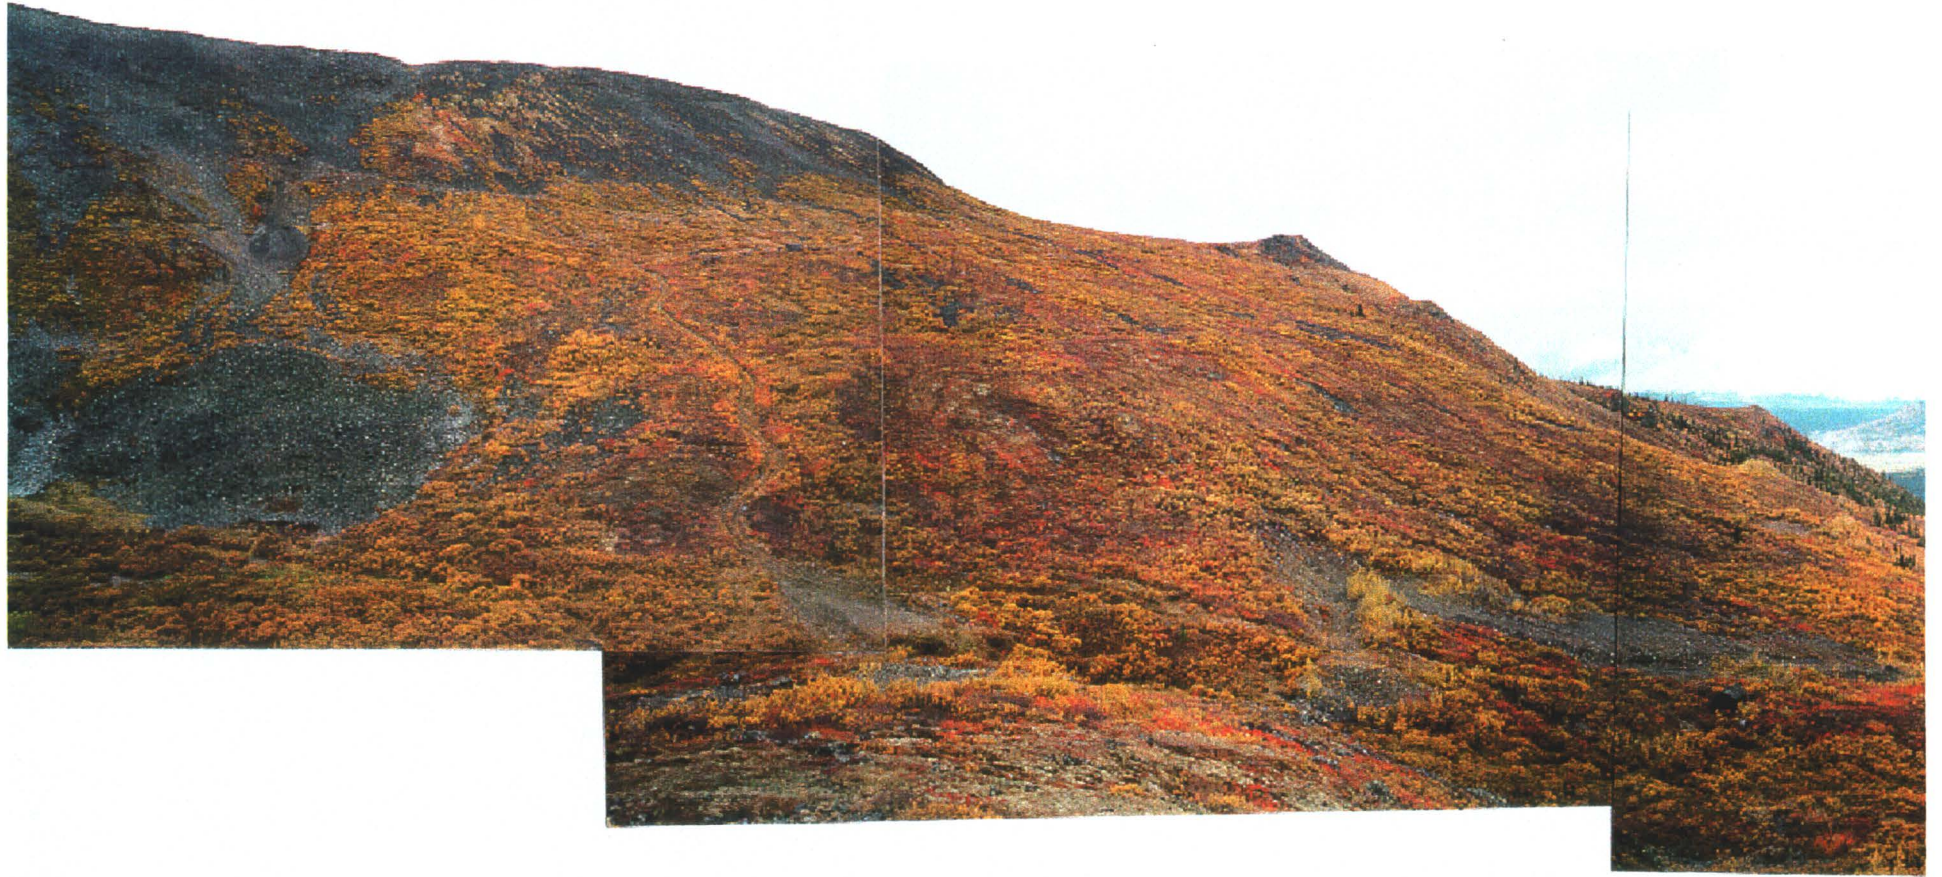
There are six bulldozer trenches located in a cluster at the base of the slope roughly 250 metres east of the camp buildings. A cat road turns east down the slope from the access trail just past the camp. Three of the trenches are 50m in length and oriented at 045°, 047° and 050°. The other three trenches are 20m in length and oriented at 110°, 110° and 160°. The trenches are easily accessed, shallow and have been partially backfilled.

Photo 73-1: Overview of Gambler site showing mine workings to left, camp buildings left of middle, and more recent surface cat trenches at bottom.

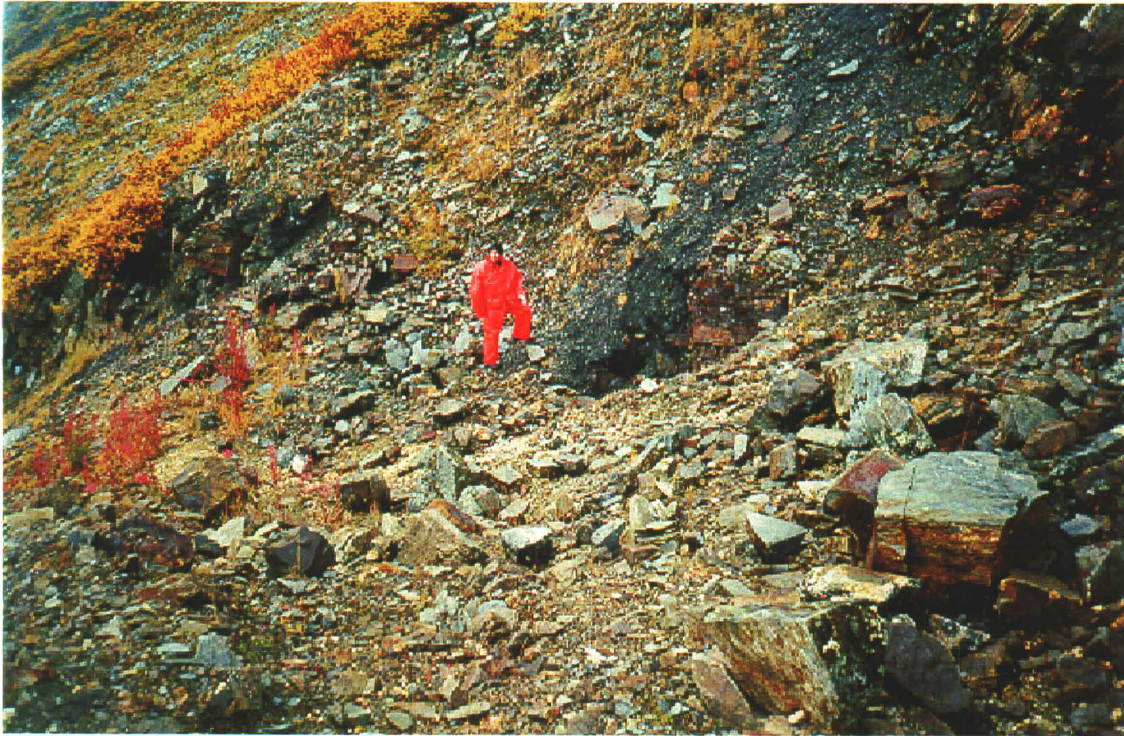
The entrance to the adit is collapsed and is buried with waste rock and overburden.

Dimensions (L x W x H): The adit is collapsed, so the width and height could not be determined. The adit was driven to a length of 167.1m.

Supports: The original supports for the portal have been buried in the rock debris.

Condition: The adit appeared stable at the time of the site visit.

Accessibility: Due to the collapse, the adit can not be accessed.

Photo 73-2: Overview of lower adit level from upper adit level. Photo Direction (Azimuth 060°)

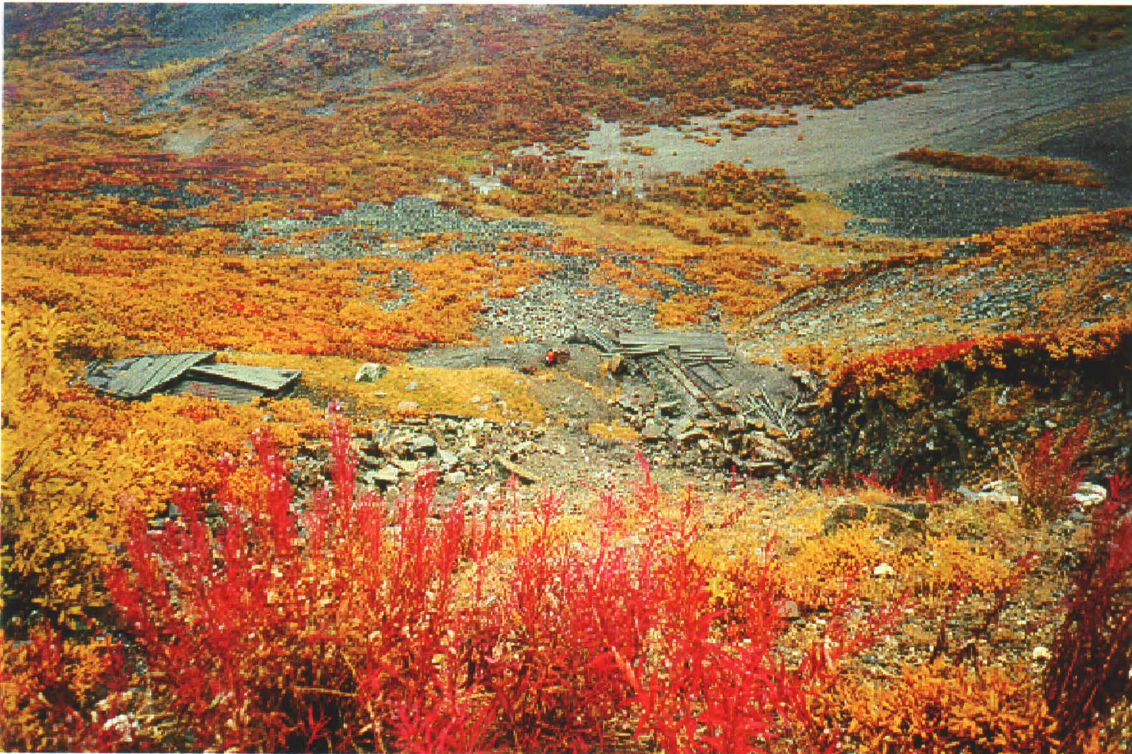
The entrance to the adit has collapsed.

Dimensions (L x W x H): The adit is collapsed, so the width and height could not be measured. The adit was driven to a length of 15.2m.

Condition: The adit appeared stable at the time of the site visit, although intermittent rock fall from excavation is expected.

Accessibility: Due to the collapse, the adit can not be accessed.

Photo 73-3: Upper Gambler adit level. (Azimuth 170°)

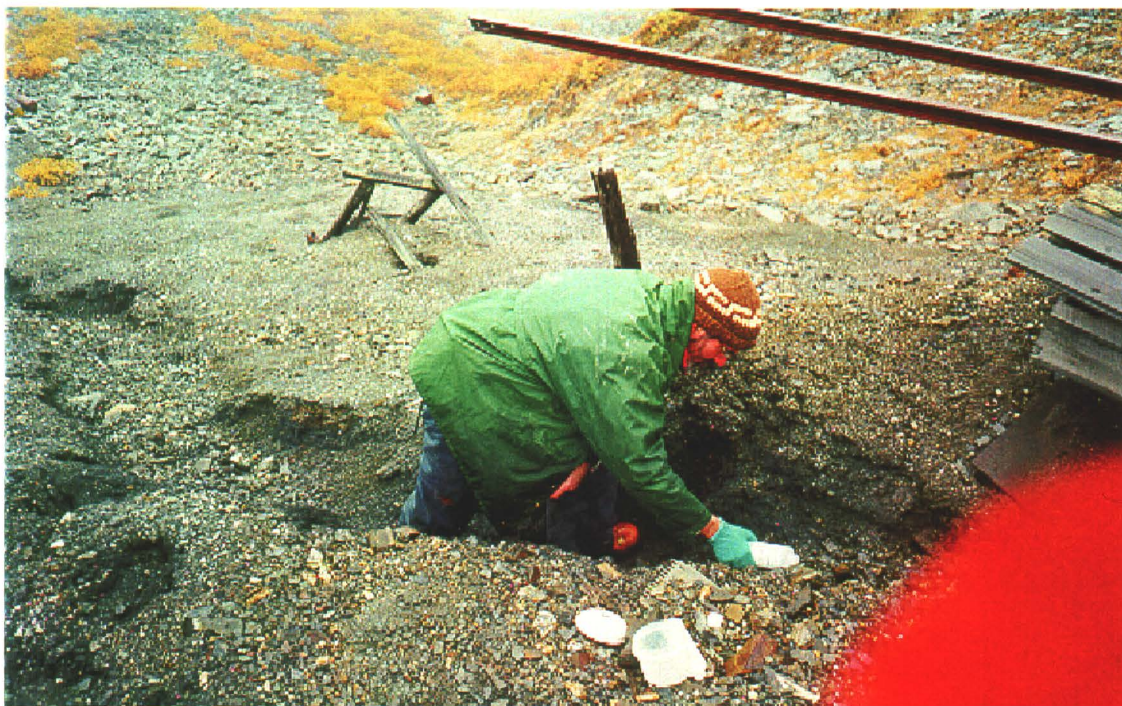
The only surface water encountered at the site was flowing from the lower adit at a rate of less than 1 L/s (visual determination). The water flowed at the surface for less than 10m before disappearing into the ground at the northern edge of the waste pile. No water was observed flowing from the upper adit.

Photo 73-4: Lower Gambler adit drainage sample site (73-WQ-A01-01/-02). (Azimuth 070°)

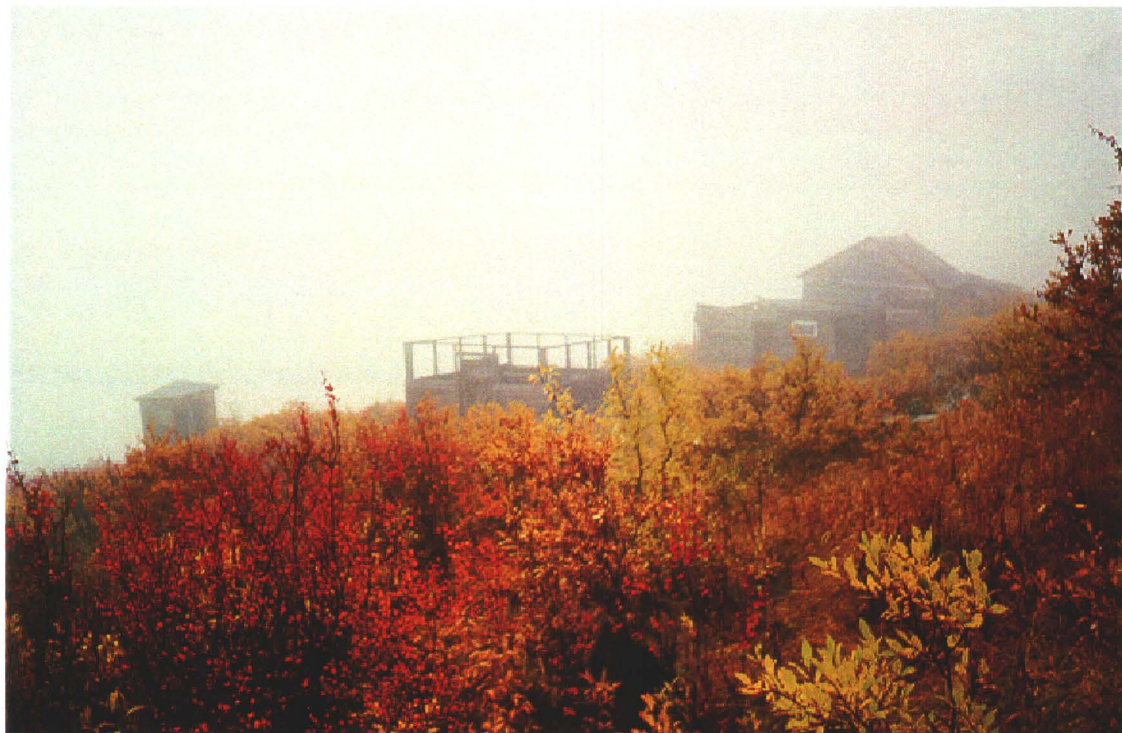
There are 5 buildings at the site. Most of the buildings appeared to be in the same condition as they were in 1996 (PWGSC, 1997). Buildings locations are marked on the site map (Figure 1). A pile wooden platforms or collapsed walls occurs adjacent to the lower adit. There could be part of a collapsed

The shed is fairly unstable: the roof has partially collapsed and the floor is in fair to poor condition.

The floor is in fair to poor condition.

This open topped structure was designed to be covered by a canvas roof. The walls and floor are in reasonable condition.

The outhouse leans at angle, but is in stable condition.

Photo 73-5: Overview of Gambler camp buildings. No changes noted since 1996 inspection. (Azimuth 130°)
