BEMA (#75)
(MINFILE# 105M 073)

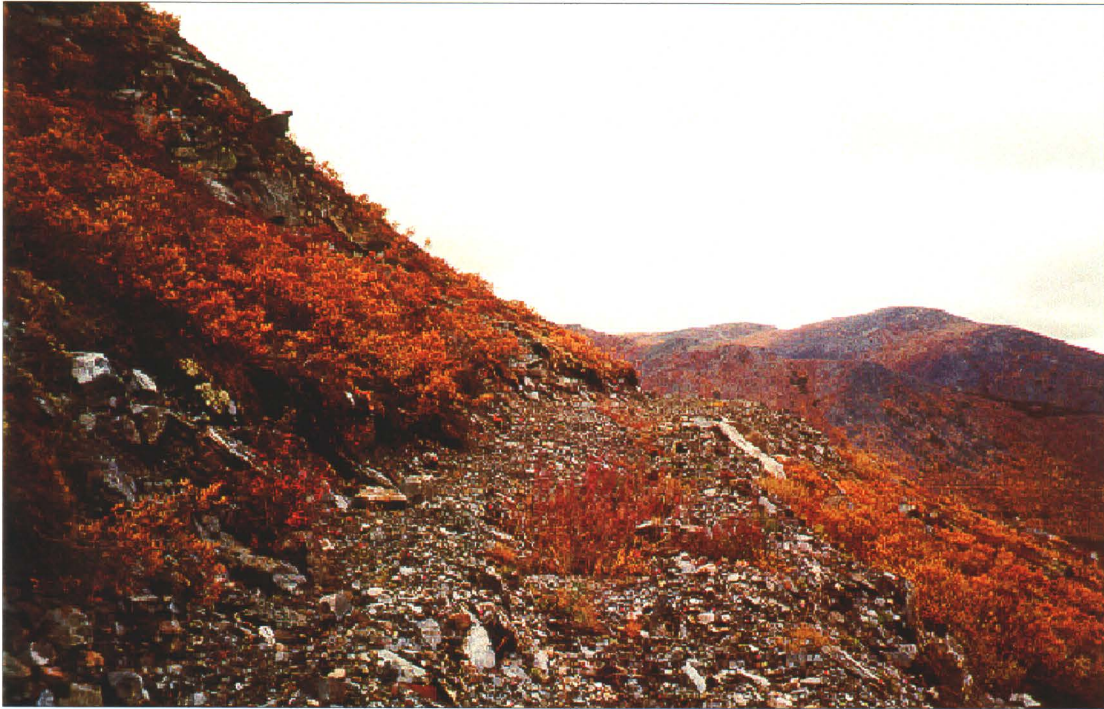
Trench 1 (photo 75-1)

Trench 1 is the only development at the Bema site. It is an exploratory bulldozer trench cut along the contour of the hill. A ripper slot extends about 150 m north down a spur from the trench.

Dimensions: 118 m x 3 m x 1.5 m

Condition: stable

Photo 75-1: View along length of trench cut into side of hill (Trench1) at Bema site.
