TOWNSITE MINE # 76
(MINFILE # omitted from minfile)

Public Works And Government Services Canada	Travaux publics et Services gouvernementaux Canada	designed by: conçu par:	date:
		drawn by: dessiné par:	C.S. Nov. /99
Architectural & Engineering Services Western Region		approved by: approuvé par:	revisions:
Drawing title: Townsite Mine Site #76 Site Assessment Yukon Territory	Titre du dessin:	project no. no. du projet:	sheet no. feuille no.:
		125-12.01	1 of 1

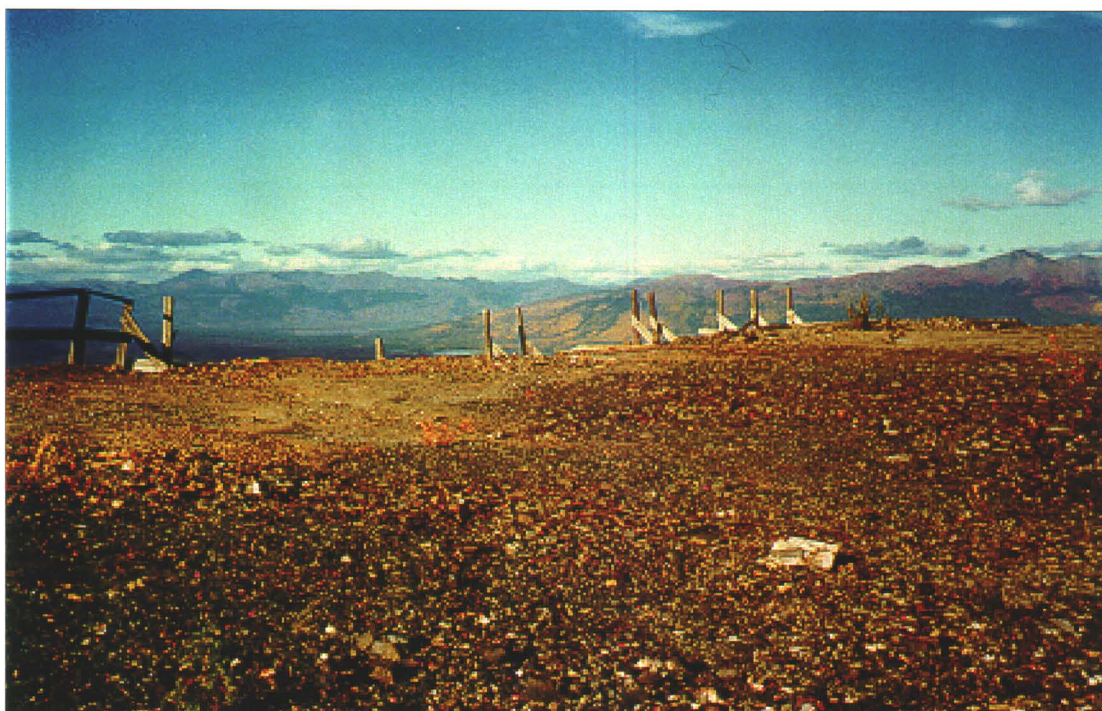
Comprised of development waste rock, vein material and the quartzite excavated to collar the portal. (~ 13,000 tonnes). The dump consists of barren quartzite, schist and quartz veining. It exhibits moderate limonite staining (Oct. 1 F05-P09). There is a small kill zone directly below the dump (~30 m down slope x ~10 m Wide), which does not appear to be regenerating vegetation. There is no sign of any appreciable surface drainage through the dump. Two samples were reported in the literature. These samples consisted of ABA testing conducted in 1995 on two samples, one indicating that it had the potential to produce acid.

Photo 76-1: Facing north from the adit across loading area and dump site.

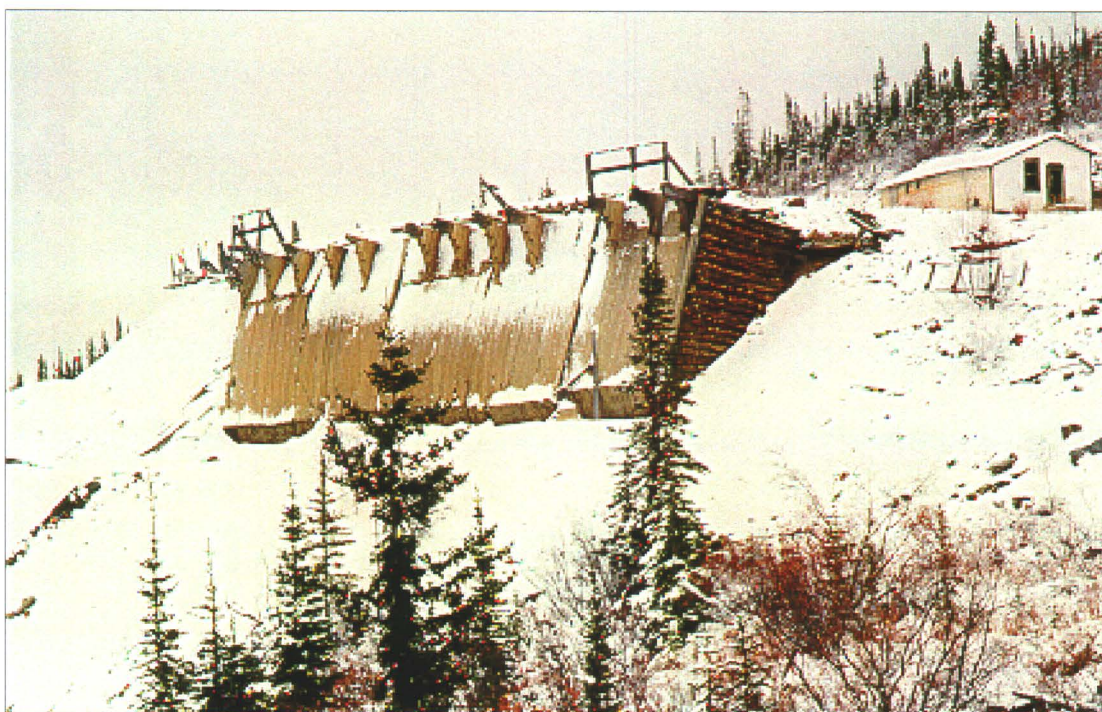
There are two buildings at the site. Building 76A serves as a workshop and office accommodations on two separate levels. Building 76B is the portal entranceway. There was building debris scattered around the site, however, there was no visual sign of staining on the surrounding soils. Wood cribbing and some wood sheathing (photo 76-1) is located to the west of the road to reinforce a waste rock dump that was used as a loading area (photo 76-2).

Photo 76-2: Timber retaining structure for the loading area.

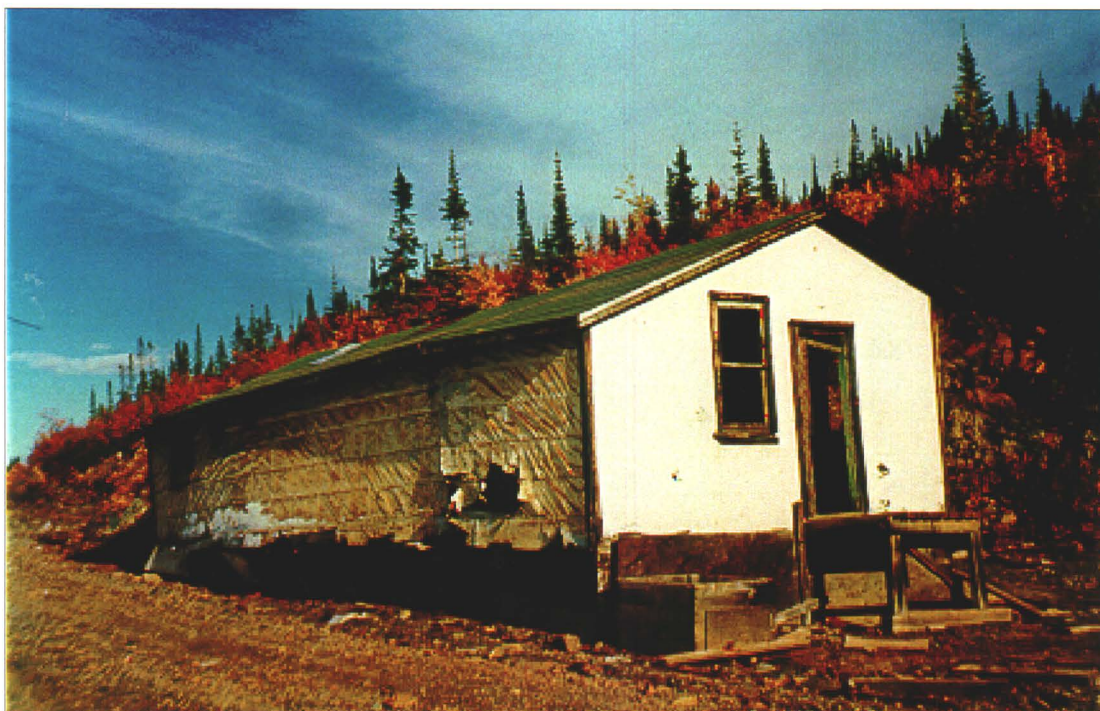
Building 76A – Office/Workshop (photo 76-3)

Office and workshop combined. Flooring is dirt on the lower level that has sustained some staining due to the nature of operations. Fibreglass insulation was used in the office area.

Samples: No samples were taken at building 76A. The tile flooring in the building was similar in nature to the tiles found at the Dixie Mine in Building 4A. Analyses completed on the sample indicated that there was some asbestos fiber in the sample, however, it tested between 1-10% indicating that there is very little asbestos in the tiles.

Photo 76-3: Timber frame structure to the northeast of the adit.

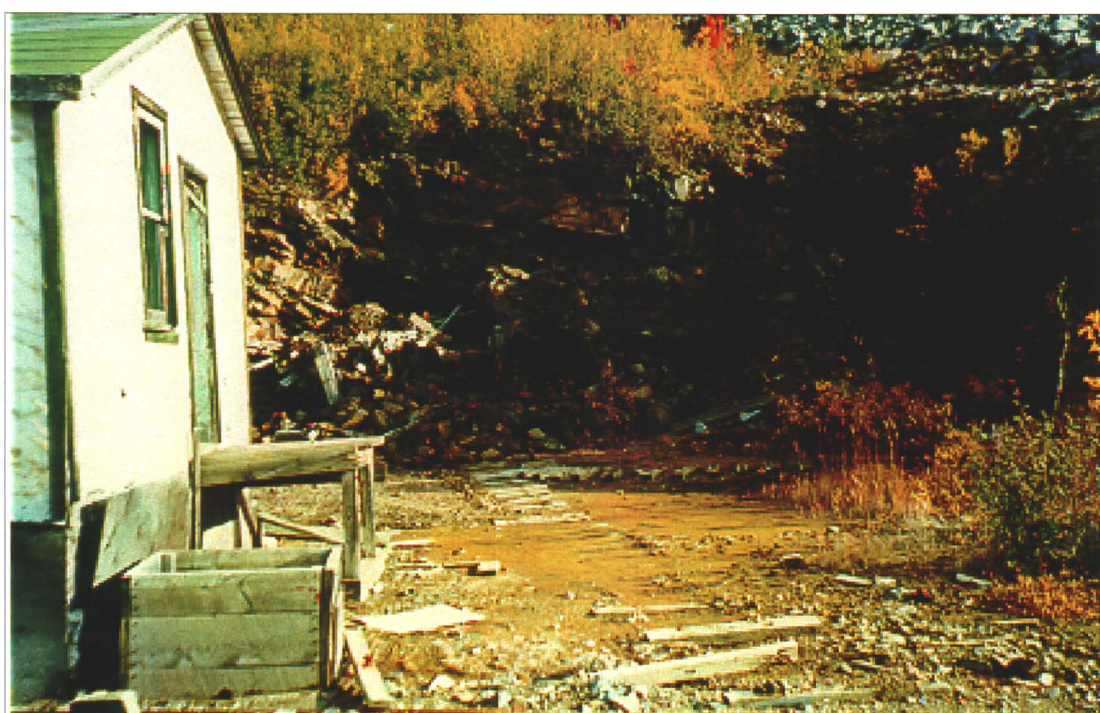
Building 76B - Adit Entrance (photo 76-4)

The portal is caved and totally blocked. There is no sign of any drainage from the adit. All rail and services appear to have been removed prior to the cave in. The estimated dimensions of the drift are 2m wide x 2.5m high. The adit is reported to be 350m in length with over 650m of crosscuts and drifts on the 500 level. The adit is inaccessible and the portal area constitutes a minor hazard of rock fall from the walls of the excavation.

The portal structure was collapsed, there is timber cribbing visible, however, the rock overhang has caved in and the structure is considered a safety hazard. No services were noted at the portal. There was no drainage evident from the structure. No samples were taken at building 76B.

Photo 76-4: Tcollapsed adit in the background.

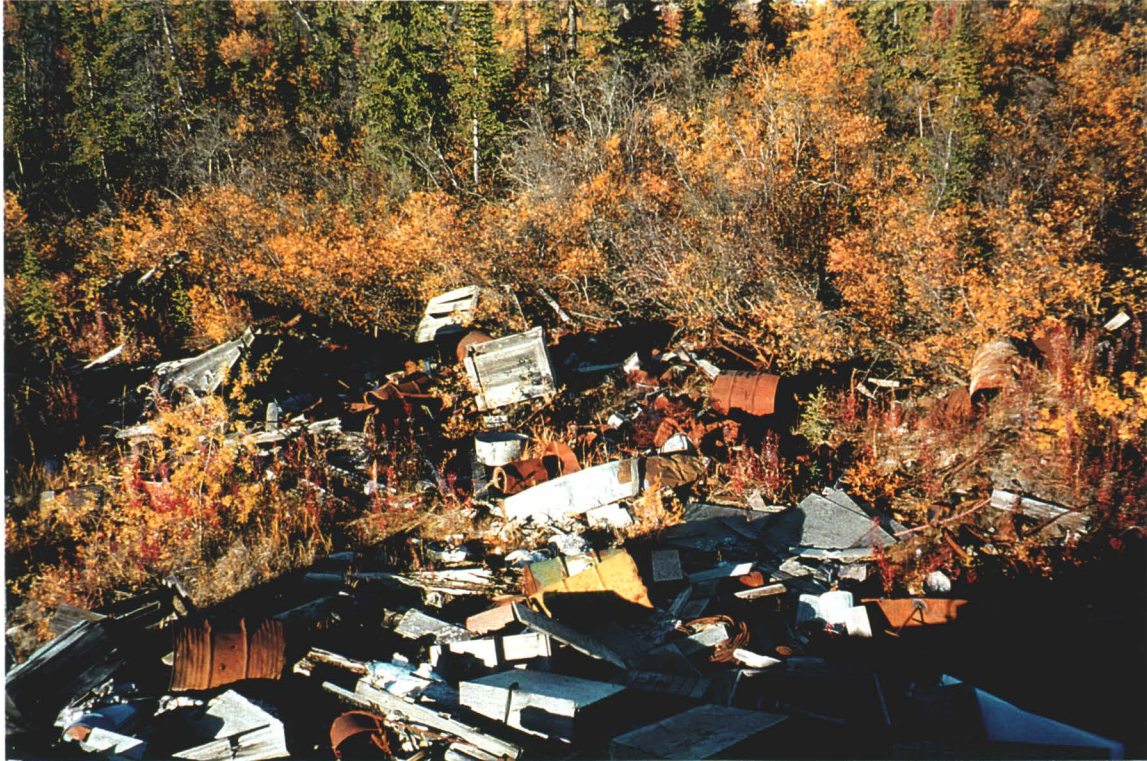
There is a landfill (~60 m x 25 m x 4 m) situated approximately 150 meters west of the Townsite site (photo 76-5). The landfill reportedly contains metal debris (rails, bed frames, pipe & discarded machinery), empty drums and lumber capped with mine waste rock. This site was used by the Calumet town and nearby mines as their garbage dump (Personal Communication - M. Phillips) and may contain other unidentified wastes. There is no sign of any appreciable drainage through the dump. There is no sign of any vegetation stress around the toe of the landfill and the surface of the landfill is revegetating. No sampling was conducted.

Photo 76-5: Photo taken 150m below the Townsite mine waste dump of the solid waste dump.
