ELSA VILLAGE

SITE #78

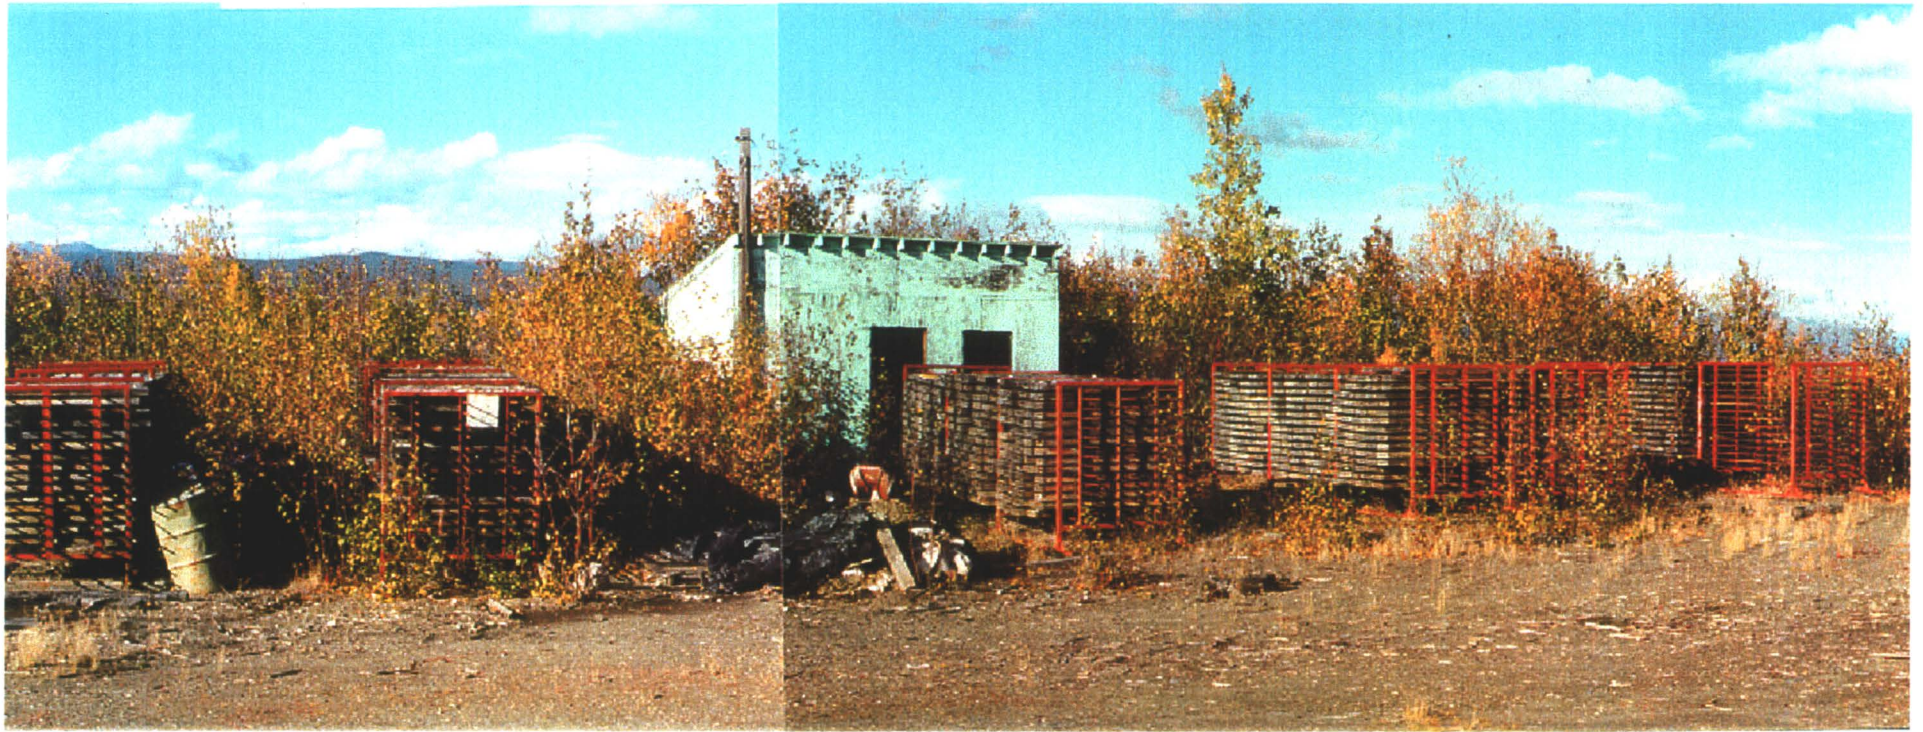
Photo 78-1 : Elsa. Core racks in the sawmill area, with Building #1 (Green shack) in background. Drums with fuel are stored between the core racks to the left of the Green shack area. (Azimuth 360°)

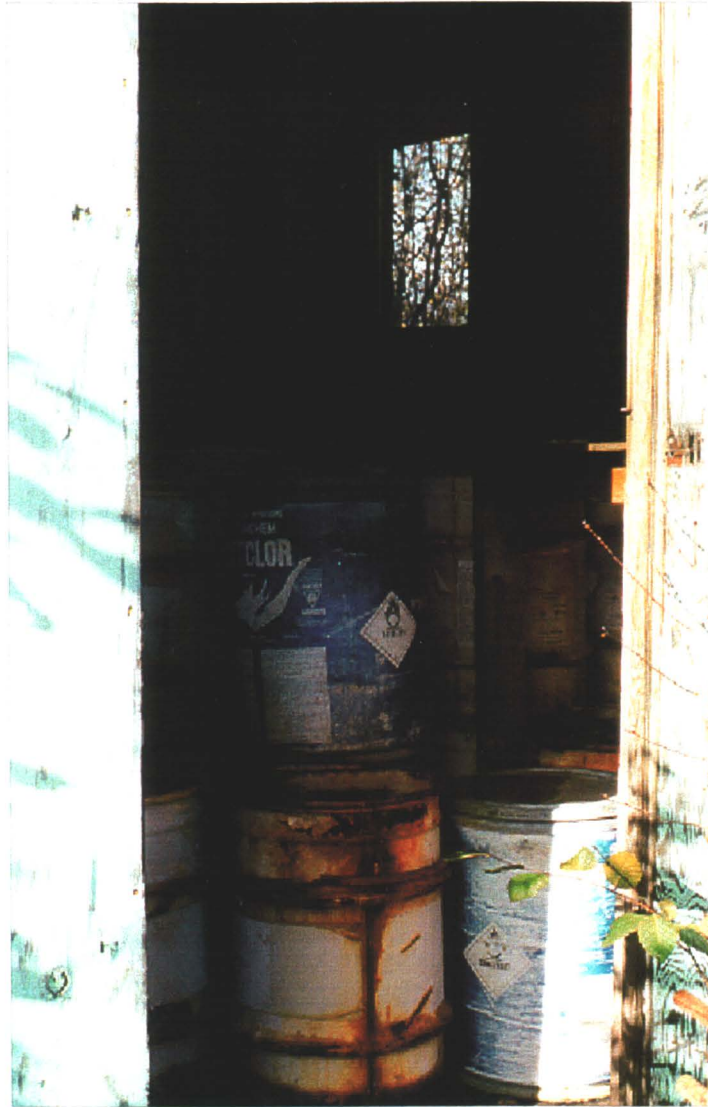
Hazardous Contents: The building currently stores more than 140 45kg pails of calcium hypochlorite.

Photo 78-2 : Elsa. Building #1 is being used to store pails of calcium hypochlorite. (Azimuth 360°)

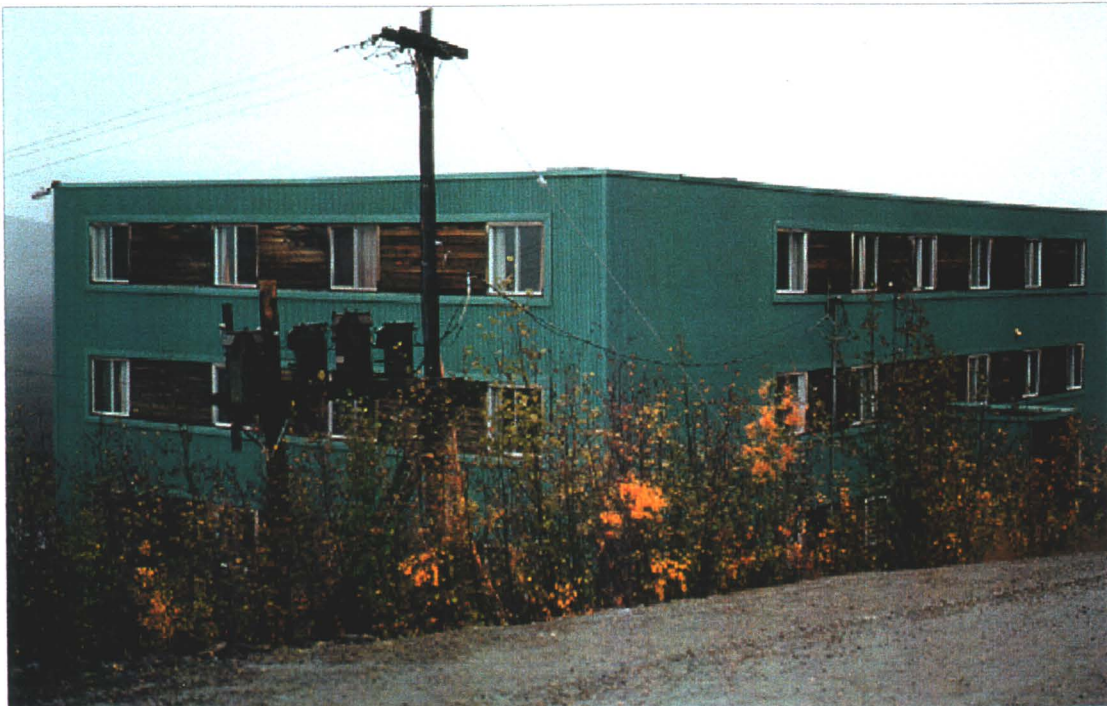
Two transformers were found across the road from the new bunkhouse. The first transformer (serial number 213260) weighs 140.6 kg (310 lbs) and contains 38.6 l (8.5 gals) of oil; the second transformer (serial number 15-219), weighs 225.4 kg (497 lbs) and contains 52 l (11.5 gals) of oil.

Photo 78-5 : Elsa. Building #7 is one of the newer bunkhouses. Note transformers in the foreground. (Azimuth 010°)

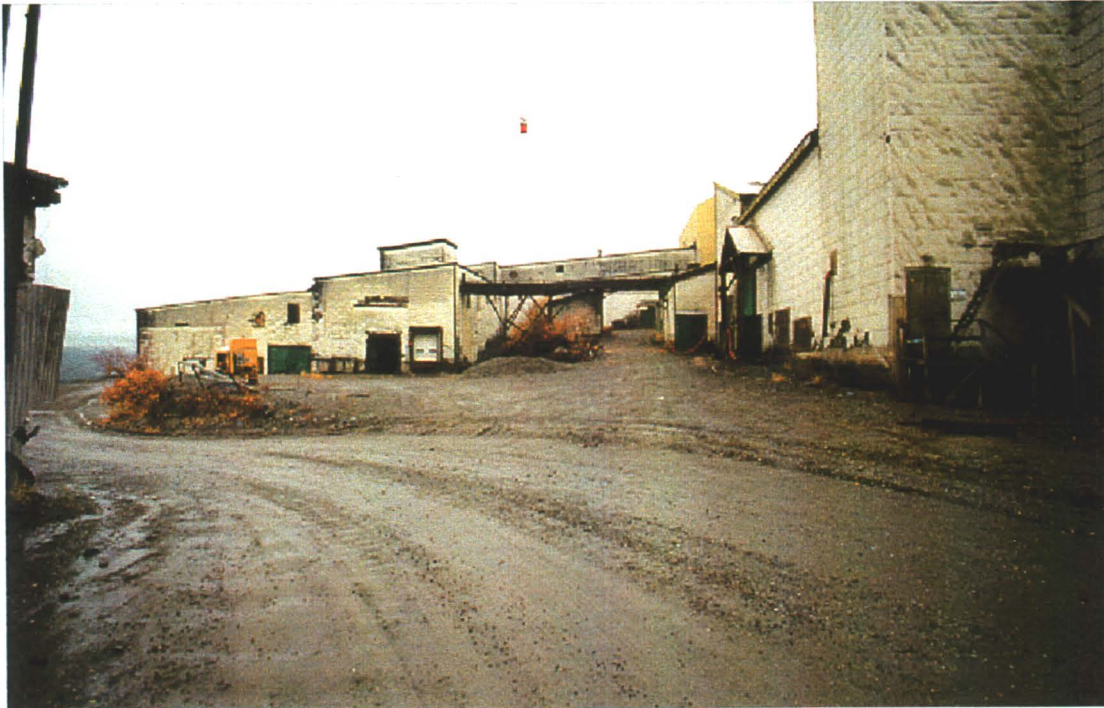
The crusher house/floatation mill building is located near the village centre. The northern half of the mill is 3 stories high and features post and beam construction on a concrete wall and floor foundation. There are 3 bay doors on the west side, 2 of which were open. The interior and exterior of the mill's west side appeared structurally sound.

Hazardous Contents: Inside one of the open bays on the west side were four pallets of lime packed in supersacks, more than 10 pallets of sodium sulphide and more than 10 drums of cresylic acid.

Photo 78-14 : Elsa. View of the western side of the floatation mill (Building #20).
The yellow sided part of the building is the crusherhouse.

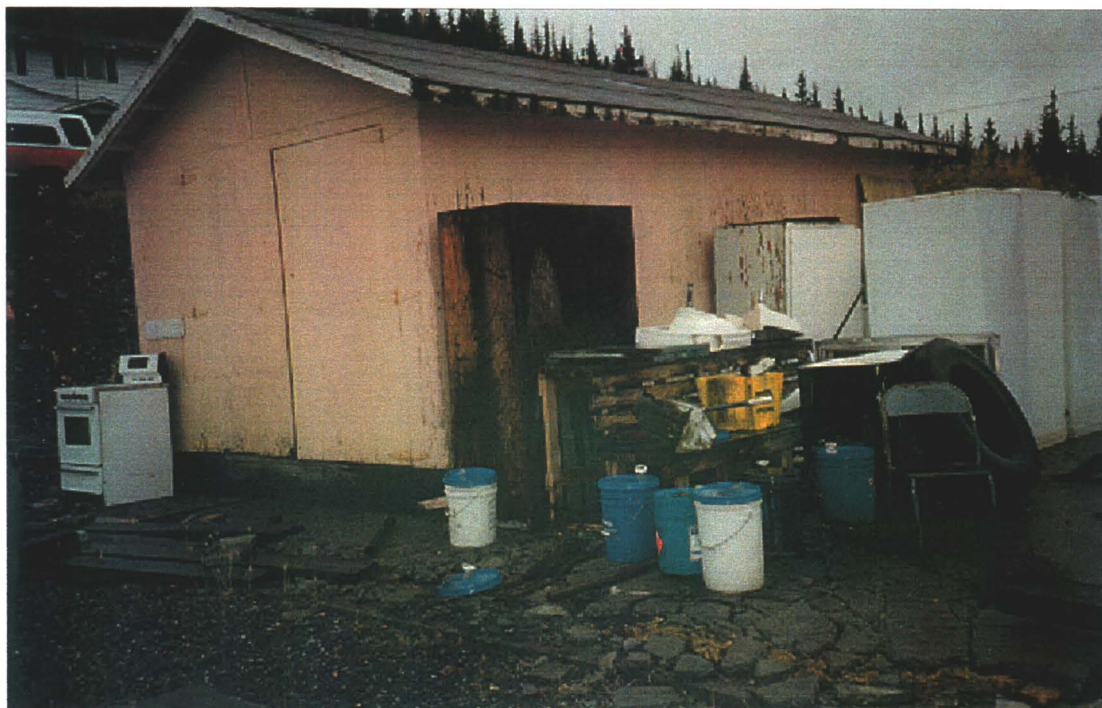
Hazardous Contents: Waste oil pails and associated spills were noted. No other hazardous contents were observed.

Photo 78-35 : Elsa. Storage shed below mine houses. Note pails full of waste oil. (Building # 52)

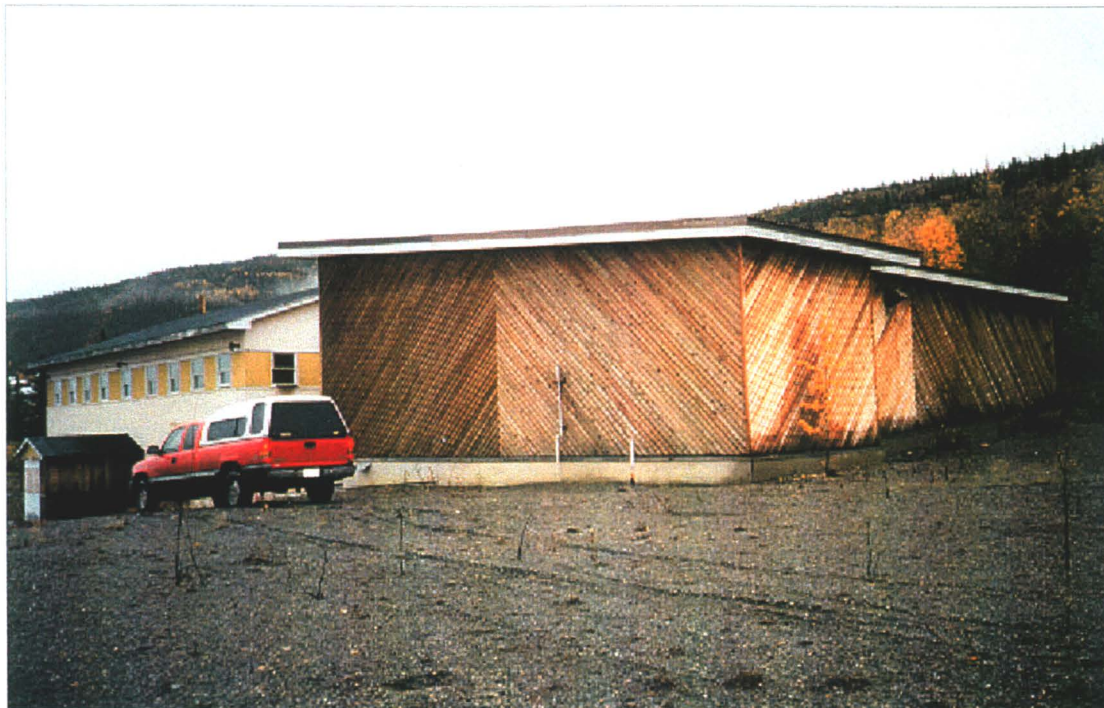
Photo 78-37 : Elsa. Elsa school. Note white probable underground fuel storage tank stand pipes at nearest corner. (Azimuth 090°)

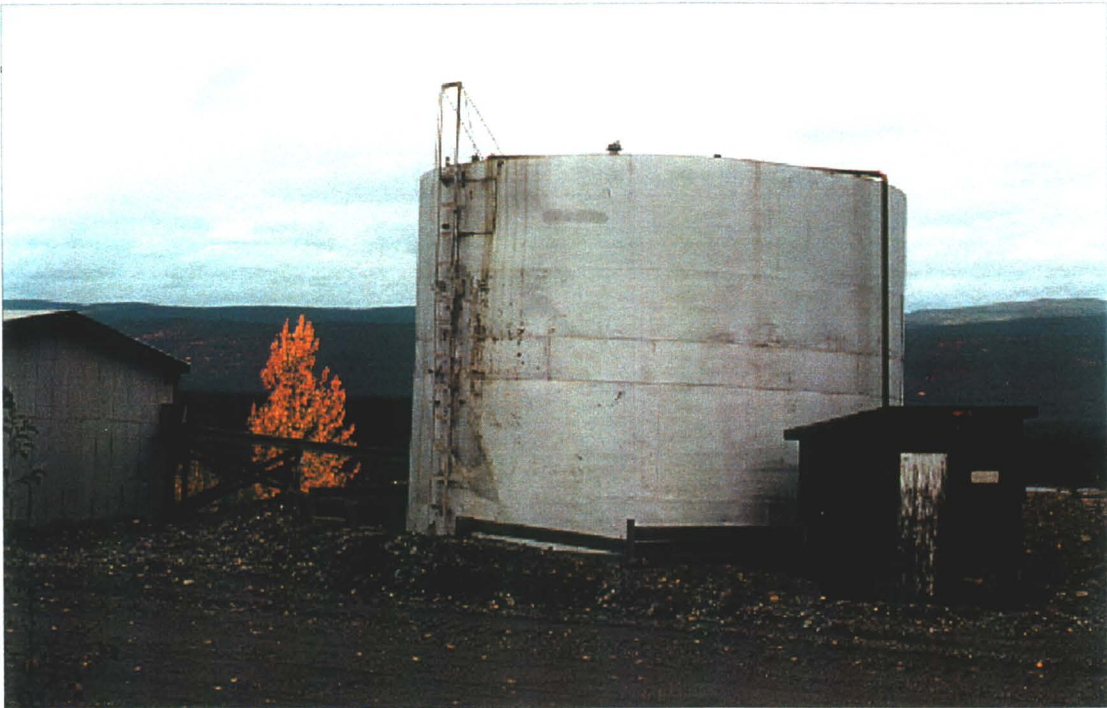
Photo 78-40 : Elsa. Fuel Storage Area #3 - an oil storage tank located beside the rescue building.
There are numerous oil stains around the tank. (Azimuth 290°)

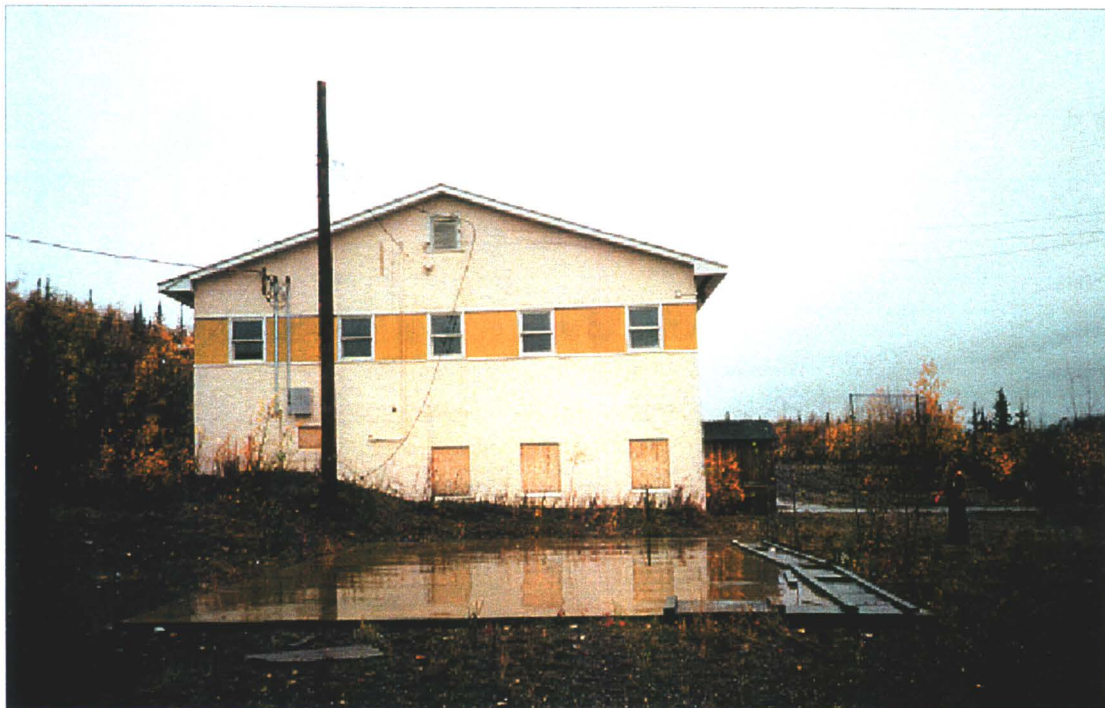
Photo 78-43 : Elsa. Elsa school. Note black underground fuel storage tank stand pipe at
right side corner. (Azimuth 210°)

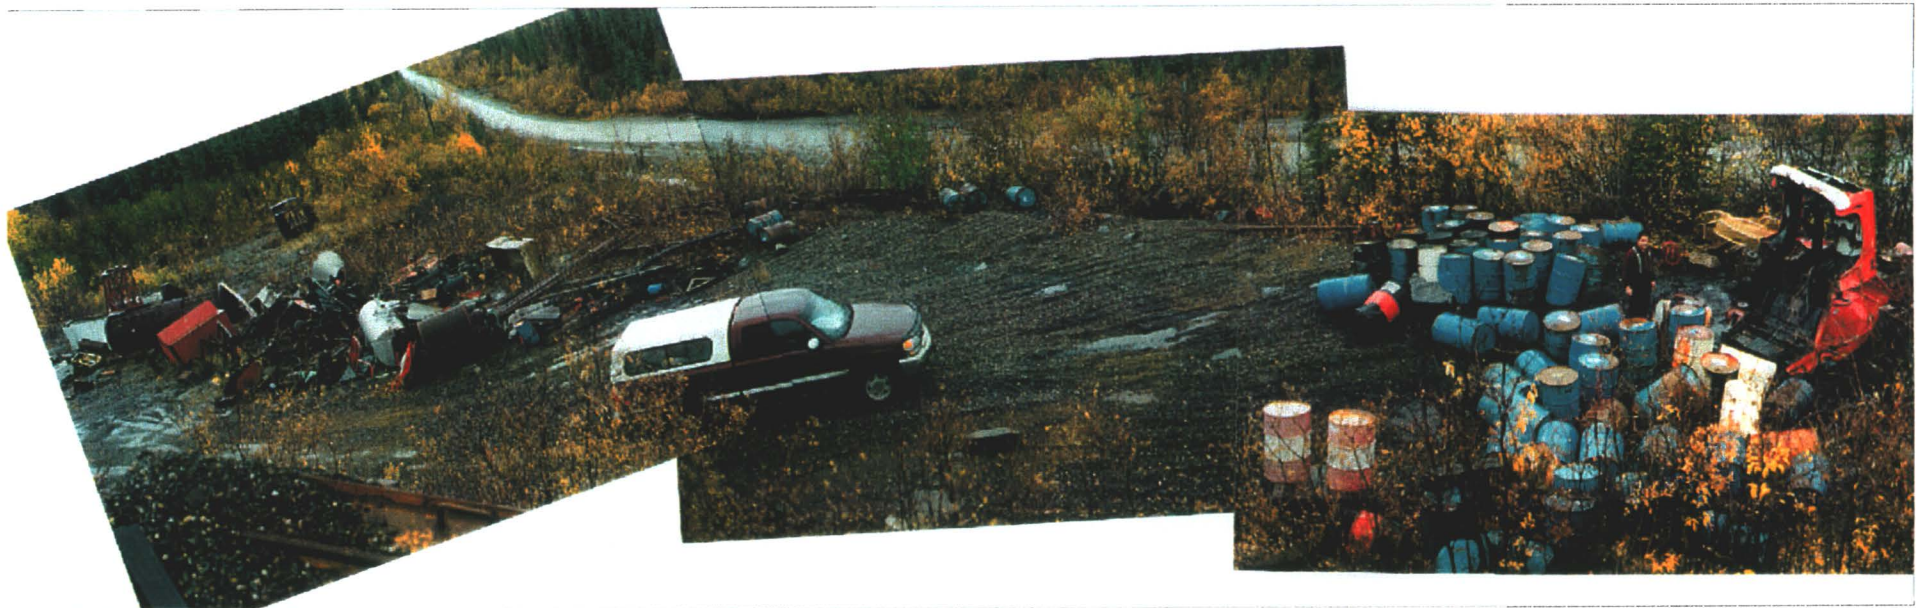
Photo 78-45 : Elsa. Waste Fuel Storage Area #1 is on the right and the Solid Waste Dump Area #6 is on the left. The gravel area in front of the truck is saturated with oil. Hwy #2 is in the background. (Azimuth 290°)

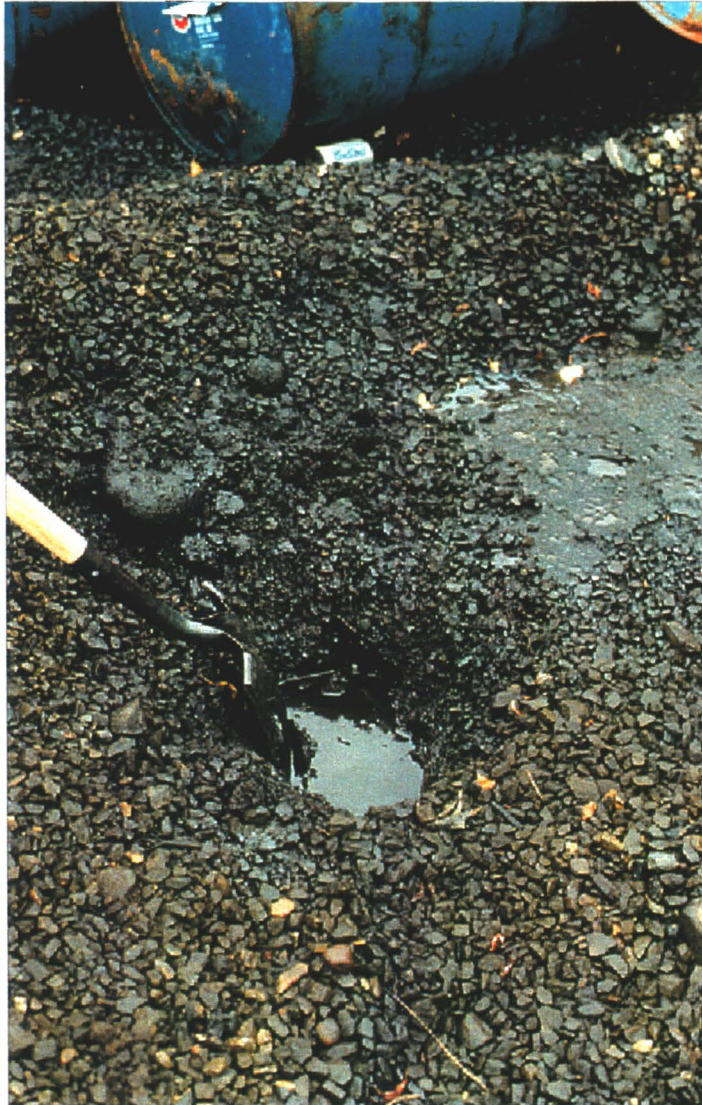
Photo 78-46 : Elsa. At Waste Fuel Storage Area #1 a small test pit revealed that the gravel was saturated with oil to at least 40cm. (Azimuth 350°)

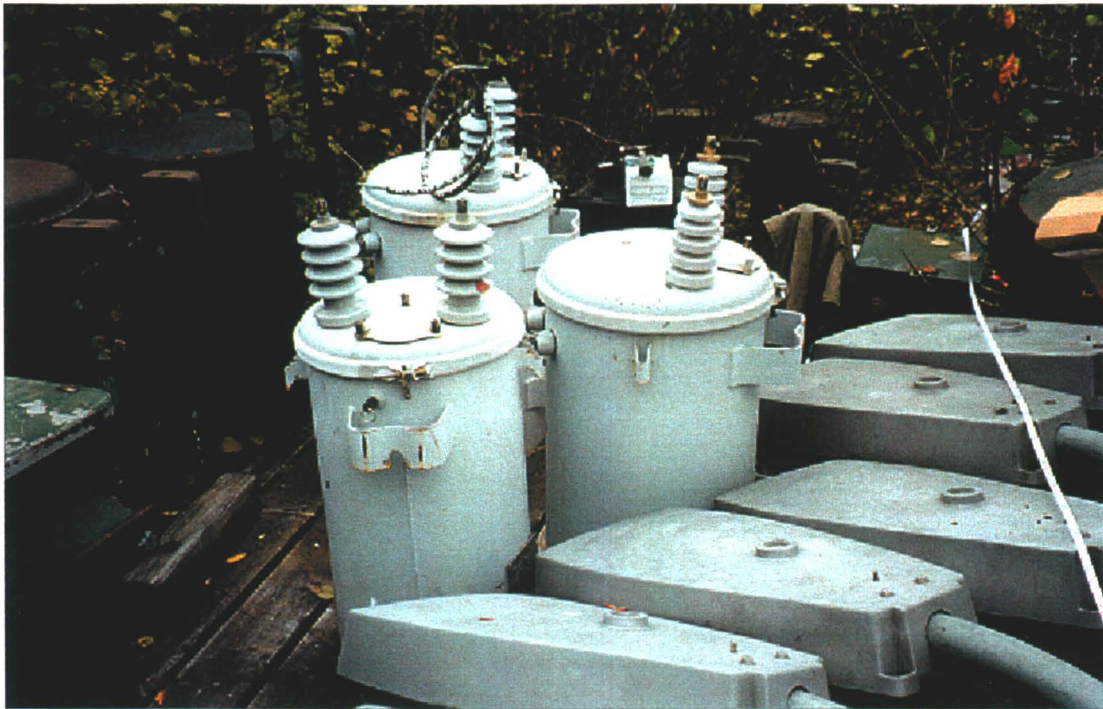
Photo 78-47 : Elsa. Electrical Equipment Area #1 : transformers near Carpentry Building (Building #5).

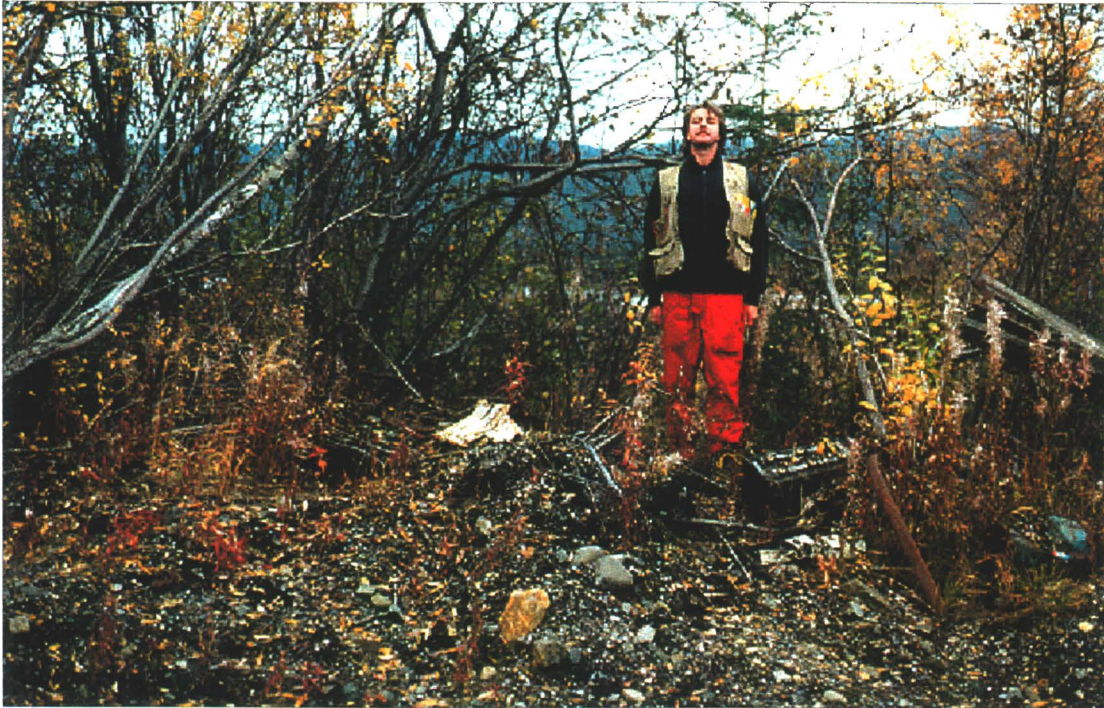
Photo 78-53 : Elsa. Solid Waste Dump Area #2 : Battery pile. (Azimuth 260°)

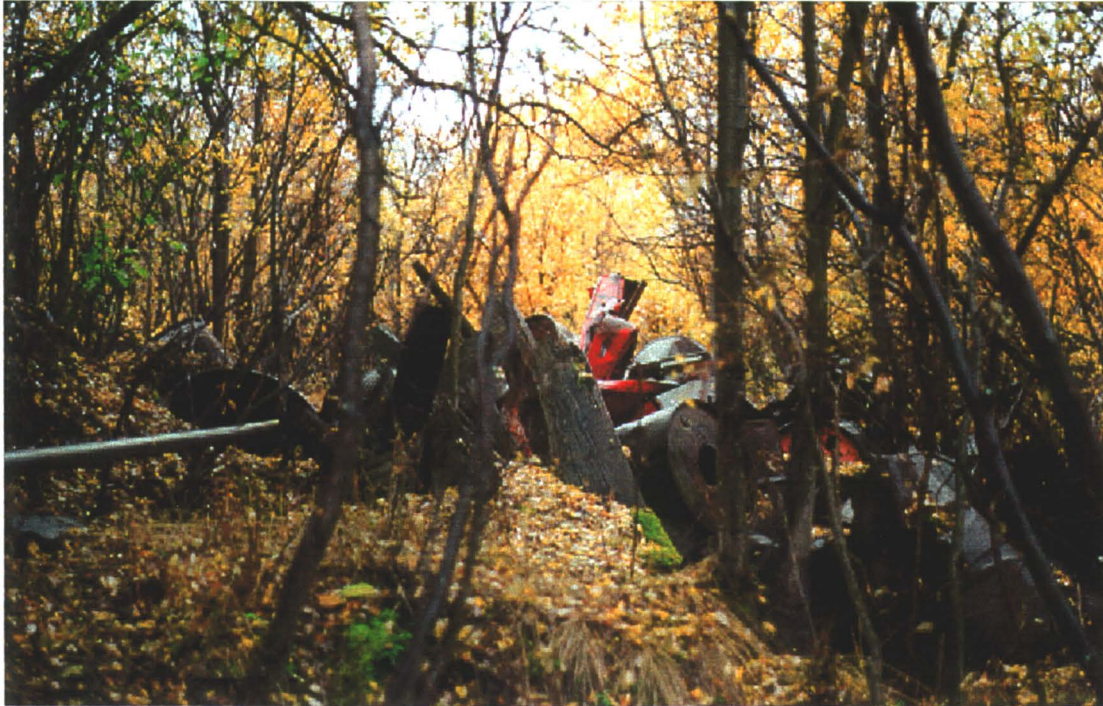
Photo 78-56 : Elsa. Solid Waste Dump Area #4a. A dump containing mainly 45-gallon drums is located on the slope behind Bunkhouse #7. (Azimuth 270°)

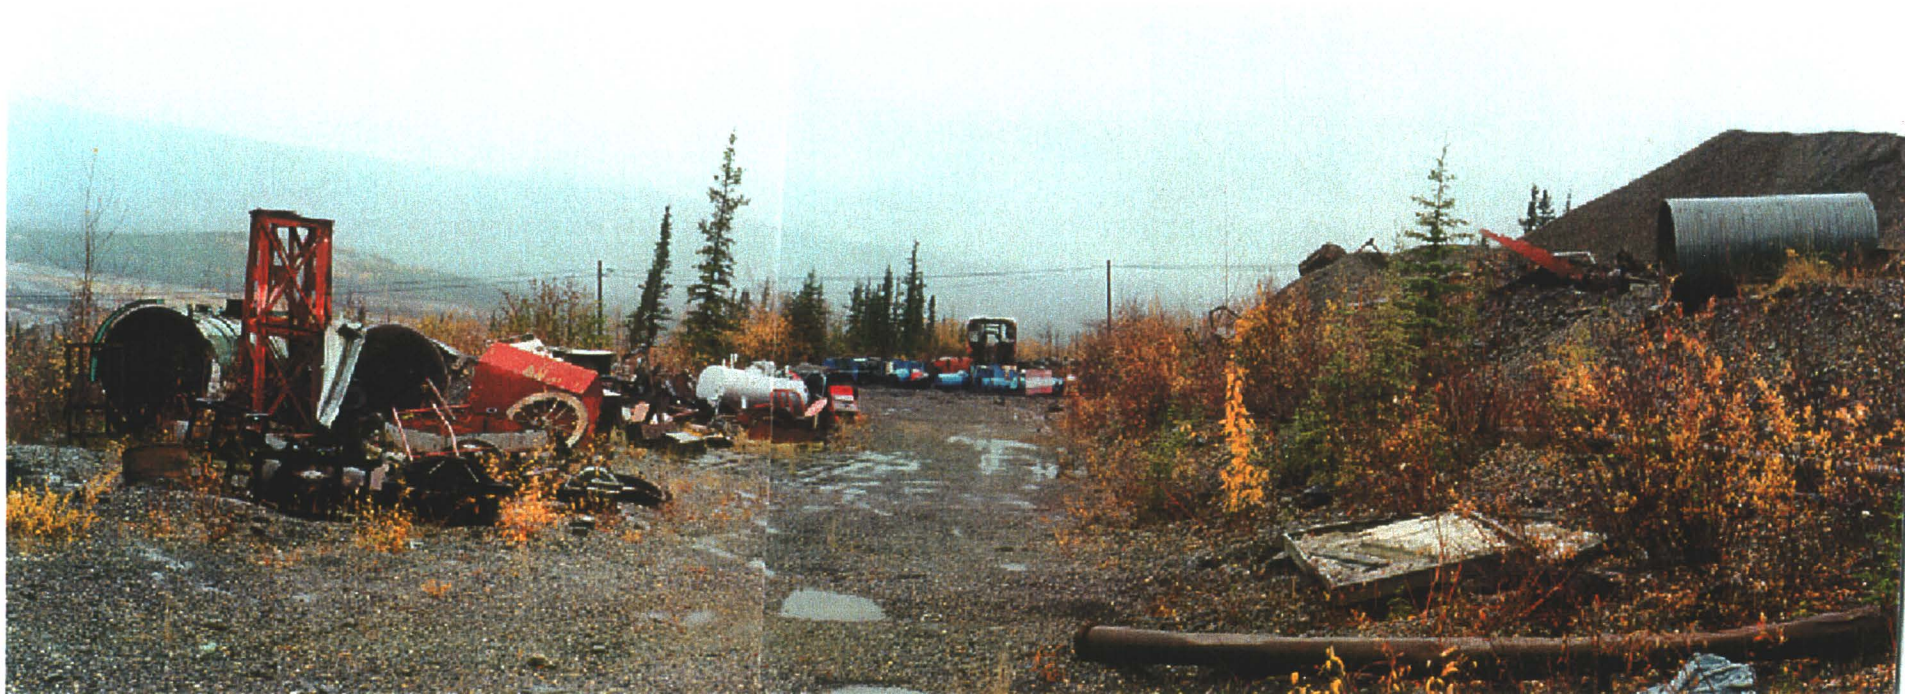
Photo 78-59 : Elsa. Solid Waste Dump Area #6. This dump is mostly scrap metal and is located just downhill of the Mill, beside Hwy #2. (Azimuth 040°)

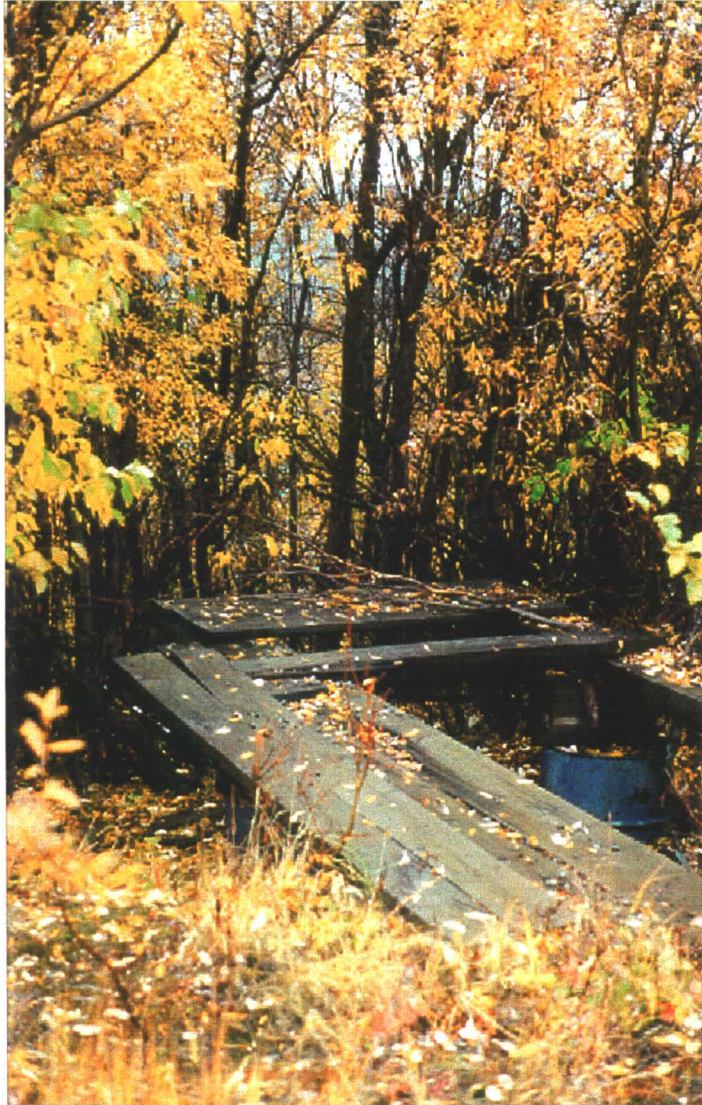
Photo 78-61 : Elsa. Waste Fuel Storage Area #3 : Oil
Change ramp. (Azimuth 340°)
