ELSA TAILINGS
SITE 79

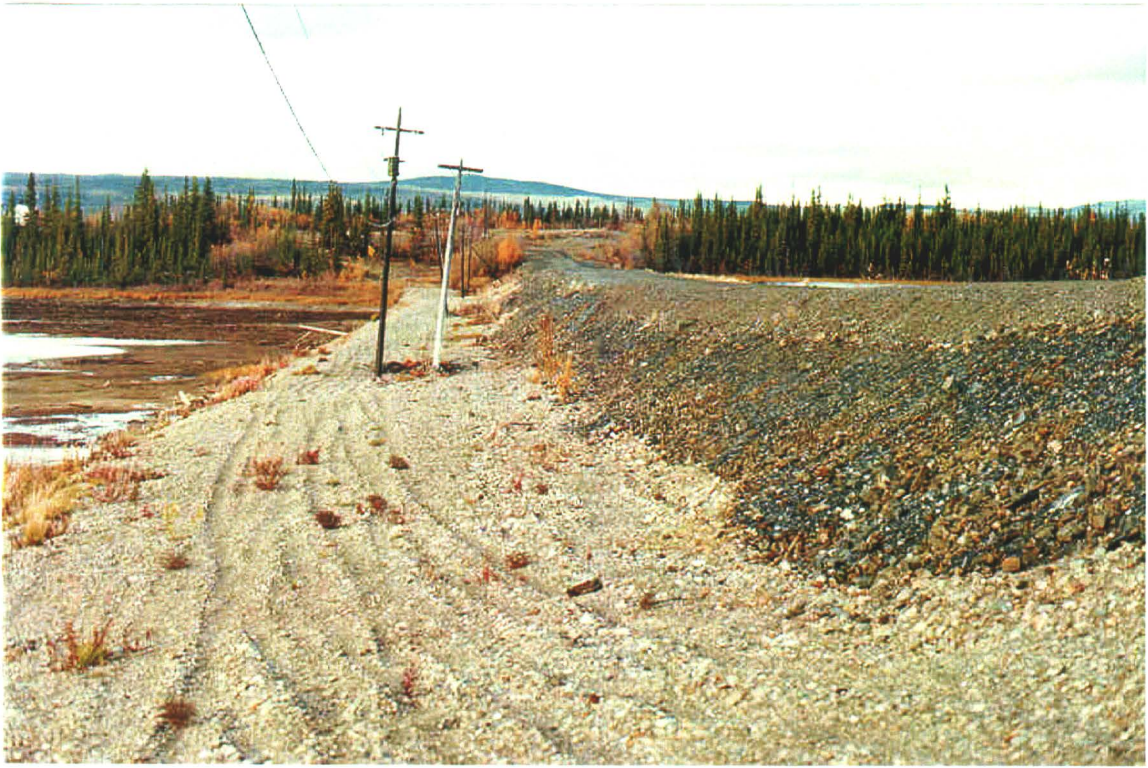
Breakthroughs: The dam was breached several times from 1962 to 1972. A toe berm was placed on the downstream side of Dam No. 1 in 1996 (Photo 79-1). The toe berm extends about halfway up the dam and is approximately 5 m wide. It is constructed of gravel underlain by a layer of synthetic mesh added to limit piping of the dam. The mesh is porous but keeps the fines from being washed away with any seepage through the dam. No evidence of erosion of Dam No. 1 or the toeberm was seen.

Photo 79-1. Toe berm (light-colored material) at the base of Dam No. 1, looking northwestward.

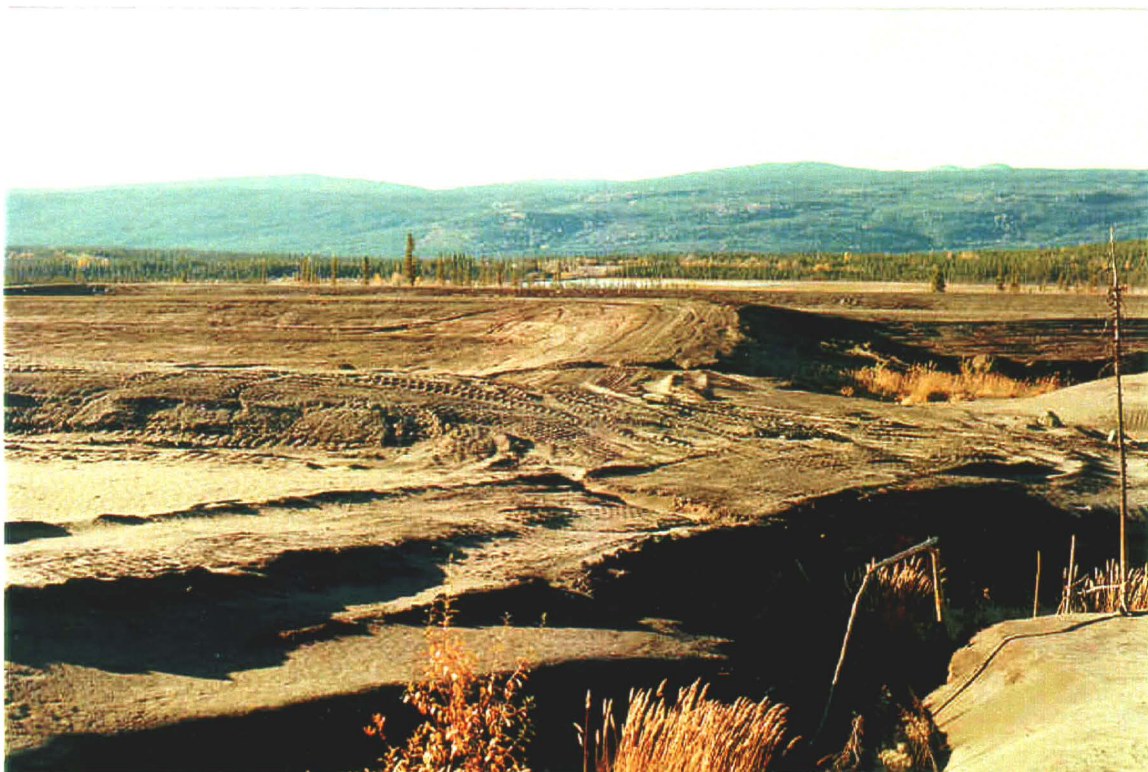
In 1996, a toe berm was placed to reinforce Dam No. 1 (Photo 79-1). Five tailings cells were also constructed behind Dam No. 1 to hold future tailings, however, these cells have not been used (Photo 79-2). During this time, work was done on the Porcupine diversion ditch, and active lime treatment of the pre-1960 tailings decant was begun.

Photo 79-2. Tailings cells for future tailings, looking northward.

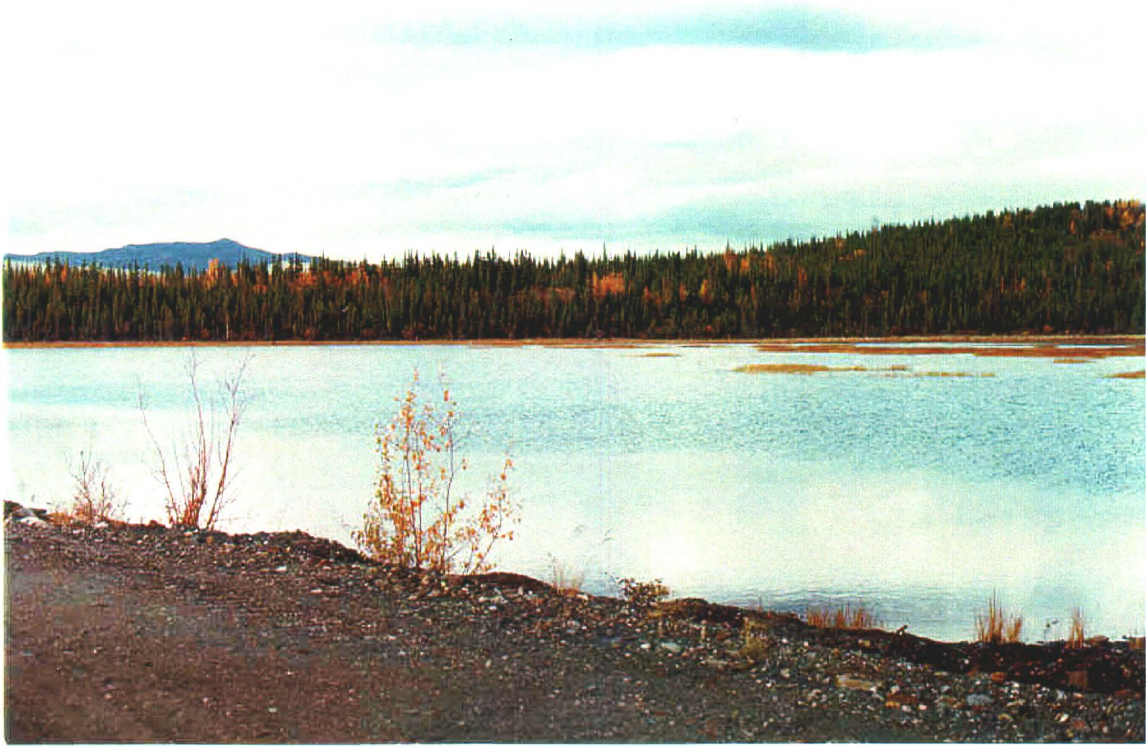
Pond area (L x W x Depth): 1150 m x 625 m x 1m. Depth of tailings varies from ~5m against the dam to ~2 m at the east edge near the valley slopes Photo 79-3.

Photo 79-3. View of tailings pond No. 1, taken from Dam No. 1.

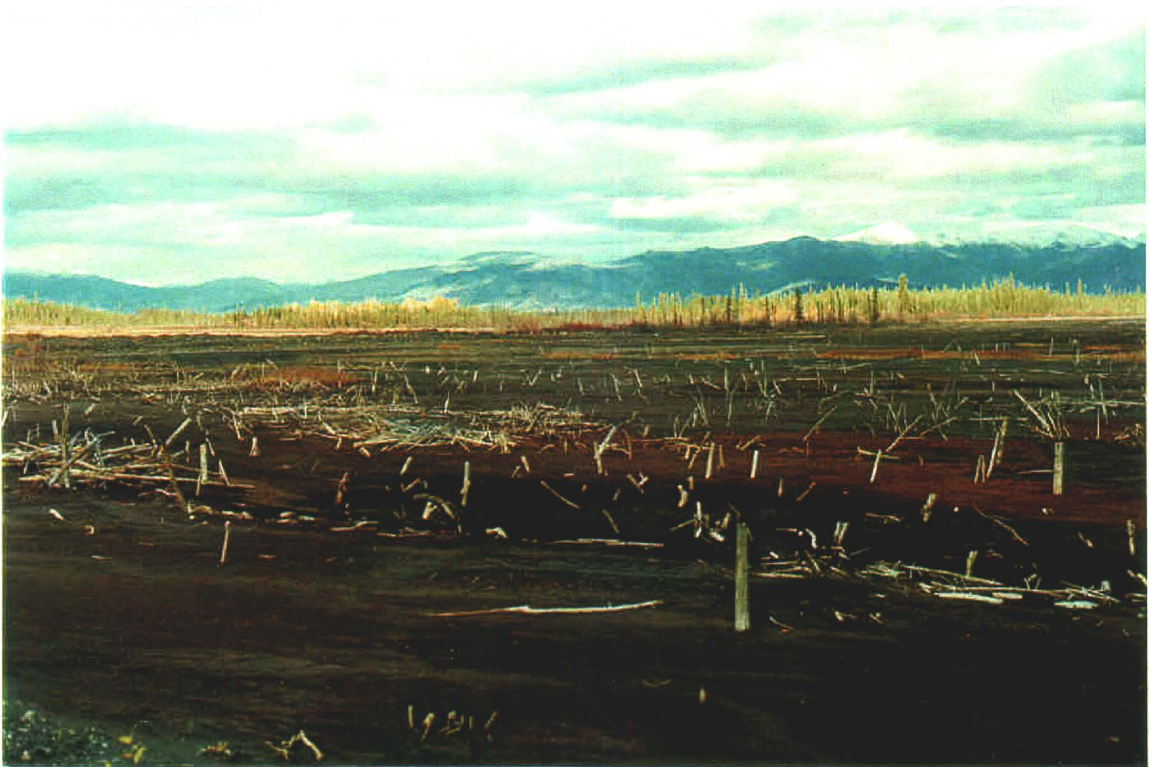
Oxidation: Most of the tailings behind Dam No. 1 are unsaturated. The surface of the tailings are dark brown (Photo 79-4). UKHM (1996) did not report iron staining in pits 1, 8, 10 and 11 but did report "orange brown sands in pit 11" at a depth of 100cm.

Photo 79-4. Exposed tailings behind Dam No. 1.

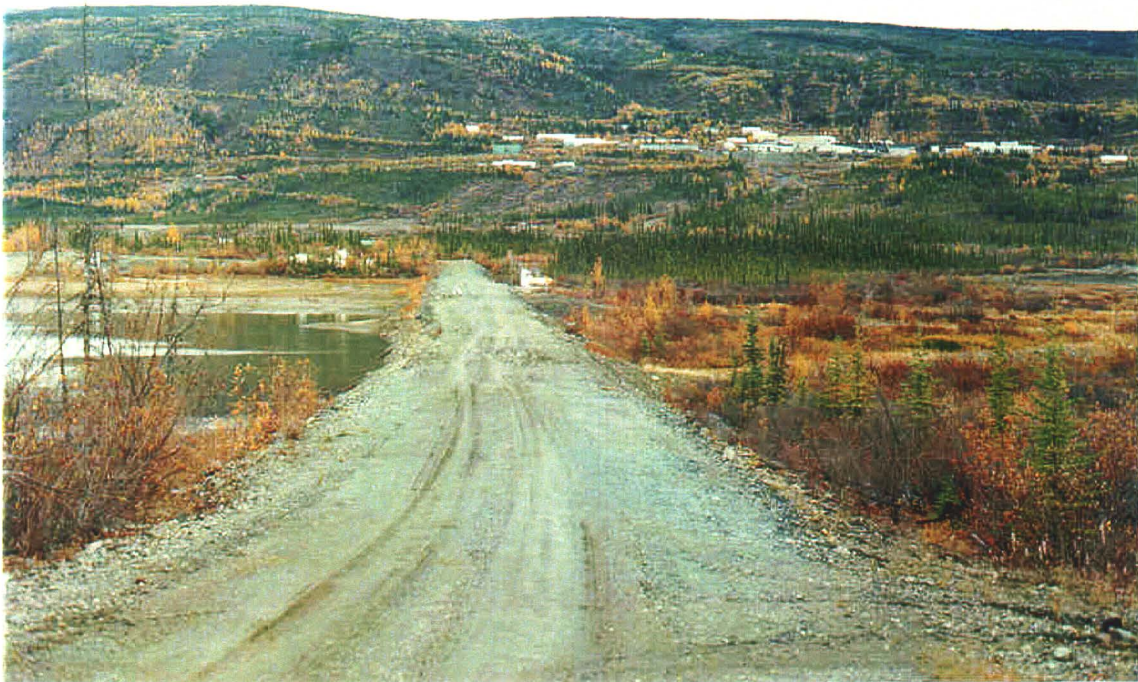
Photo 79-5. Tailings Dam No. 2, looking southeastward. The lime treatment plant can be seen at the far end of the dam. The Elsa townsite is in background on the hill.

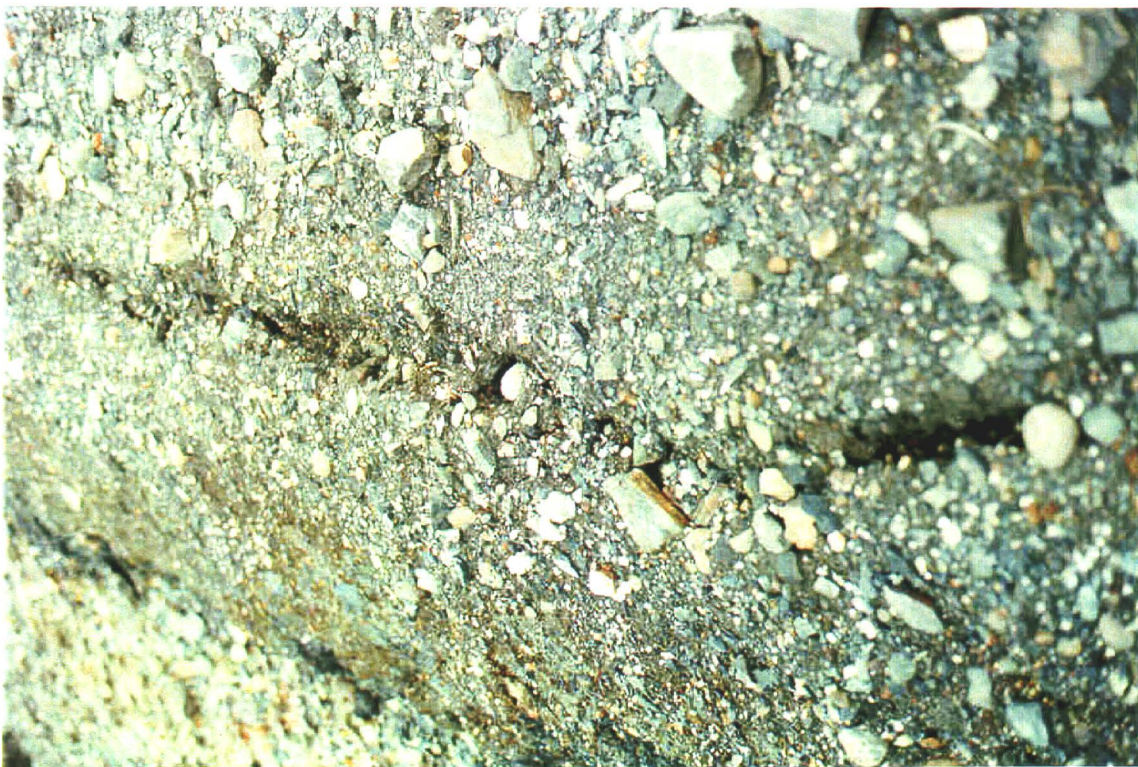
Some tension cracks were seen in the dam (Photo 79-6). Ponding immediately below the dam has abundant red iron oxide precipitate (Photo 79-7). Grasses are growing in this ponded water.

Photo 79-6. Tension cracks in tailings Dam No. 2.

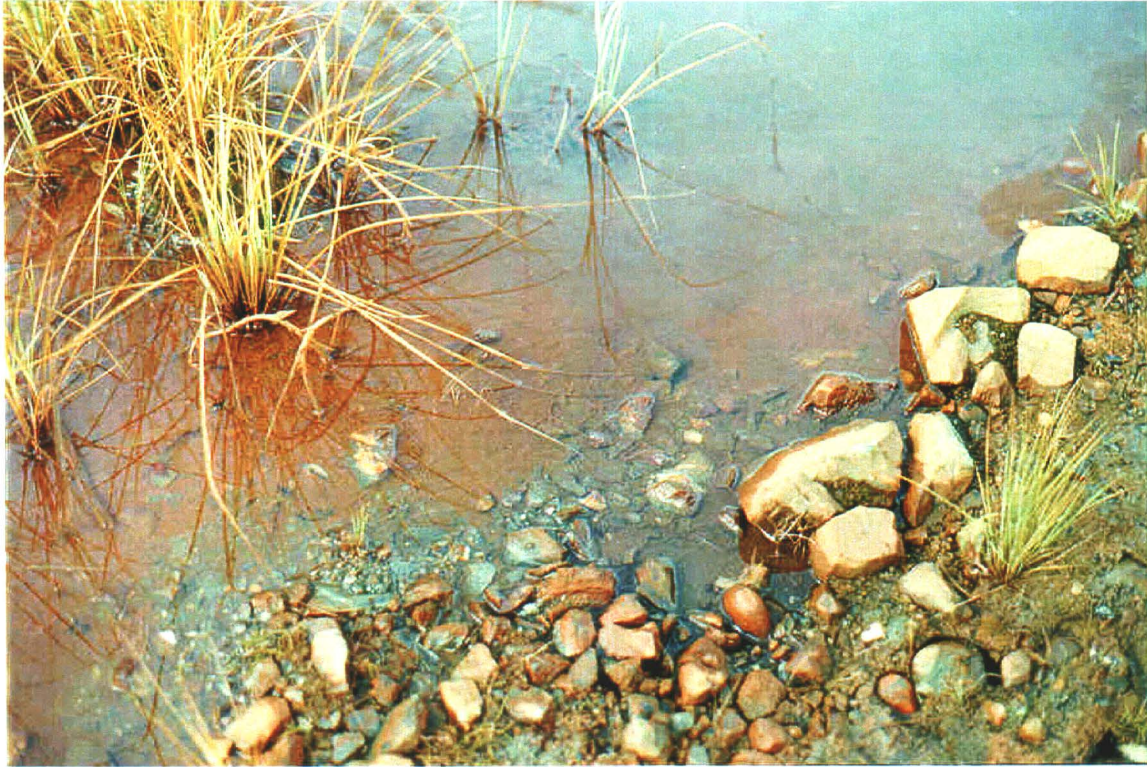
Photo 79-7. Ponded water below Dam No. 2. Note red iron-oxide precipitate in water.

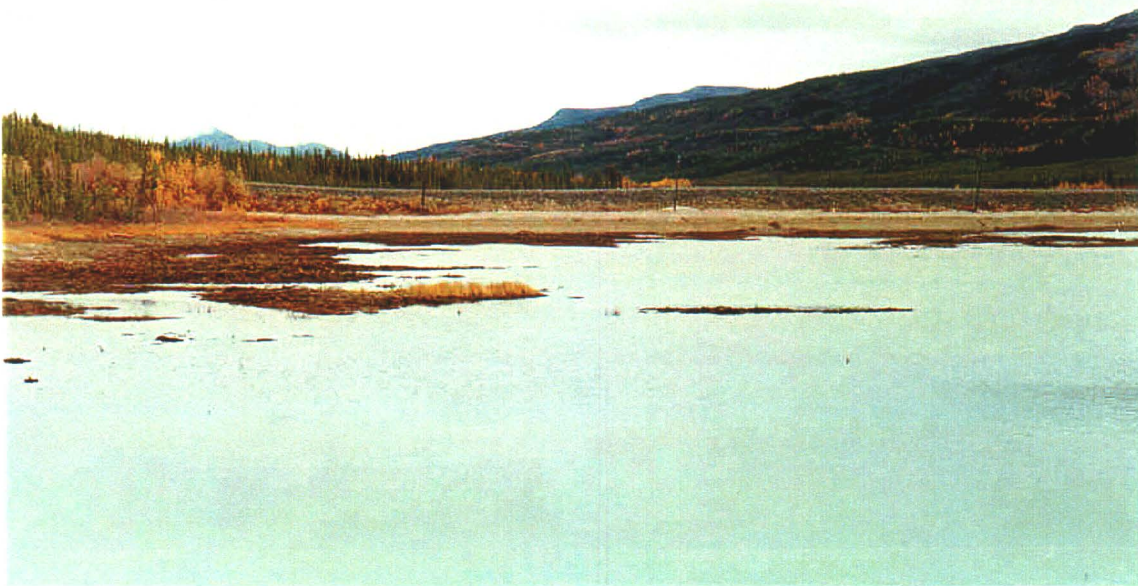
Oxidation: All of the tailings behind Dam No. 2 are saturated (Photo 79-8). UKHM (1996) reported no evidence of oxidation in this material.

Photo 79-8. Tailings pond No. 2, taken looking eastward from Dam No. 2.

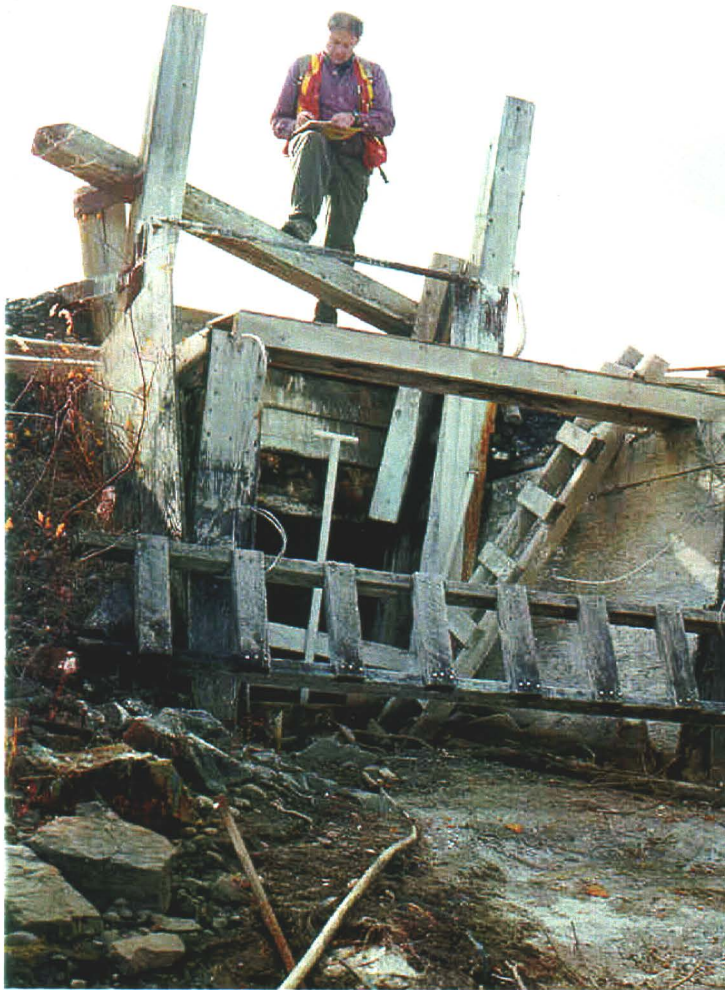
Decant structures and piping: The decant structure is shown in Photos 79-9 (upstream) and 79-10 (downstream). The decant structure is constructed of wood and measures approximately 2.5 m high by 2 m wide. The decant is in poor condition.

Photo 79-9. Decant in Dam No. 2, upstream side.

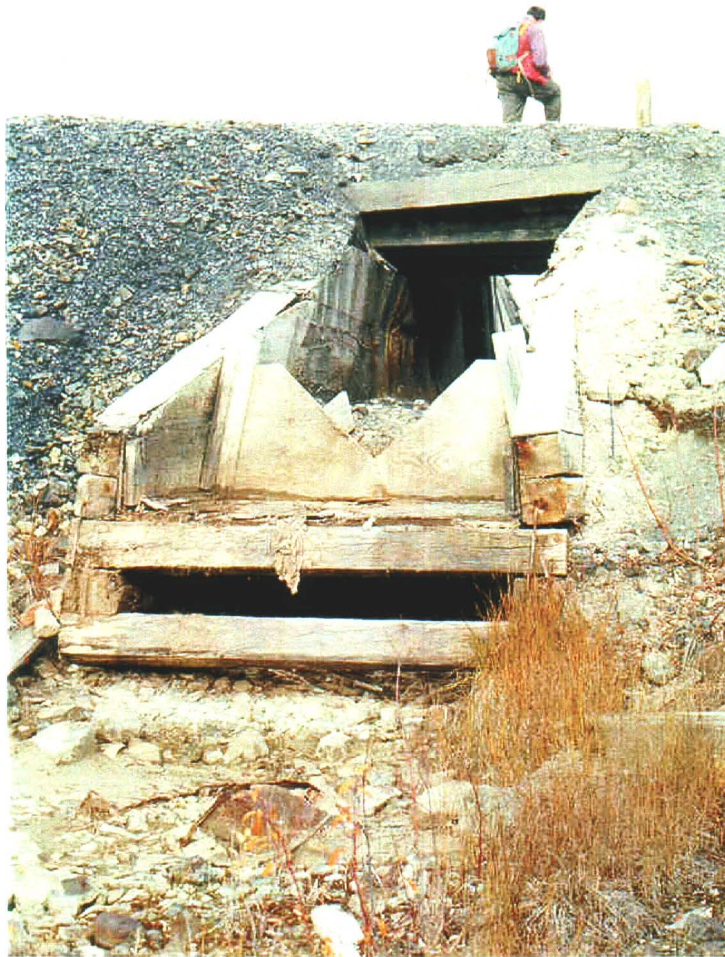
Photo 79-10. Decant in Dam No. 2, downstream side. Note lime precipitate around decant.

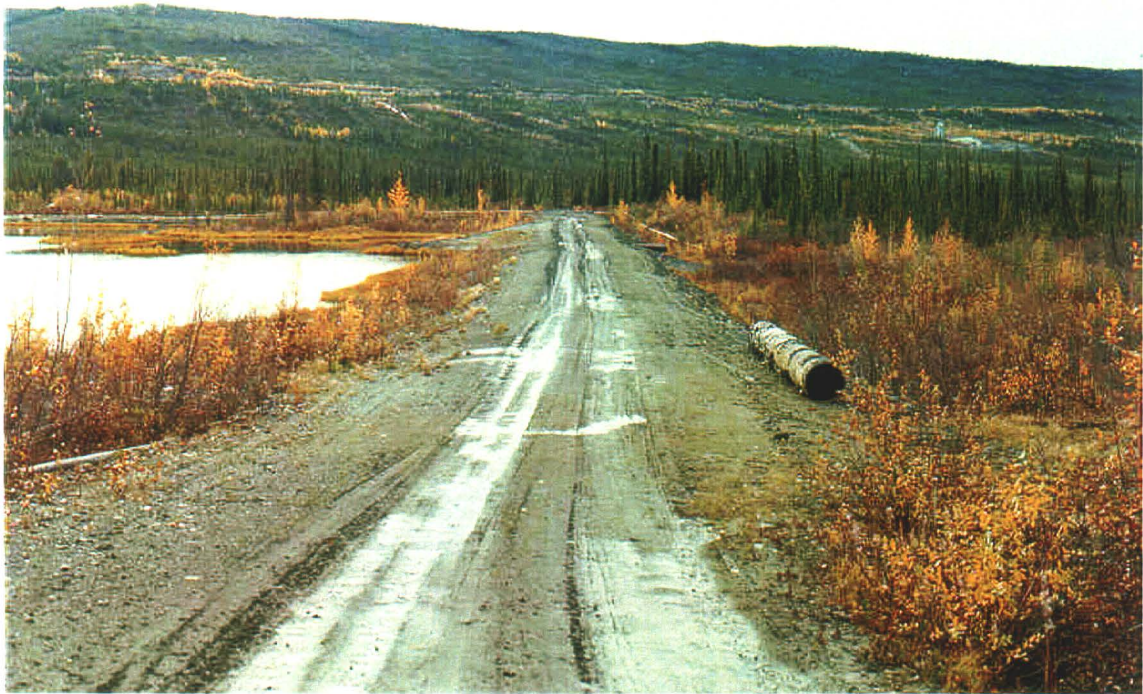
Photo 79-11. Tailings Dam No. 3, looking south.

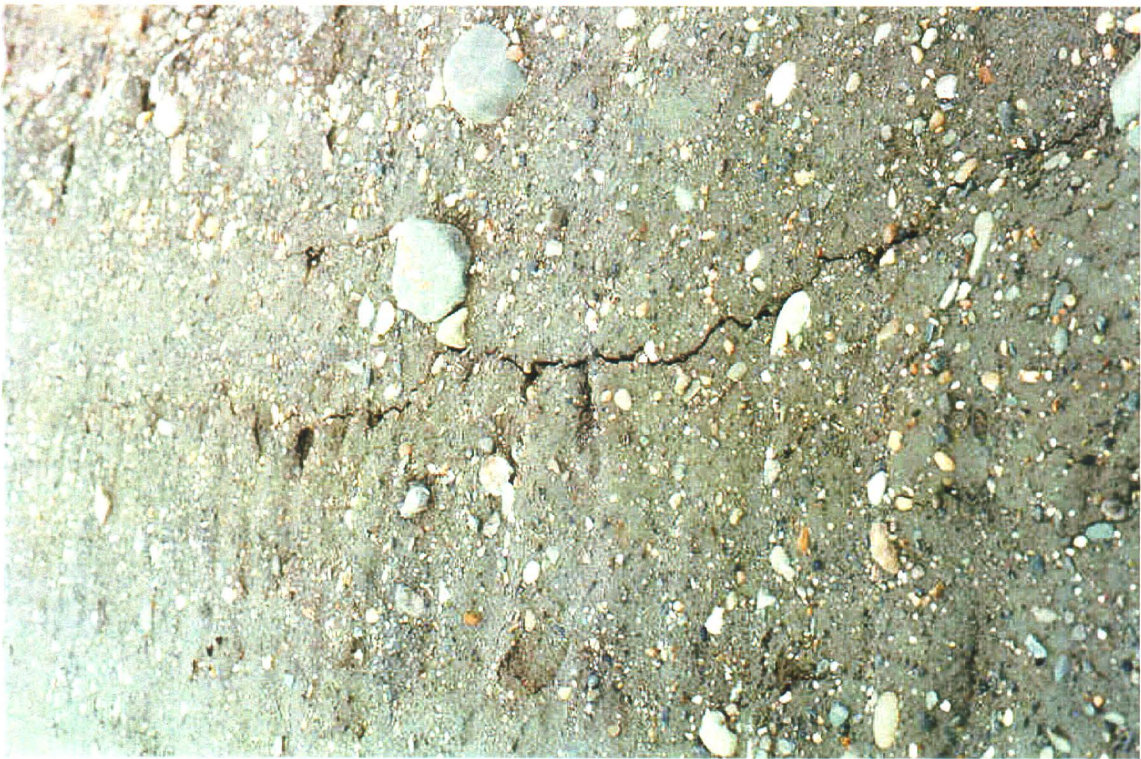
Surface composition: Gravel and glacial till. Some tension cracks were seen in the dam (Photo 79-12). Tension cracks can also be seen on areas of the dam. There is some iron oxidation at a depth of about 10 cm in the gravel that composes the dam.

Photo 79-12. Tension cracks in Dam No. 3.

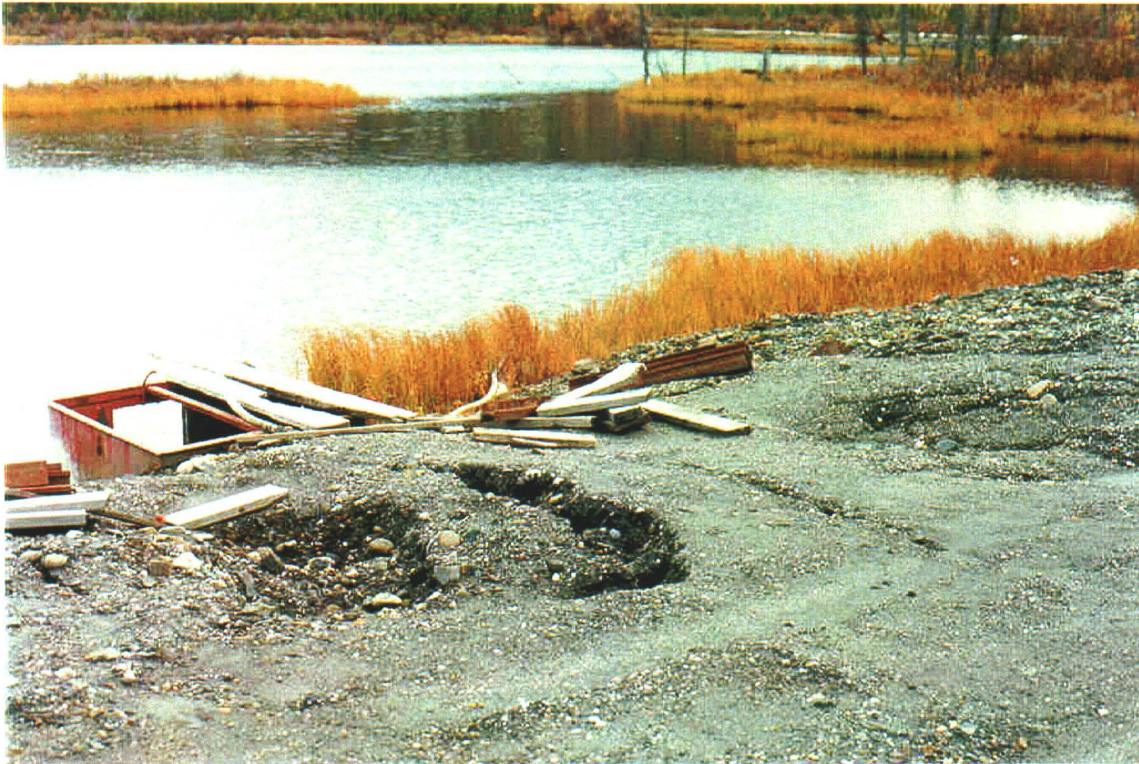
Decant structures and piping: The decant structure is composed of a wooden v-notch weir on the upstream side (Photo 79-13) and a metal pipe on the downstream side (Photo 79-14). Some subsidence can be seen around the weir in Photo 79-13. The decant is in fair condition. There is an emergency overflow ~ 50 m south of the decant structure, this consists of an open 1.2m diameter corrugated, galvanized pipe whose invert is ~0.3 m above the water level.

Photo 79-13. Wooden decant and v-notch weir in Dam No. 3. Note subsidence around decant.

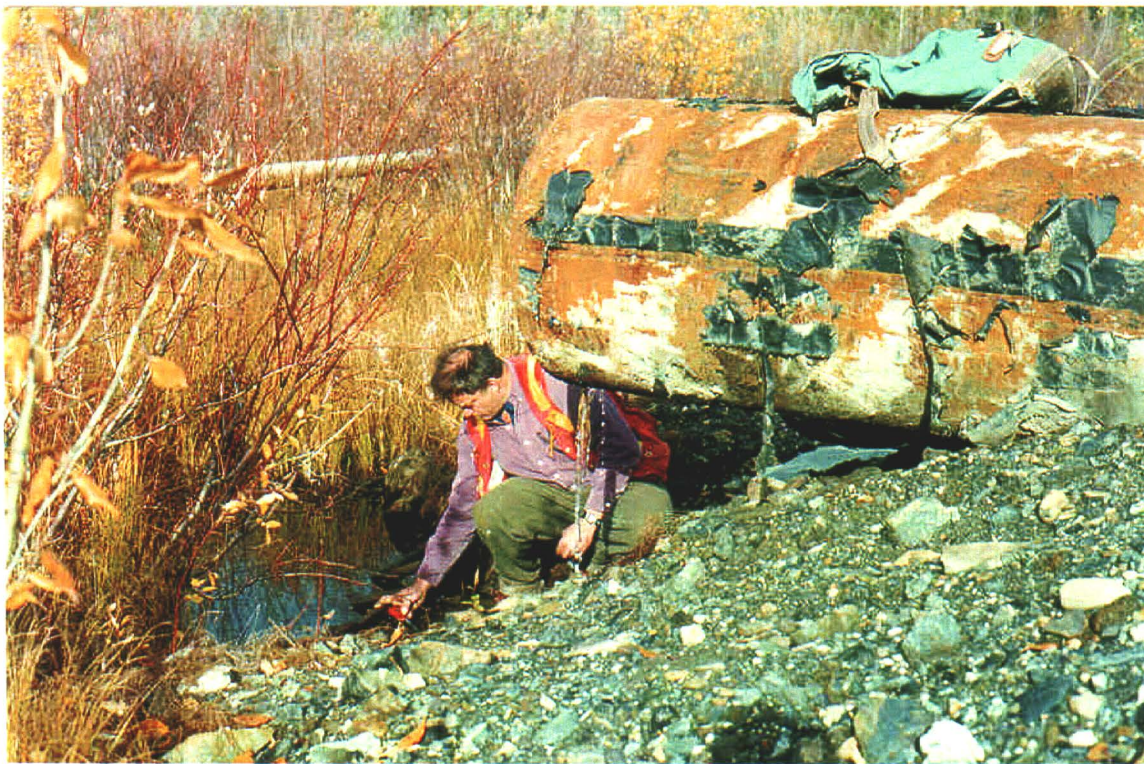
Photo 79-14. Pipe on downstream side of decant on Dam No. 3. This is also sampling site 79-WQ-02.

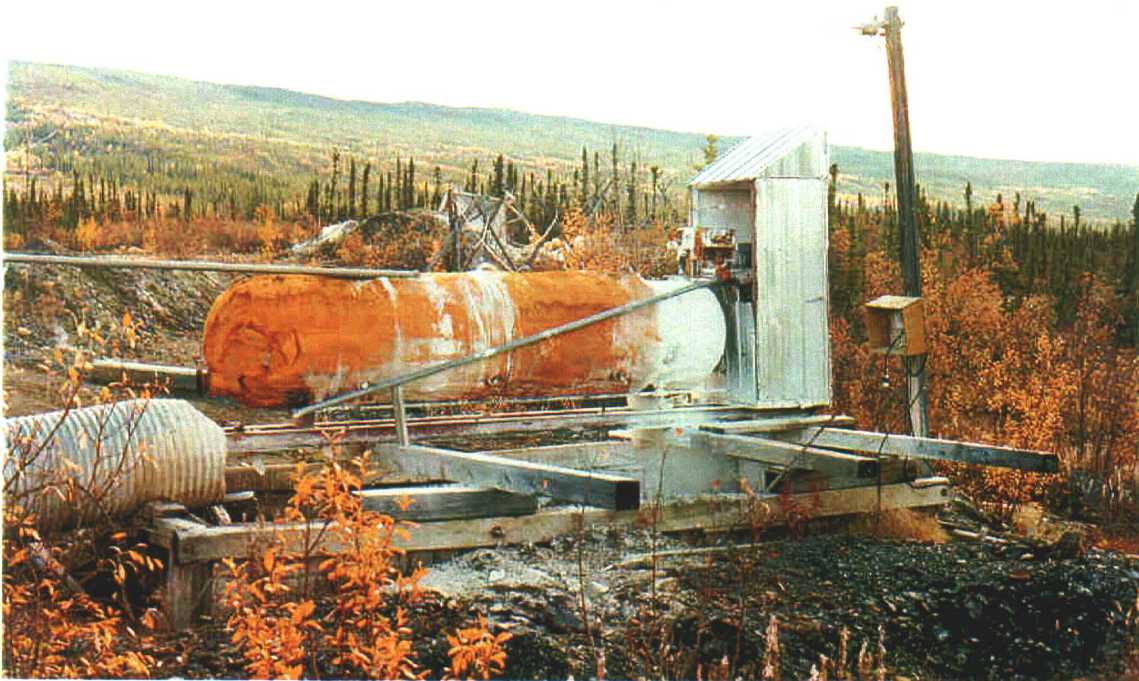
Photo 79-15. Lime treatment plant on Dam No. 1.

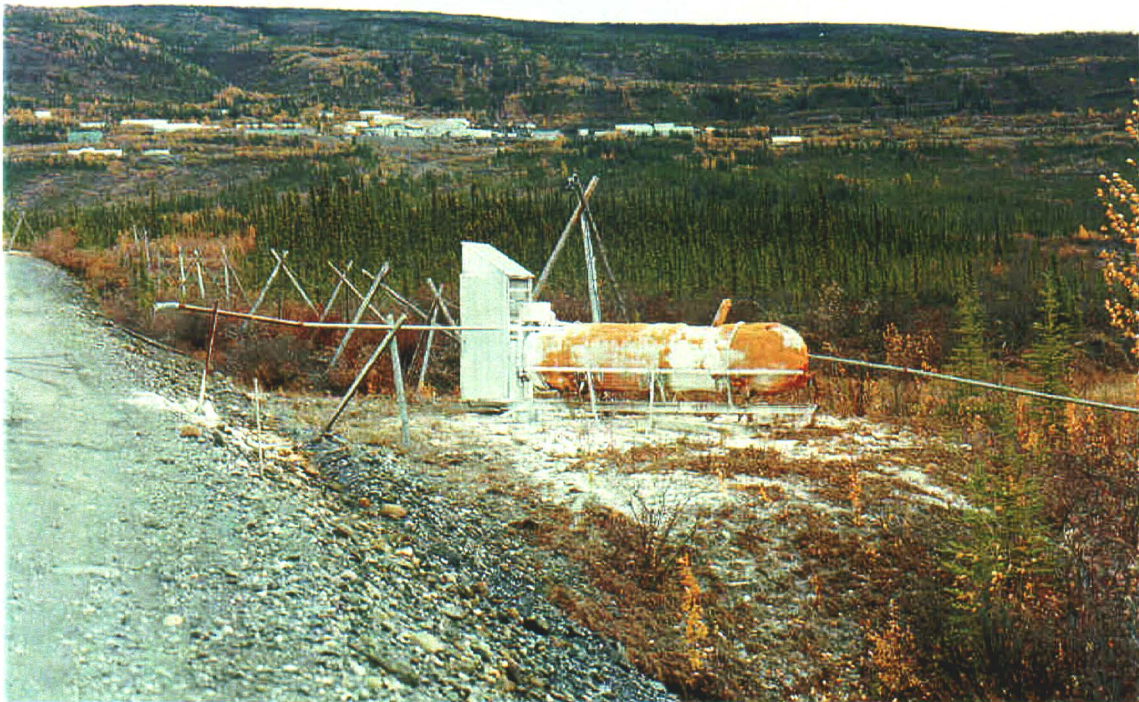
Photo 79-16. Lime treatment plant on Dam No. 2.

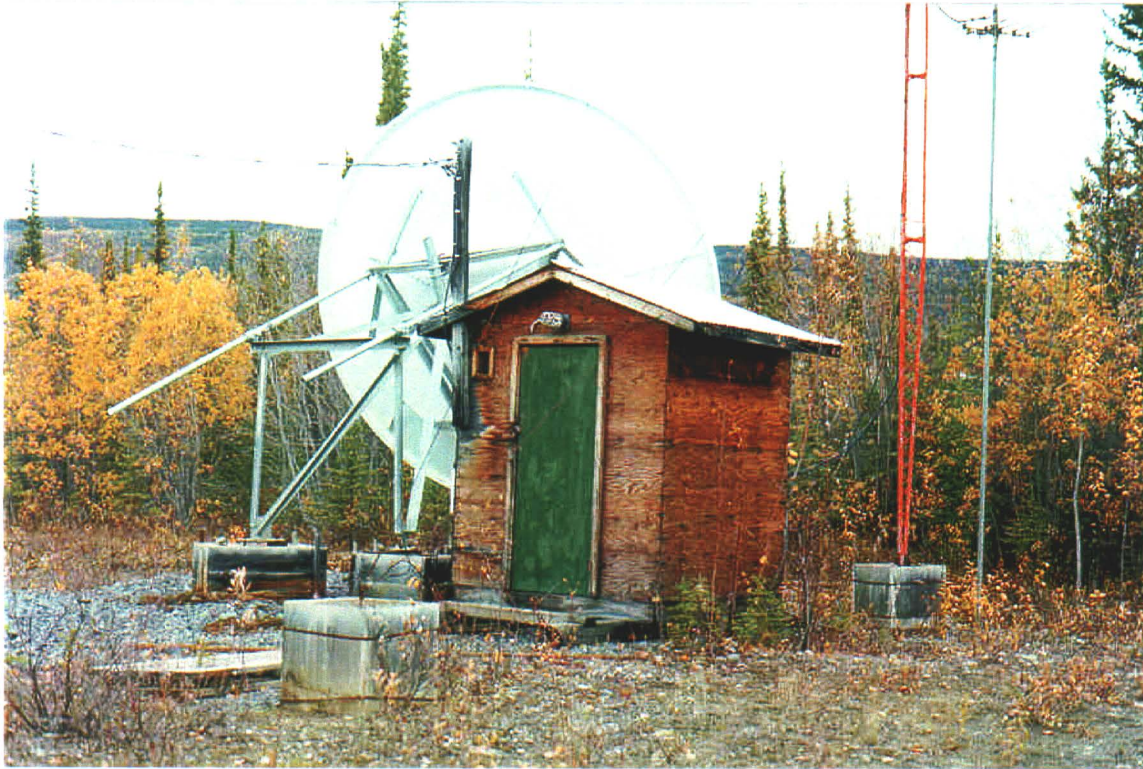
Each of these stations has a small, wooden building measuring 2m x 2 m x 3 m (L x W x H) with a large satellite dish adjacent to it. 79A is located on the road to the freshwater supply and has a door painted green (Photo 79-17). 79B is located at the northwest end of tailings pond No. 2 and is entirely painted green. The contents of the buildings were not examined. No asbestos was seen but the buildings were not opened.

Photo 79-17. Transmission building (79A) and satellite dish.

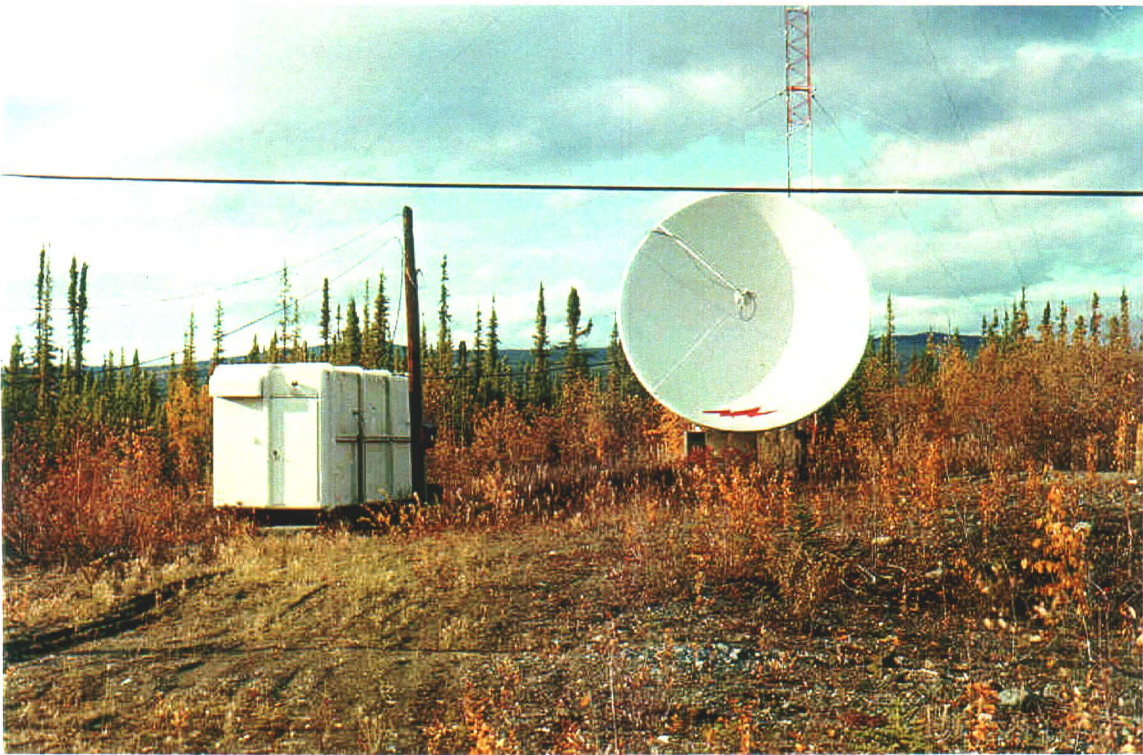
This fiberglass building measures approximately 3 m x 2 m x 5 m and is located near Building 79B, at the northwest end of tailings pond No. 2 (Photo 79-18). It also has a large satellite dish next to it. The building was not opened but there appears to be no hazardous material associated with it.

Photo 79-18. Northwestel building and satellite dish (Building 79C).

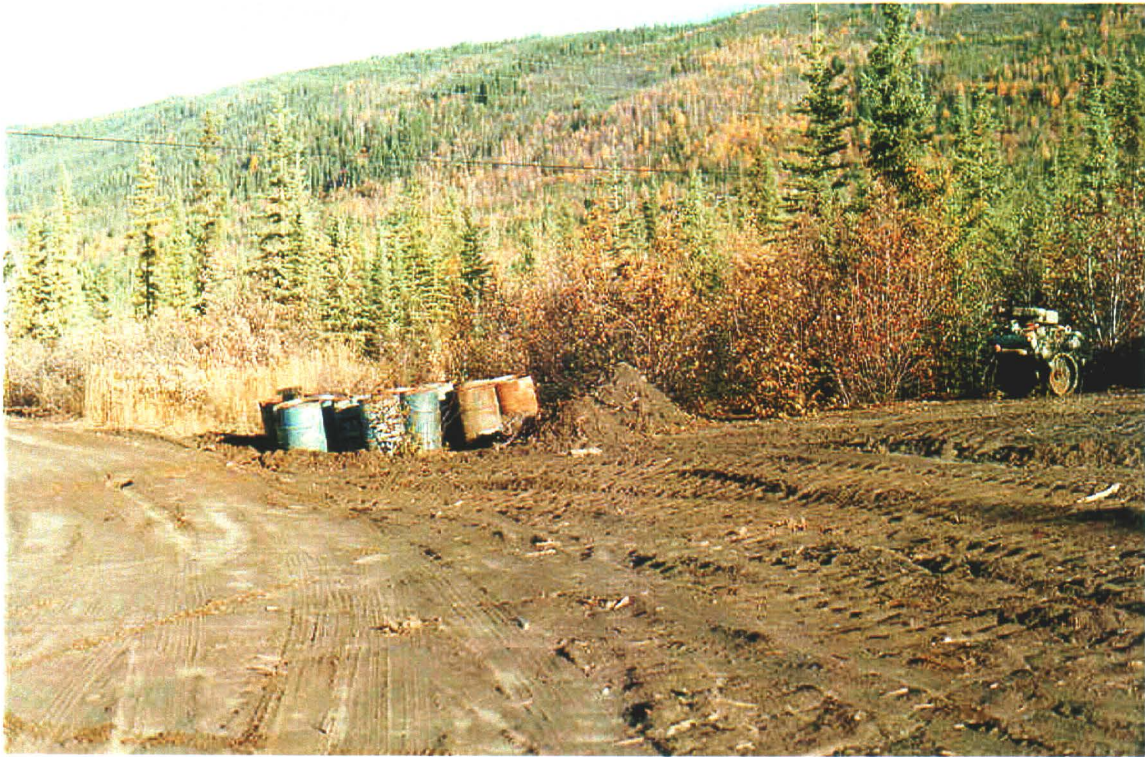
Drum Storage Area(s): Approximately 20 empty barrels are stored in the "boneyard" (spare parts area).

Photo 79-19. Barrels stored in boneyard.

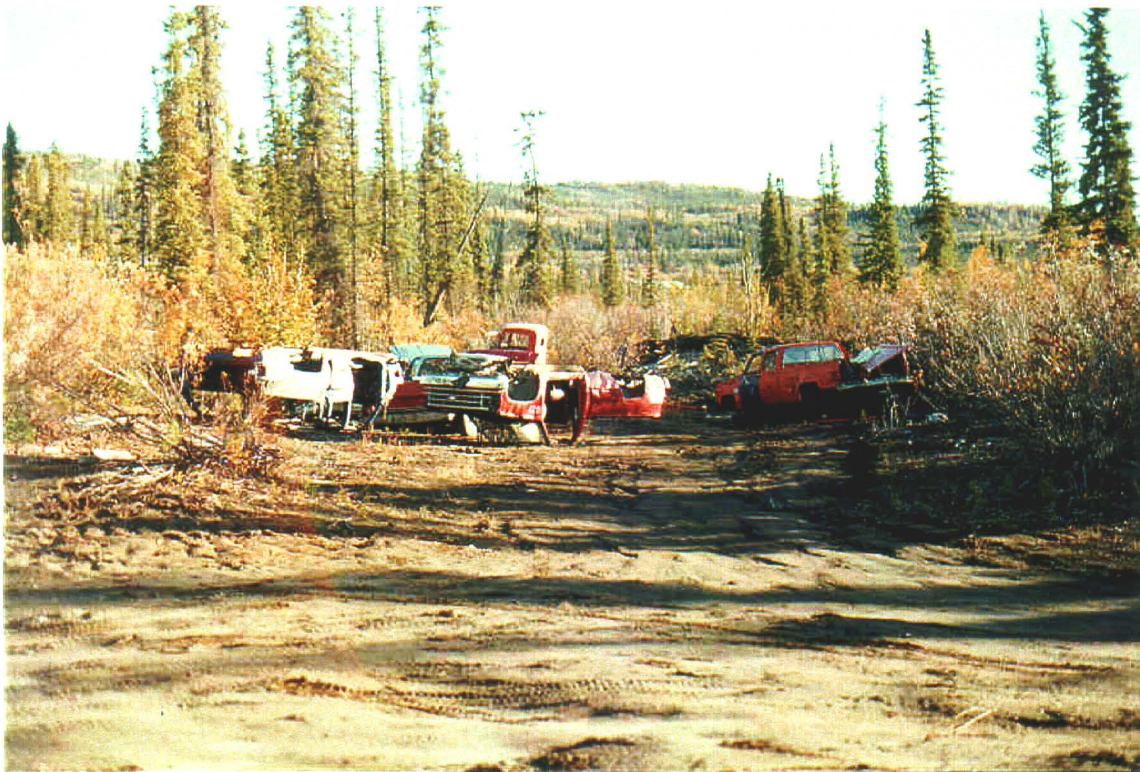
Photo 79-20. Old vehicles stored in boneyard.

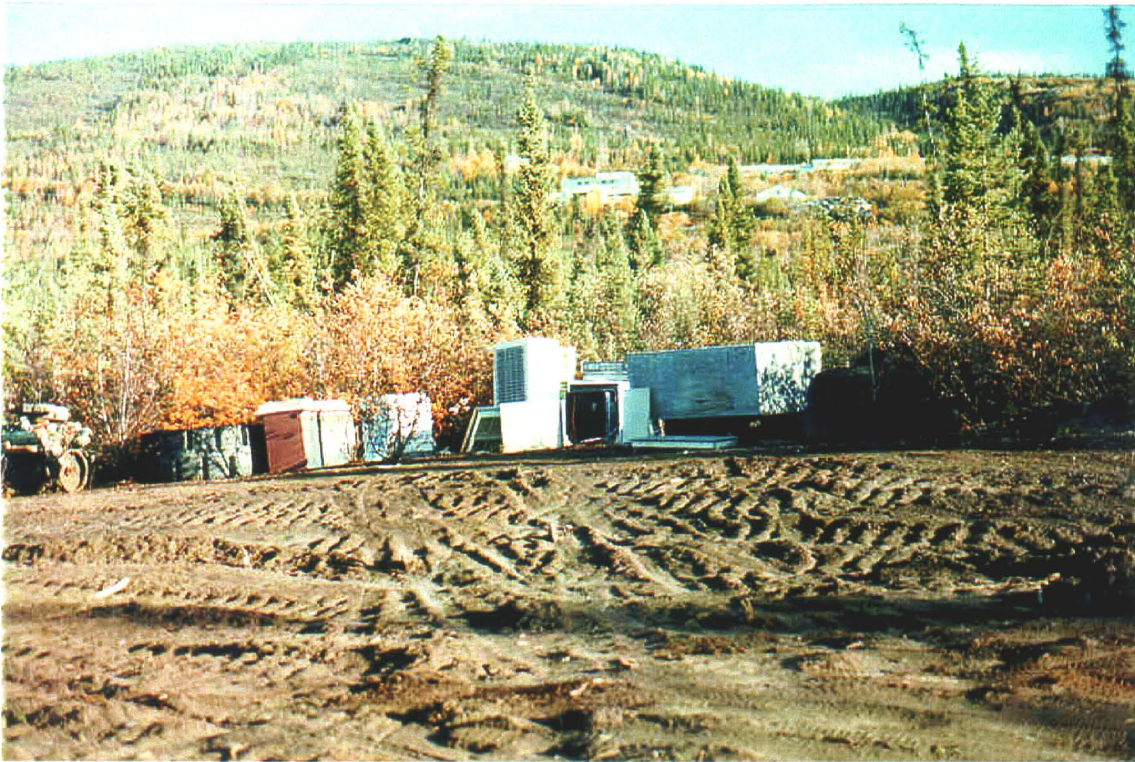
There are no solid waste dumps associated with the tailings impoundment. However, there is a "boneyard" (spare parts area) located east of the road from Elsa townsite to the tailings (Figure 2). The site has 8 abandoned vehicles (Photo 79-20) with batteries located near them, and several household appliances (Photo 79-21). Empty barrels are also stored in this area.

Photo 79-21. Old household appliances stored at boneyard.

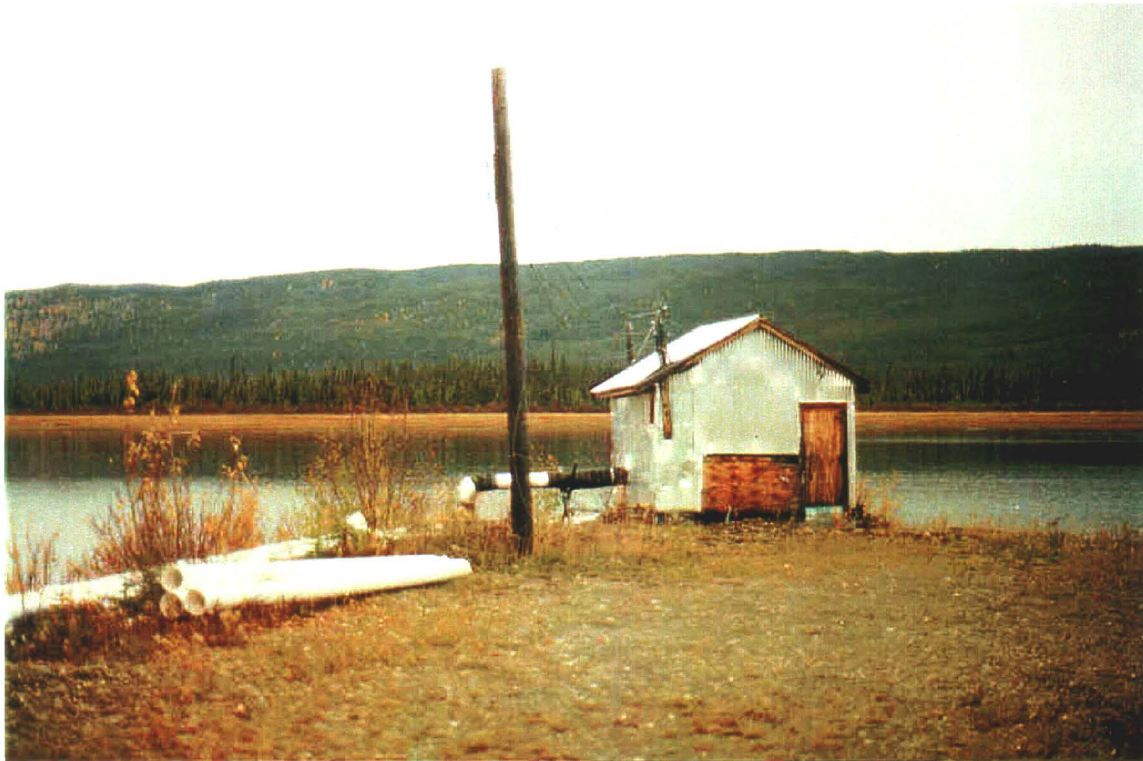
Photo 79-22. Pump house on unnamed lake that is the fresh water supply for the Elsa townsite.

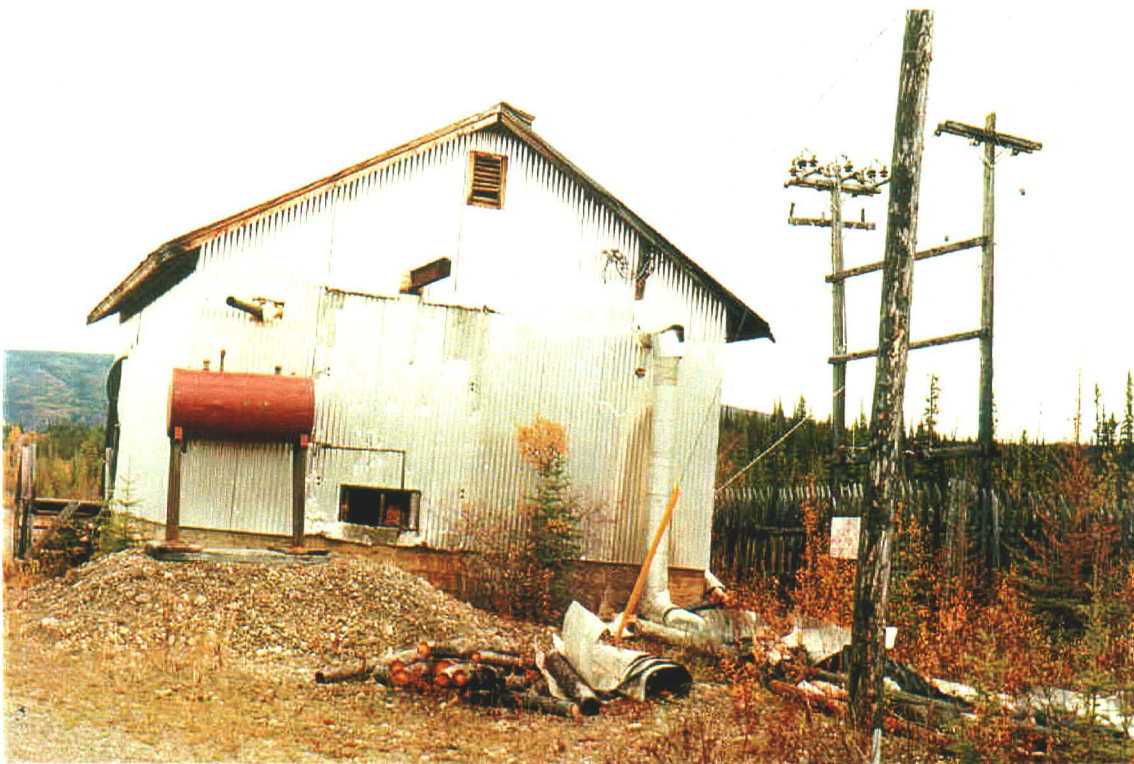
The piping carries water approximately 100 m to the pressure pump house which contains a 75 hp electric pump (Photo 79-23). This pump is large enough to pump the water to the Elsa townsite a distance of 5 km with an elevation gain of 150 meters. The pressure pump house is 16 m x 8 m x 8 m, wood frame construction with corrugated aluminum sheet walls and roof. The foundation is concrete. On the west side of the house is a transformer that was described in Section 6.5.

Photo 79-23. Pressure pump house that pumps the fresh lake water to the Elsa townsite. Note picket fence to the right of the house that contains the transformer that is in use.
