MACKENO (#81)
(NO MINFILE)

Public Works And Government Services Canada	Travaux publics et Services gouvernementaux Canada	designed by: conçu par:	date:
	Architecture & Engineering Services Western Region	drawn by: dessiné par:	C.S., I.B.	Nov. / 99
Drawing title:	Titre du dessin:		approved by: approuvé par:	revisions:
Makeno Site # 81 Site Assessment Yukon Territory		project no. no. du projet:	dwg. no. dessin no.	
		125-12.01	1 of 1

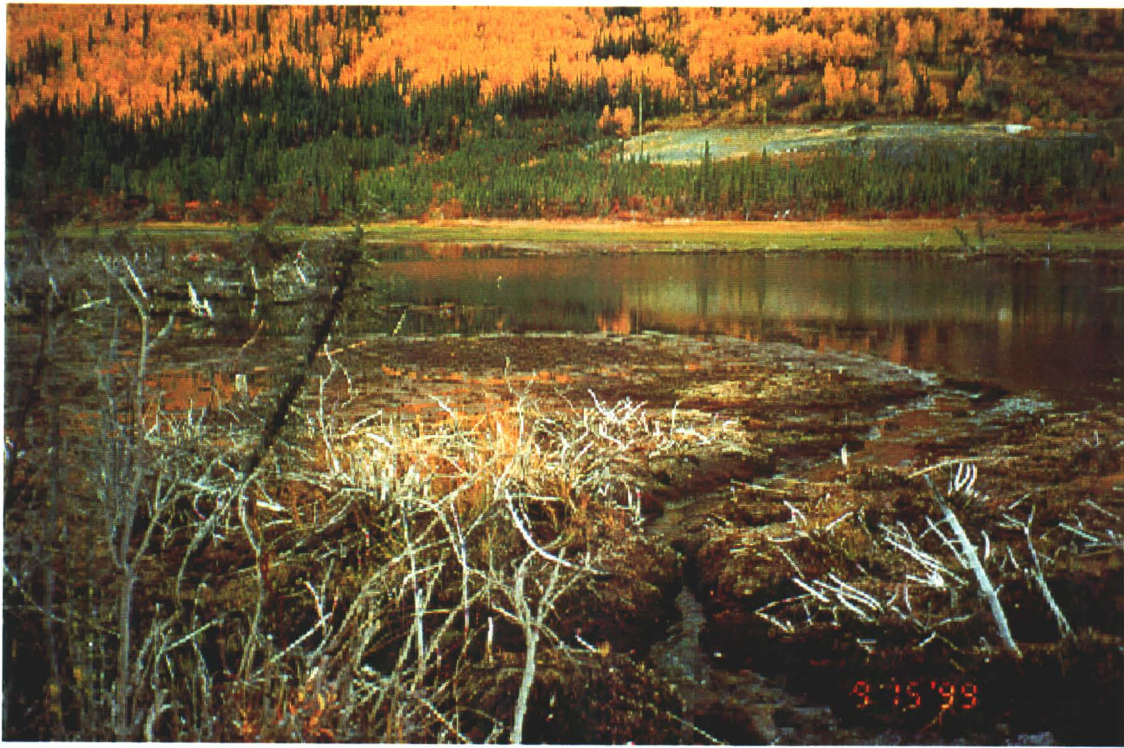
The tailings area abuts directly on the lakeshore, with some tailings noted in the lake (photos 81-3 & 81-4). A portion of the tailings also forms a fan at the mouth of Christal Creek at the north end of the site (photo 81-5). The site slopes gradually down to the lakeshore to the west. East and south of the tailings area is a mature spruce forest. A seasonal creek flows through the forest, entering the lake immediately south of the tailings area (photos 81-1 & 81-6).

An unnamed creek flows from the east into Christal Lake, approximately 80 m south of the Christal Creek effluent through the forested area between the millsite and tailings (photos 81-1 & 81-6). The creek was sampled (81-WQ-Str-CD-04) upstream of the pumphouse. Christal Lake and Christal Creek (photo 81-3) are immediately downstream of the site and both were sampled adjacent to the tailings area. A water sample (81-WQ-Str-CD-02) was collected from the lake immediately west of the beaver dam enclosing the tailings pond. Another water sample (81-WQ-Str-CD-03) was collected from Christal Creek immediately downstream of the small tailings fan where tailings were reportedly pumped directly into the creek.

Photo 81-1: Mouth of unnamed creek at Christal Lake.

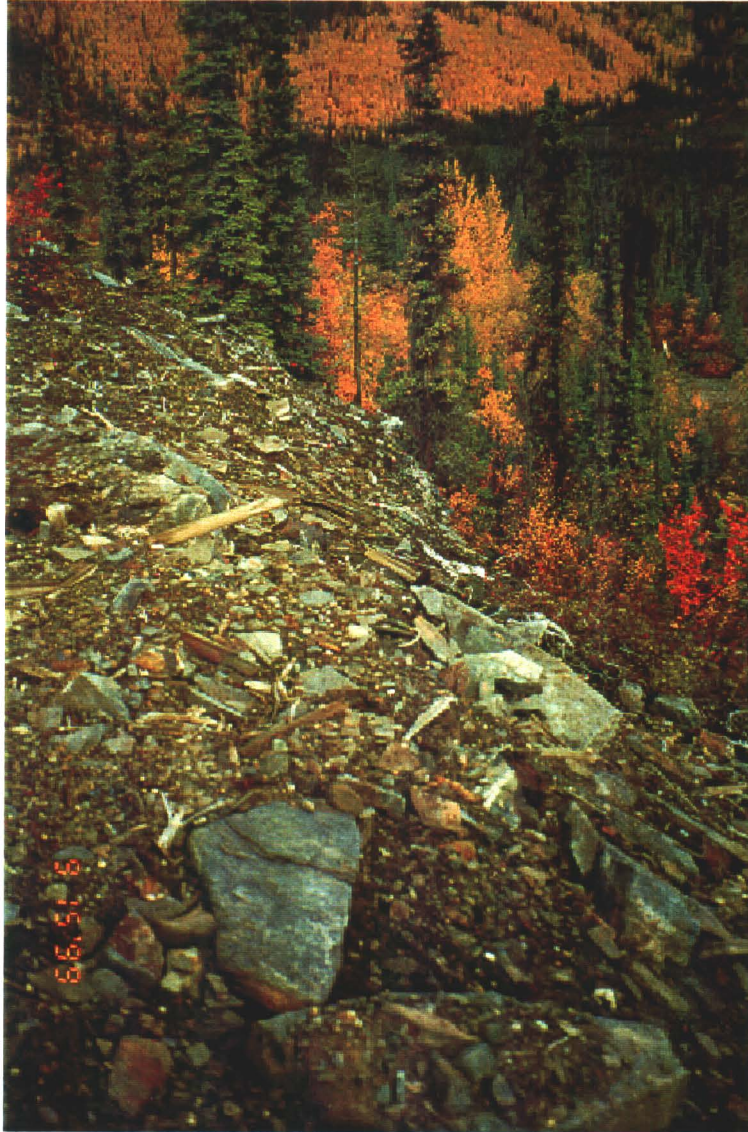
The site is located on the east and north east shore of Christal Lake (photo 81-1). The site slopes gradually to the west and south west down to the lake. The millsite itself consists of two adjacent cleared areas separated by a steep embankment approximately 3 m high running east-west (photo 81-2) and the tailings area, approximately 200 m to the north of the main site through a primary forest. South and south west of the millsite, much of the property is forested with considerable areas of second growth willow saplings. Further south, the forest is dominated by mature spruce forest and the area is relatively flat, sloping down towards Christal Lake to the west.

Photo 81-2: North slope south millsite area. Note wood debris.

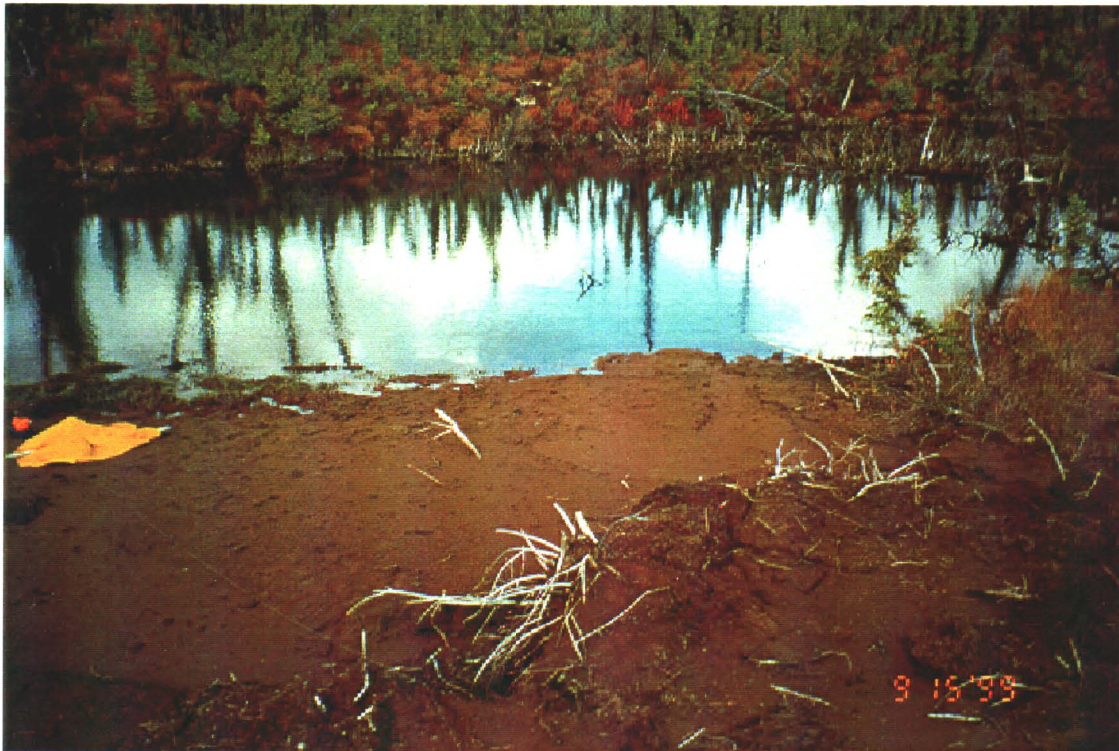
Photo 81-3: Small tailings fan directly on Christal Creek.

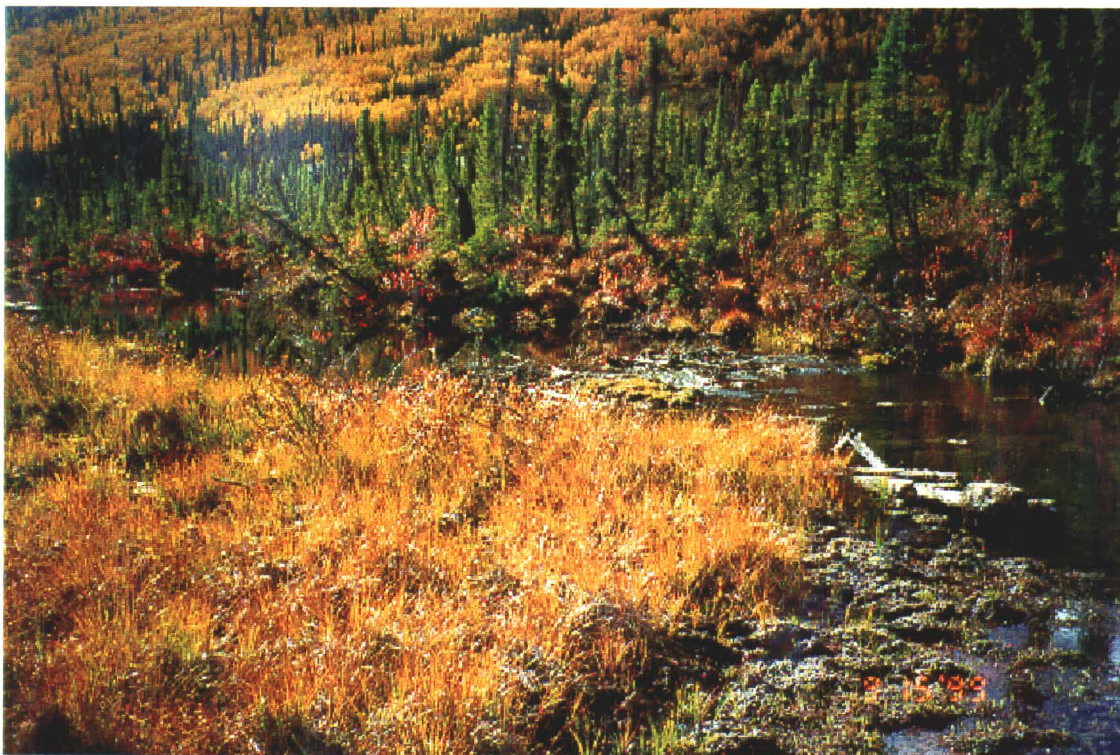
Tailings were deposited in a depression near the lakeshore, and overflowed into the lake. A wetland (sedge) area has formed between the tailings and the lake. A small portion of the impounded area immediately off-shore remains unvegetated.

Oxidation: Discoloration (orange) of tailings (on surface and at depth).

A tailings pond has formed immediately west of the main tailings area where the tailings have entered Christal Lake (photo 81-4). The outer edge of the pond has been contained by a (temporary) beaver dam, however, water in the tailings pond is obviously hydraulically connected to the lake. A single water sample (81-WQ-Str-CD-01) was collected from this location.

Photo 81-4: Upstream from small tailings to near mouth of Christal Creek.

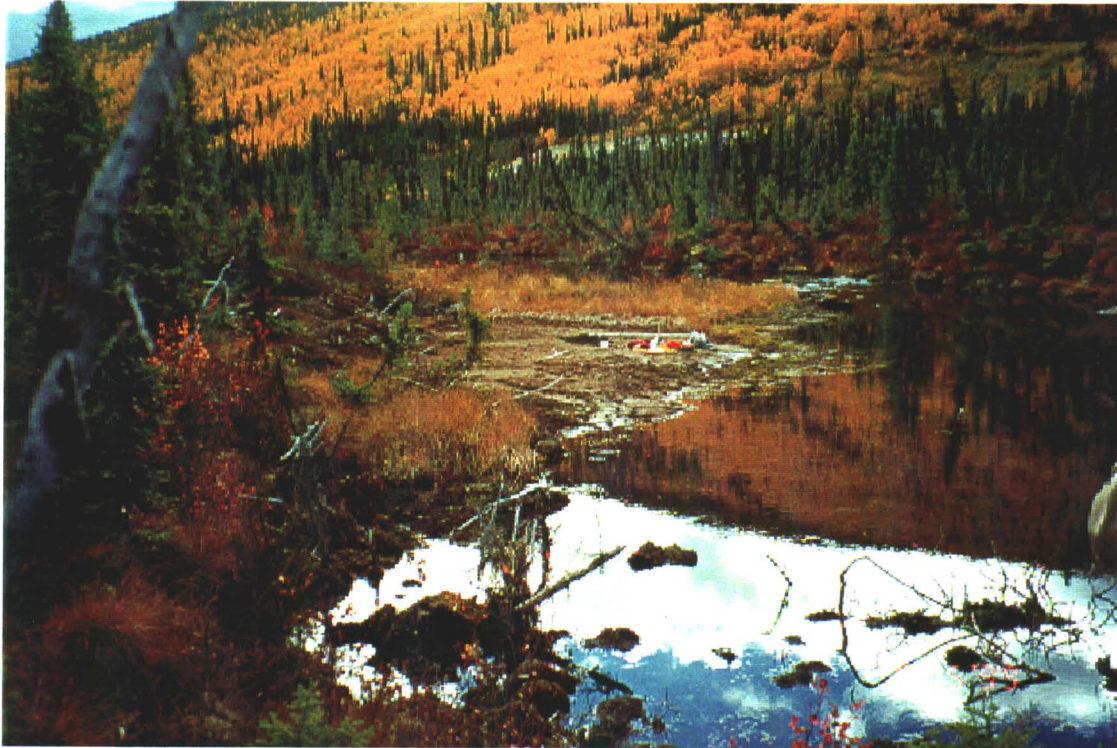
Photo 81-5: Upstream to small tailings fan on Christal Creek.

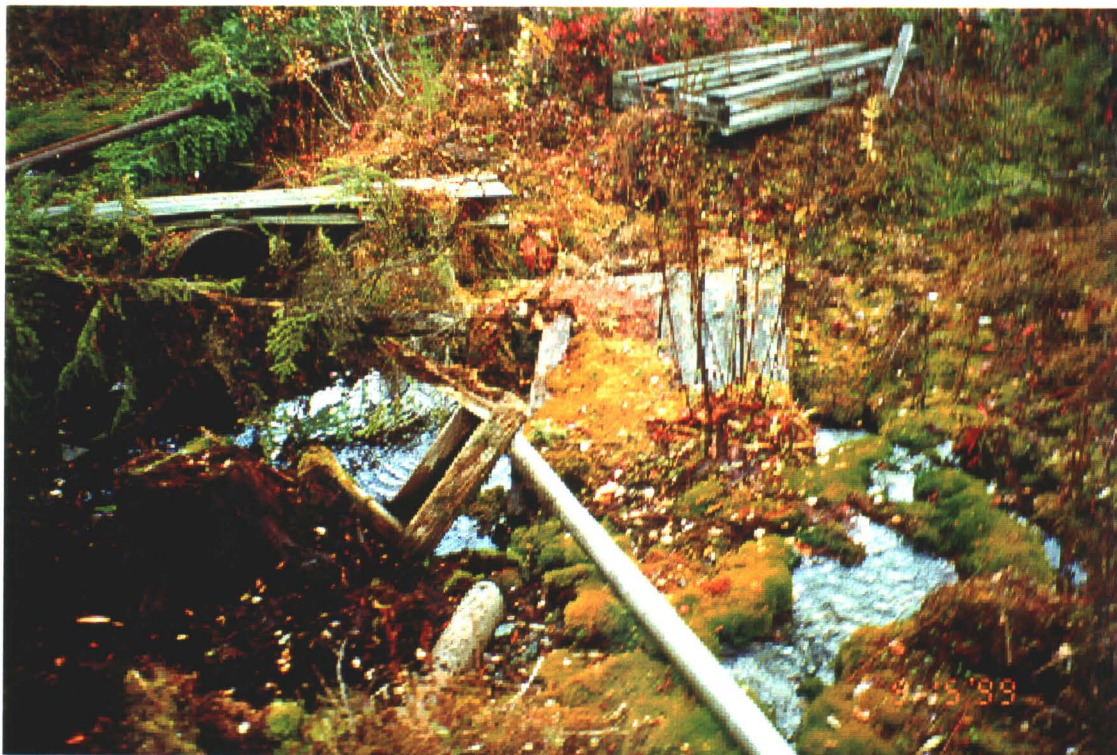
Piping between tailings pumphouse and pond: 4 and 6 inch; approximately 150 m in length; still in place through wooded area running directly along ground and through pumphouse (photo 81-6).

There has been no attempt to reclaim the old tailings site. The pumphouse and associated pipeline are present within the wooded area. The onshore tailings remain uncovered and unvegetated.

Photo 81-6: Tailings pipeline in forested area north of millsite.

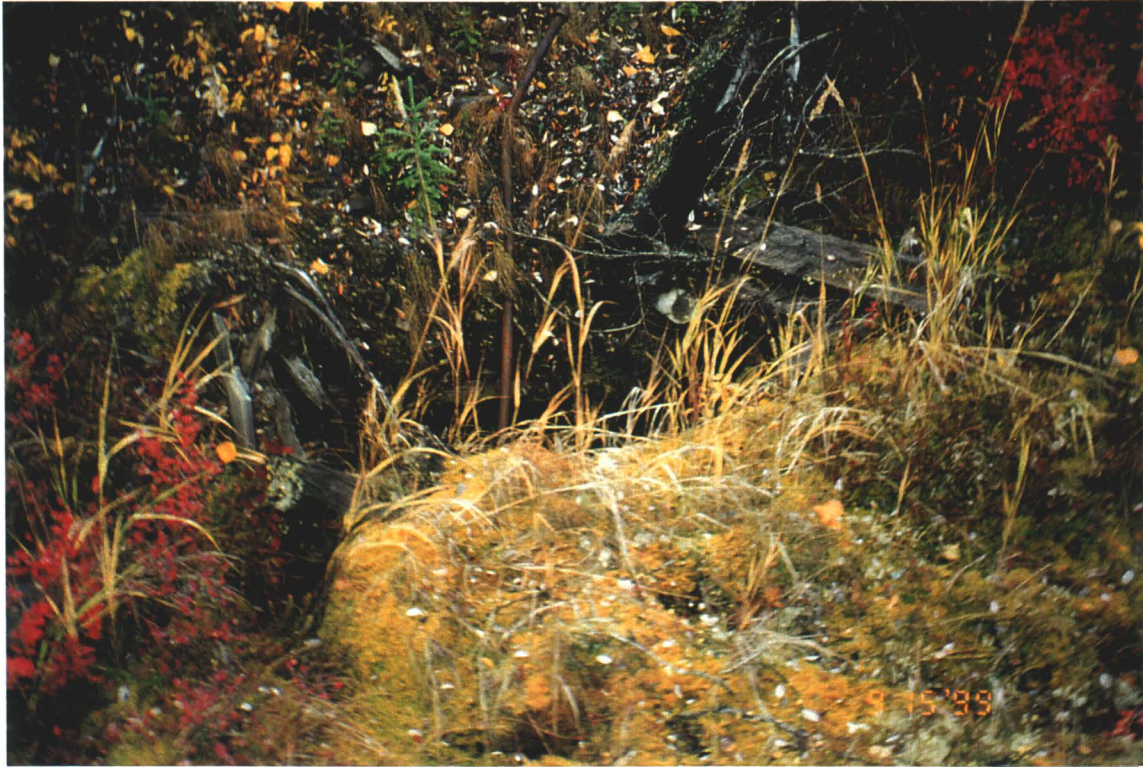
Open Pits (photo 81-7)

Dimensions (L x W x H): 1.5 m x 1.5 m x 1.5 m.

Supports: Wooden timber-lined shaft.

Condition: Timbers are rotten, site is revegetated.

Accessibility: Easy access by foot, but low risk to public due to shallow depth.

Photo 81-7: Small timber-lined test pit south west of millsite.

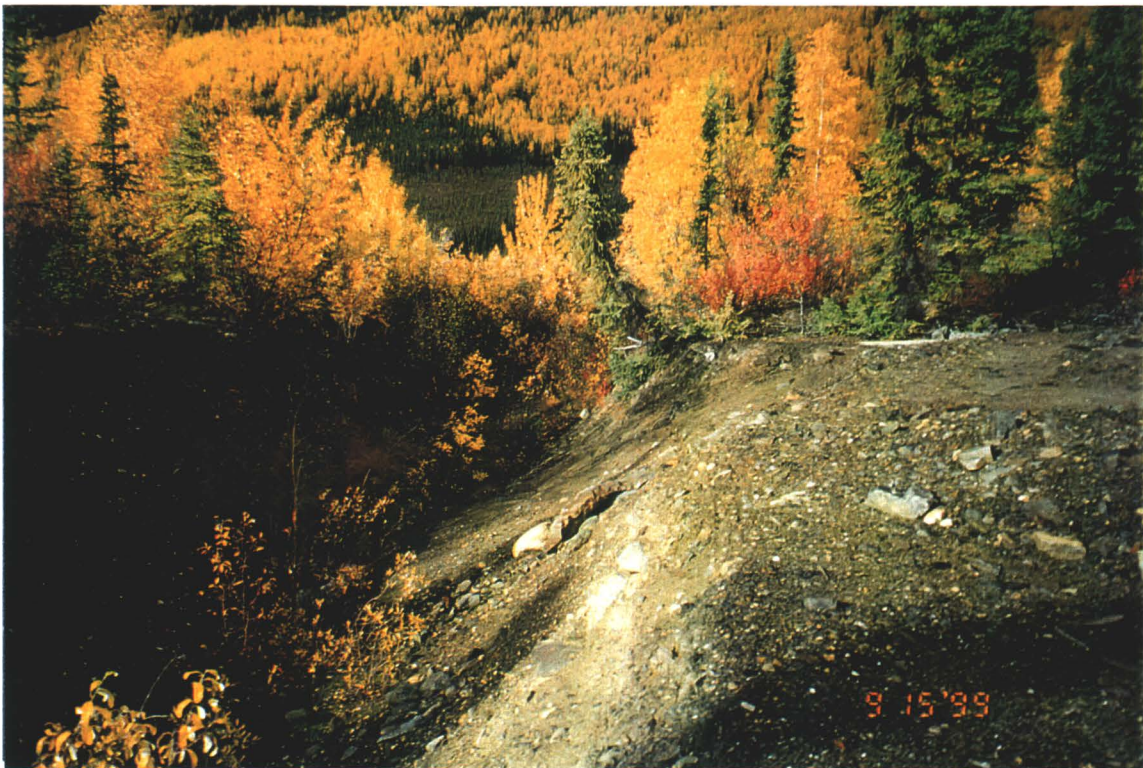
Trenches (photo 81-8)

Exploration trenches are present to the south of the millsite. They cut overburden for the most part.

Dimensions (L x W x H): 35 m x 5 m x 3 m.

Condition: Fairly stable; partially revegetated.

Photo 81-8: Trench directly south of millsite.

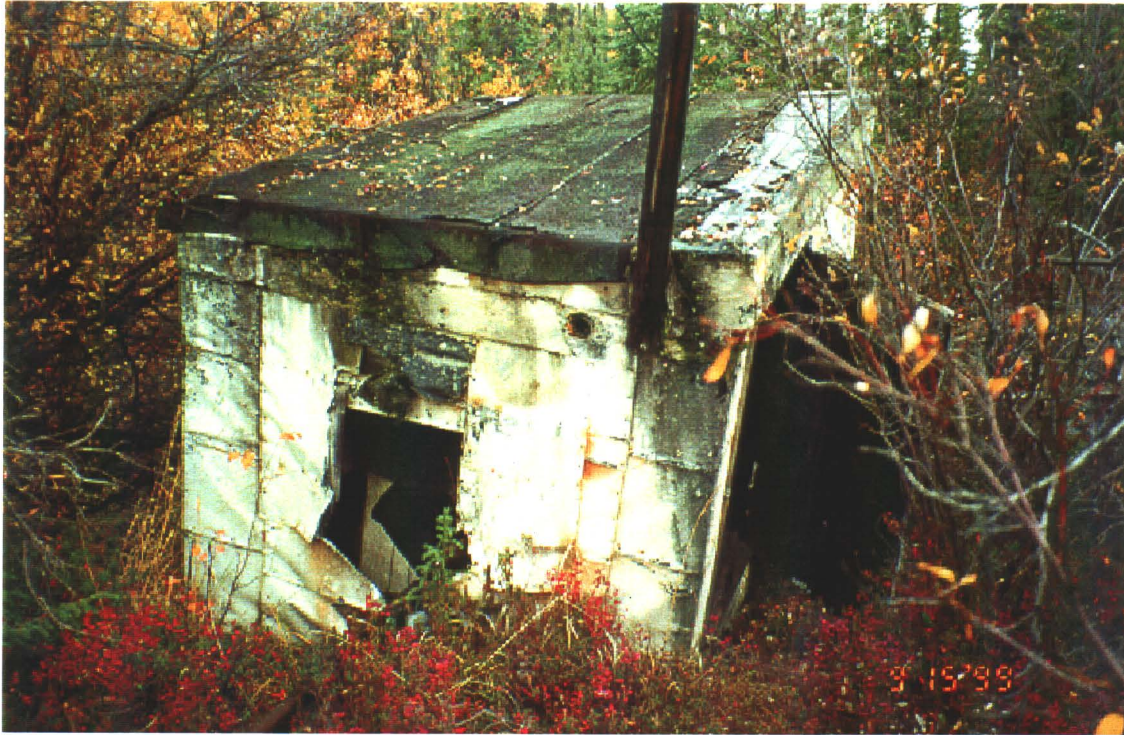
Building 81A- Pumphouse (photo 81-9)

Pumphouse consists of a small deteriorated wood building positioned over a small creek.

Construction: Wood frame with asphalt roofing and asbestos tarpaper siding.

Asbestos: Asbestos-impregnated tarpaper was present on the building exterior and was not sampled. Asbestos wallboard is present on the interior walls. Asbestos is considered non-friable in both of these forms.

Photo 81-9: Tailings pumphouse in forested area north of millsite.

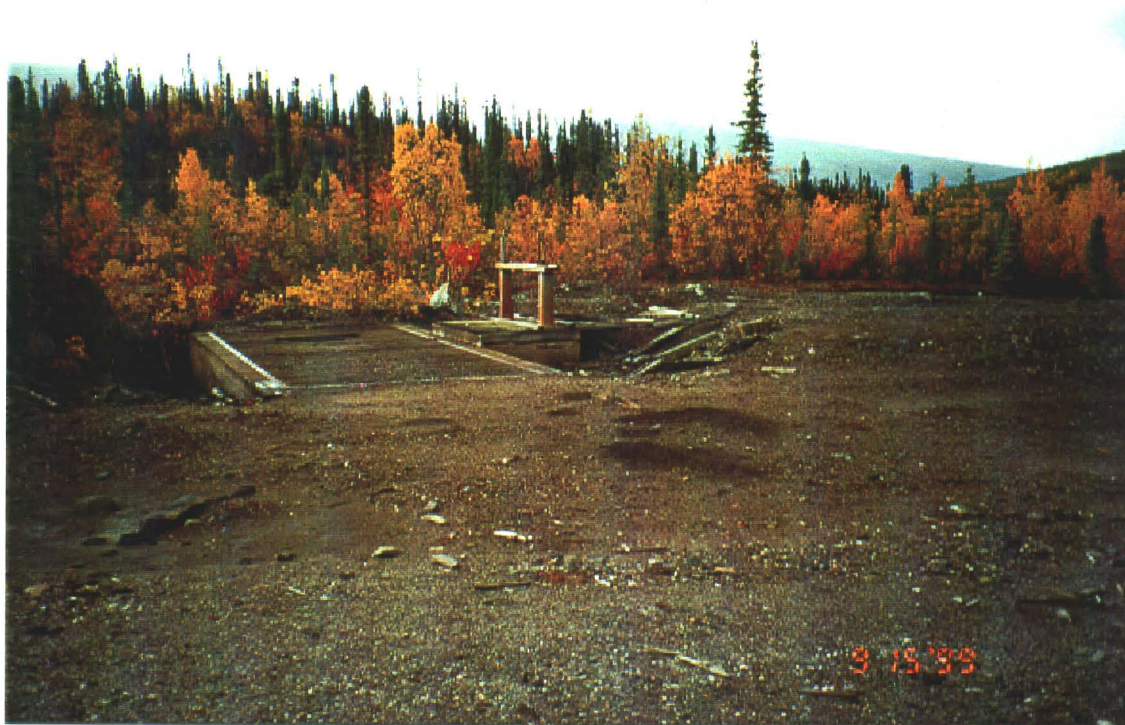
Building 81B – Weigh Scale (photo 81-10)

All that remains of the scale is concrete foundation and scale well.

Construction: Concrete foundation well covered with timbers.

Six very small surface stains with a total area of approximately 1 m³ were noted immediately north of the weigh scale foundation. Stains may be the result of waste oil leakage and had a faint hydrocarbon odour. Staining was not present below 0.10 m below grade. This portion of the site is a considerable distance from the nearest water body and no samples were collected.

Photo 81-10: Concrete foundation of weigh scale at south end of millsite.

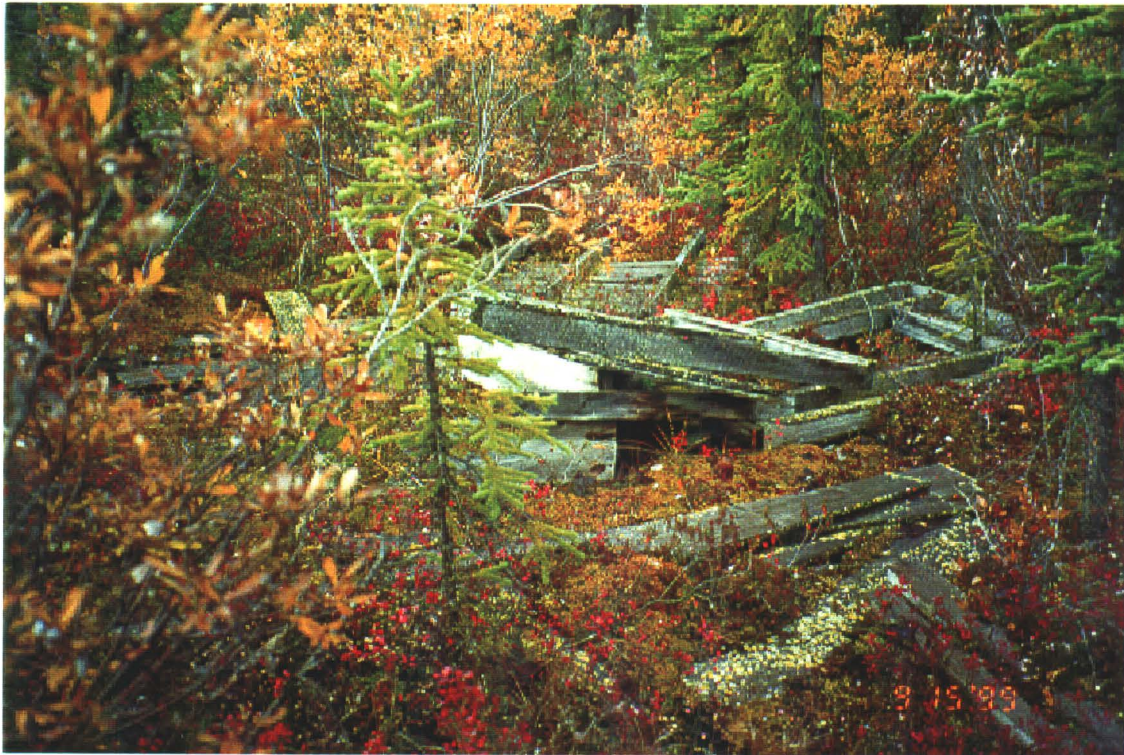
Building 81C – Shack (photo 81-11)

Demolished shack probably used for living quarters.

Construction: Wood frame; demolished.

Photo 81-11: Wood debris remaining from former shack south west of millsite.

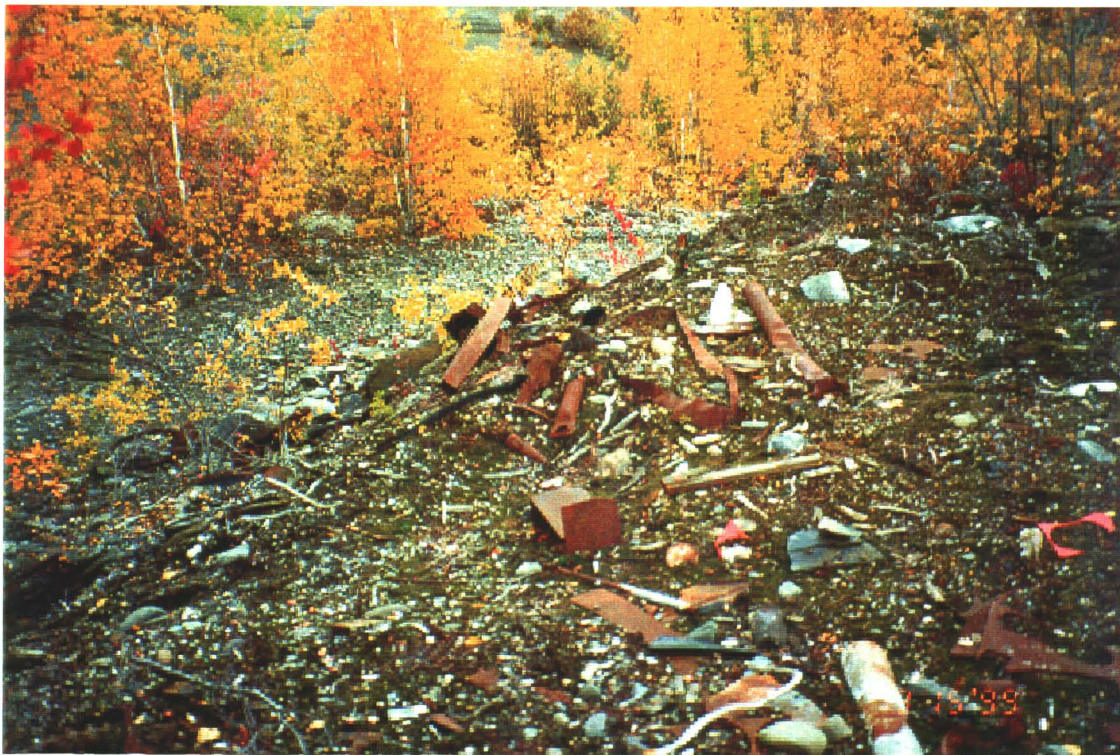
General composition: Non-friable asbestos wallboard; approximately 10 empty barrels; large volume of wood (timber and other) and metal debris; large cogged wheel; loader bucket; lengths of various sizes of pipe (>100 m); and victaulic piping lengths (<20 m).

Photo 81-12: Metal and wood debris at west end of upper millsite area.

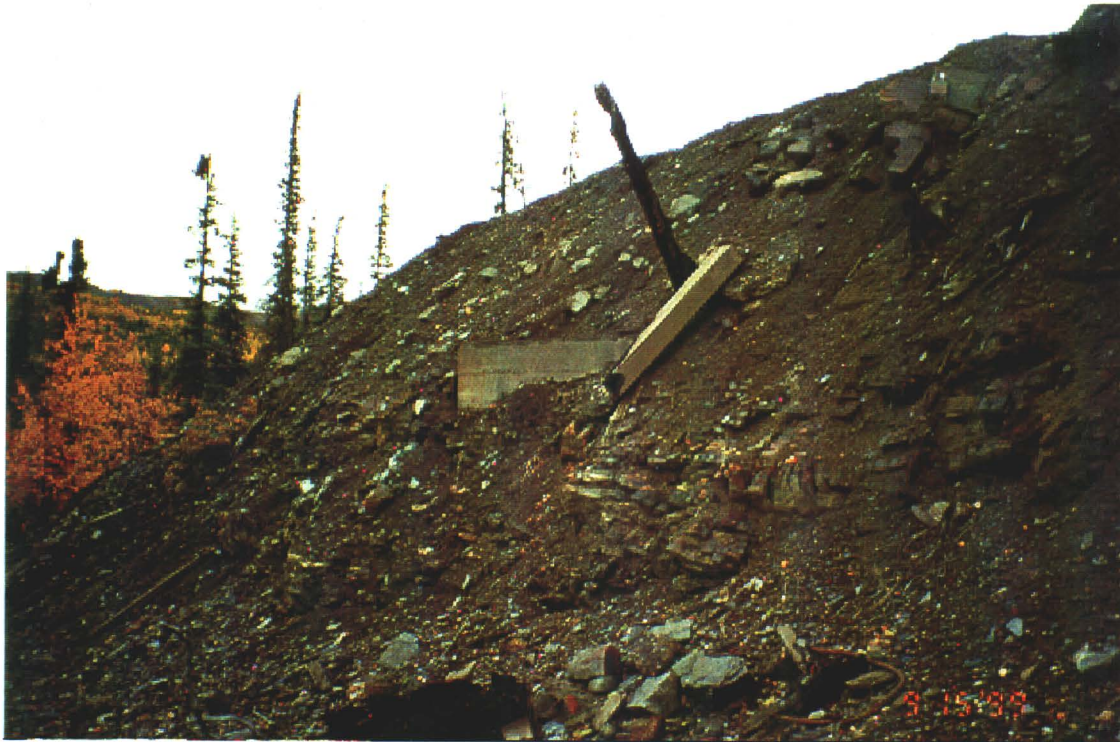
Mill facility: The mill has been removed or buried onsite since it discontinued use in 1954. Evidence of the former mill facility are indicated by the weigh scale at the south end of the site as well as a large volume of assorted debris on the surface and partially buried throughout the site. A concrete foundation was noted protruding from the north end of the upper millsite. A cogged wheel (debris from former heavy equipment) was also noted protruding from the northwest corner of the site.

Photo 81-13: Concrete foundation protruding from north slope of upper millsite area.
