DUBLIN GULCH - EAGLE ZONE

SITE #88

(MINFILE #106D 025a)

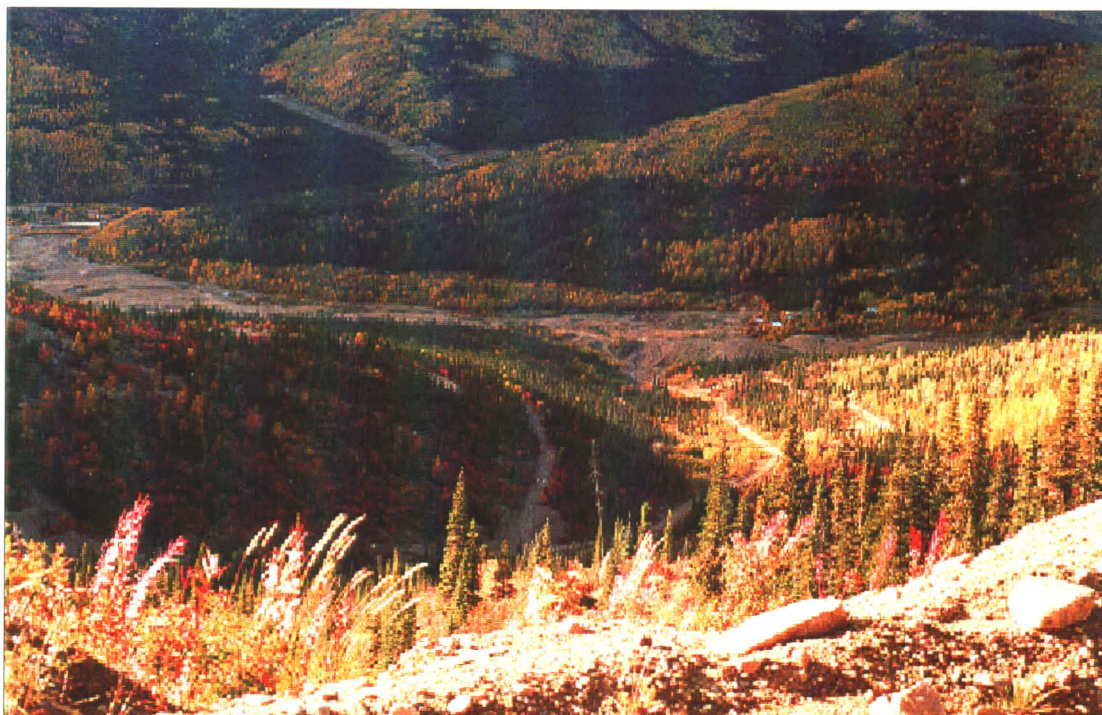
The main exploration camp is located along the north site of Dublin Gulch along a raised shoreline out-wash terrace approximately 20 m north from the gulch tributary. Over-burden from placer activities in the Gulch have also significantly altered surface hydrology in the area (see Photo 88-1). The presence of permafrost soils could not be ascertained; however, the presence of small trees and the high elevation suggests the possibility of discontinuous permafrost.

Photo 88-1 : Dublin Gulch facing N.

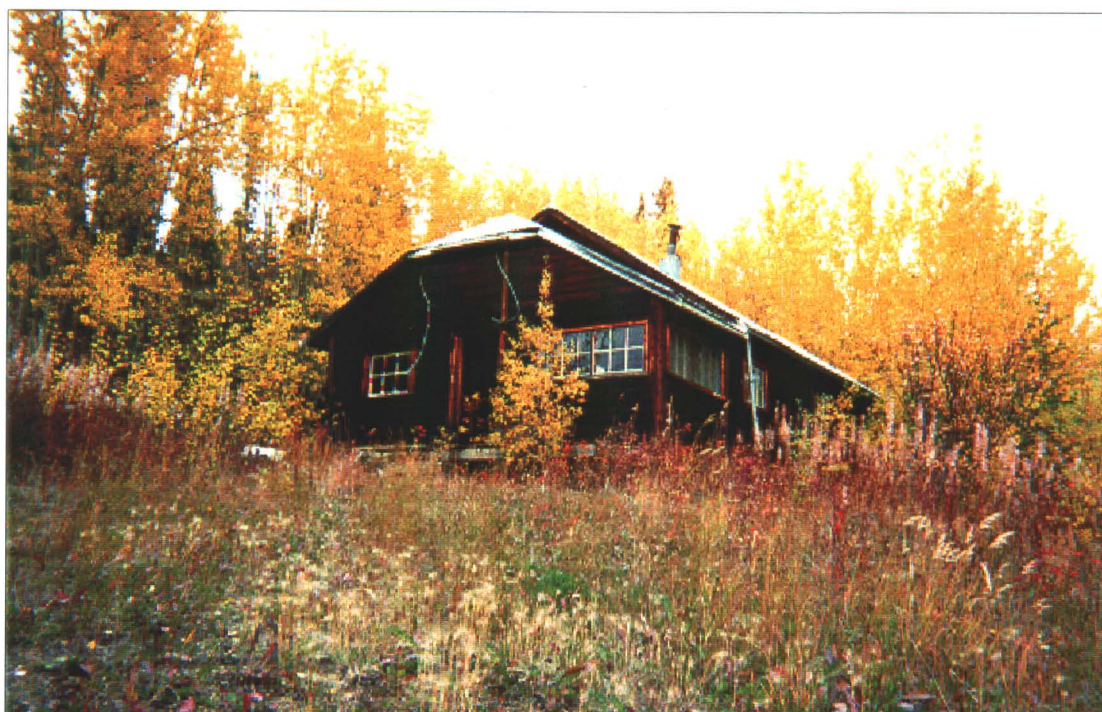
Building 88-A (Photo 88-2)

Cabin 1 was of stained wood construction (9 m W x 10 m L) with an aluminum metal reinforced roof, trimmed windows and painted interior. The building was stable and in good repair. Non-hazardous contents consisted of corebags, an old drum stove, domestic debris, clothes and mattress. No hazardous materials were found within the building; however, a drum of kerosene along with two other barrels with water and garbage were found outside along the northwest side of the building.

Photo 88-2 : Dublin Gulch. Exploration Camp - cabin 1 looking N.W.

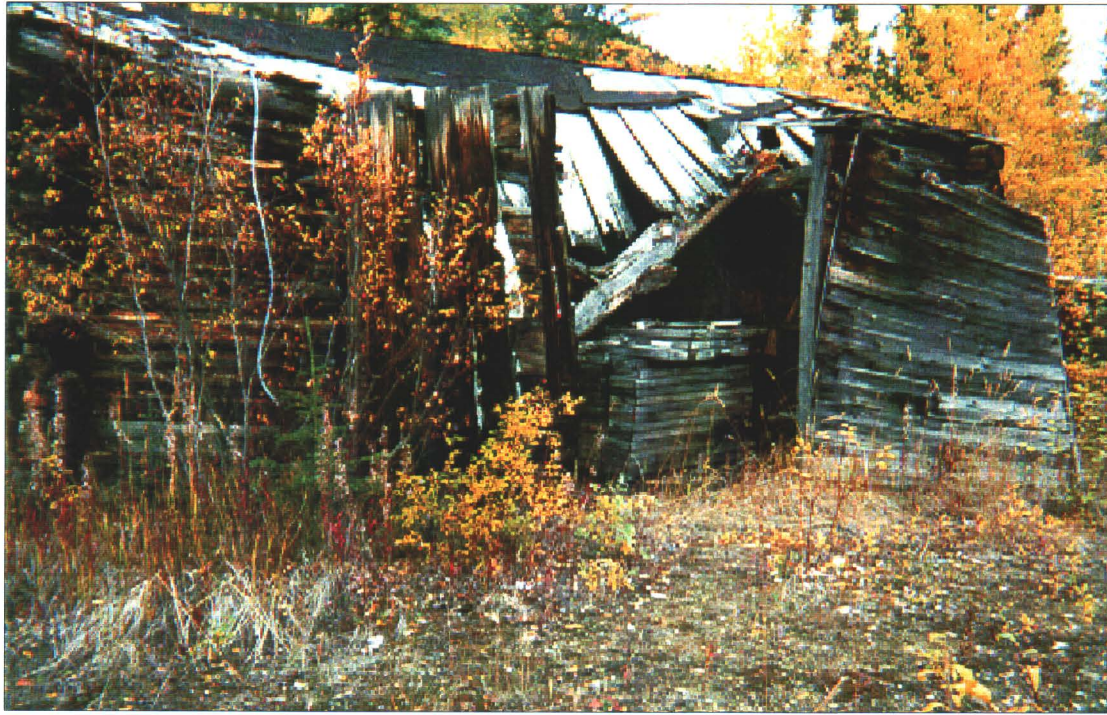
Building 88-D (Photo 88-3)

Cabin 2 was of wood plank construction (5 m W x 8 m L) located on the southeast side of Dublin Gulch Road. The building was in ill-repair and partially collapsed. Non-hazardous contents consisted

of full coreboxes, an old stove, packages of quick-gel (~ 12), and wood debris. No hazardous materials were found within the cabin.

Photo 88-3 : Dublin Gulch. Exploration camp - cabin 2 looking N.W.

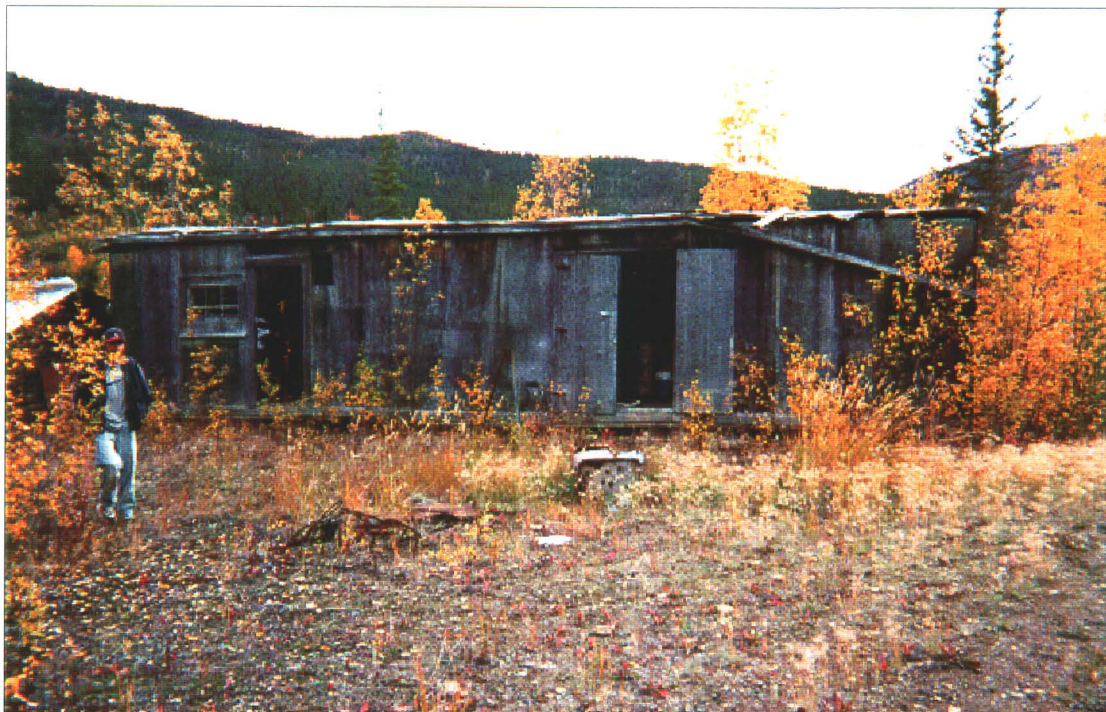
Building 88-E (Photo 88-4)

Two-room workshop and core/rock sample storage shack of plywood construction (3 m W x 12 m L) with aluminum metal reinforced roof directly across (southwest) from Cabin 3. The building was stable and in good repair. Non-hazardous contents consisted of a large number of cans of rock samples in plastic bags, storage racks of rock samples (library) and two empty drums. No hazardous materials were found within the shack.

Photo 88-4 : Dublin Gulch. Exploration Camp - workshop & storage looking S.

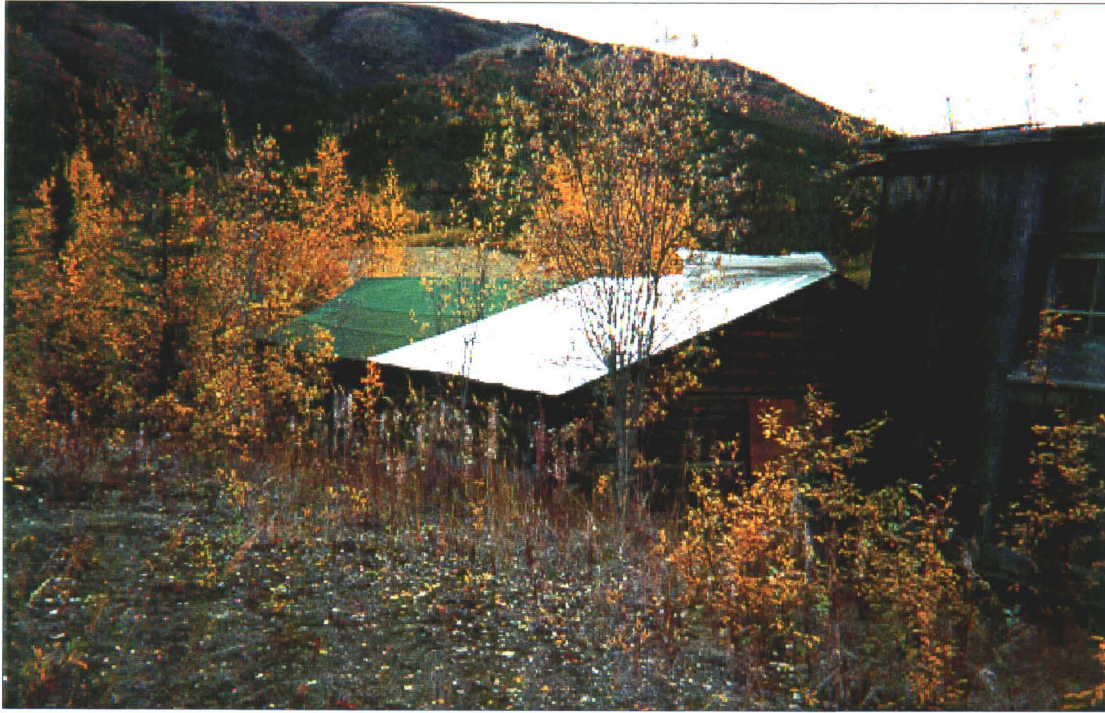
Building 88-F (Photo 88-5)

Cabin 3 was of log wood construction (5 m W x 10 m L) with a combination shingle and aluminum metal reinforced roof and shingles, located immediately southeast of the workshop and core storage shack. The building was stable and in good repair. Non-hazardous contents consisted of core storage in racks and two empty drums. No hazardous materials were found within the cabin.

Photo 88-5 : Dublin Gulch. Exploration Camp - cabin 4 looking S.E.

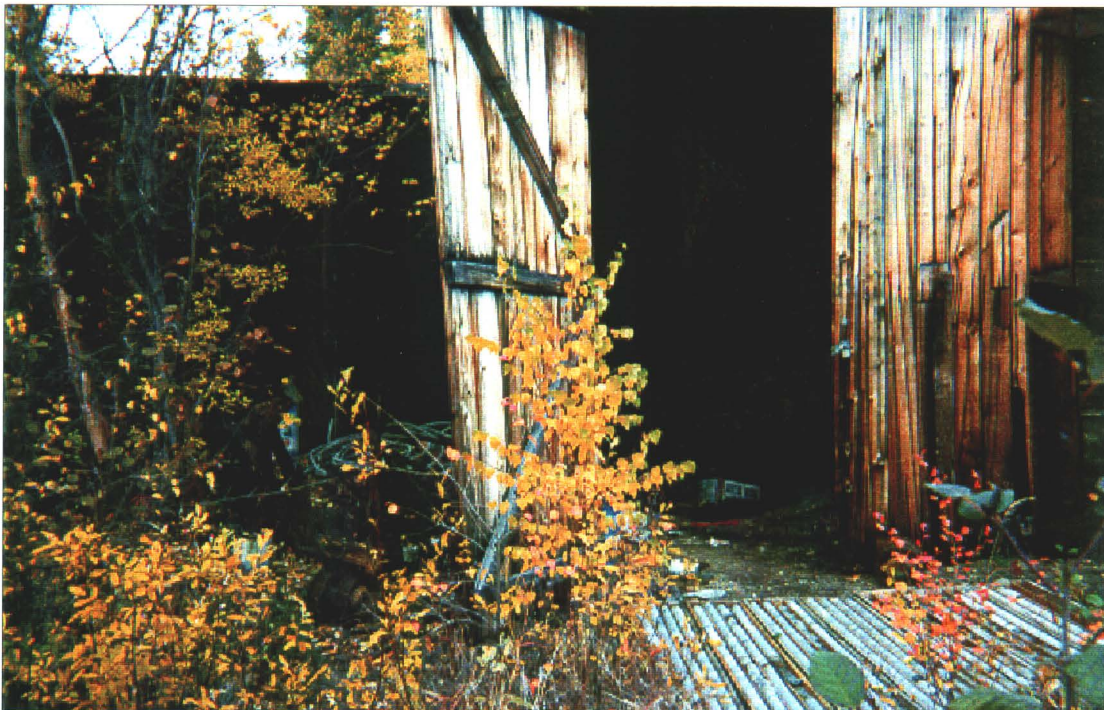
Building 88-H (Photo 88-6)

Drill equipment shop and garage of wood plank construction (3 m W x 6 m L) east of Cabin 3. The building was stable and in good repair. Non-hazardous contents consisted of drill bits and equipment; full core boxes were also laid out in front of the garage entrance. Potentially hazardous materials found within the garage included single cans each of antifreeze and oil, a very minor oil stain was also noted on the dirt floor of the structure.

Photo 88-6 : Dublin Gulch. Exploration Camp - equipment building & garage looking N.E.

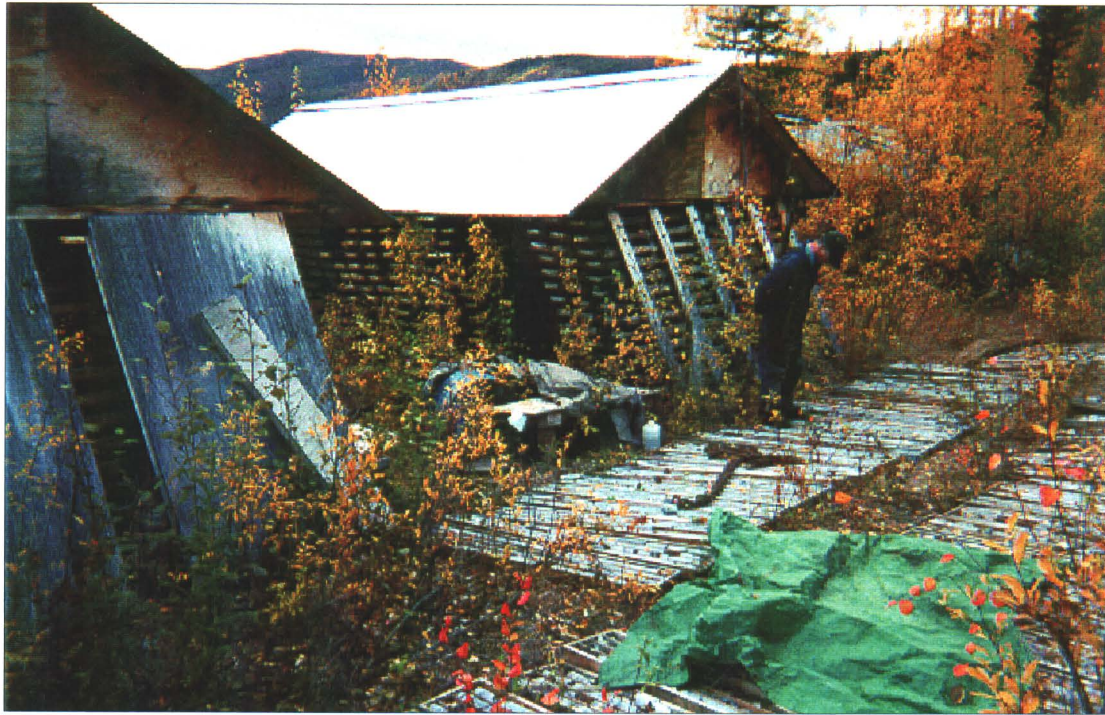
Building Cluster 88-I (Photo 88-7)

Five core shacks of wood construction (3 m W x 7 m L) and aluminum metal reinforced roofs. Three of these were intact and contained core boxes, while another had been previously marked and used for dynamite. The fifth shack, closest to Dublin Gulch Road, had collapsed. Aside from core boxes within some of the structures and scattered in the vicinity, no other non-hazardous materials were noted. No hazardous materials were apparent within or around the structures.

Photo 88-7 : Dublin Gulch. Exploration Camp - core shack looking W.

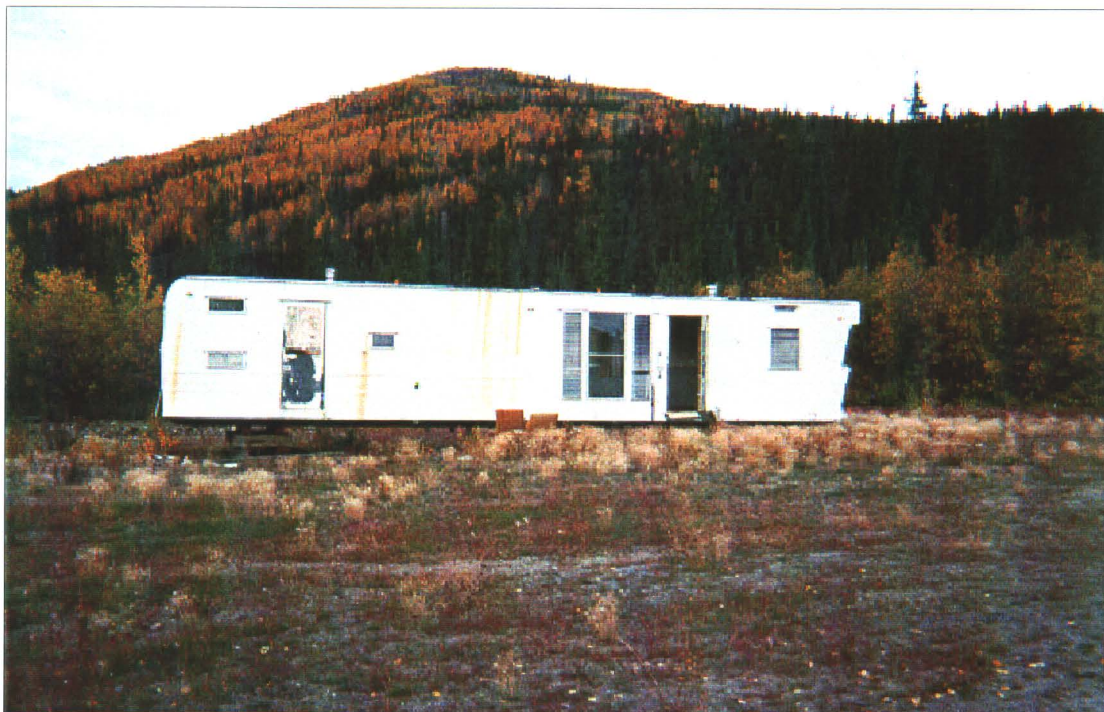
Building 88-J (Photo 88-8)

Old trailer of aluminum and steel construction (2.5 m W x 13 m L) located along the north side of Dublin Gulch Road. The trailer was in relatively good structural condition. The trailer had been fully equipped and contained non-hazardous domestic debris including a tub and sink, in addition to an old couch and other domestic garbage outside of the trailer. No hazardous materials were apparent within or around the structure.

Photo 88-8 : Dublin Gulch. Exploration Camp - trailer along access road
- possibly used for placer mining (looking N.W.)

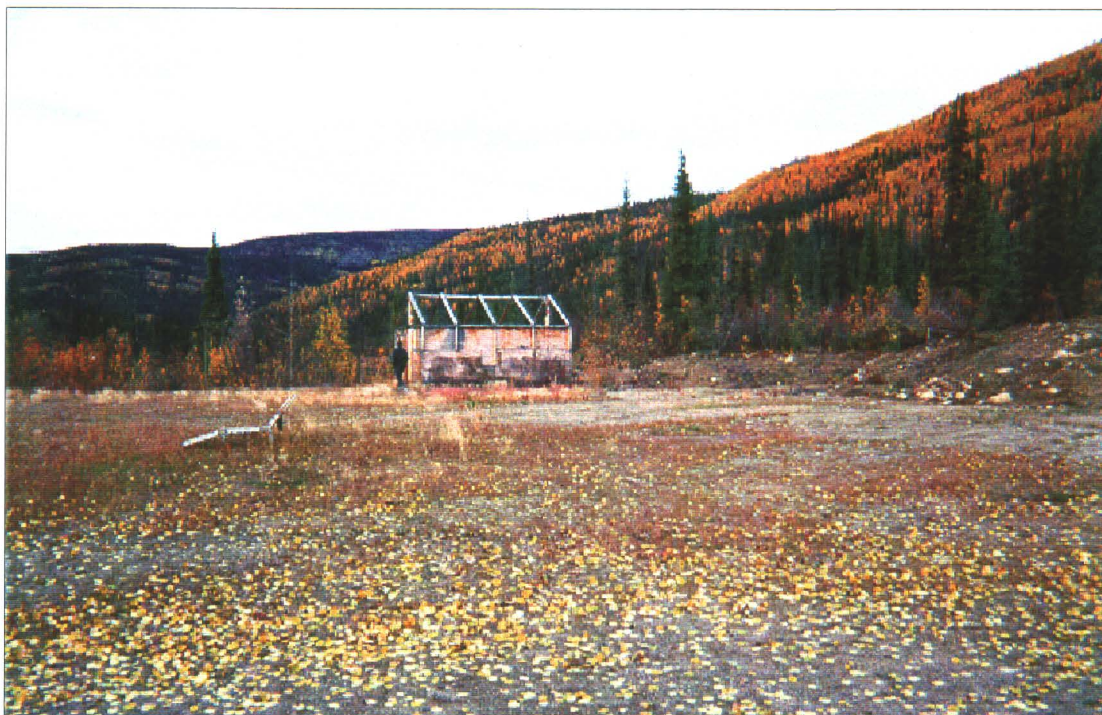
Building 88-K (Photo 88-9)

Old tent frame of wood construction (4 m W x 5 m L) located northwest of the old trailer along the north side of Dublin Gulch Road. No hazardous or non-hazardous materials were apparent within or around this structure.

Photo 88-9 : Dublin Gulch. Exploration Camp- tent frame near access road (looking N.W.).

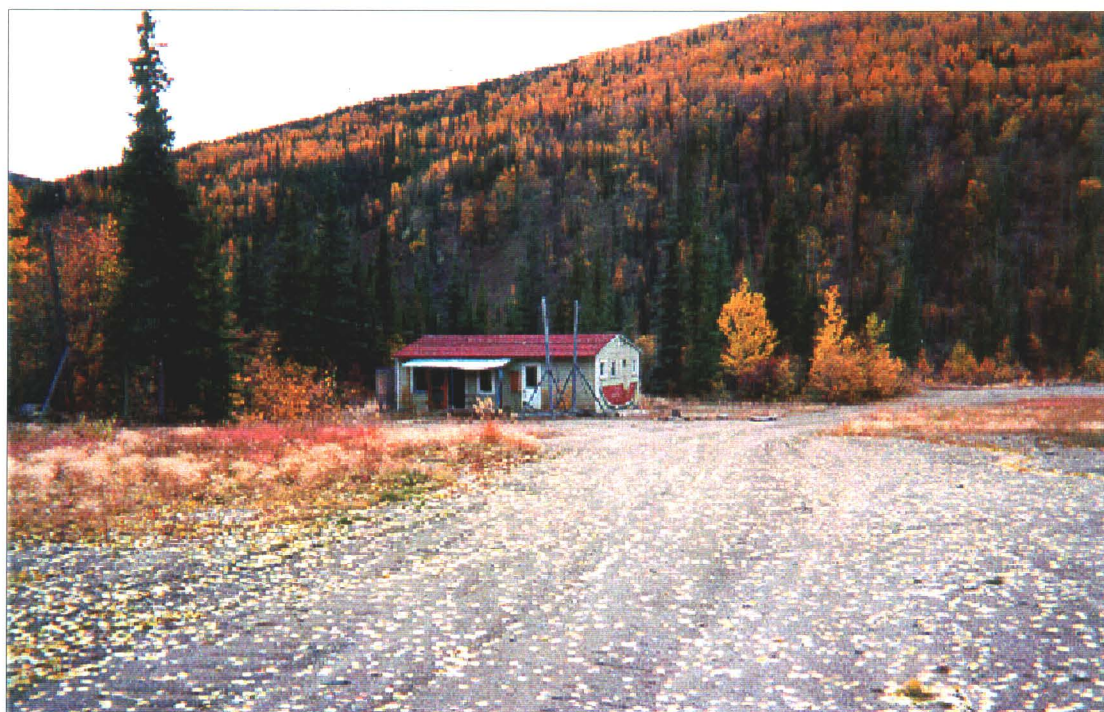
Building 88-L (Photo 88-10)

"Watermelon" shack of wood construction (3 m W x 8 m L) located along the south edge of Dublin Gulch Road. Building is stable and well-maintained. Non-hazardous materials within the building consisted of domestic debris. A cluster of corebox piles (Photo 88-11) were also observed to the east of the shack. No hazardous materials were apparent in the vicinity.

Photo 88-10 : Dublin Gulch. Exploration Camp - "watermelon" shack along access road (looking S.)

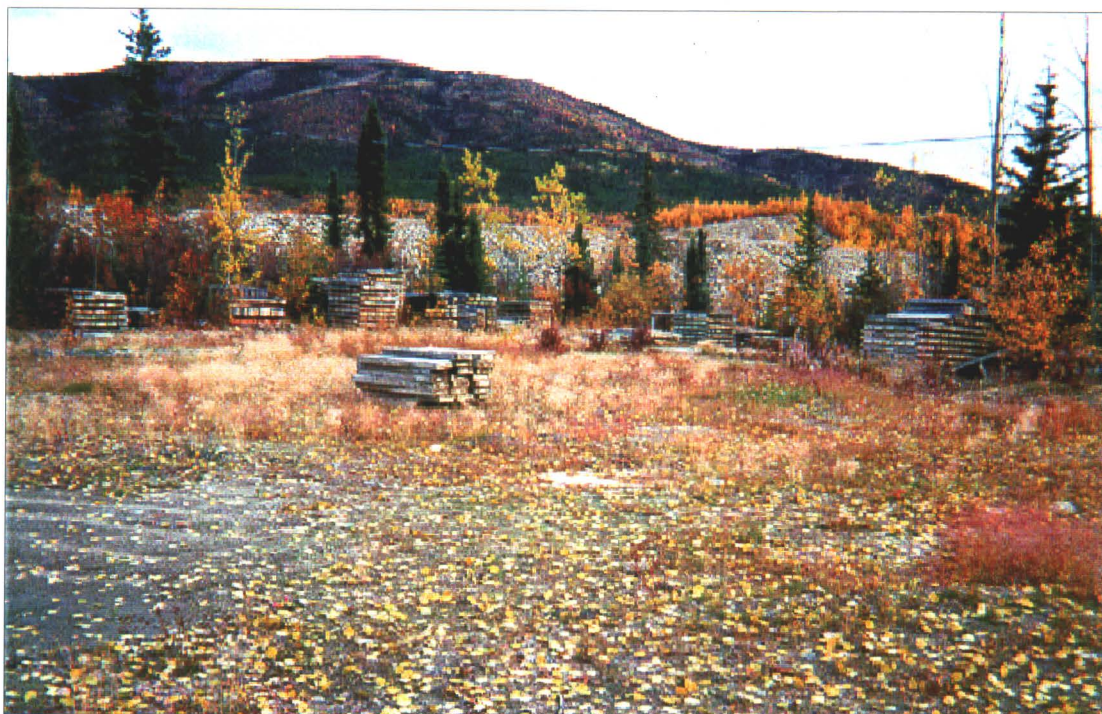
Photo 88-11 : Dublin Gulch. Exploration Camp - core boxes along access road near "watermelon" shack.
