# Enhancing Yukon trade corridor resilience to northern geohazards

Overview of winter hydrology geohazards  
and icing mitigation strategies | Overview  
Report | August 2024

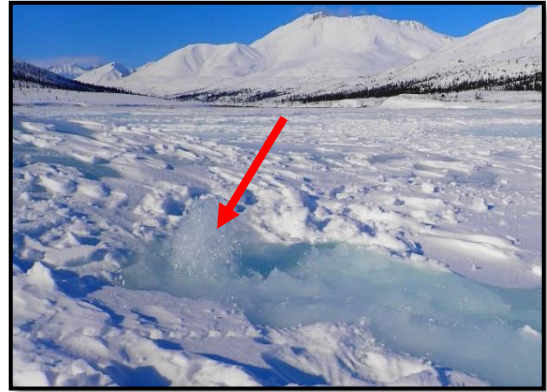
Figure 3. Pressure-driven overflow through an augered hole at km 72 on the Dempster highway on Apr 4, 2024.

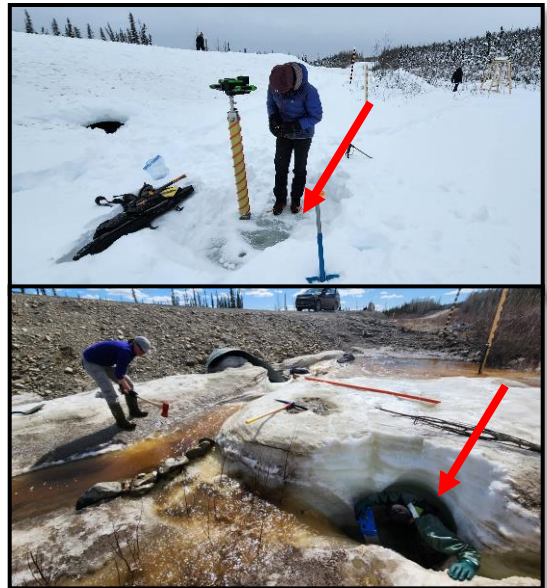
Figure 4. location of an augered hole at km 32.6 on the Dempster highway in March 2023 (top) and the expansion of this drainage hole by early May 2023 (bottom).

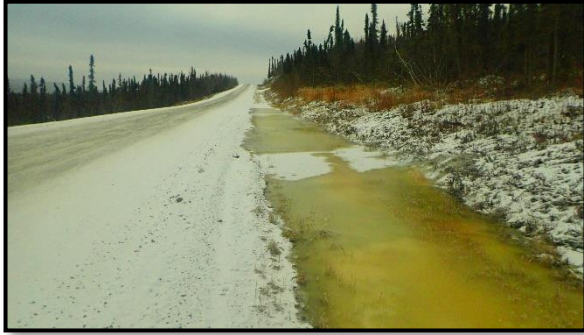
Figure 6. Groundwater-induced icing near km 29 on October 28, 2022.

In years where groundwater discharge remains high throughout the winter (i.e., after a wet fall), extensive icing occurs, originating from the highway's left or west side (upslope). In most cases, this discharge seeps into the ditch, causing icing along hundreds of metres along the road. Seven discrete areas of icing were observed in winter 2022-2023 between Km 16 to 32 for a total of 1.8 km of affected highway, but the most intense groundwater seepage site is located close to km 29. Culverts within these active icing zones quickly become plugged with ice, causing drainage problems in the spring, if not before.

- Blockage of targeted culverts in the fall
- *Investigation of historical upslope groundwater disturbance*
- \*Frost belts upslope of highway
- \*Thermosyphons upslope of highway
- \*Groundwater drainage or dewatering

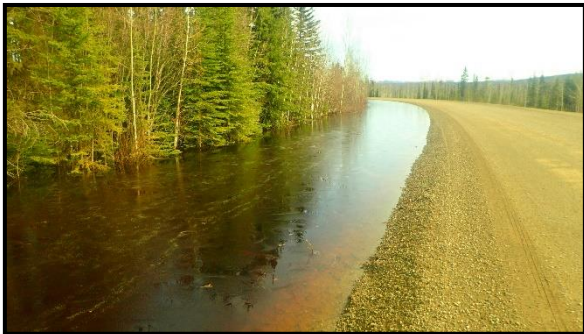
Figure 7. Water ponding on the upslope of the Dempster Highway near km 29 on May 9, 2023.

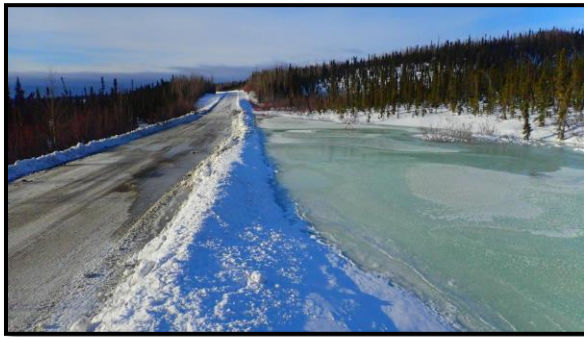
Figure 9. Unnamed Creek (km 32.6) wetland on March 24, 2022.

- Removal of decommissioned steam pipes and heat tapes
- Blockage of culvert #3 with inflatable device
- Snow damming of auxiliary culvert #5
- Reduction of generator operation time
- Solar panel energy source for heat tape
- Spring drilling in front of main culvert #4
- Snow management (protect culvert outlet against snow accumulation)

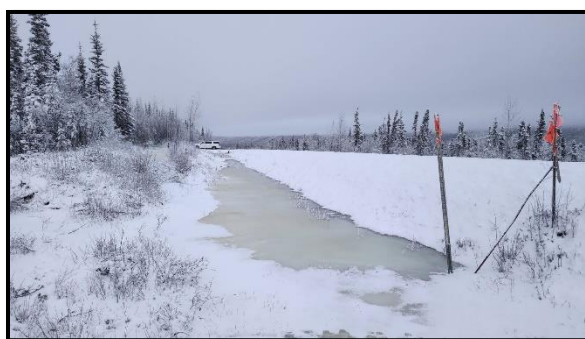
Figure 11. Unnamed Creek (km 33.8) culvert head and ditch on Dec 9, 2022.

A stream drains a wetland complex that lies north of the highway. The stream reaches the highway at km 33.8 at an angle through an artificial ditch. During winter, the ditch fills with aufeis, and a depression in the berm enables overflow to reach a secondary culvert at km 33.9. A heat tape is installed at that secondary location (the culvert is damaged and needs to be replaced) to guide overflow to the culvert. Unfortunately, this mitigation is only partially successful.

- Addition of an auxiliary culvert made of plastic (currently being considered with HPW-TMB)
- Reduction of generator operation time
- Solar panel energy source for heat tape
- Improvement of surface drainage to auxiliary culvert
- Snow management

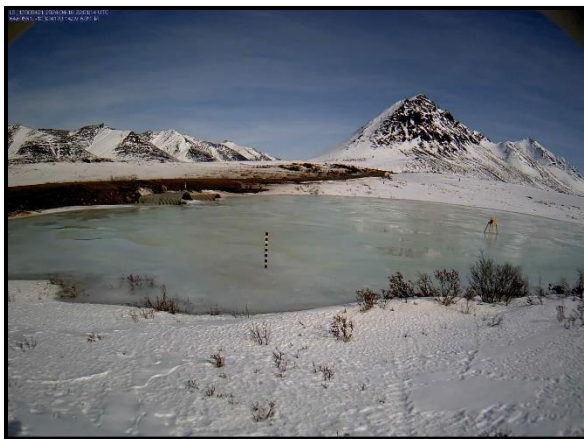
Figure 18. Timelapse photo of East Blackstone River culvert head on Apr 18, 2024.

The East Blackstone River headwaters lie in the Ogilvie Mountains. The river drains several alpine valleys through a permafrost-rich lowland that parallels the Dempster Highway from ~km 80 – km 85.9, where it crosses the road through two large (Ø 4.5 m) structural culverts. The East Blackstone River continues to parallel the highway downstream of the crossing until it reaches the Blackstone River near km 115. Aufeis routinely forms upstream and downstream (down to km 88) of the culverts (Figure 17/Figure 18), causing drainage concerns across the road before and during snowmelt. Aufeis also forms on the river surface at other locations along the East Blackstone River. However, it only seems to represent an immediate road infrastructure or safety hazard between km 85.9 and km 87.5. High winds and wind-blown snow play a role in forming this aufeis.

- Snow management (removal from culverts, snow dams upstream of culverts during mid-winter period)
- Late-winter ice surface darkening
- Heat sources fed by solar panels
- Replace culverts by a bridge or move crossing to another location

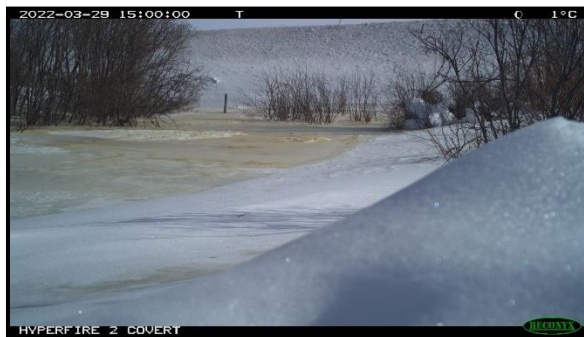
Figure 20. Slavin Creek (km 98.6) timelapse photo of culvert head buried by aufeis on March 29, 2021 (Photo provided by McMaster University, Sean Carey's research team).

A groundwater-fed creek drains through permafrost-rich tundra west of the highway at km 98.6. The creek crosses the highway through a single culvert which downstream end is hanging above a relatively deep pool. Aufeis plugs the culvert at this site each winter, affecting a large area immediately upstream of the culvert during the spring. The permanent steaming pipe has apparently been damaged and has not been replaced. Blockage begins during the first cold nights and usually reaches 100% before the end of winter. The thickness of this aufeis is likely limited to 2 m, either because of low winter water supply or by the porous nature of the lower road embankment. However, the spring overflow can be many meters deep.

- Early observation and assessment of ice conditions
- Solar panel energy source and new heat tape
- \*Ice drilling from downstream end of culvert
- Installation of an auxiliary culvert at higher elevation to carry snowmelt runoff

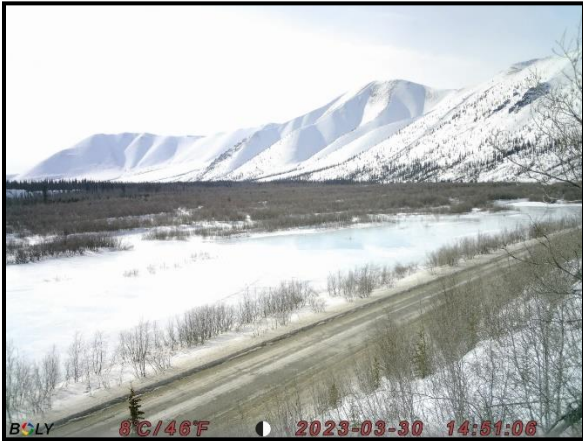
Figure 22. Timelapse photo of Blackstone River at km 143.7 on March 30, 2023.

The Blackstone River flows parallel and generally some distance from the highway until km 145.6, where the highway turns west into Windy Pass. Between km 142 and 144, riprap has been installed to protect the road against erosion. The Blackstone River develops aufeis on its surface at many locations, including along that segment. Aufeis commonly achieve a thickness of more than 2 m near km 143, and this probably represents a higher flood risk than high open water flow conditions. This aufeis can damage riparian vegetation and rip rap. Ice blisters have been observed in recent winters, confirming that winter flow conditions can be pressurized.

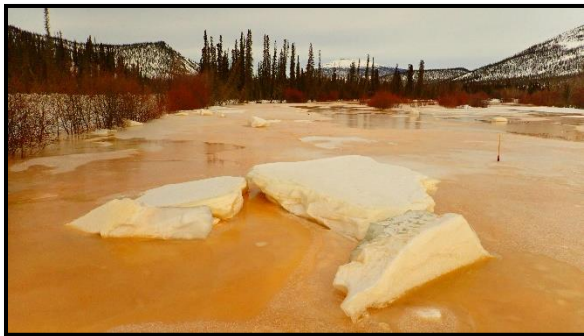
Figure 24. New (colored) overflow and aufeis along Engineer Creek near km 173 on April 3, 2024.

Engineer Creek is a sediment-rich and iron-rich (orange) creek that drains from the south and reaches the Dempster Highway at km 160.6. It crosses the highway at this location and then flows parallel to the highway until km 195. Engineer Creek is highly streams susceptible to erosion processes but also experiences river aufeis (Figure 24) and flooding, just like several other streams such as Red Creek (km 168.2) that cross the Dempster Highway in that area. Engineer Creek flows immediately beside the road embankment at many locations, exposing it to water-related hazards in all seasons. Stream crossings at km 160.6 (Engineer Creek, Figure 23) and km 168.2 (Red Creek) comprise large culverts that seem to initiate and promote aufeis development.

- Monitoring and early-observation of aufeis development at stream crossings (e.g., km 168.2)
- Solar panel energy source and new heat tape (km 160.7, km 168.2)
- Snow management (removal from culverts, snow dams upstream of culverts at km 168.2)
- Replacement of culverts by a bridge (km 160.7)

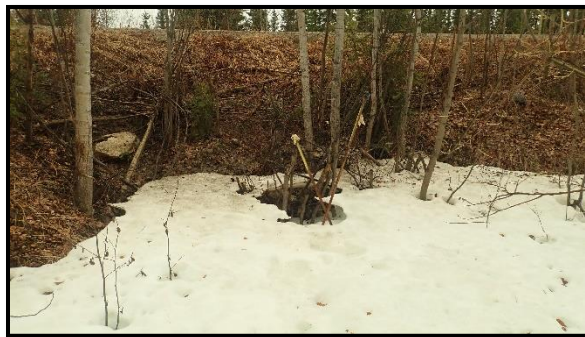
Figure 27. Gochis Creek after the partial melt of a 1.5 m-thick aufeis in May 2022.

Gochis Creek drains north to south into the Stewart River, intercepting the Silver Trail at km 3.9. Stream aufeis develops upstream of the Trail and can entirely plug one of the culverts, as observed during winters 2021-2022 and 2023-2024. The steam pipes at the culvert heads contribute to intercepting debris, preventing optimal drainage and potentially promoting a complete blockage by ice. In most years, the creek may carry enough groundwater heat to continue flowing under an ice cover without causing overflow events. However, this condition is only achieved under specific winter weather sequences and could be supported by accessible, low-energy interventions. Aufeis at this location may be initiated downstream of the culvert, which influences mitigation strategies.

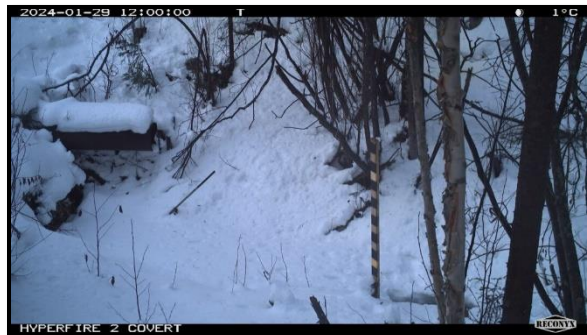
Figure 29. Timelapse camera photo of Unnamed Creek (km 17.1) on Jan 29, 2024.

An unnamed creek drains from the northwest and intercepts the Silver Trail in a relatively deep canyon at km 17.1, where it drains through a damaged (capacity reduction of about 20%) primary culvert. Though stream-fed augeis filled the lower part of this canyon in winter 2021-2022, no significant augeis developed in winter 2022-2023 or 2023-2024. As stated for km 3.9, and as high-resolution data revealed, the creek carries enough heat to maintain an under-ice flow throughout the cold season without producing overflow events and augeis under most early and mid-winter weather scenarios. However, in years where overflow would occur, simple mitigation measures could resolve the issue.

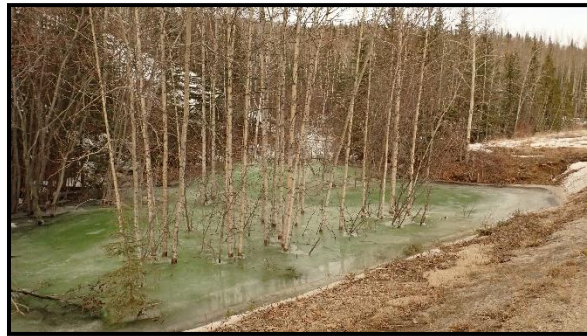
Figure 31. Photo of Lightning Creek with massive overflow on April 2, 2024.

Lightning Creek drains from the north and crosses the Silver Trail at km 23.1 through damaged (capacity reduction of about 20%) culverts before reaching farmland and, ultimately, the Stewart River. The creek was affected by aufeis formation upstream of the culverts during the winters of 2022-23 and 2023-24 (this is the opposite of what was observed at km 17.1). Both culverts were submerged by ice, suggesting that the staggered culvert mitigation strategy does not work efficiently. It seems that this creek may carry less heat than those located at km 3.9 and 17.1. At the end of winter 2023-2024, the high backwater on the upstream side of the Trail drowned the steam pipe heads and caused significant damage to the road embankment (closed lane for several weeks).

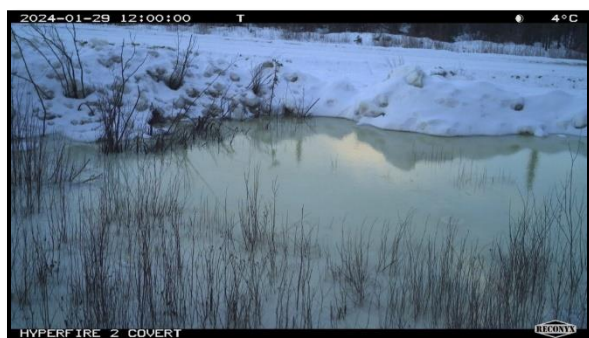
Figure 33. Timelapse photo of Glacier Hill Creek (km 60.1) culvert heads on Jan 1, 2024.

Glacier Hill Creek drains from the east in an area referred to as “glacier hill,” reaching the Silver Trail at km 60.1. The site, a low-gradient wetland, has developed significant aufeis in the past (as stated by HPW personnel), including during the winters of 2022-23 and 2023-24. The culvert seems to be responsible for this situation. Additional overflow soon compromises road safety, requiring frequent ice removal and steaming. Repairs to the road embankment along the culvert have also been required. In the spring of 2023, snowmelt overflow was carried by the east ditch to km 61.4, flooding segments of the eastbound lane. Fine sedimentation also seems to represent a challenge to mitigate.

- Installation of a short heat tape operated as needed
- \*Snow insulation was proposed by HPW personnel, and this could be tested. If not successful, a snow berm could be built to temporarily control overflow.
- Installation of heat tape connected to the grid or to solar panels (in the spring) and operated as needed
- \*Heat tape and wood posts in the ditch from km 60 to km 60.3
- \*Replacement of culvert by a small bridge and restoration of the Creek channel

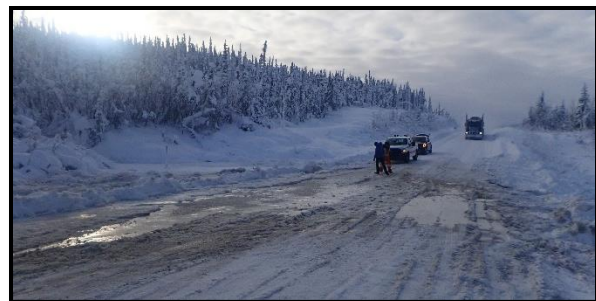
Figure 36. Overflow and glaciation on the Silver Trail at km 81.6 on Feb. 13, 2023.

A very shallow creek drains from the east, intercepting the Silver Trail at km 81.6. Many broken steam pipes encumber this site in the upstream ditch, and an excavator has damaged the culvert head. Significant stream-fed aufeis formed at this site during the last three winters of observation, resulting in a flooded and damaged road embankment (Figure 36). The culvert seems to be initiating and causing some of the aufeis. During the winter of 2023-2024, groundwater seepage from the right slope (when looking upstream) contributed to the development of a massive icing mount.

- Removal of all existing steam pipes as they probably contribute to aufeis development in the culvert
- Installation of a short heat tape operated as needed
- Installation of a vertical graded rod or pole at the head of the culvert
- \*Rising the water depth upstream of the culvert and install wood posts to promote the early formation of an ice cover
- \*Replacement of metal culvert by two plastic culverts, one to be entirely blocked at its upstream end each fall

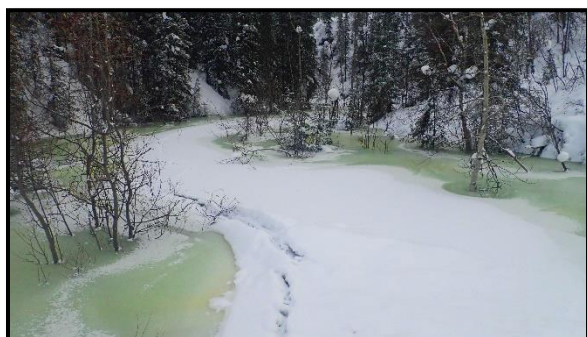
Figure 38. Photo of Corkery Creek with about 5 m of backwater on March 22, 2022.

- Improvement of snow management (reduce velocity of snowplows so that the snow does not block the culvert inlet)
- Extension of heat tape connector to improve accessibility from the road
- Connect heat tape to a generator or a solar panel (during later winter), as needed, when backwater is first observed
- Consider removing heat tape from steam pipe to reduce heat loss
- \*Addition of an auxiliary culvert made of plastic at higher elevation
- \*Prevent cold air from entering downstream end of culvert

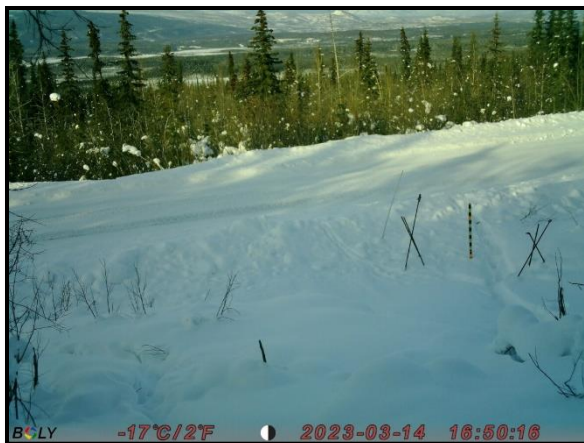
Figure 40. Timelapse camera photo of Unnamed Creek (km 98.3) on Mar 14, 2023.

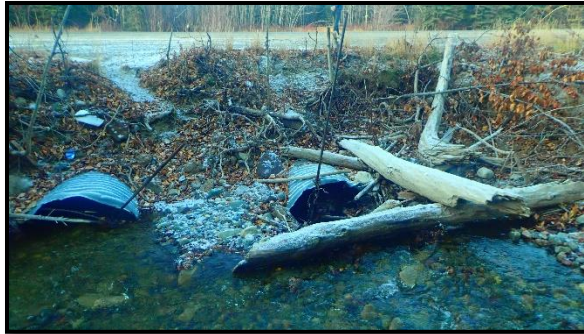
Figure 48. Head of three culverts in the Montague roadhouse rest area in October 2022 (culverts are mostly blocked by debris).

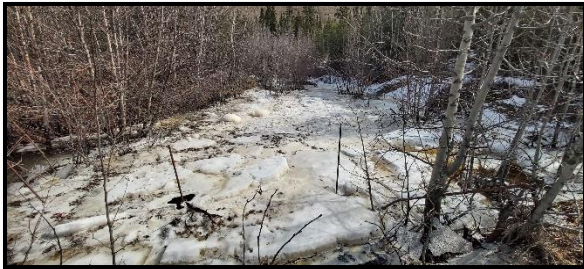
Figure 49. Same location as in Figure 45, but looking upstream, in May 2022 (creek is full of augeis, overflow was redirected in ditch to the next culvert located 1 km away).
