# Vulnerability of the north Alaska Highway to permafrost thaw

## Design options and climate change adaptation

Northern Climate ExChange  
YUKON RESEARCH CENTRE • Yukon College

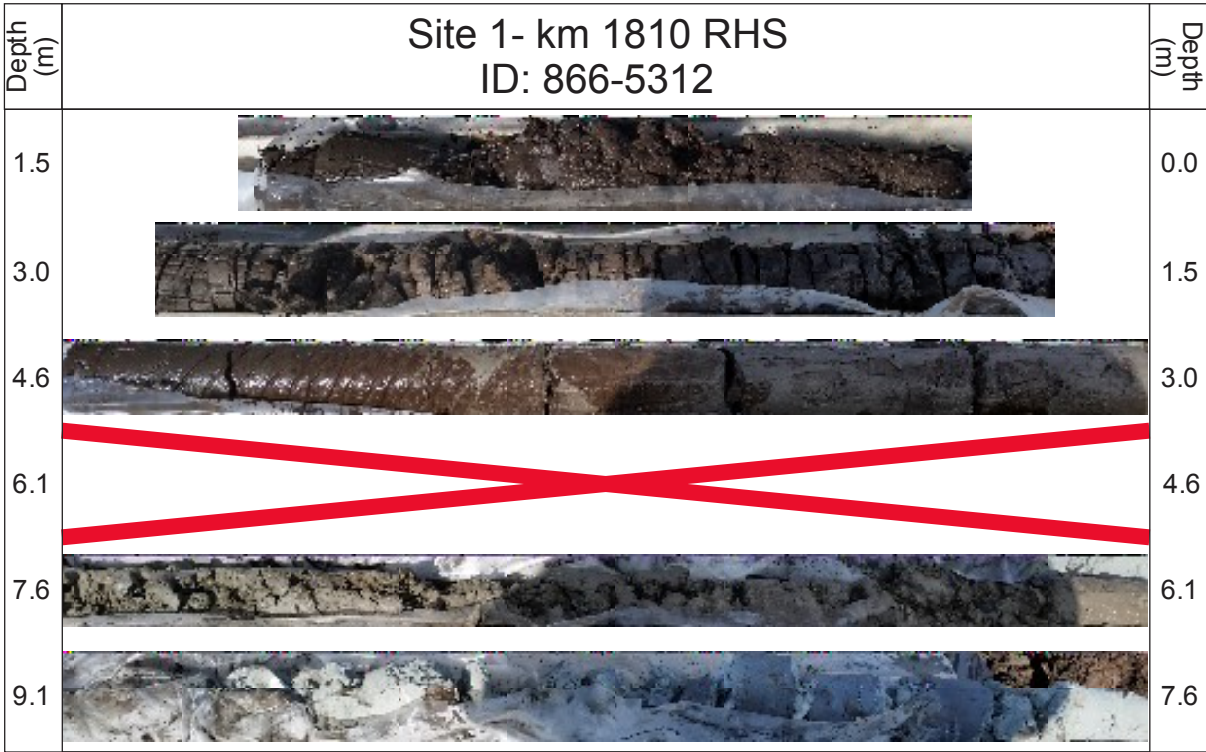
**Figure 4.1.4. Cores collected from borehole 866-5312**

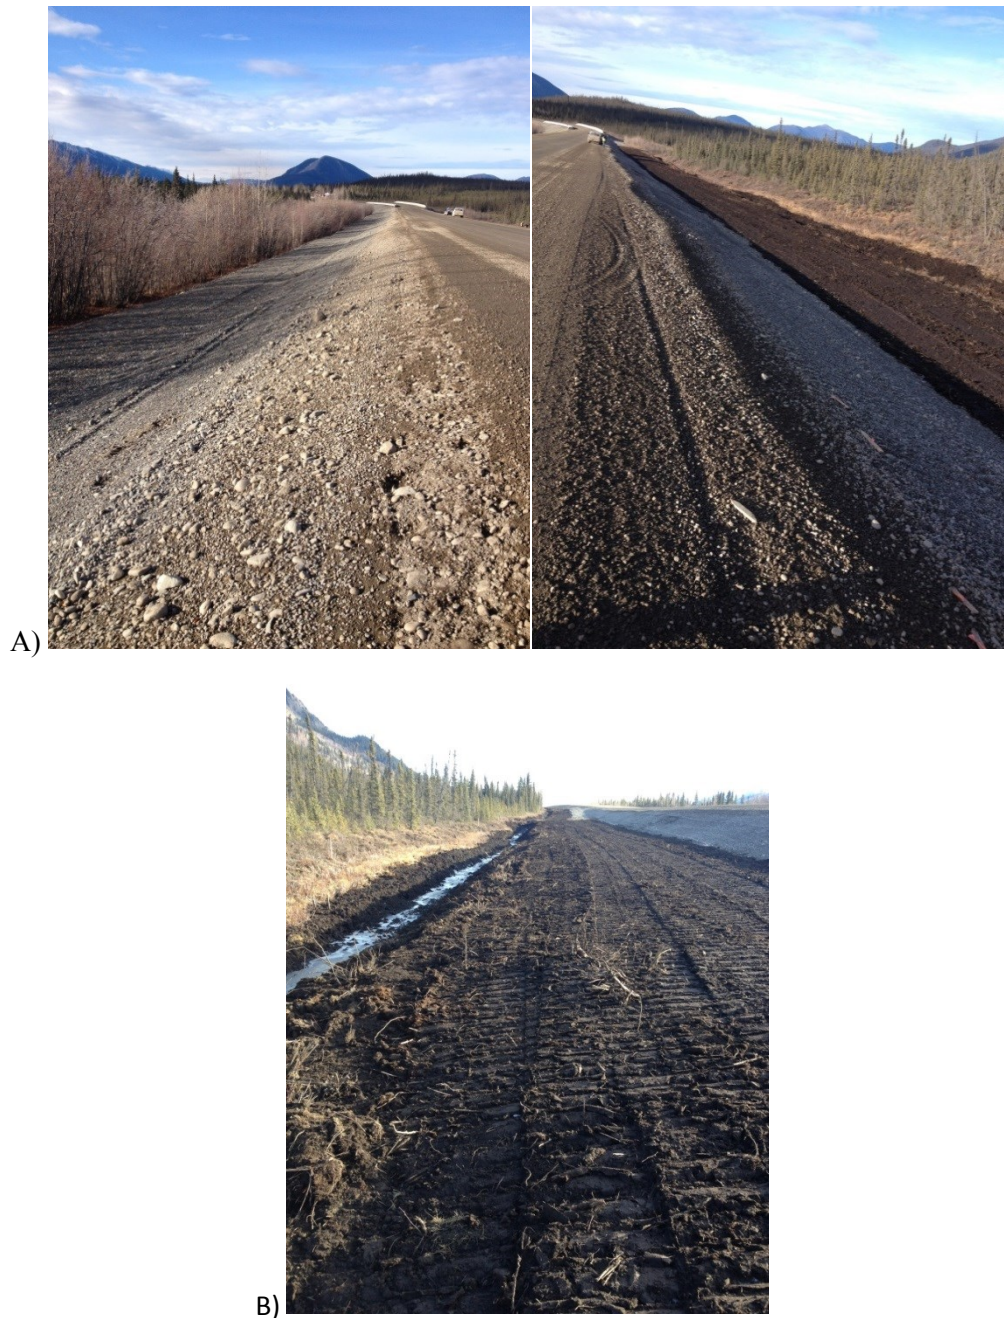
The black topsoil on the right side of embankment was laid in September 2015 using the material removed from the ditch (Figure 4.1.8.). While this topsoil will increase heat intake in the ground at the toe of the embankment during the few first years, vegetation cover will develop and progressively contribute to ground cooling along the embankment.

**Figure 4.1.8. Koidern No. 2 adaptation site, km 1810.2 for A) Left and right sides of the embankment, facing north; B) Right side of the embankment, facing south.**

The vegetation cover on both sides of embankment is comprised of trees, shrubs and other plants (Figure 4.1.8). Specifically, on the left side of the road (when facing north), high-density vegetation is distributed (about 90% of land covered) about 4 m from the toe of embankment. On the right

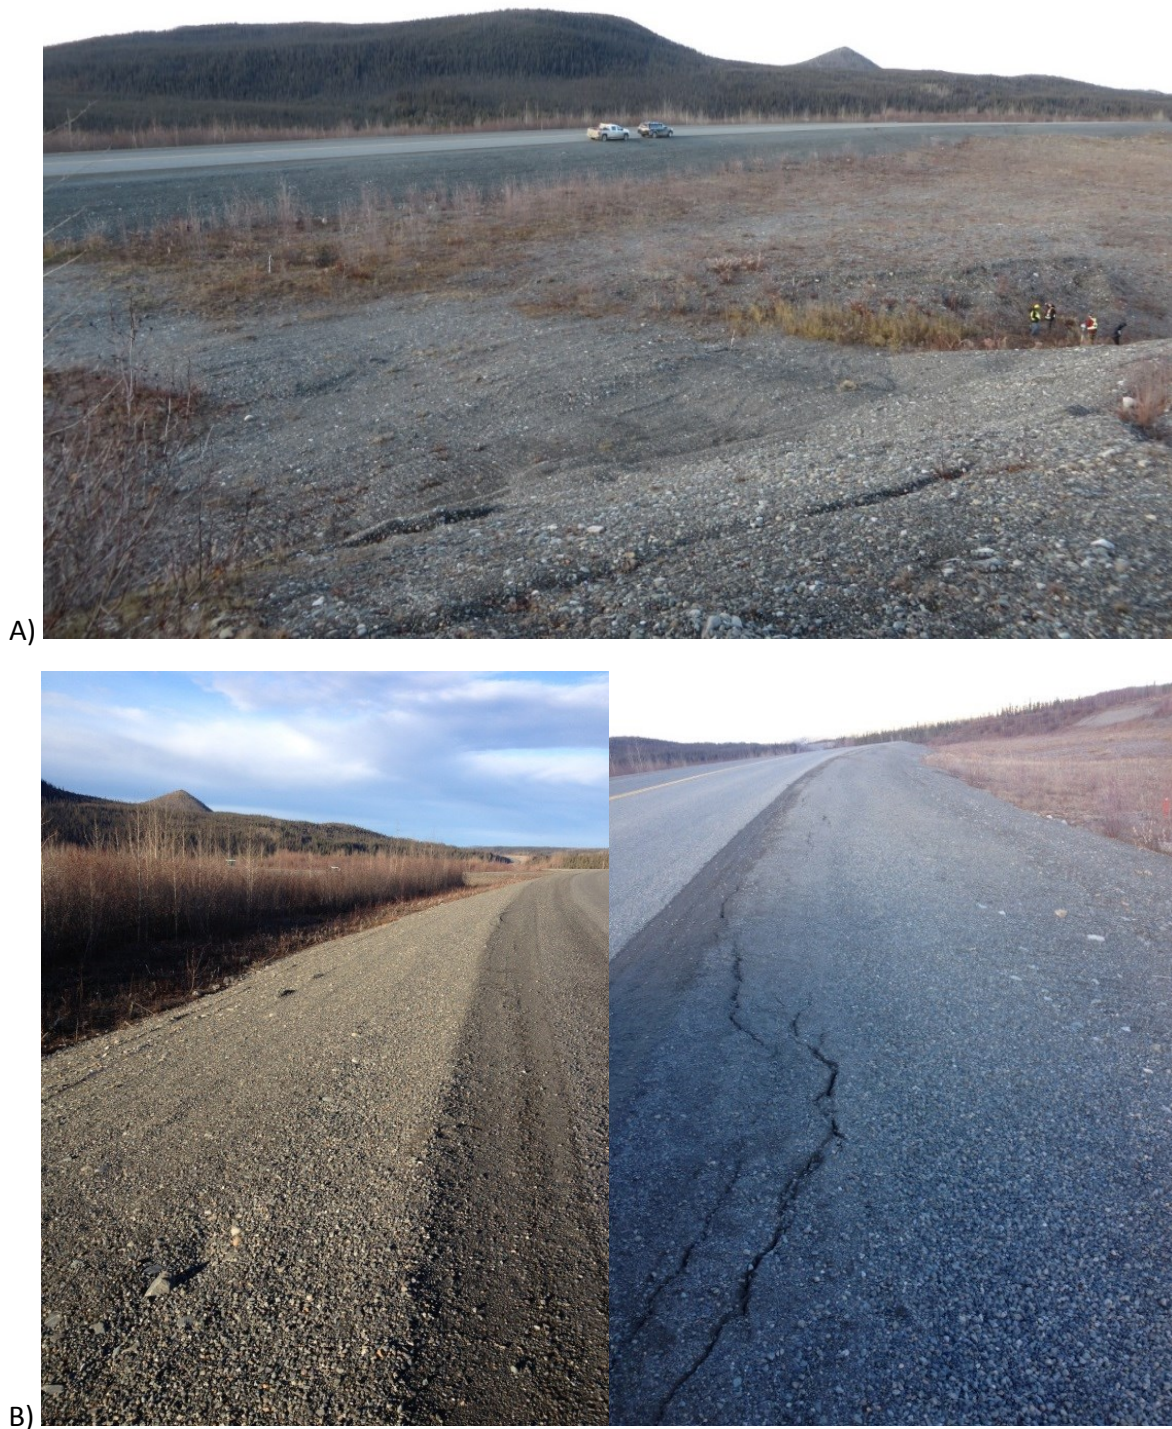
A large thermokarst pond is present on the Left Hand Side of the road. Its formation is attributable to the melting of a substantial amount of ground ice thaw following the construction activities.

Figure 4.2.11. Dry Creek adaptation site, km 1841.3 for A) General view of the site, facing west; and B) Left and right hand sides of the embankment, facing north

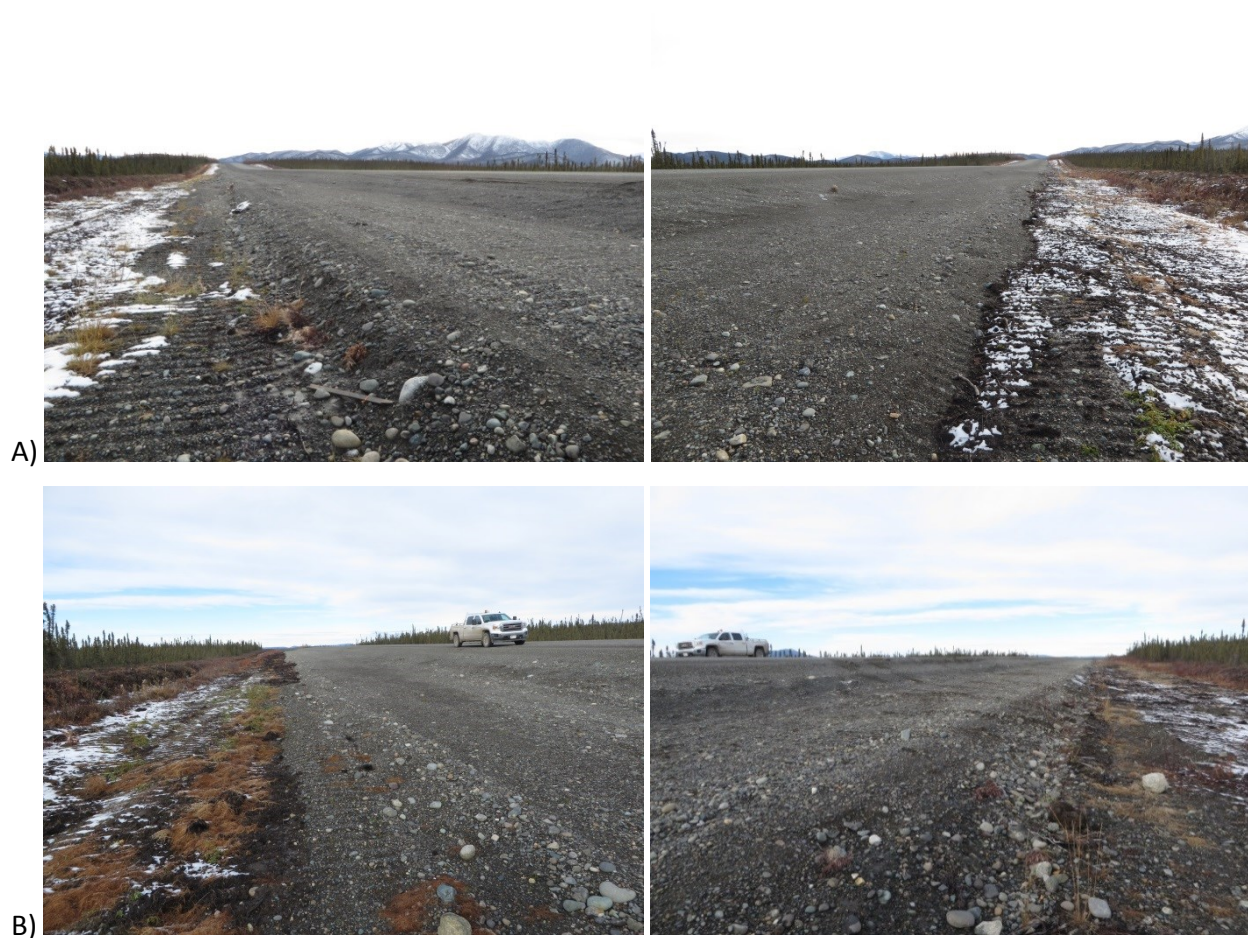
This road passes through a forested area and only the areas along the road are vegetation-free (Figure 4.3.8). Specifically, between the toe of the embankment and the ditches on both sides, the only vegetation is scarce grass, while the tree coverage outside the ditches is relatively thick.

**Figure 4.3.8. Enger Creek adaptation site for A) Left and right sides of the embankment facing south; and B) Right and left sides of the embankment facing north.**

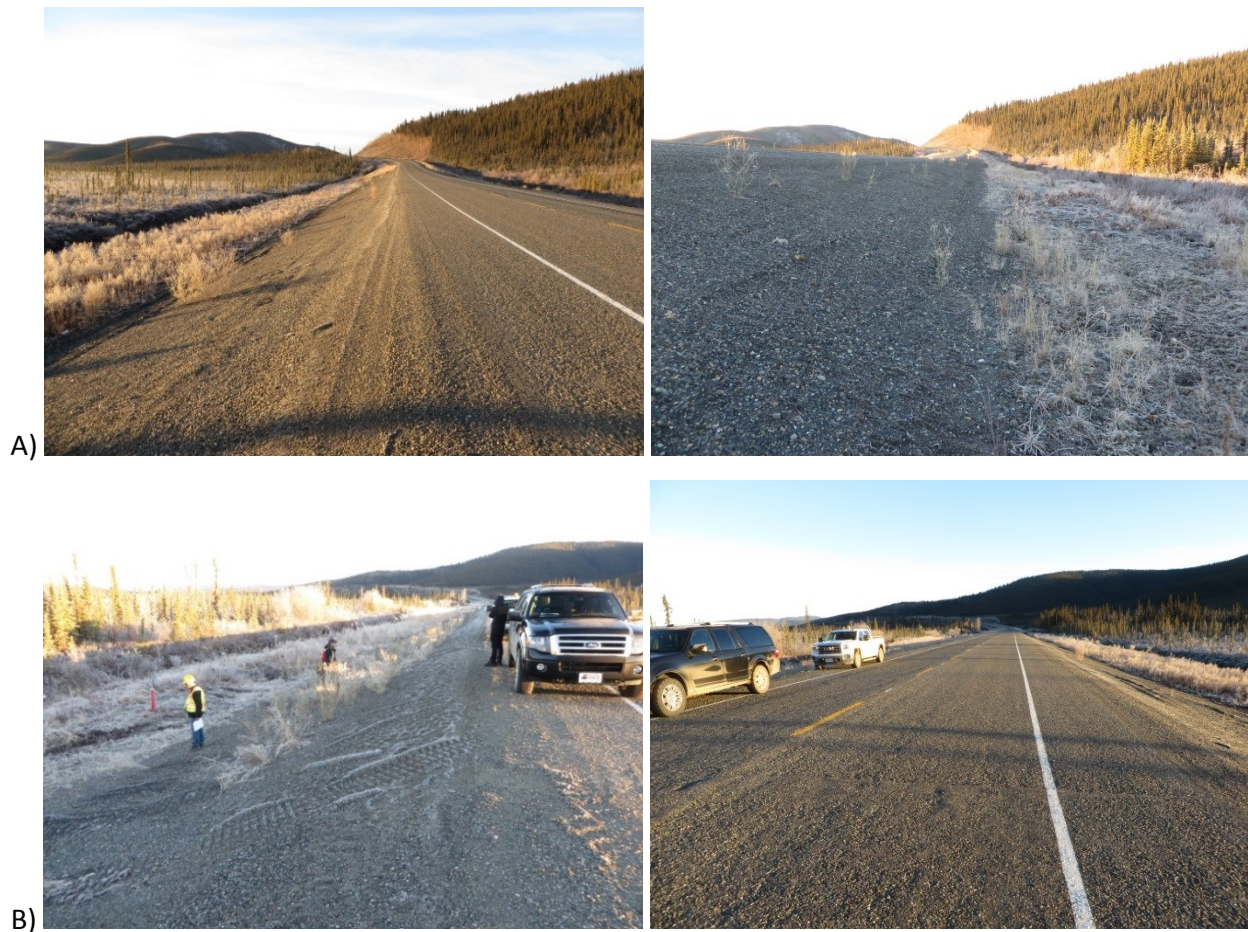
The areas between the toe of the embankment and the ditches are partly covered by grass, shrubs and other plants. Outside the ditches, the site is characterized by a higher concentration of trees and shrubs. The trees have lower density than the shrubs.

**Figure 4.4.10 North to Beaver Creek adaptation site, km 1896 for A) Left side and right sides of the embankment, facing south; and B) Right side and left sides of the embankment, facing north.**

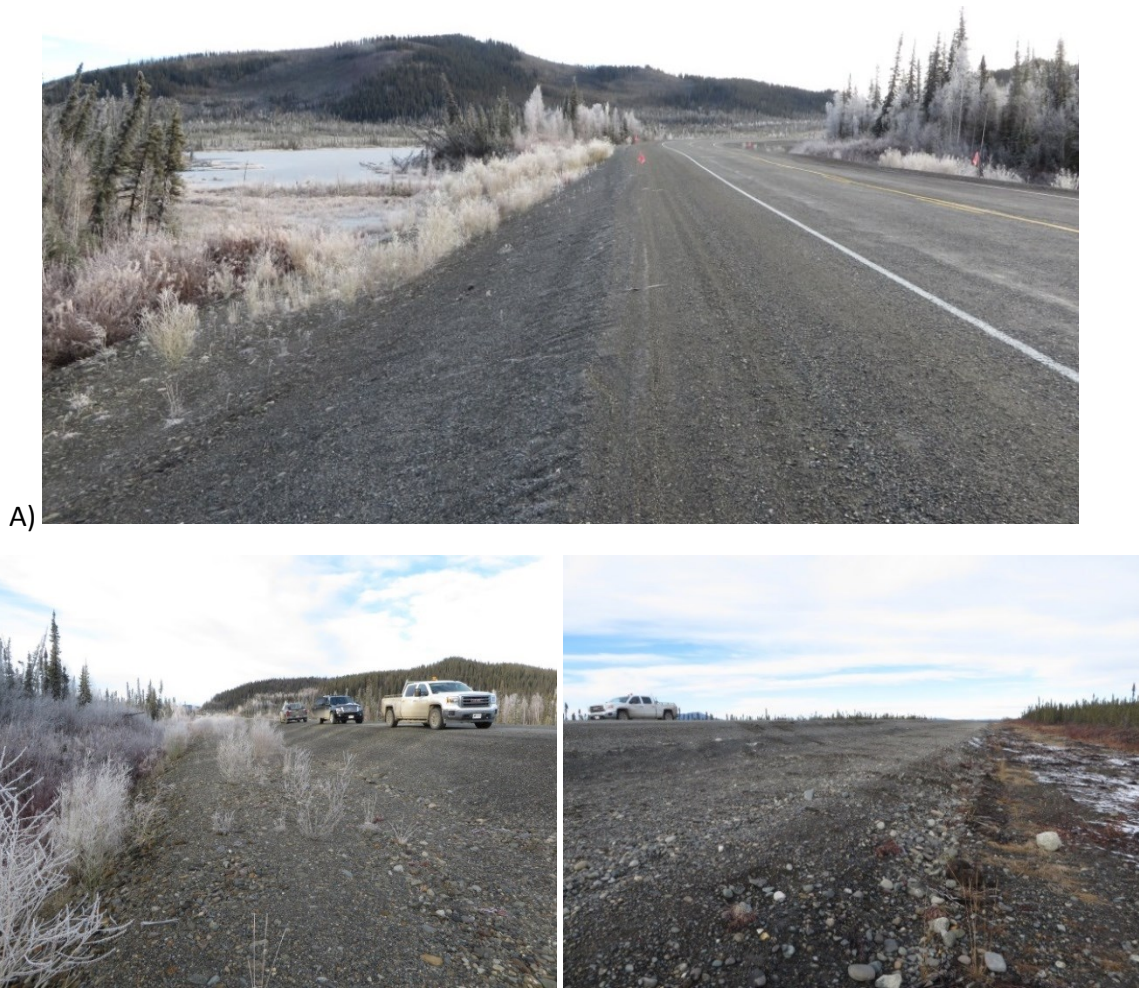
Bogs are present along the left side, they developed in the meanders of a relict fluvial system. Most of the terrain of this site is covered by vegetation, except in the areas along the road where sparse grass and shrubs can be observed (Figure 3.5.11).

**Figure 3.5.11** Mirror Creek adaptation site, km 1886 for A) Right side of the embankment, facing south; and B) Left and right sides of the embankment, facing north.

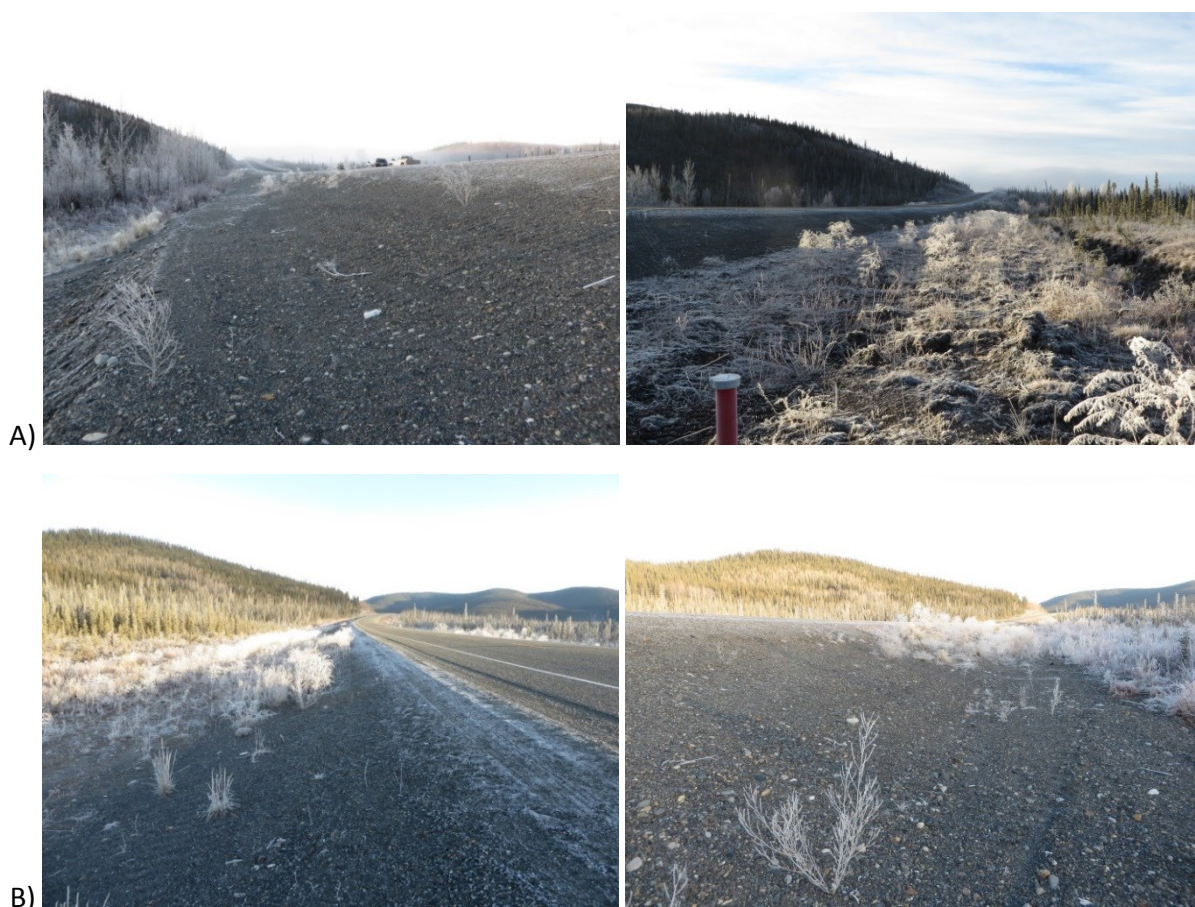
Some notable features of this site are two ditches that were dug in 2013, parallel to the road. The distance between the toe of the embankment and the ditches, are about 12 m at the left hand side, and 10 m at the right hand side. They are 4 m wide and 1.5 m deep, the shortest one being at the right hand side (Figure 4.6.9). A camera has been fixed near the long ditch to monitor the development of the ditch slump. The result shows that this ditch is strongly affected by thermal erosion and is becoming wider (Figure 4.6.10). A stream (① in Figure 4.6.9A) is intercepted by the ditch at the left hand side, flowing perpendicular to the ditch. Yet the ditch cut an ice wedge, at the same level as the stream that is also perpendicular to the ditch and the embankment. From spring to fall, the stream is fed by runoff water, and erodes the ice wedge. Now, thermal erosion has developed and is incising the terrain starting from the ditch to the west, exposing additional ice-rich permafrost and wedge ice. Besides stream (①), water also was flowing through culverts (② and ③ in Figure 4.6.9A) at the time of site visit in October 2015.

**Figure 4.6.10. North of Beaver Creek adaptation site, km 1895 for A) Right and left sides of the embankment, facing south; and B) Left and right sides of the embankment, facing north**

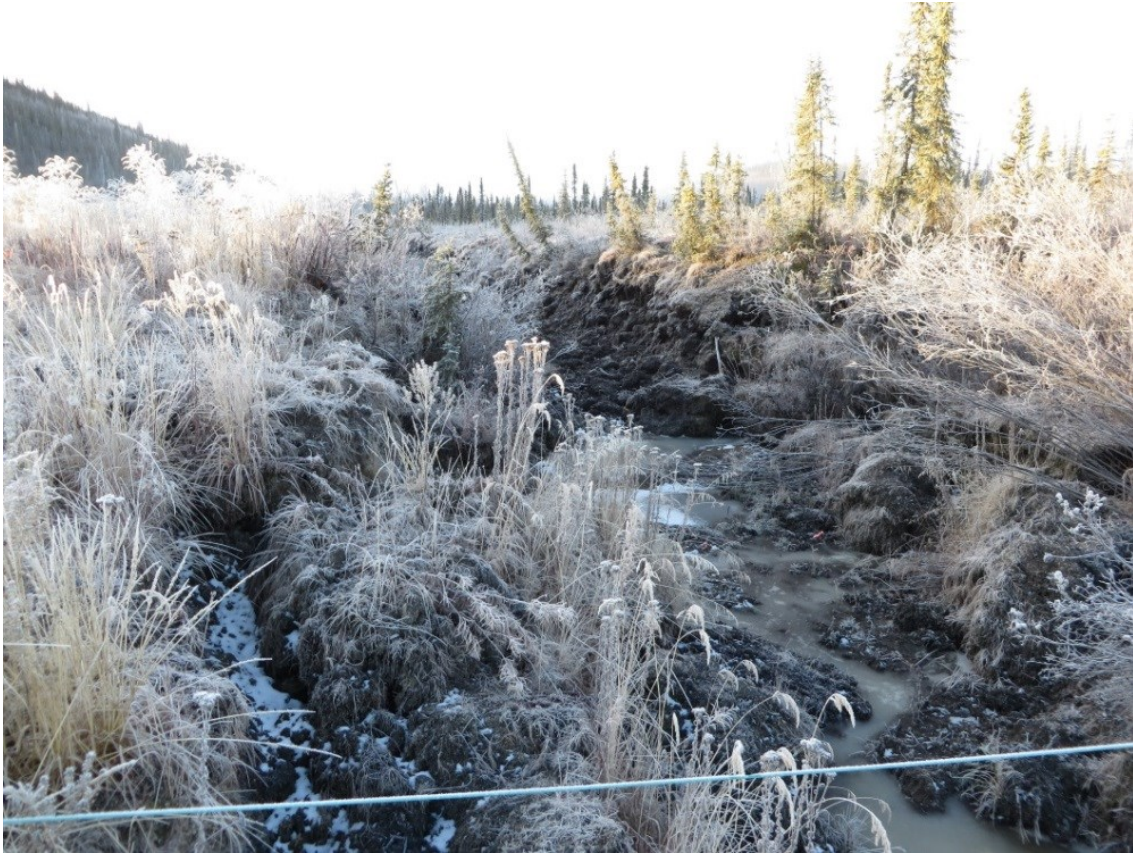
**Figure 4.6.11. Thermal erosion in the ditch, facing southwest.**
