APPLICATION FOR PIPELINE ABANDONMENT

**Report on an Inspection of the Deactivated Skagway, Alaska to
Whitehorse, Yukon Petroleum Products Pipeline**

**National Energy Board
June 1995**

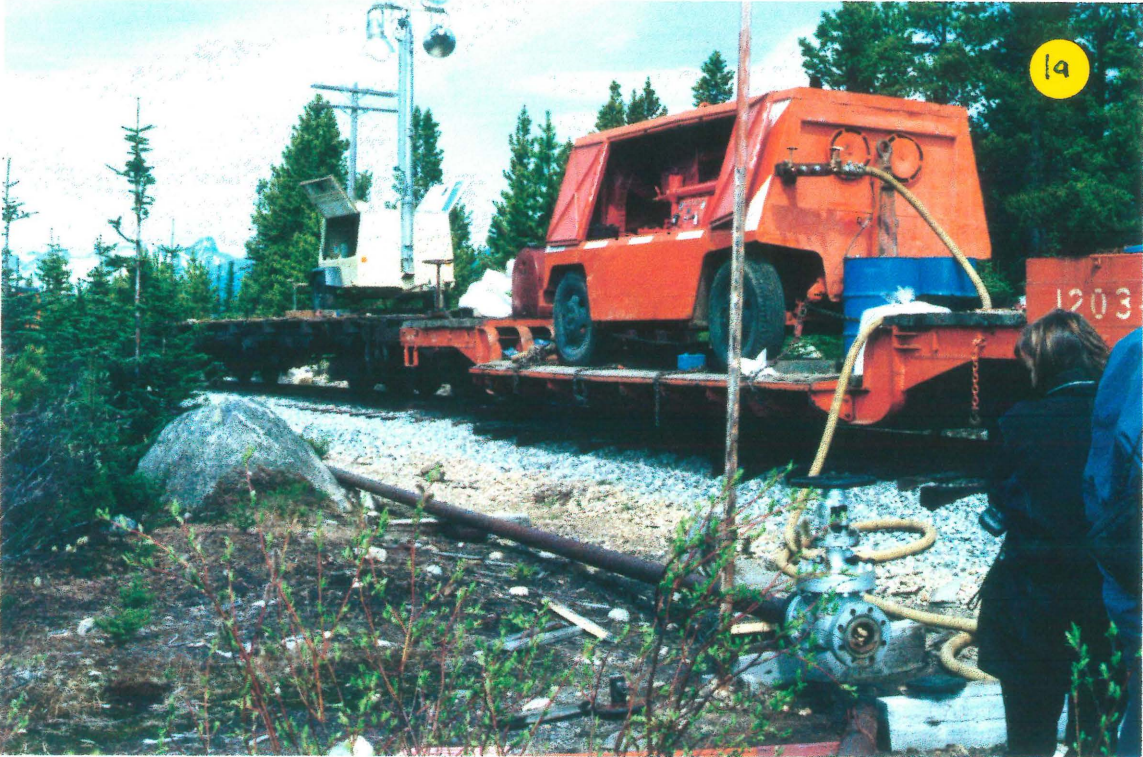
3.1a: Compressor for Pigging Pipeline

The first stage of the pigging program was underway at the time of the inspection (see photographs). According to YPL personnel, the pig was launched with about 600 kpa and was moving steadily with about 300 kpa air pressure behind it. After 20 hours, the pig had travelled to about mp 14, well onto the Alaska portion of the pipeline (i.e. mp 0.0 - 20.7), and an estimated 11,000 litres was recovered. The compressor and pig launching arrangement are shown in the attached photographs (see Photographs 3.1a and 3.1b).

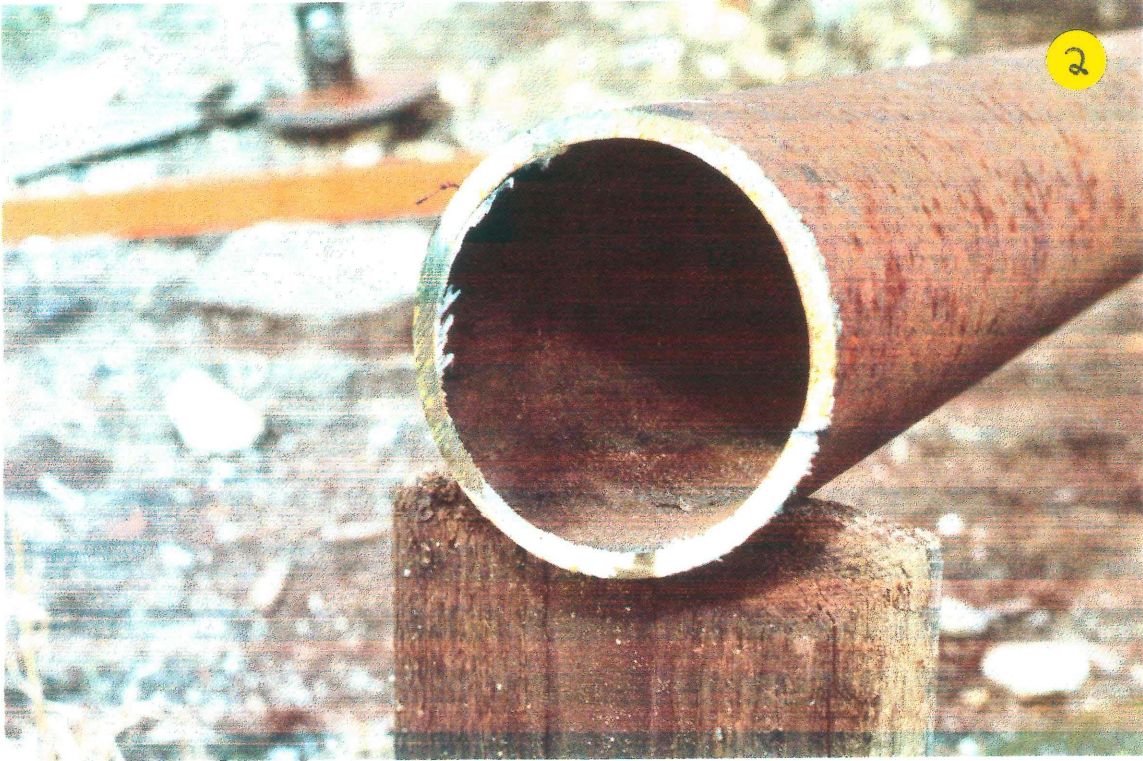
3.2: Inside Surface of Pipeline

According to YPL the pipeline has only transported clean refined products and that the inside walls will be adequately clean following pigging. It was observed at mp 33 that the inside surface of the pipe is smooth and free of oxides (see Photograph 3.2).

A more appropriate pigging procedure would involve measurement of the recovered volume as well as a series of pipeline taps, under controlled conditions, at low points to confirm that all fuel has been removed. At mp 33 it was observed that the interior surface of the pipe was clean and according to YPL cleanliness of the inside surface has been observed at the numerous locations where pipeline cut

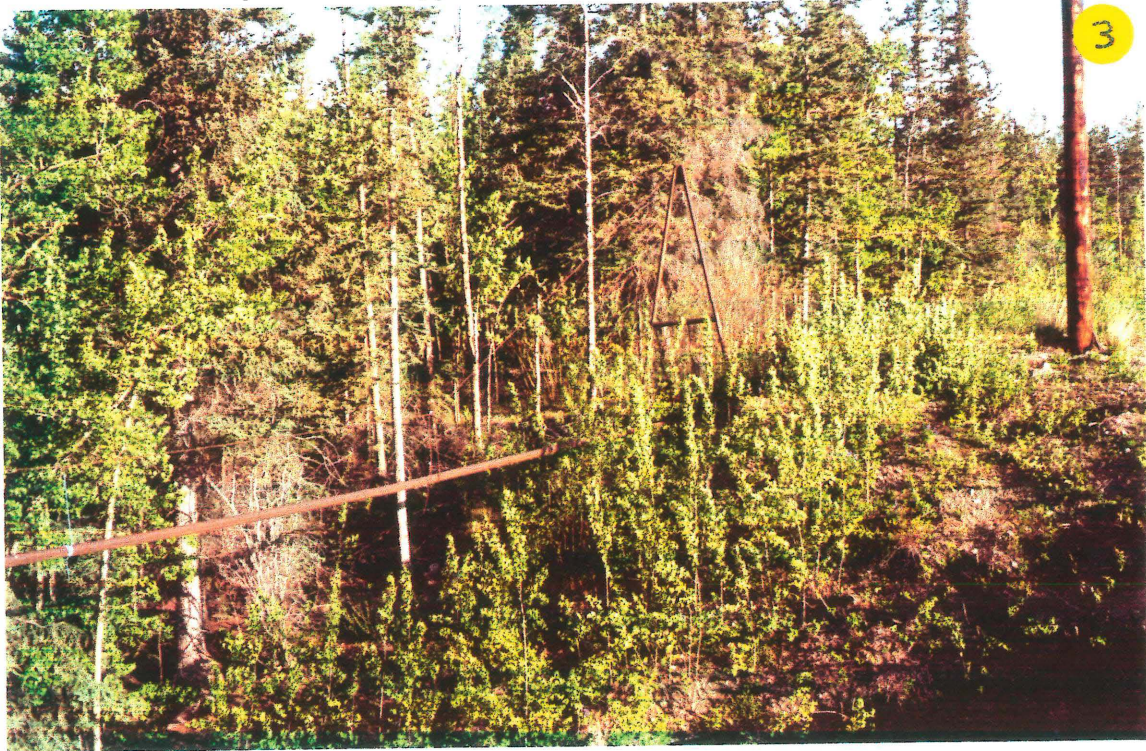
3.3: Pipeline and Support over Creek, Alaska Highway kmp 1470

Inspection of the pipeline in the City of Whitehorse and along the Alaska Highway revealed several locations where the pipeline is buried beneath the highway itself and developed roads intersecting the pipeline. Between Whitehorse and Carcross the pipeline is buried beneath several improved and unimproved roads. Through Carcross much of the pipeline passes beneath a road and a parking lot near the town centre. Immediately south of the town the pipeline is suspended from a railway bridge across the Nares River. At about mp 32.8 the pipeline passes beneath the S. Klondike Highway. A typical arrangement for supporting the pipeline across a creek was observed at Kilometre post ("kmp") 1470 of the Alaska Highway (see Photograph 3.3).

While YPL's current plan involves removal of the pipeline, in terms of public safety the empty pipeline will not present a significant hazard except at those creek crossings and gullies where the pipeline is suspended above the ground. At these locations, unauthorized persons climbing on the pipeline could fall a considerable distance and the pipeline and cables used to support the pipeline could be hazardous to persons operating snowmobiles and all-terrain vehicles along the pipeline. At several crossings of significant creeks and other natural obstacles the pipeline is suspended from railway bridges. With time the cables and straps supporting the pipeline will deteriorate and fail which will allow the pipeline to sag into the creek or gully. This in turn will catch debris and impede natural drainage.

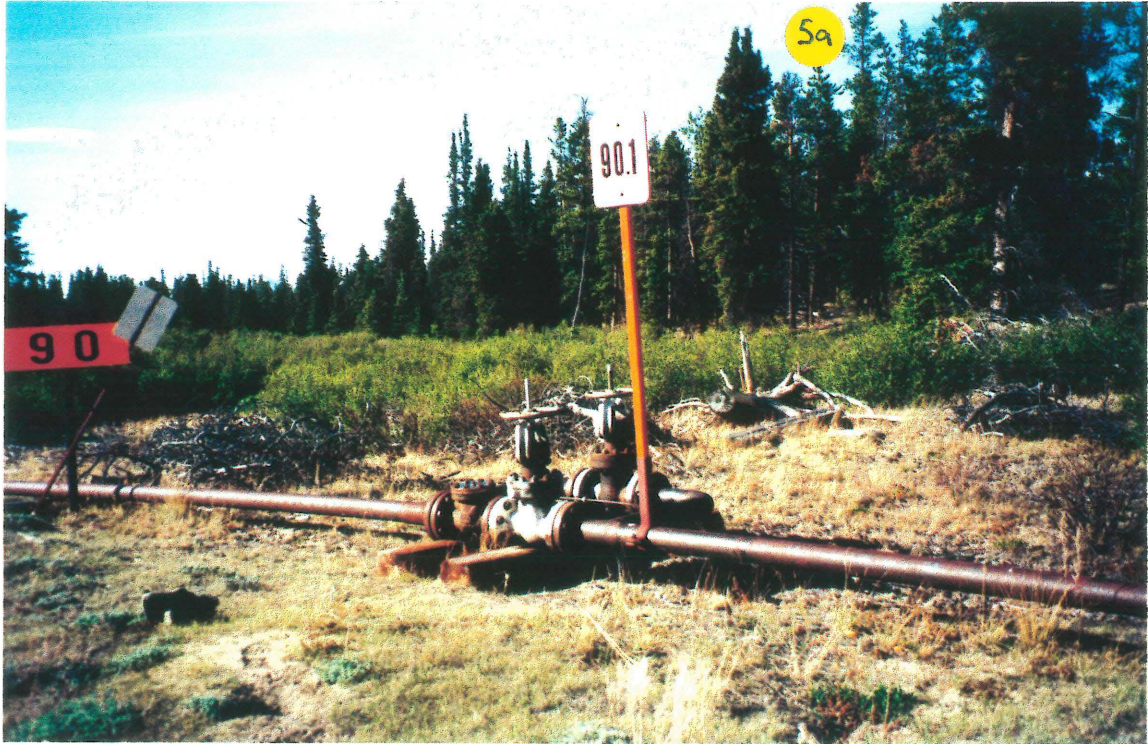
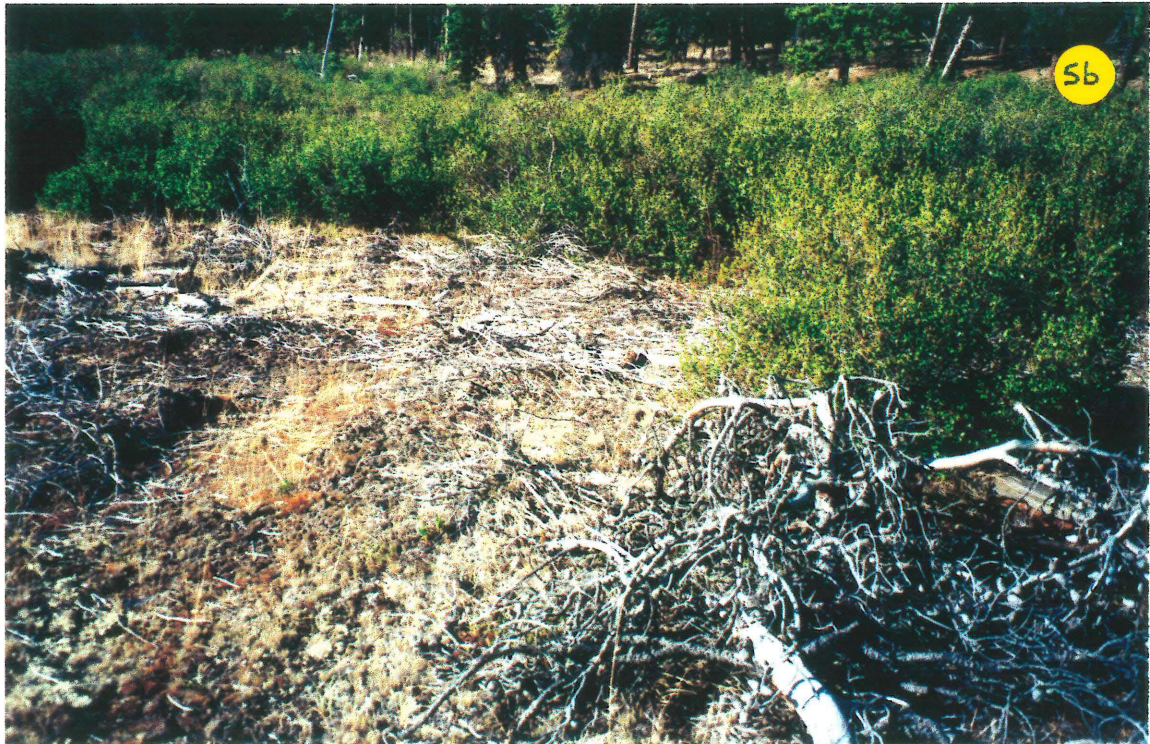
3.5a: Spill Site, mp 90.1

Due to the length of the pipeline, staff focussed its observations to areas of previous spills, based on the incident reports on file with the Board. Observations were made at kmp 1469 of the Alaska Highway, and mp 90.1, 29.9, 24.5, 24.1, and 23. Other sites where relatively large spills occurred in the past were not accessible. Only one of the visited sites, mp 90.1, where a spill of 78,000 litres (489 barrels) of gasoline occurred in 1985, showed visible signs of soil contamination (see Photographs 3.5a and 3.5b). The gasoline appeared to have pooled in two relatively small areas where the vegetation is now sparse or dead. A slight hydrocarbon odour still persists in the soil of one of the areas. A small area near mp 29.9 had a faint odour of hydrocarbons in the soil (see Photograph 3.6). Due to the rocky area, it was difficult to determine whether vegetation growth is still being affected by the contamination at mp 29.9.

One of the concerns associated with the previous gasoline spill sites is the presence of tetra-ethyl lead, a toxic substance. In 1987, 70,000 litres (416 barrels) of leaded gasoline were spilled at mp 42. This site was inaccessible during the site visit, however, at the time of this spill it was estimated that 5 barrels of tetra-ethyl lead (toxic material) would remain in the local environment after the gasoline had either migrated into the surrounding area or vaporized. Two additional spills (mp 29.9 and 90.1) of leaded gasoline occurred in 1987 and 1985, respectively. As indicated above these two sites were included in the 1995 site visit and both locations showed some signs of contamination, with mp 90.1 showing more obvious signs.

With respect to any residual contamination along the pipeline, limited soil contamination probably exists in the wet and/or rocky areas, as most of the product would have been washed away. The area at mp 90.1 that was found to have some soil contamination and should eventually support vegetative growth, however, it may be advisable to undertake some activities to speed up the remediation process (i.e. fertilizers, site preparation activities). Soil analysis at this site would provide information on lead levels in the soil. Tetra-ethyl lead will persist in the environment and it may be the levels of lead that is hindering the regrowth of vegetation at mp 90.1. It should be noted that only selected accessible portions of the line were visited and there may be additional areas along the pipeline with soil/groundwater contamination. These additional areas would most likely be limited to other areas of previous spills and valve sites where existing contamination is evident.

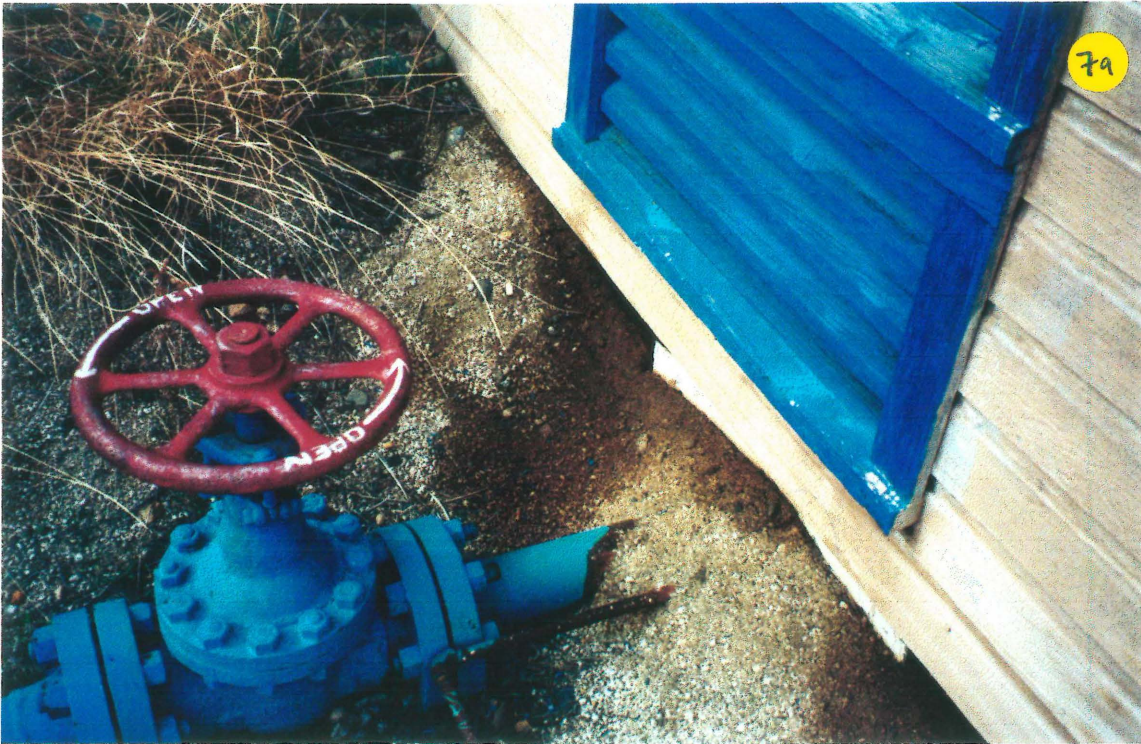
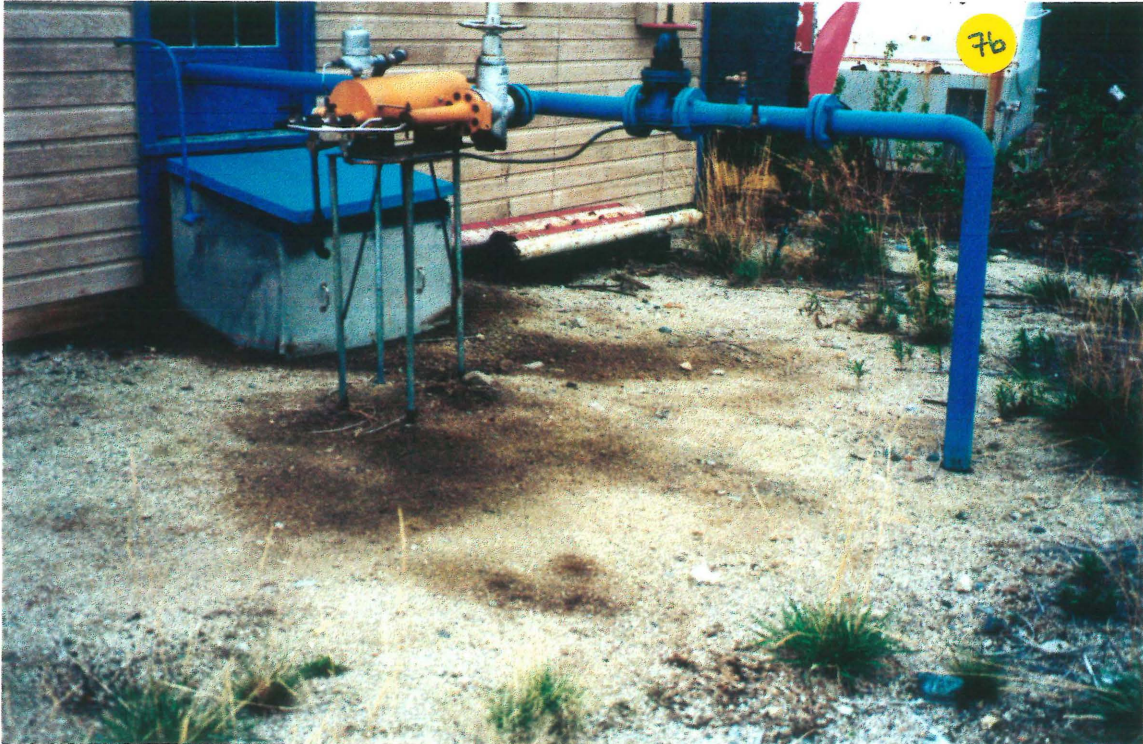
3.7a: Soil Staining near Meter Building

A number of areas of soil staining was observed within the tank farm. This mainly included areas around the meter building (see Photographs 3.7a and 3.7b), the truck loading area (see Photographs 3.8a and 3.8b), a number of the tanks, some of the valve locations, and the barrel storage area. The most severe soil staining was observed at the truck loading area. With respect to the truck loading

The areas of the tanks, meter, truck loading area, valves, and storage areas are of particular concern as all of these areas showed some signs of soil contamination. Representative samples should be taken by a specialist (soil sampling and remediation expert) at all of these areas to determine the type and level of contaminants. Ground water sampling should also be undertaken due to the length of use of the facilities and the amount of soil staining visible at the tank farm site. Evidence of the use of herbicides is prominent at the tank farm. In order to determine whether there is a potential for environmental effects associated with the herbicide residues, YPL should provide further information on its past use of herbicides.

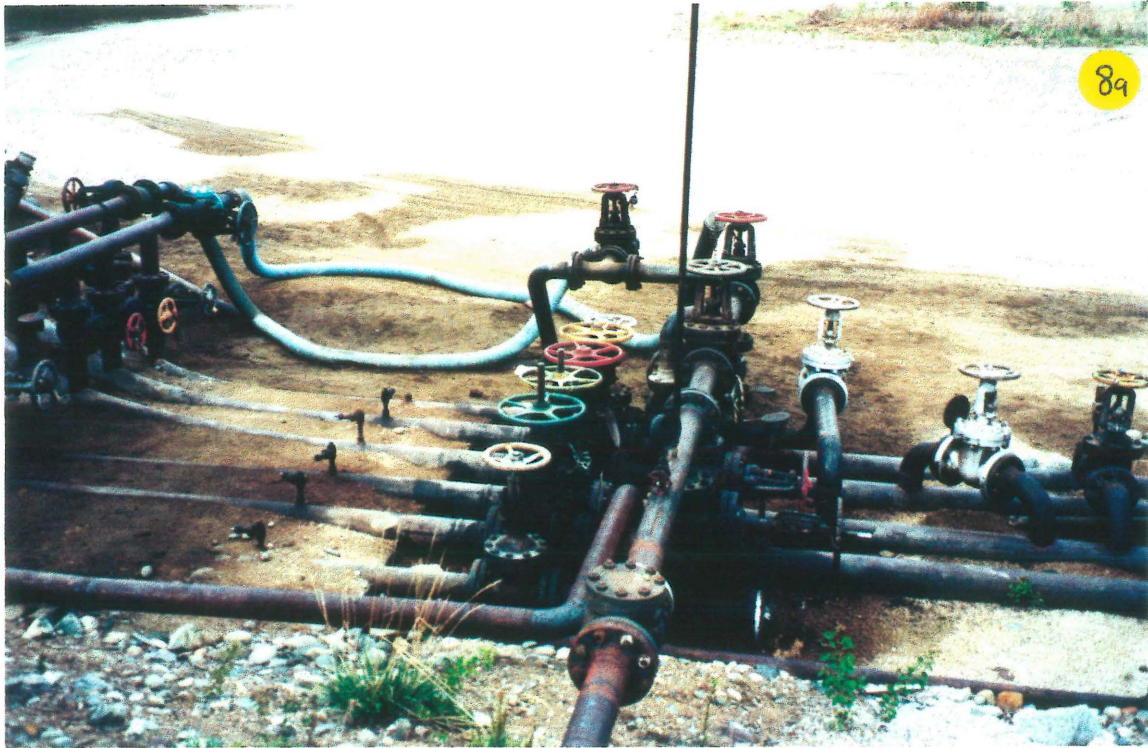
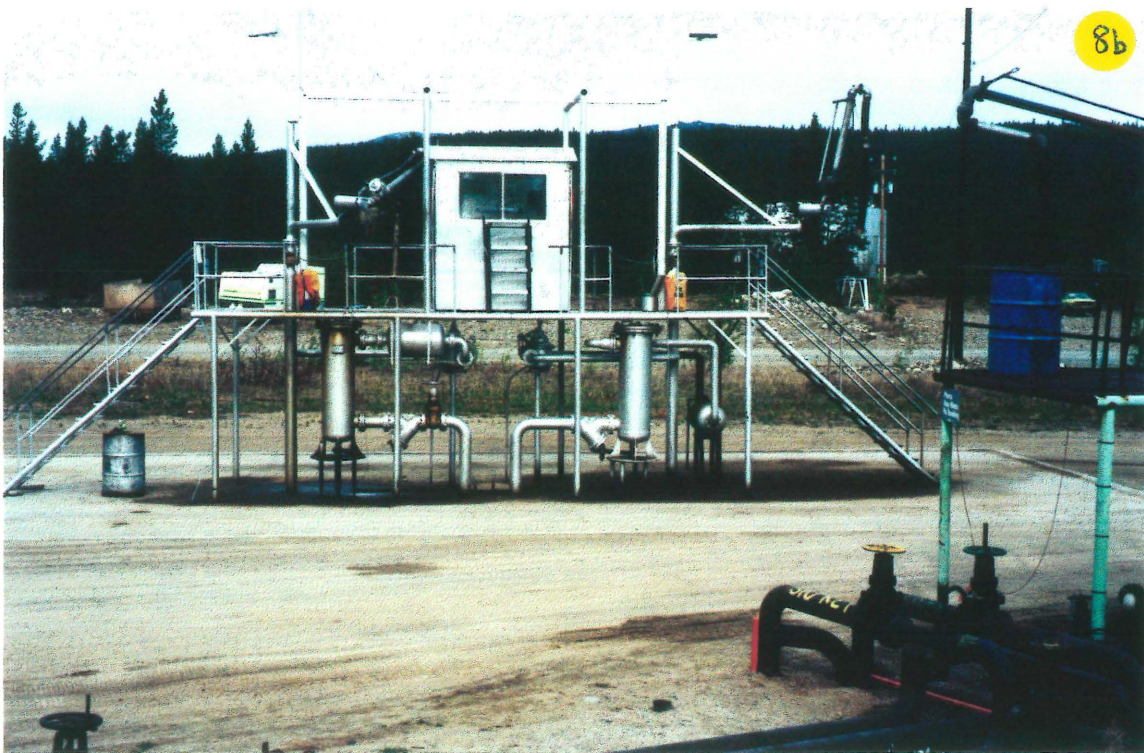
3.8a: Soil Staining near Truck Loading Area

area, very prominent soil staining around the numerous valves was noted. Soil staining and a strong hydrocarbon smell were noted, along with dead vegetation, in a depressional area adjacent to the truck loading area (see Photograph 3.9).

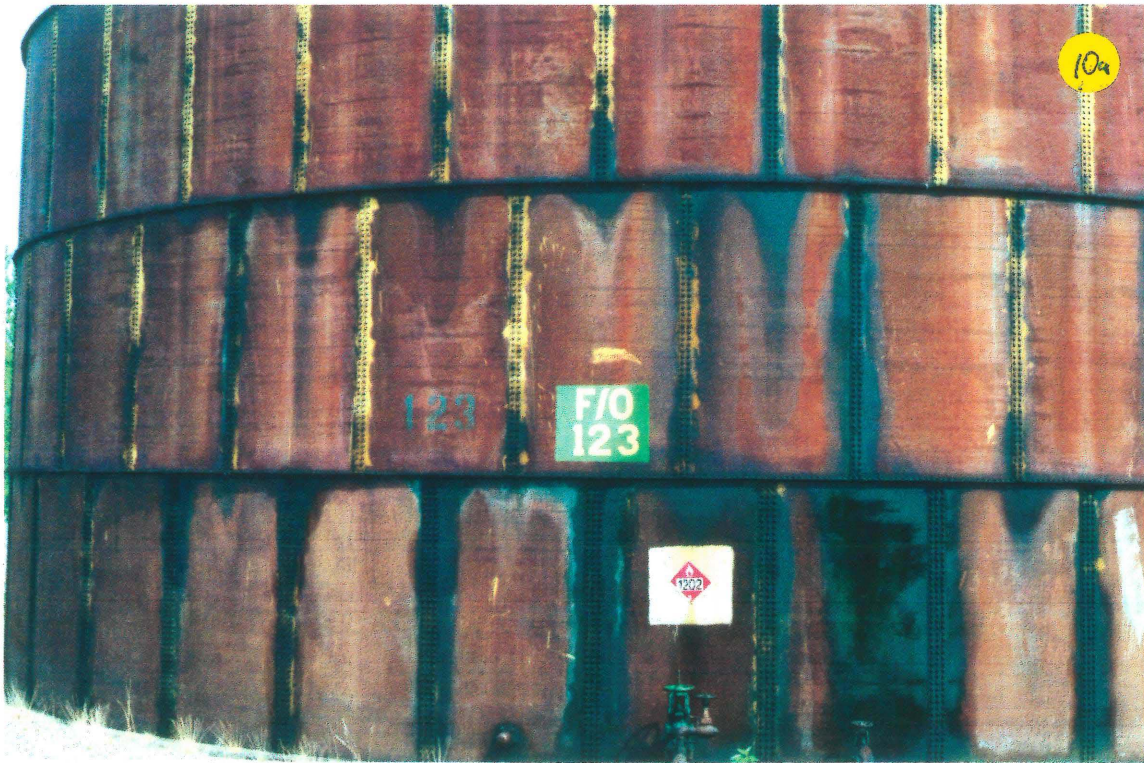
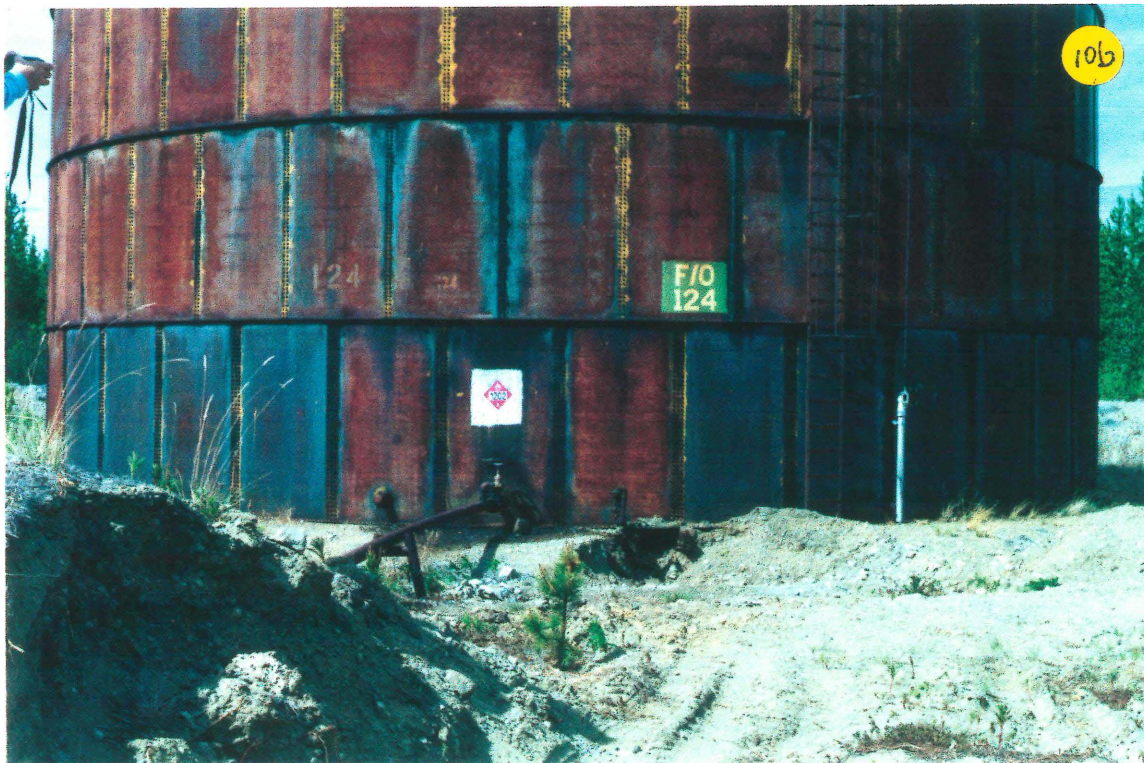
3.10a: Leakage from Tank Wall Seams

At several tanks, it was evident that fuel was leaking from the vertical seams in the walls of the tanks. This was most evident in tanks 123 and 124. At these tanks it was evident that this type of leakage may have occurred over a long period as the original yellow sealant on the wall seams was washed away completely (see Photographs 3.10a and 3.10b). The severity of soil staining varied at the tank sites. Tank 118, at one time designated for fuel oil, was not in use and soil staining was not observed. Tank 122 had some soil staining at the base of the tank and had very noticeable soil staining at a valve connection in the vicinity of the tank (see Photographs 3.11a and 3.11b). Tanks 123 and 124, tank 124 being empty but having contained fuel oil at one time, had more severe soil staining around their bases with the most severe staining at the valve connections into the tank (see Photographs 3.12a, 3.12b and 3.12c). These two tanks had the most prominent soil staining of the tanks that were inspected. Tank 101, marked as a gasoline tank, was not in use and very little staining was observed. Several tanks had been refurbished, which included painting the outside surface and in at least one case applying a resin to the inside surface to seal leaks. Tank 113 had been sealed with resin and no evidence of leakage existed at this tank. It was full of gasoline at the time of the inspection.

It is evident that fuel has seeped from the walls of several of the tanks in the more than thirty years that the tank farm has been used by YPL. In addition, it is possible that fuel has leaked through holes in the floors of the tanks. In order to assess the extent of contamination and to remediate the soil beneath the tanks, removal of all the tanks will be necessary. Given the inherently leaky nature of the bolted seams of the tanks their reliability and value as tanks is severely limited. Accordingly, the most viable option for the tanks is that they be dismantled for scrap metal. As the tanks will contain petroleum vapours a dismantling procedure which ensures that ignition does not occur must be employed. YPL's cleaning procedure is appropriate provided such precautions are taken. Much of the yard piping at the upper tank farm contains fuel. This fuel could be removed by pigging or, alternatively, the yard piping could be removed in a systematic fashion such that the fuel inside is contained at all times.

2. The tanks at the upper tank farm have leaked over their years of service, principally from the bolted seams although leaks in the floors may also have occurred. The tanks have little or no value as storage vessels, therefore the most viable option is that they be dismantled and scrapped. Yard piping at the tank farm will contain fuel unless these lines are pigged clean. Special precautions must be implemented to avoid spilling any remaining fuel if the lines are merely to be cut up and removed. The most likely future use of the upper tank farm site would appear to be residential or as a source of sand and gravel, or both.

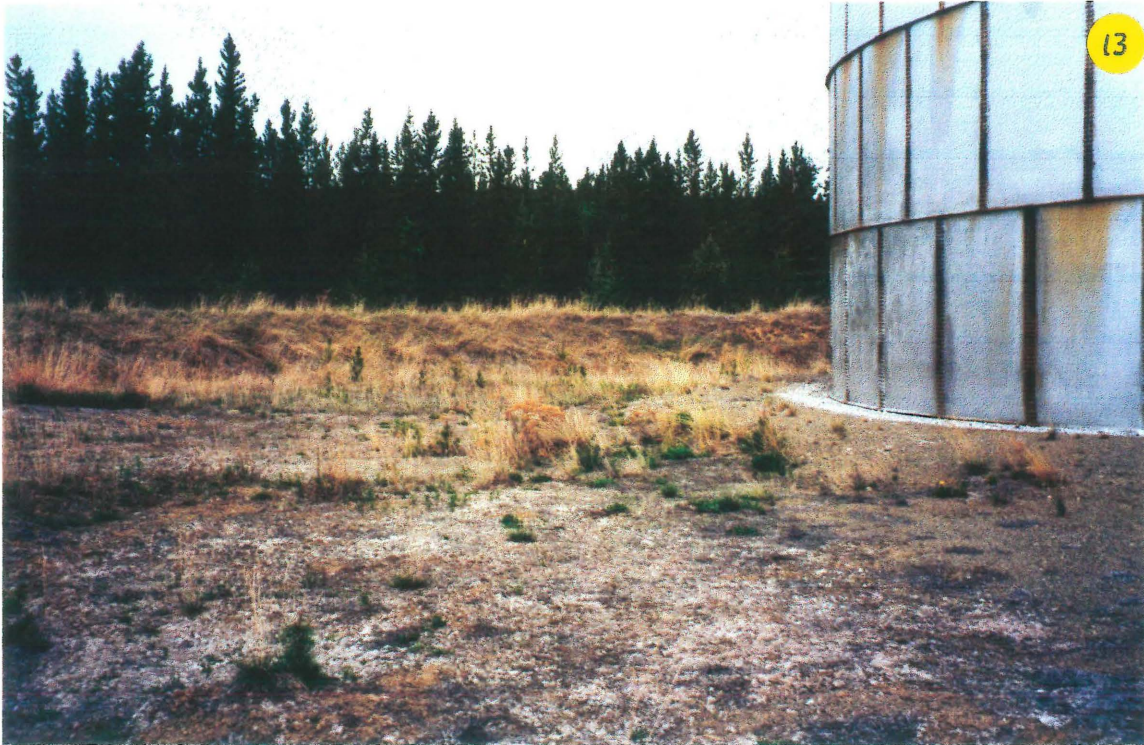
3.13: Indication of Herbicide Use on Tank Berms

Signs of herbicide use were present, as well as mechanical removal of vegetation, at the tank farm. The use of the herbicides appears to have been limited to the areas around the tanks up to and including the tank berms (see Photograph 3.13).

7. Evidence exists which indicates that herbicides have been used at the upper tank farm and along the pipeline right-of-way.
8. Numerous discarded sections of pipe and pipeline components and a considerable amount of debris resulting from the operation of the pipeline is scattered along the pipeline right-of-way and about the upper tank farm and Carcross pump station site. From an environmental perspective, the removal of all of the facilities associated with the pipeline (except buried pipe at road crossings), upper tank farm and Carcross pump station site would be preferable.

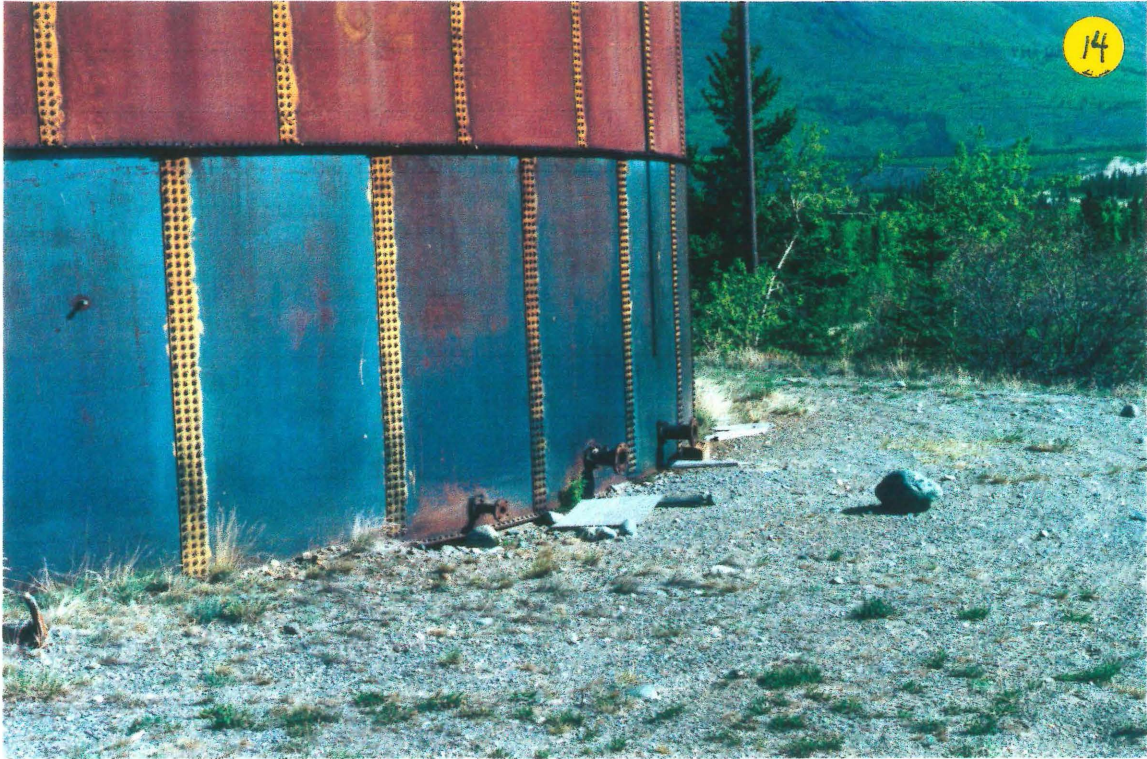
3.14: Tank at Carcross Pump Station Site

The Carcross station was never been used by YPL as a pump station although there is evidence that the tank contained petroleum at one time and that petroleum currently exists in some of the yard piping. Two small areas of soil staining were present; each occurred around a pipe end that had been cut at the ground surface (see Photograph 3.21). There were two other pipes coming from under ground, that had also been cut at the surface, with no visual surface staining.

As the tank at the site contained petroleum at one time it should be dismantled as per the dismantling procedure for the tanks at the upper tank farm. In addition, some of the yard piping could still contain fuel. It should be cut up and removed in a systematic manner which will ensure that any remaining fuel is not spilled.

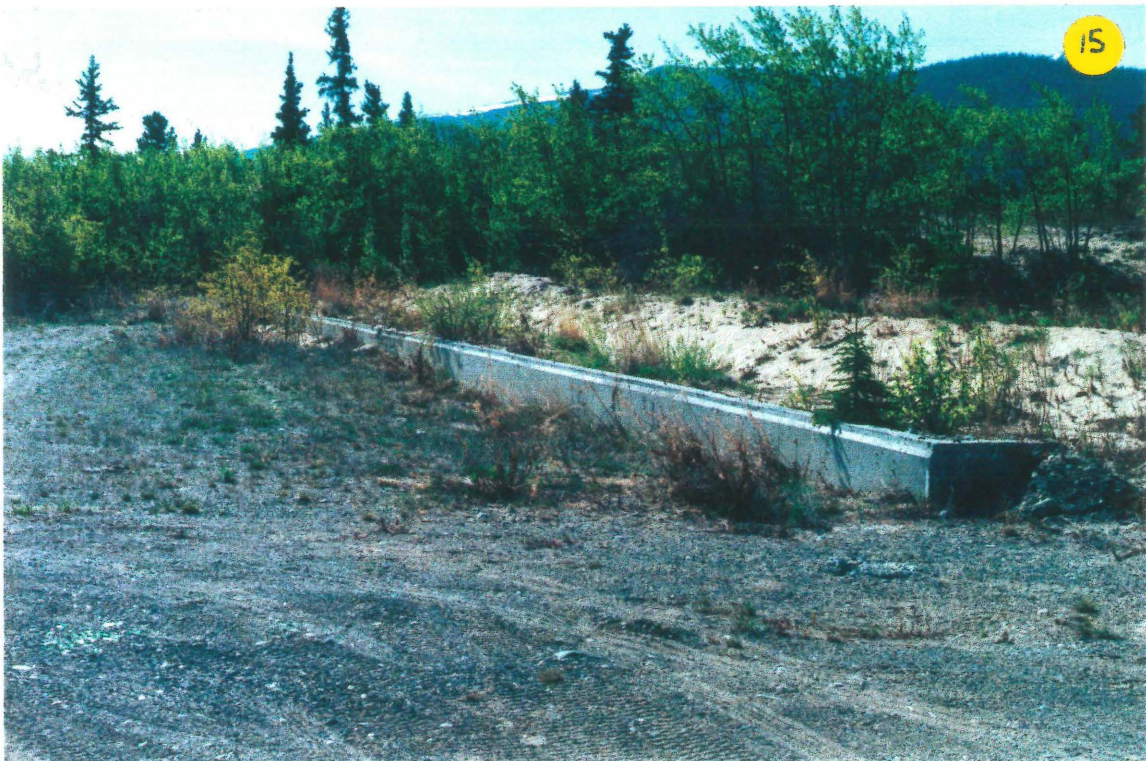
3.15: Remnants at Carcross Pump Station Site

The site of the Carcross pump station is located adjacent to the pipeline about a half a kilometre north of the town of Carcross. The pump station is situated within a rolling sandy area, with clusters of pine and poplars. The area appears to be very well drained. Facilities at the site include a tank, yard piping, concrete foundations and flooring and loose pipe and pipeline components (see Photographs 3.14 and 3.15). The tank, which is located on relatively high ground in comparison to the other facilities at the site, is empty and open to the atmosphere and disconnected from the yard piping. The ladder to the top of the tank has been removed and the manways are blocked to prevent unauthorized entry. There are also some old barrels and other refuse located approximately 30 m from the pump station site (see Photograph 3.16).

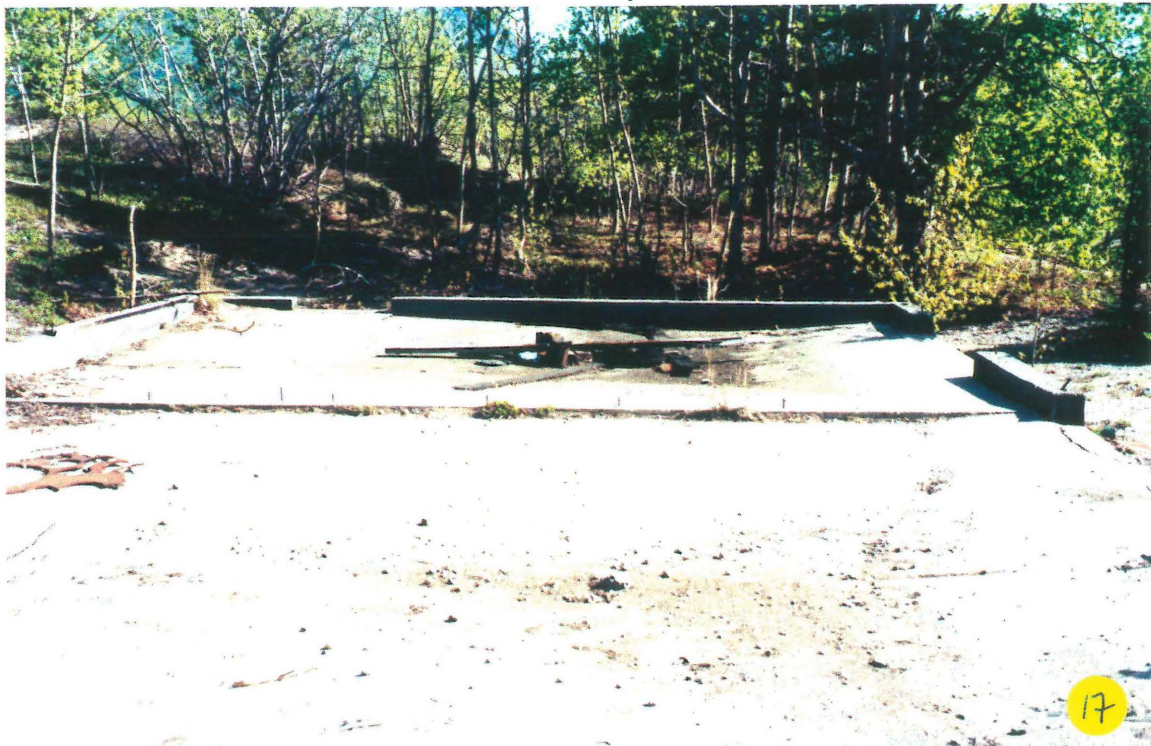
3.17: Evidence of Use of Carcross Pump Station Site for Recreation

The site is not fenced and has been used by the public for servicing vehicles and as a recreational site (see Photographs 3.17 and 3.18). Numerous empty motor oil containers and some fresh soil staining were found near concrete building foundations containing a derelict mechanics pit (see Photographs

Considering the proximity of this site to the town of Carcross and that no perimeter fence exists, controlling public access to the site will not be possible. The site will continue to be used as a recreation site and the mechanics pit at the site will continue to be used for servicing vehicles. The most appropriate option for controlling the unauthorized use of the facilities would be to dismantle and remove all the facilities and return the site to its natural state.

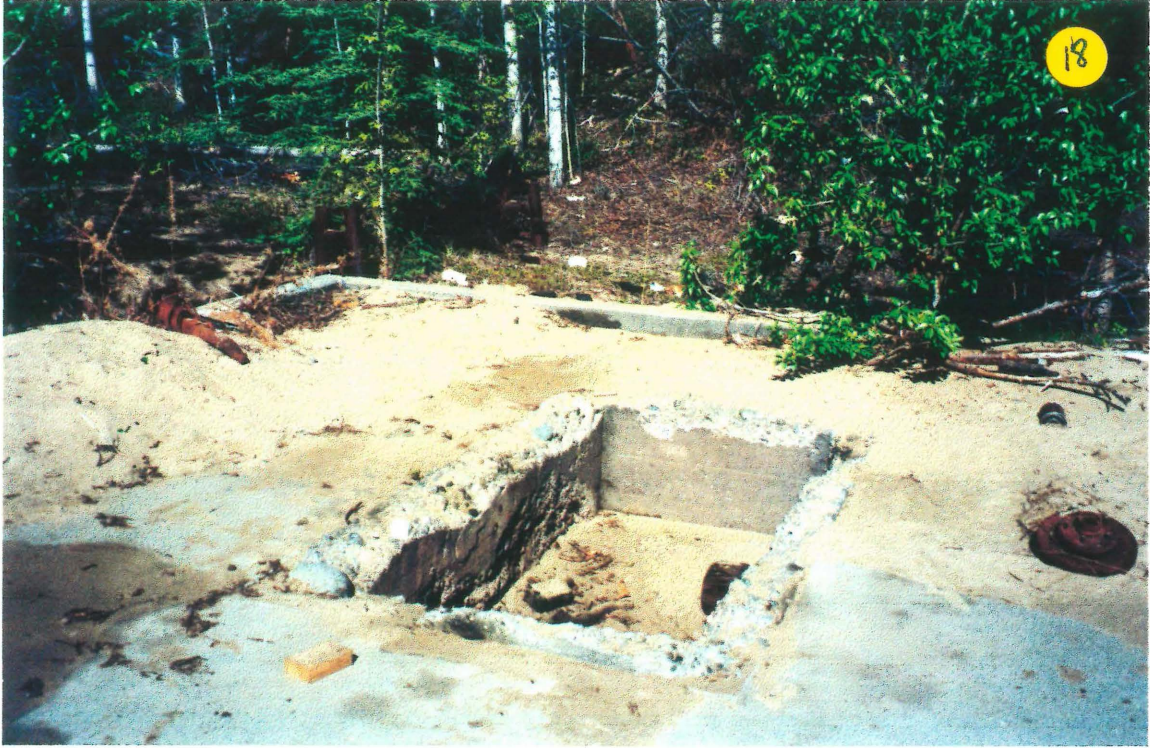
3.18: Mechanics Pit at Carcross Pump Station Site

4. The Carcross pump station site is used as a recreational site and a derelict mechanics pit is used for servicing vehicles.
5. Some areas of soil staining were found at the Carcross pump station which need further investigations and evidence was found which indicates that facilities may have been buried. A Phase I environmental assessment should provide sufficient information on the sources and extent of contamination, as well as further information on additional buried facilities. Depending on the extent of soil staining, removal of the soil may eliminate the need for a Phase II study.
