**BENNETT LAKE AT CARCROSS
HYDROMETRIC STATION**

A Water Contaminants Evaluation under the Mercury Project

Patrick Roach
Water Contaminants Scientist
Water Resources Division
Northern Affairs Program
345 - 300 Main St.
Whitehorse, Yukon Y1A 2B5

October 1997

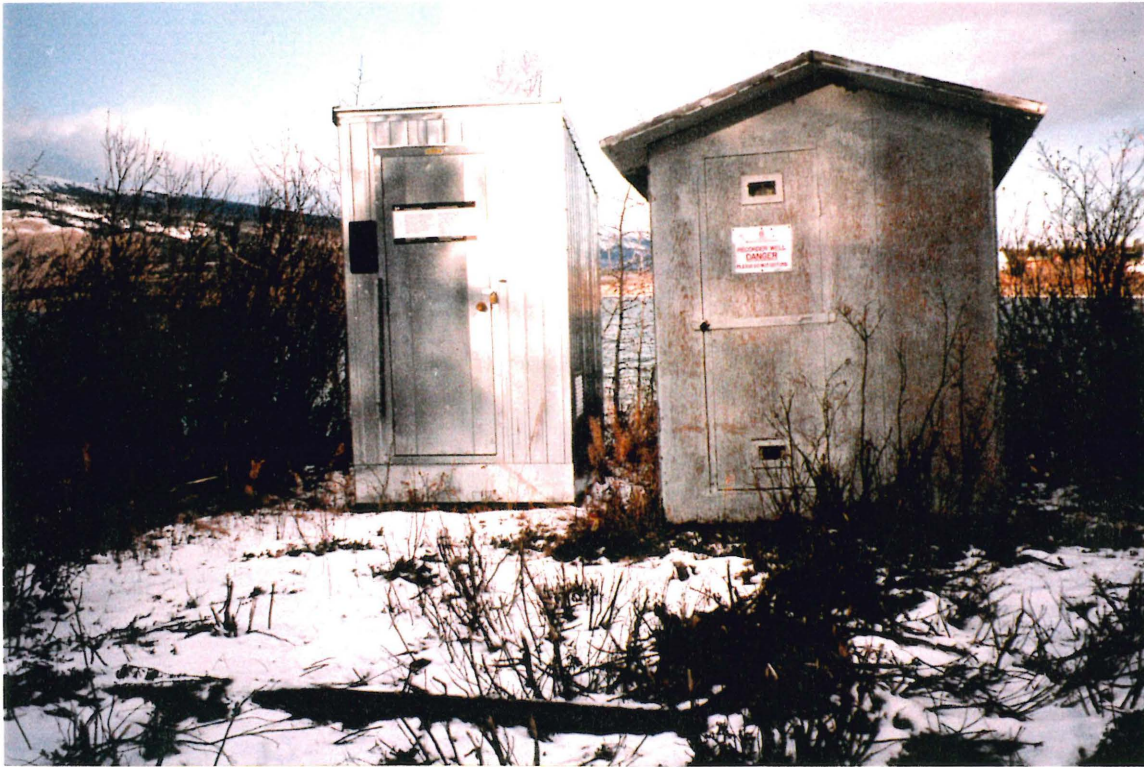
The older building is of plywood construction (photo A) with a plywood floor (photo D) and contains shredded material from rodent occupation. The orifice line is still connected to the building and buried (photos B and C) but all other equipment has been removed. There is mercury present on the floor and the recorder support, mixed with the rodent debris. Two drilled holes exist in the floor under the support (photo D). Mercury was observed on the ground beneath the building below the holes in the floor (photos E and F).

There is a second building adjacent to the existing one (photos A and H) that contains a mercury manometer in operating condition. No contamination of the interior this building was apparent.

Photo A: Old (c 1987) and new building (c 1996) on site

Removal can be accomplished easily through access down the rail line with light equipment, if permission for such access can be obtained from BY&R. It is recommended that the building be sealed and removed intact from the site for disposal outside of the community. The second building may also need to be removed from the site dependent on BY&R wishes. At a minimum, the mercury manometer in the operational building should be replaced due to its potential for future contamination and a renewal of the issue.

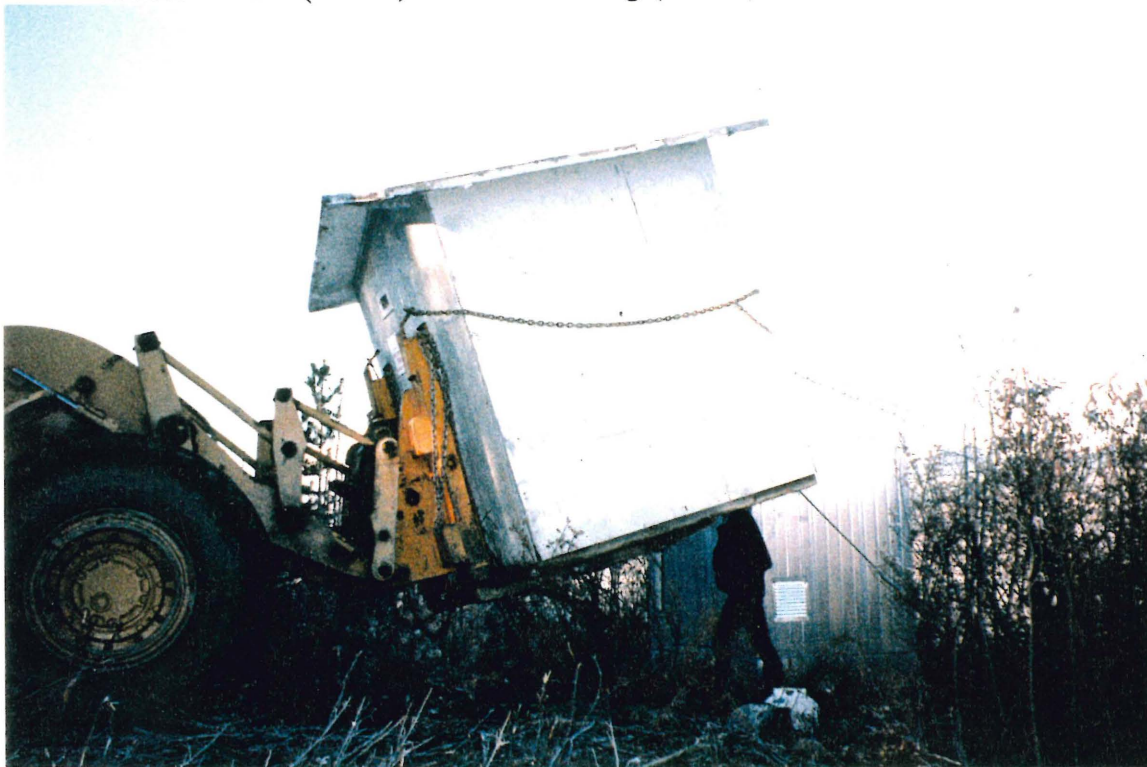
Photo B: Old building being moved

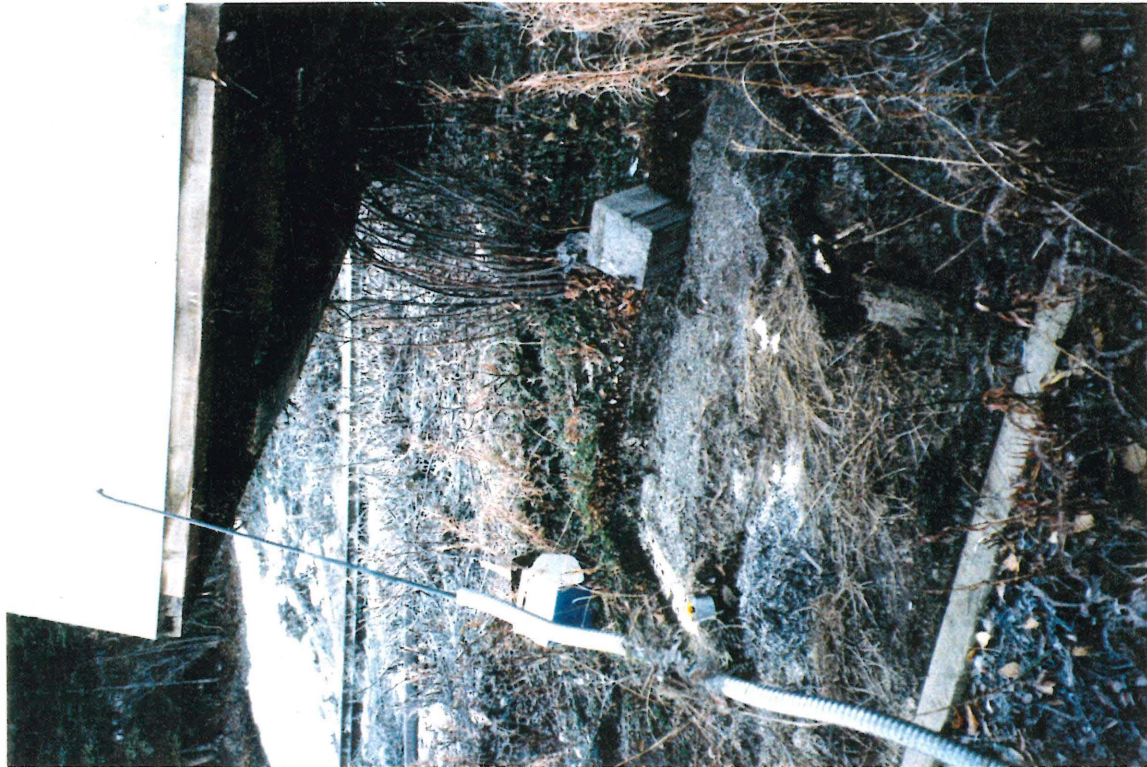
Photo C: Exposed soil under building

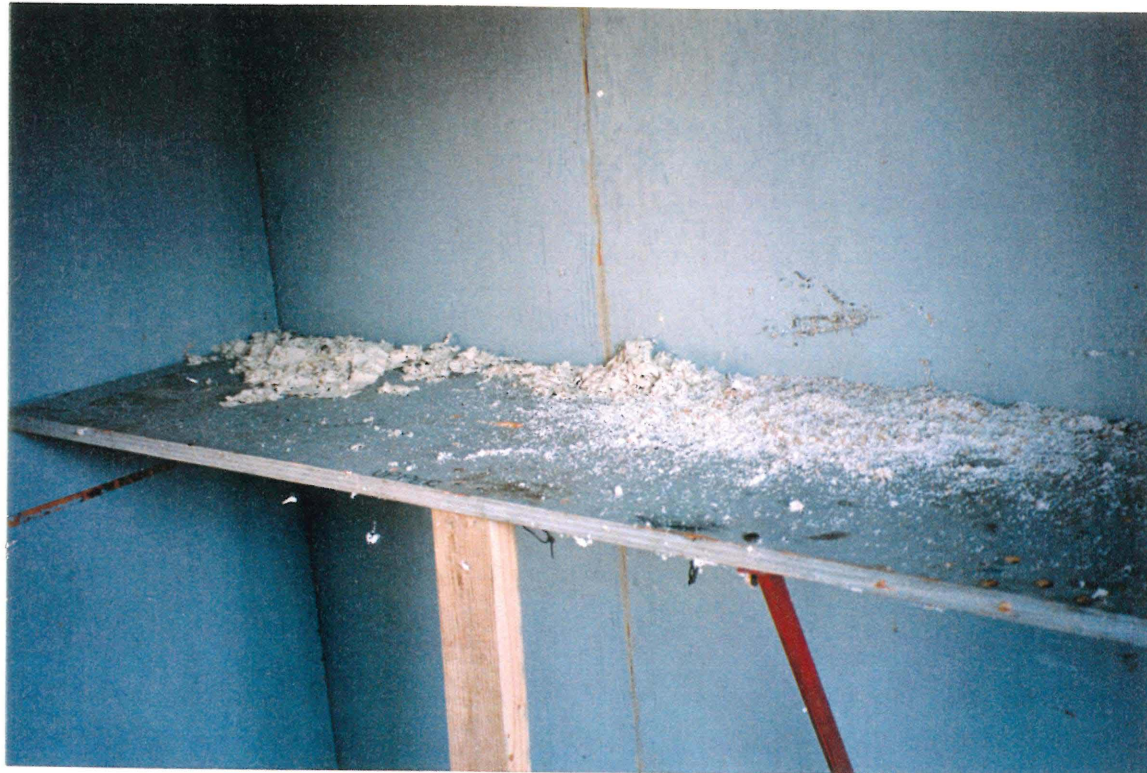
Photo D: Shelf with rodent debris

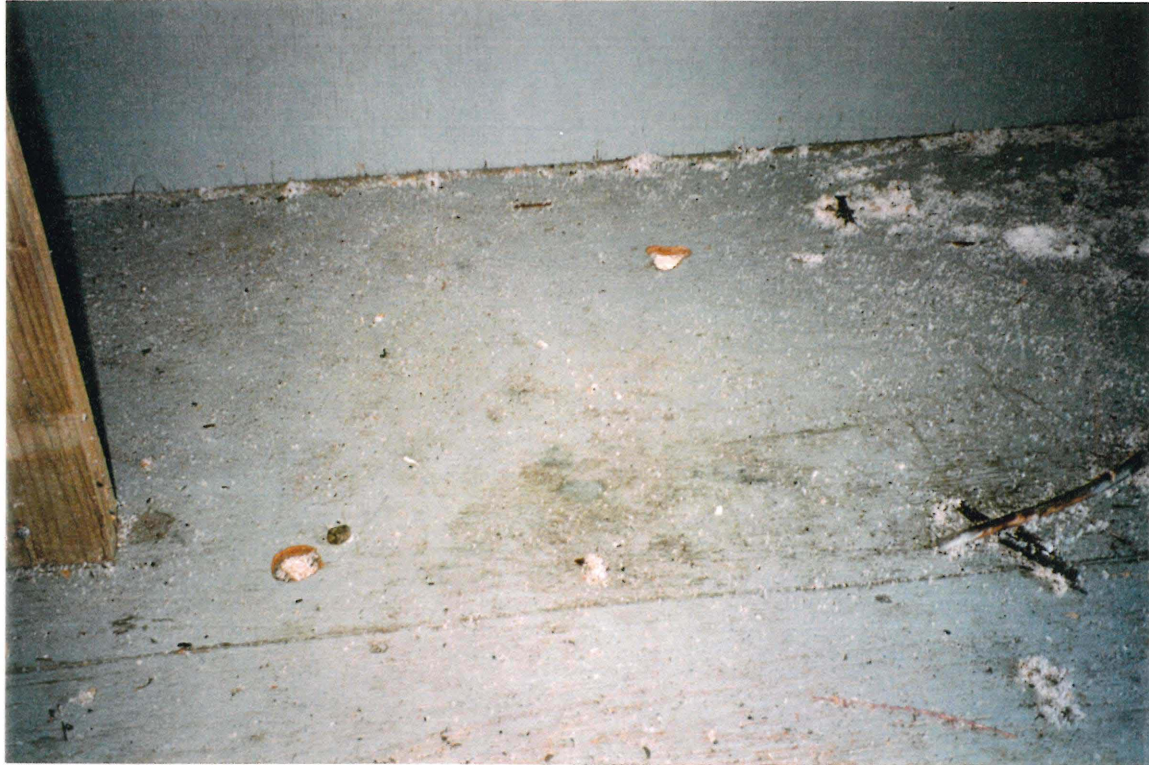
Photo E: Holes in floor of building

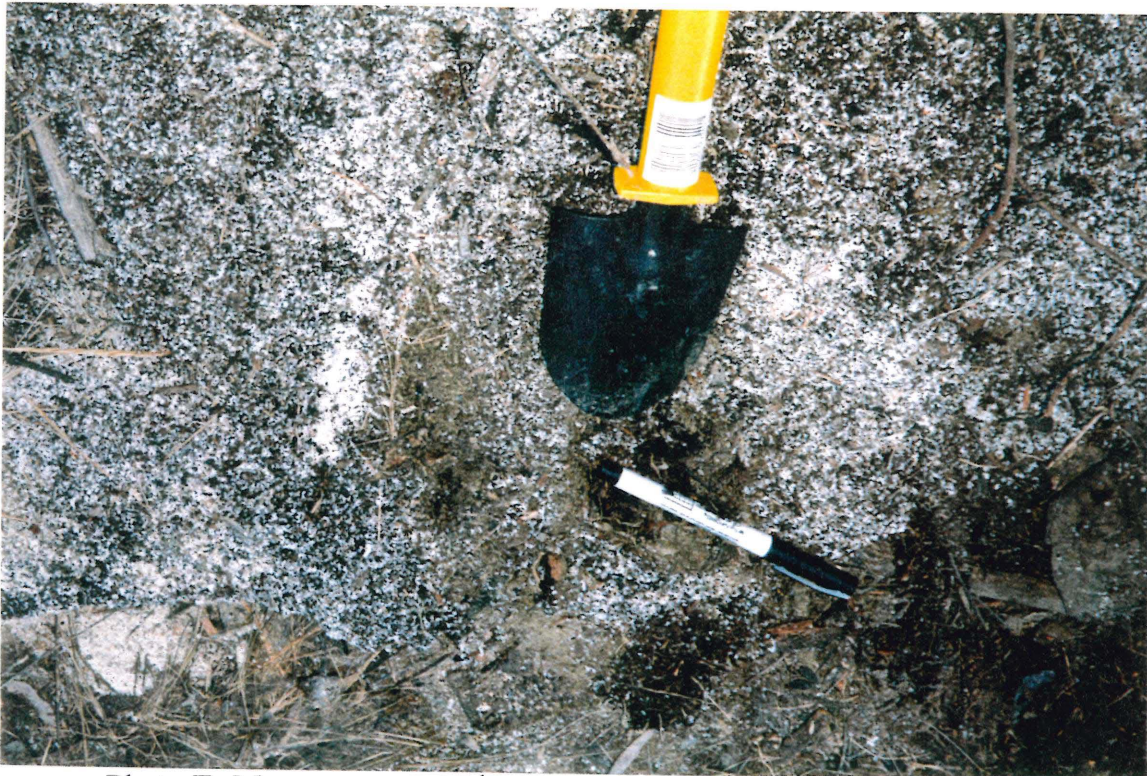
Photo F: Mercury on ground

Despite the moderate environmental and health concerns, the perception of problems and land status should make this site a priority for clean-up. This site can be cleaned with the removal of a minimum of contaminated soil unless the second building site has been contaminated as well. The older building is completely contaminated and must be handled as such, while the newer structure appears to be clean

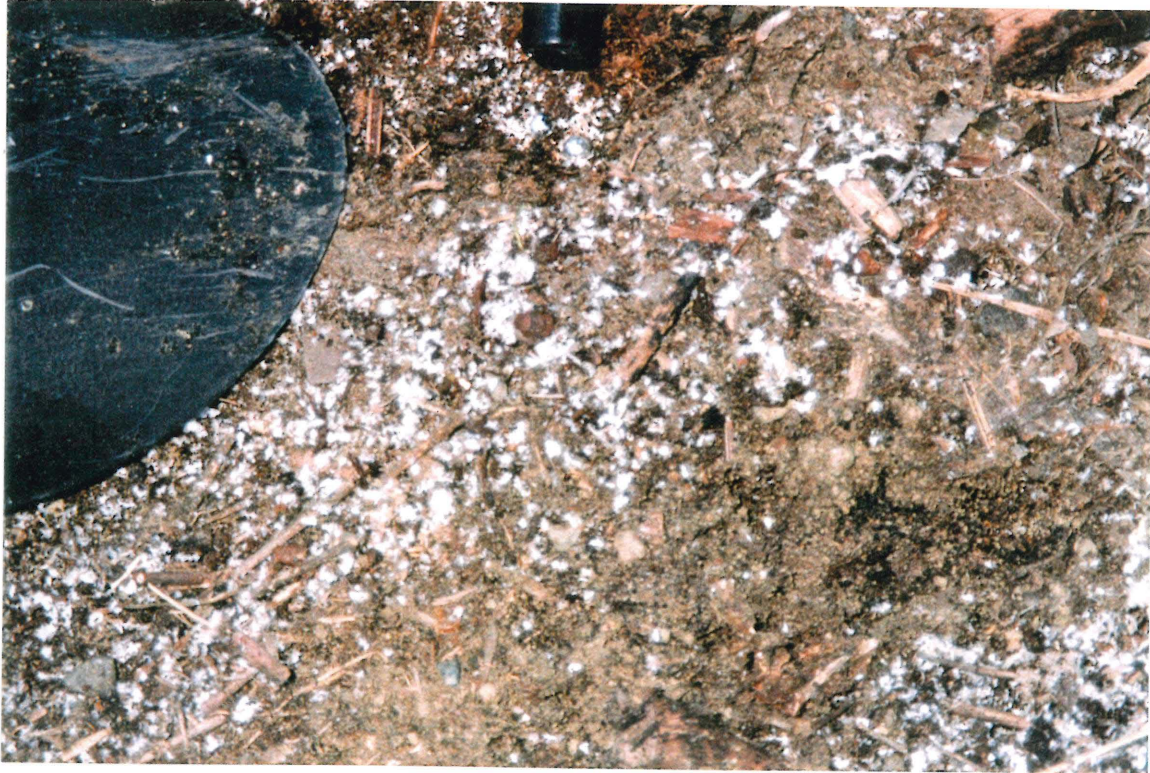
The station is located on a bench some 2 metres back from the edge of the bench above Bennett Lake (photo G) at the head of the Nares River. There is a pipeline running 2.5 metres south of the station site and the centerline of the British and Yukon Railway line is 7.5 metres south of the building (photo H). As the rail right of way is 60 metres wide at this point the site is on private B&YR land. Conversations with Water Survey of Canada staff, who operate the site, indicate no awareness of an agreement on between Water Survey and B&YR on the use of this site. To the best of DIAND staff knowledge the site is unauthorized. Soils at the site are cold, but not frozen, as there is no permafrost in this region. The soils here however may be the warmest in the Territory and should offer the highest rate of methylation available in the Yukon.

Photo G: Close up of mercury

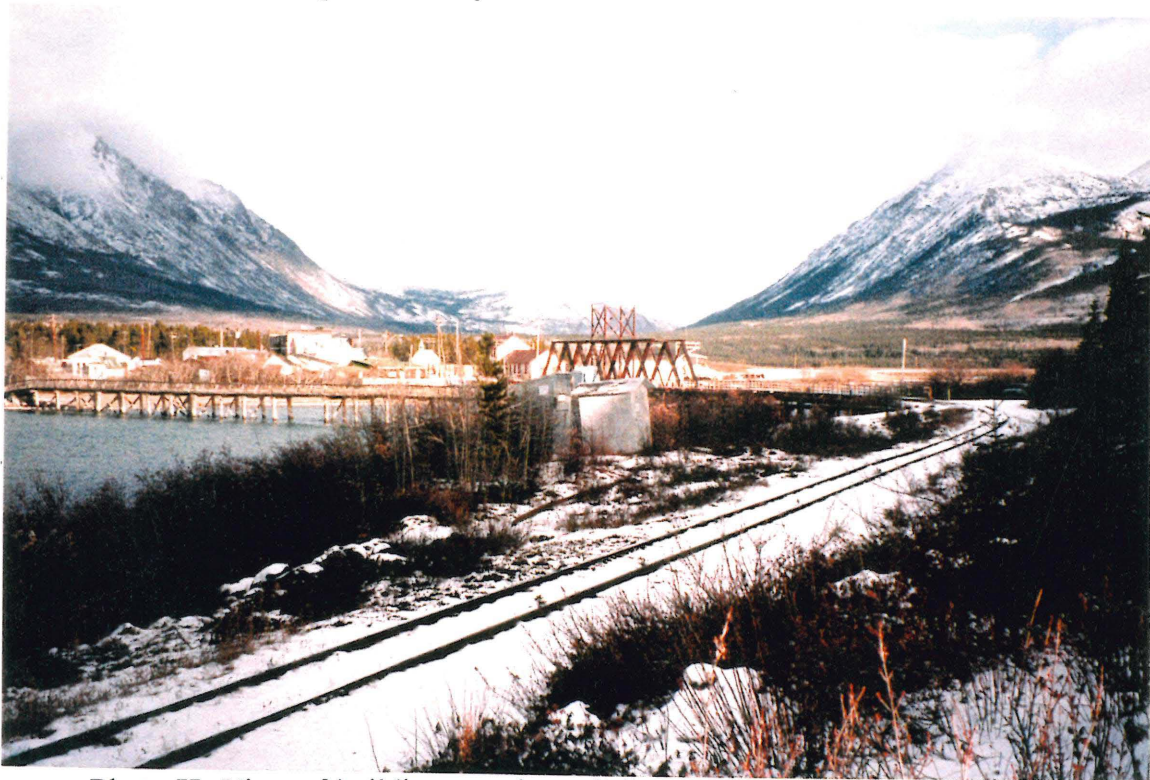
Photo H: View of buildings on site, rail line, bridge, and

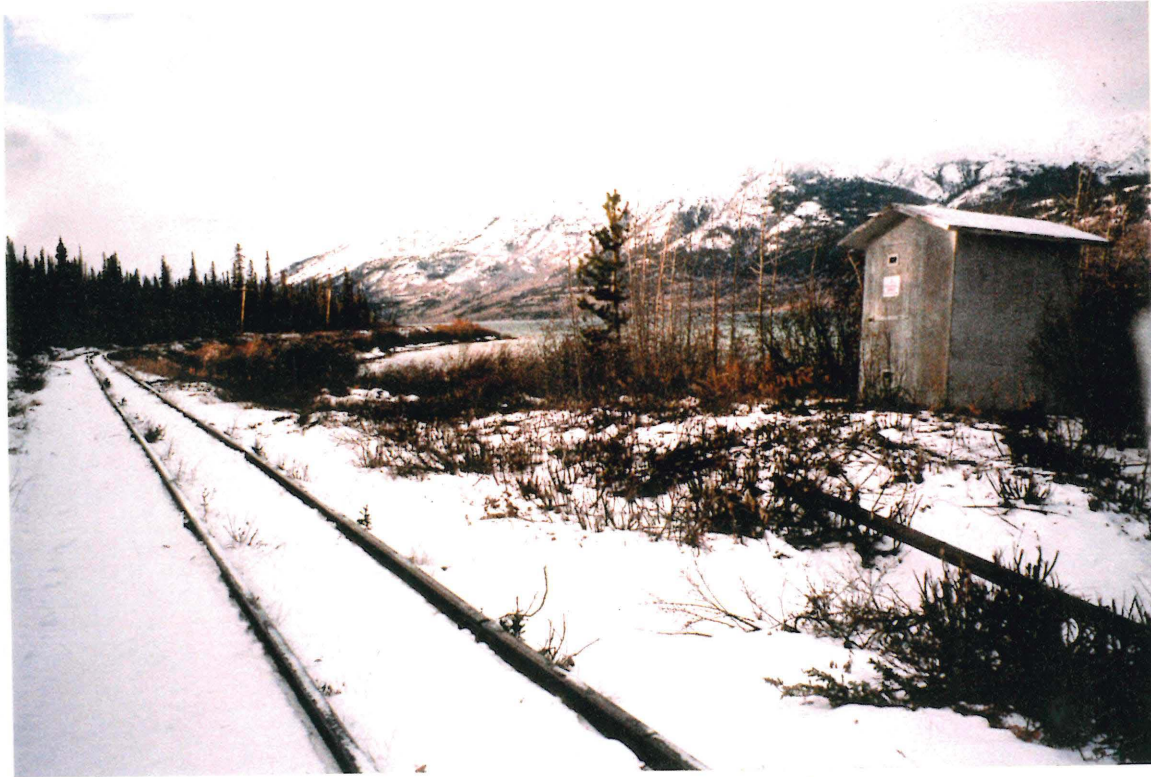
Photo I: View of site with rail line and pipe line
