ENERGY ANALYSIS OF MILE 1202 MOTOR INN - BEAVER CREEK, CANADA

PERFORMED BY: ARCTIC TECHNICAL SERVICES
1318 WELL STREET
FAIRBANKS, ALASKA 99701
(907) 452-8368

EXECUTIVE SUMMARY

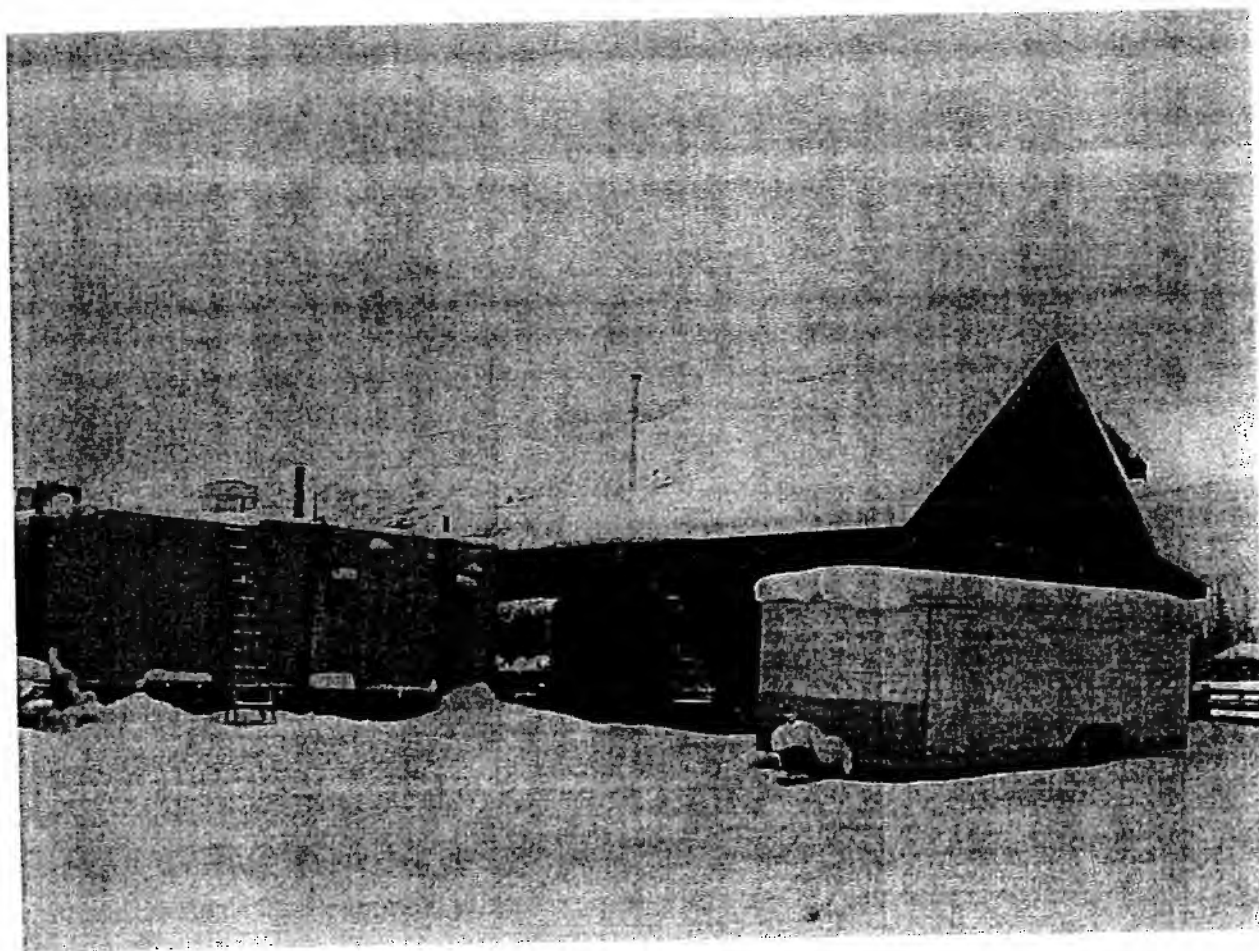
(Kitchen is on left, Lodge on right – note glaciers on lodge roof)

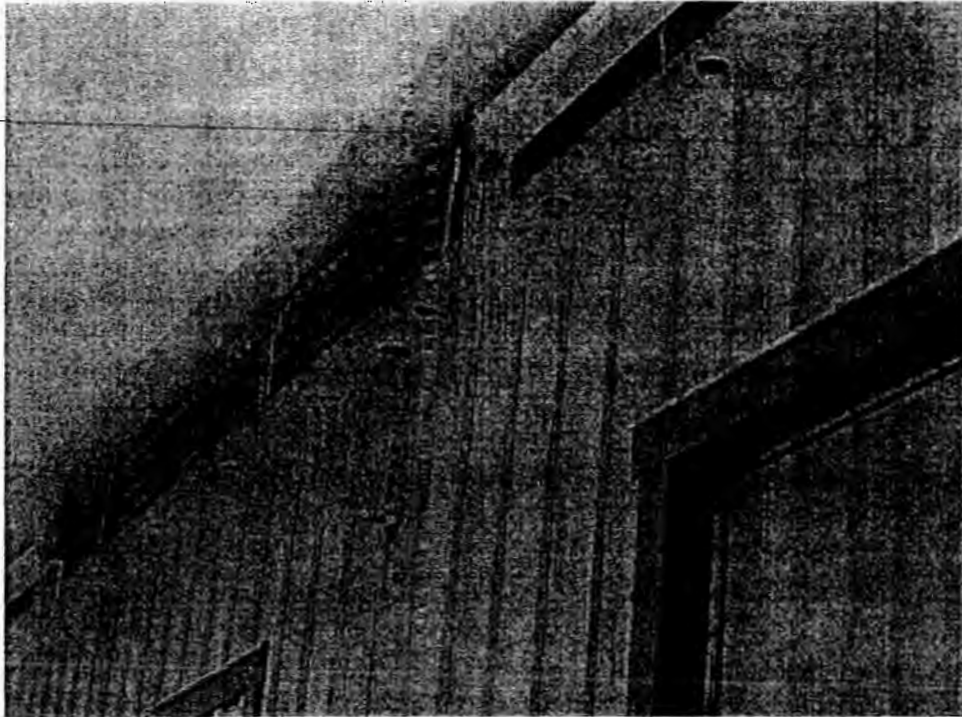
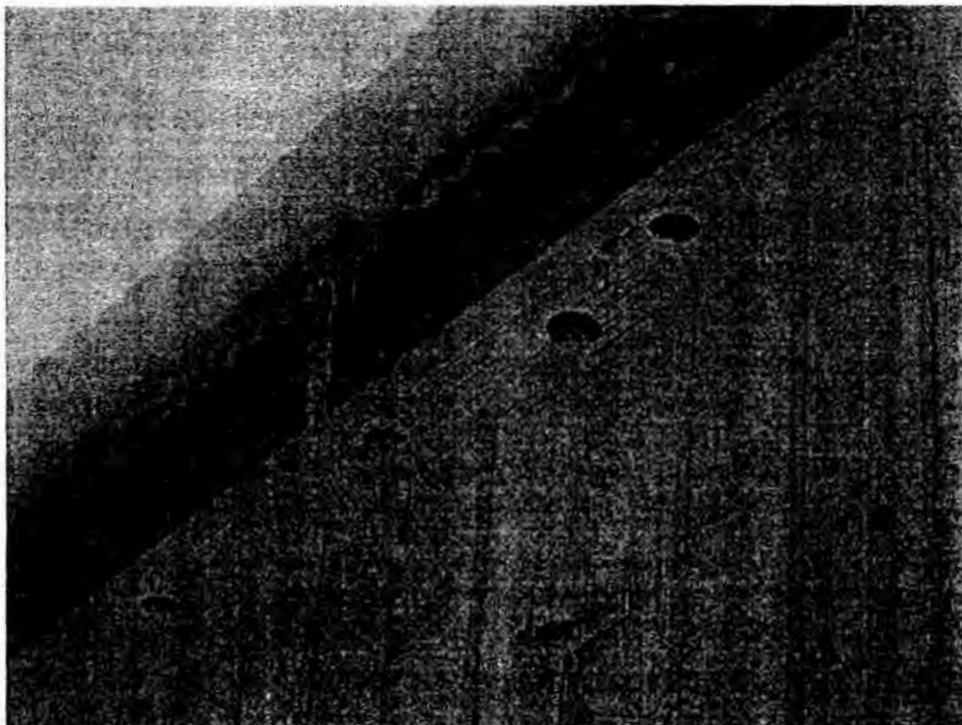
Building D – North Wall at Eave

Photos show condensation pouring out from the eave vents on building D. This indicates serious air leakage occurring from inside the building leaking into the attic. High air leakage will ultimately destroy the building and possibly cause occupants to become ill from associated mold and mildew.

Below is a close-up of the ice blocked attic vents.

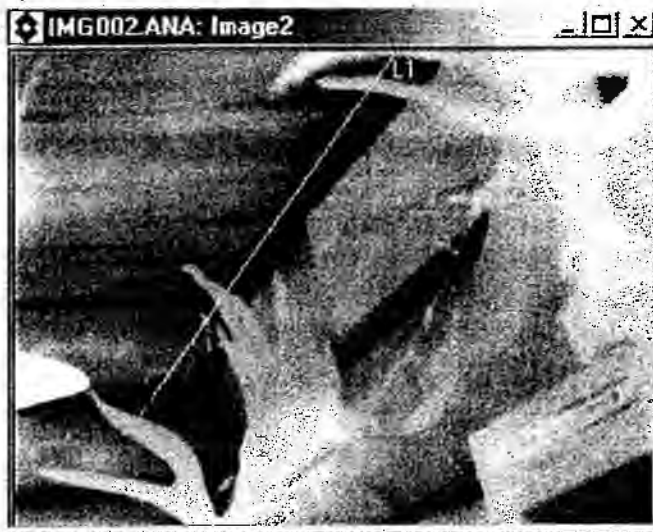
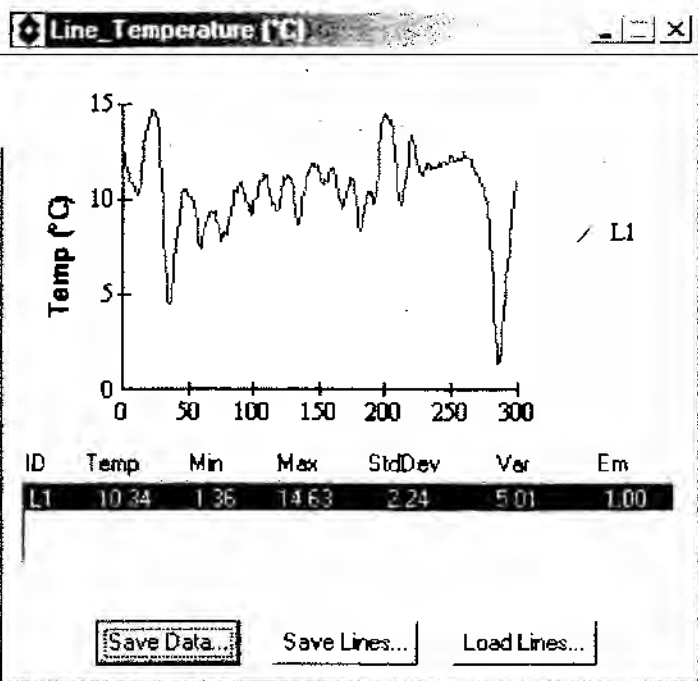
BT-03 - October 15, 2001
101 Mile Motor Inn-Beaver Creek, YT - Main Lodge
Location: Lounge - NW Corner @ Upper Wall

This image of the lounge ceiling shows the difficulty presented in sealing air leaks typical of log construction. Being diffuse and wide spread increases the challenge. Weatherall and Permachink are two products providing solutions for log building air sealing.

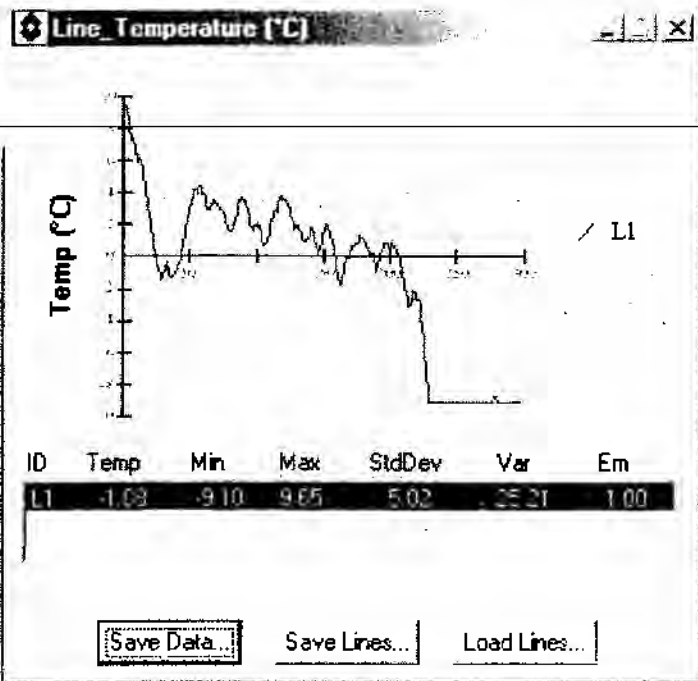
BT-04 - October 15, 2001
101 Mile Motor Inn-Beaver Creek, YT - Main Lodge
Location: Lounge - NW Wall @ Floor

Sill areas at the log wall / floor connections were found to be areas with high air leakage. Caulking this joint will greatly reduce the infiltration of cold outside air.

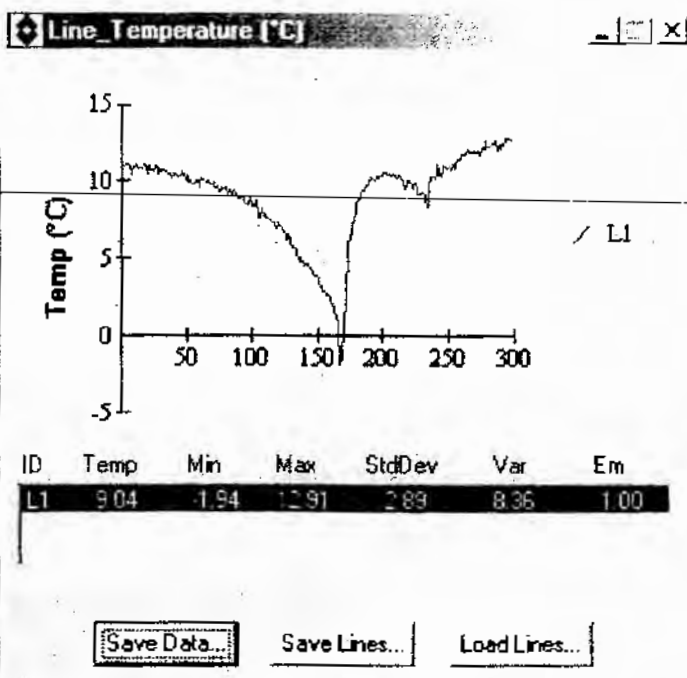
BT-05 - October 15, 2001
101 Mile Motor Inn-Beaver Creek, YT - Main Lodge
Location: Dining - NW Corner @ Floor

Another example of log wall to floor air leakage.

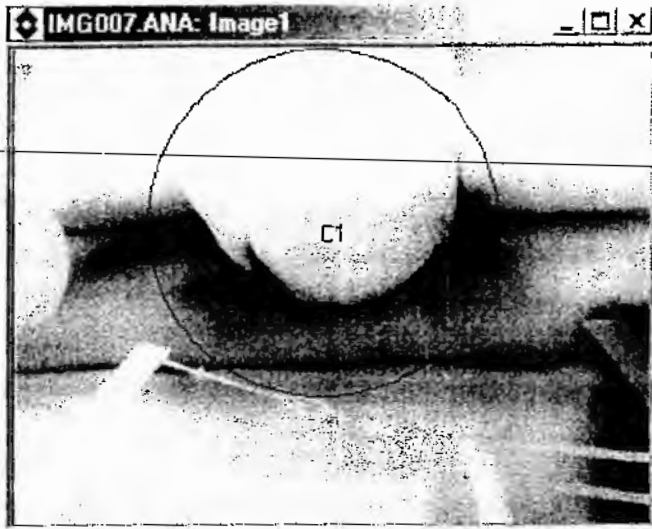
BT-07 - October 15, 2001
101 Mile Motor Inn-Beaver Creek, YT - Main Lodge
Location: Dining - Log Beam Penetration @ West Wall

All building thermograms were taken with the blower door operating. Placing the buildings under a negative pressure served to exaggerate the air leakage rate and make individual leak locations more visible.

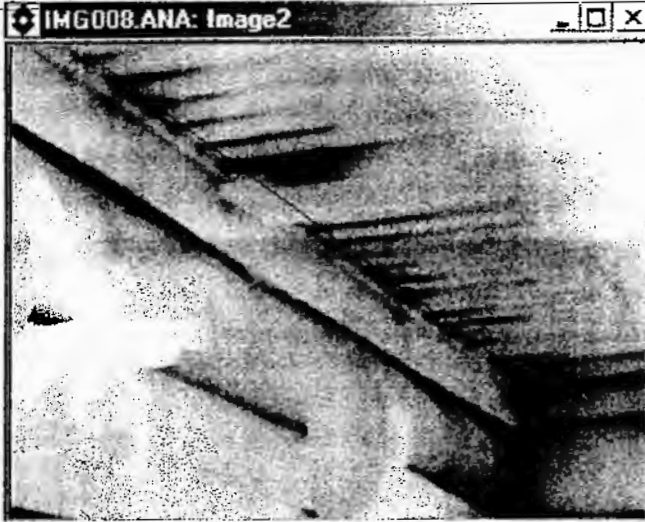
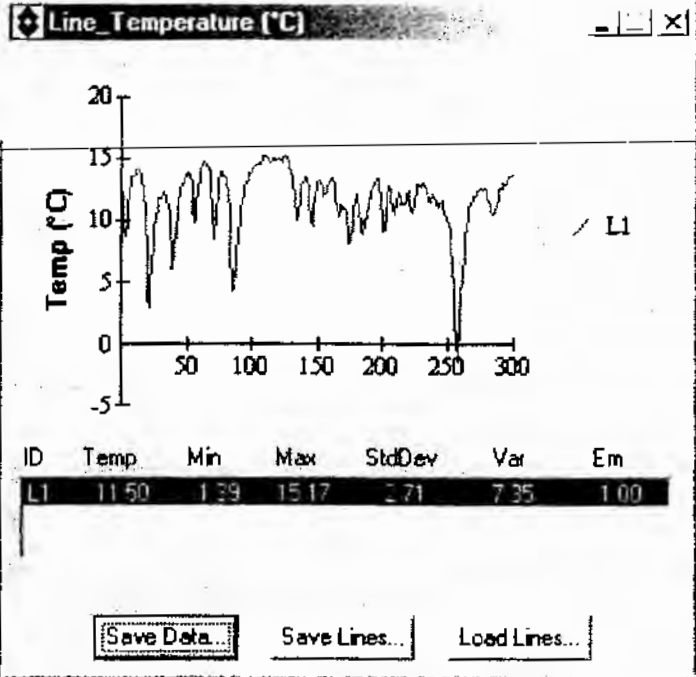
BT-08 - October 15, 2001
101 Mile Motor Inn-Beaver Creek, YT - Main Lodge
Location: Dining - West Wall @ 2nd Floor Intersection

Second floor construction shows similar leak patterns as the sill plates. Here, the T&G planks are leaking at their joints.

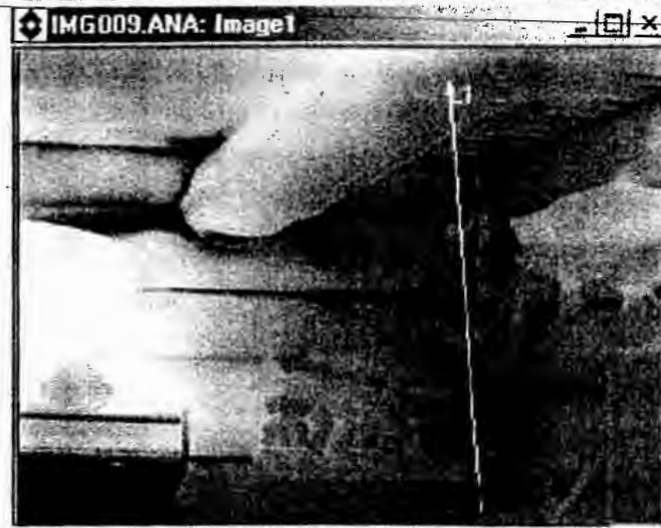
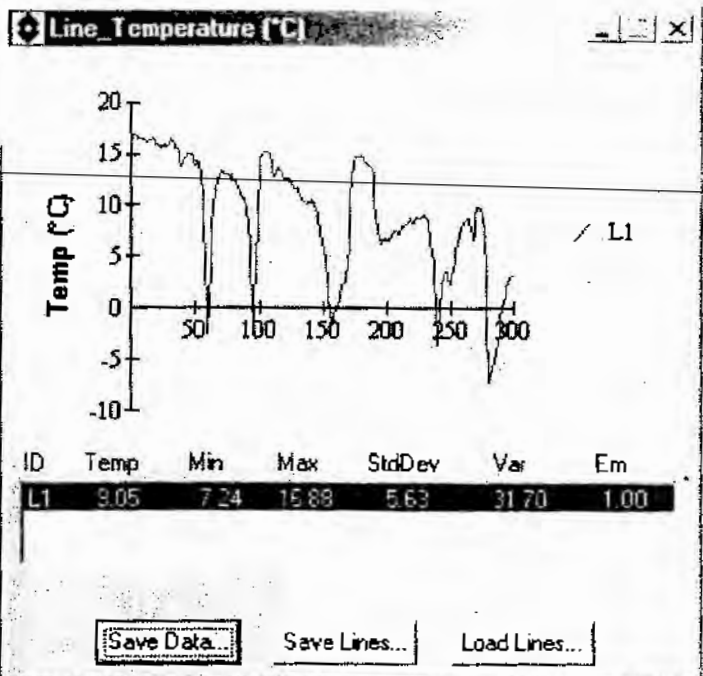
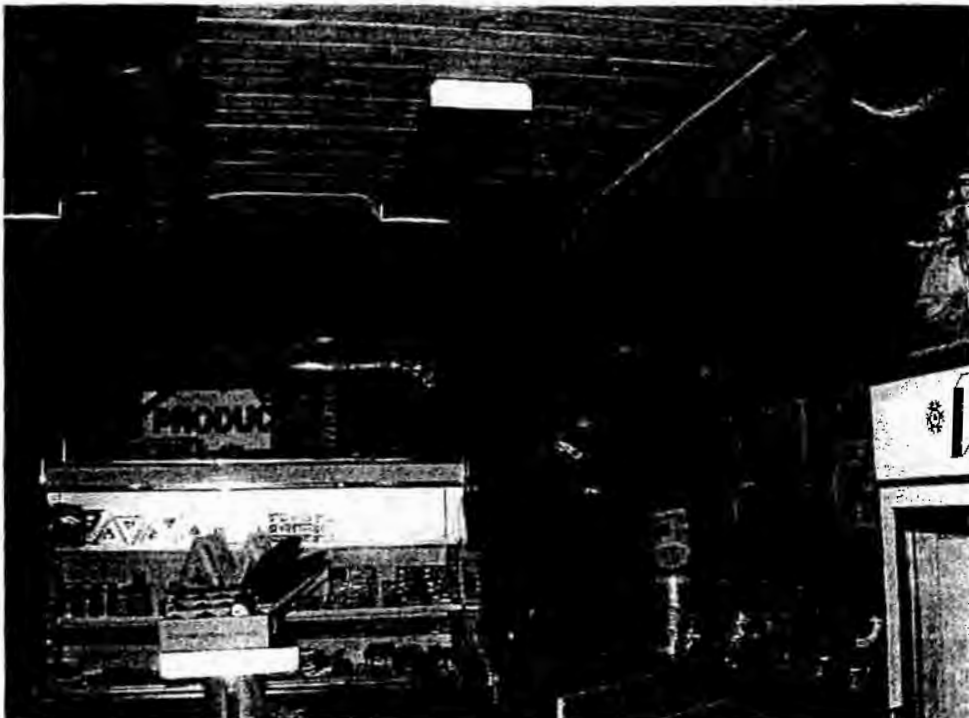
BT-09 - October 15, 2001
 101 Mile Motor Inn-Beaver Creek, YT - Main Lodge
 Location: Store - South Wall @ West Wall Corner

The building had been under negative pressure for about one half hour when this image was captured. Air is seen leaking everywhere.

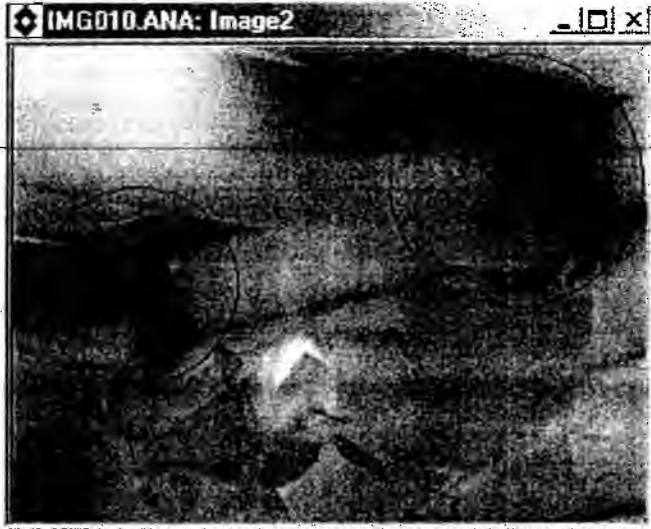
BT-10 - October 15, 2001

Log beams are difficult to seal where they penetrate outside support walls.

Using a product such as Weatherall or Permachink can substantially reduce such leakage.

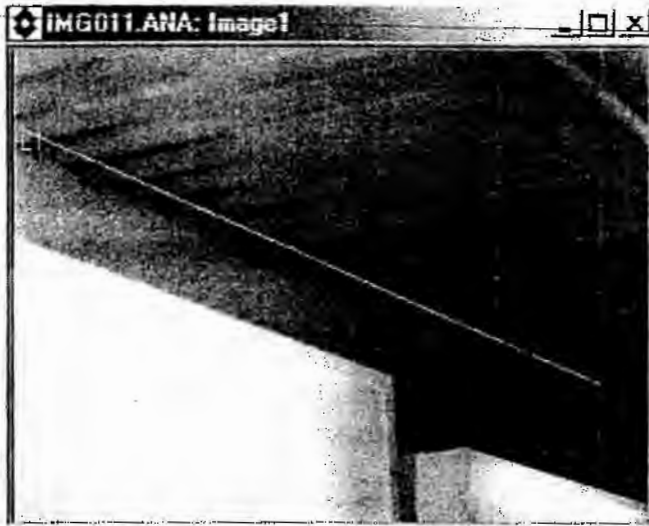
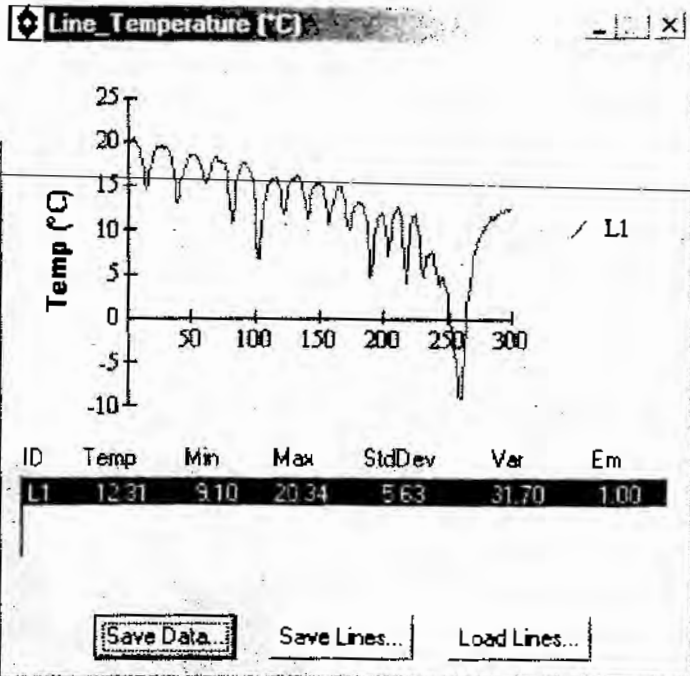
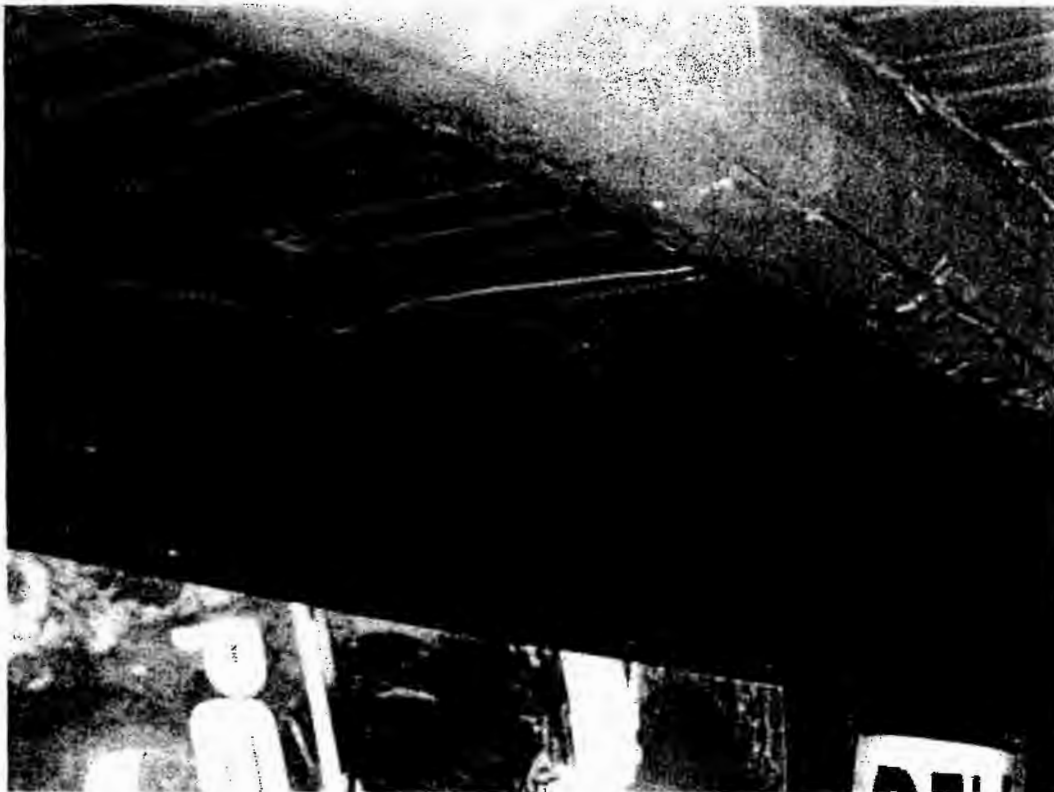
Another view of T&G decking leaking air at the joints between planks. The second floor is constructed above these boards.

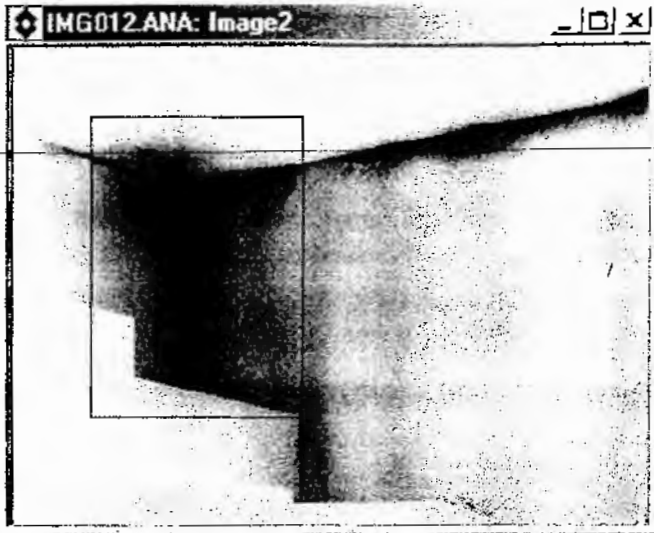
BT-12 - October 15, 2001
101 Mile Motor Inn-Beaver Creek, YT - Main Lodge
Location: Pantry @ Interior Wall Intersection

Interior wall intersections typically leak because the air vapor barrier was not installed in a continuous manner. A properly applied exterior retrofit would practically eliminate all air leakage such as this.

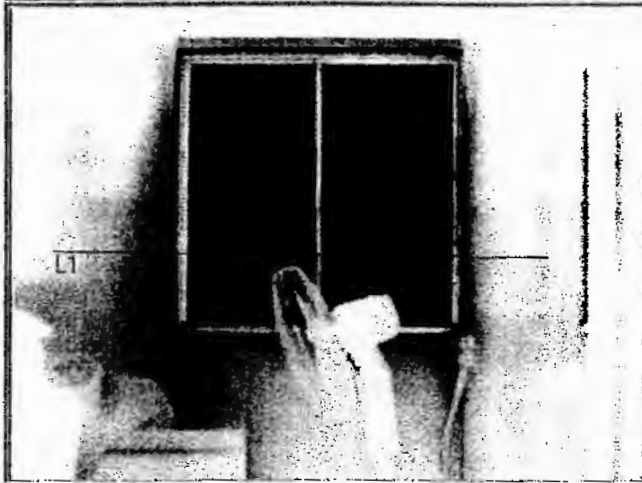
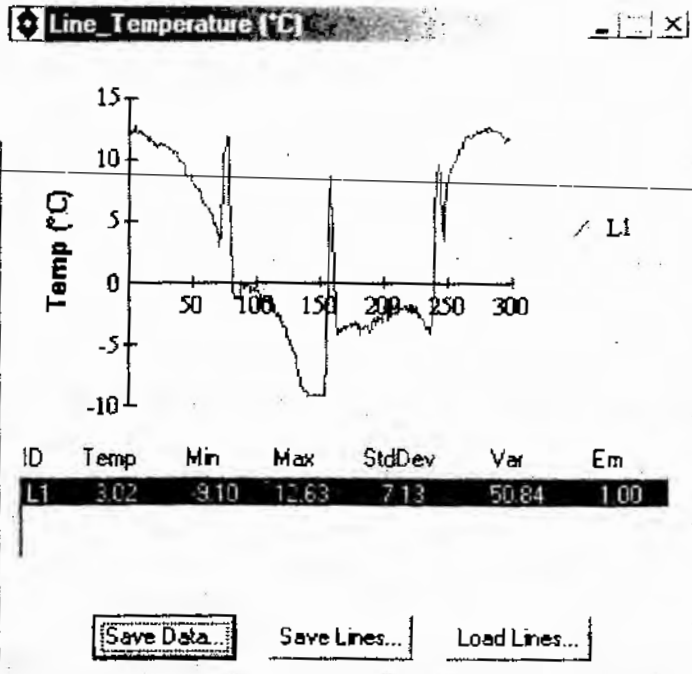
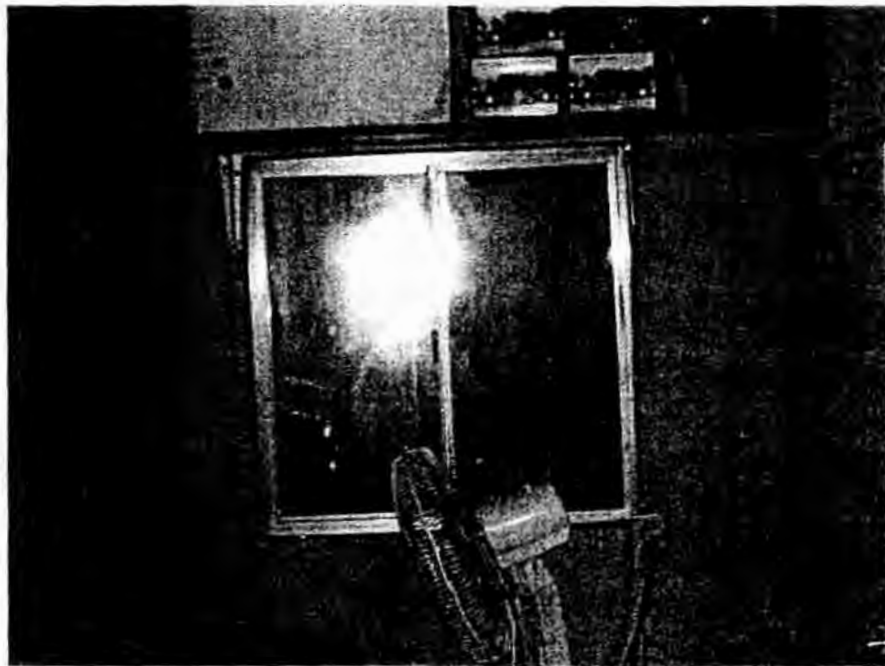
In addition to being constructed of highly conductive aluminum, this window slides to open. Sliding windows can be built to very tight air leakage standards, but with use, they often leak much more than designs which allow for a gasket compression type of seal.

Casement and tilt/turn type operating windows seem to maintain their air-tight qualities far longer than sliding designs.

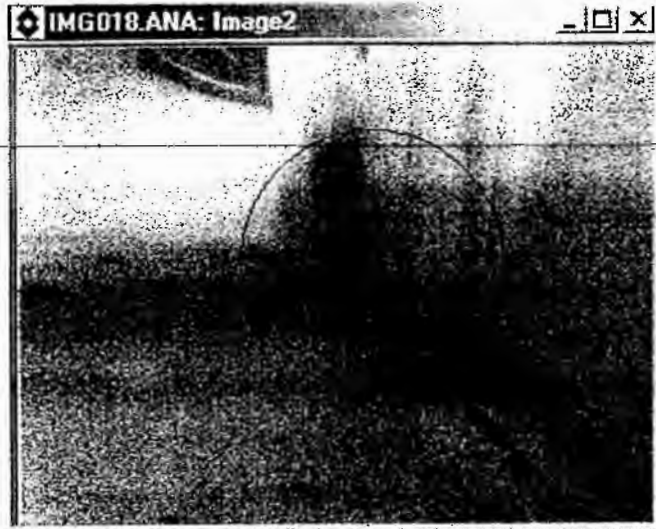
Location: Bath Hall @ Lower Wall Log / Frame Joint

The same area shown in the previous image is illustrated here, only at the bottom of the joint. We found a warmer infiltrating air temperature and believe it is due to air coming from the crawlspace. Question: is crawlspace air good, clean, healthy air?

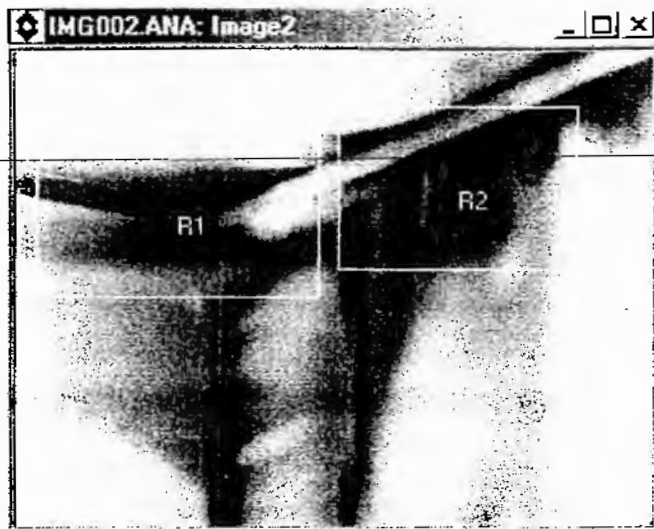
Location: Outside Corner @ Upper Wall

This manufactured housing shows air leakage at almost every intersection and corner. The only practical way for air sealing is on the exterior as the buildings are quite limited in interior space. Wrapping with an AVB and insulating the outside is one approach.

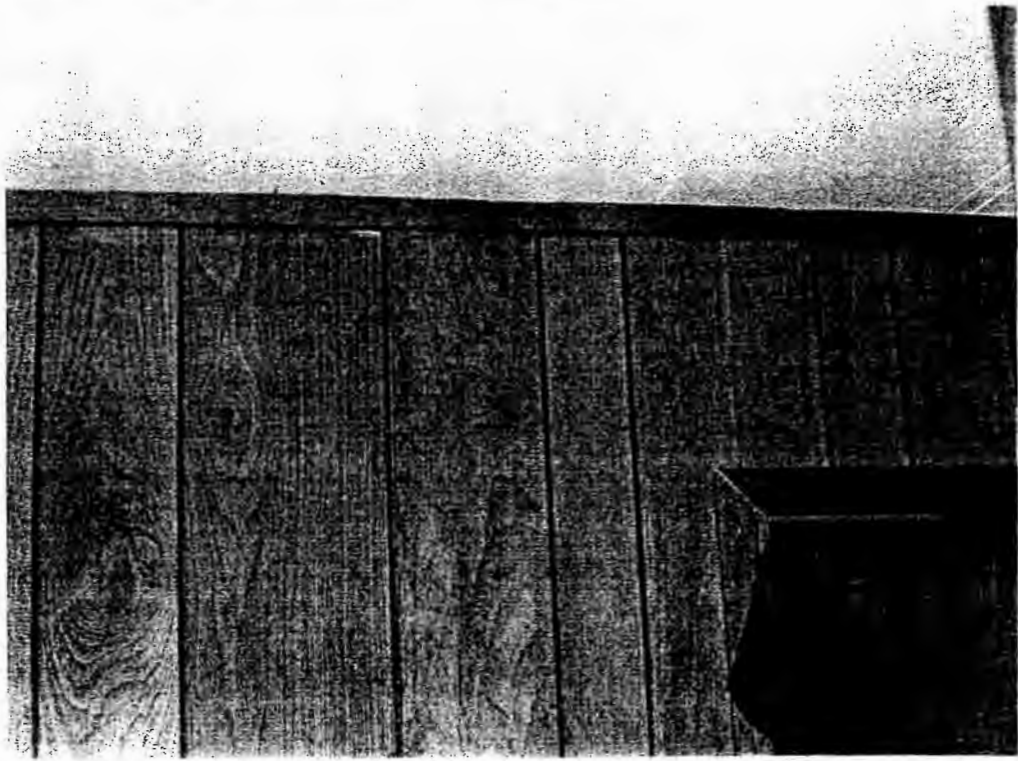
The appearance of this anomaly is usually from two deficiencies: Missing or improperly installed insulation and air leakage. Correcting it from the interior without disrupting the owners' ability to continue doing business is difficult.

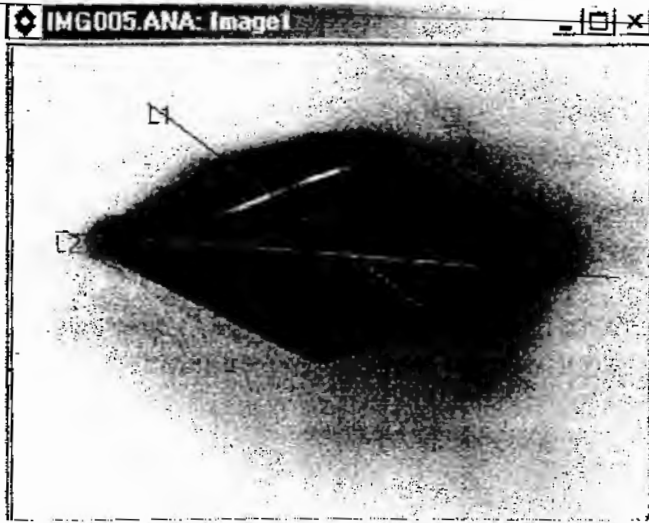
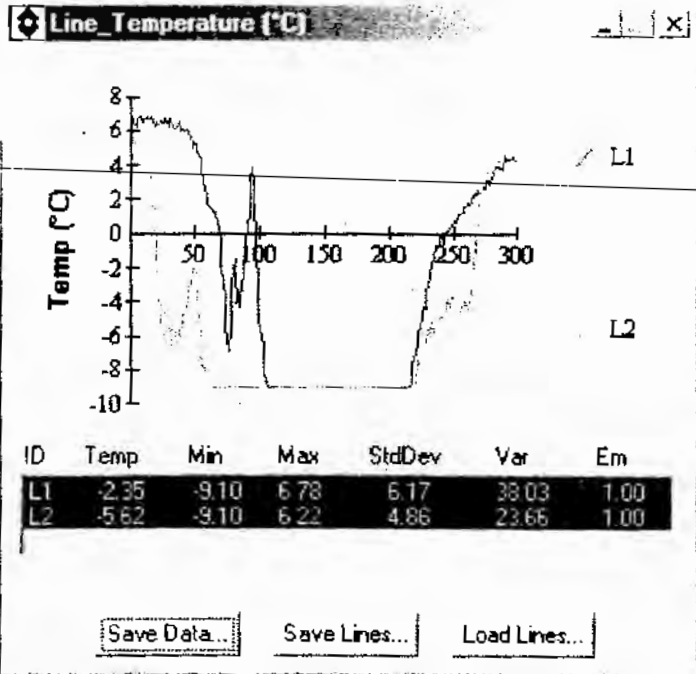
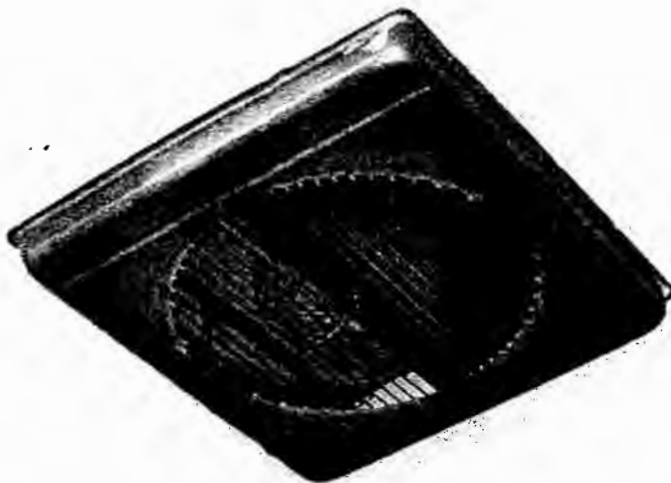
We found air to be able to exit, or enter, the building freely. No damper was installed.

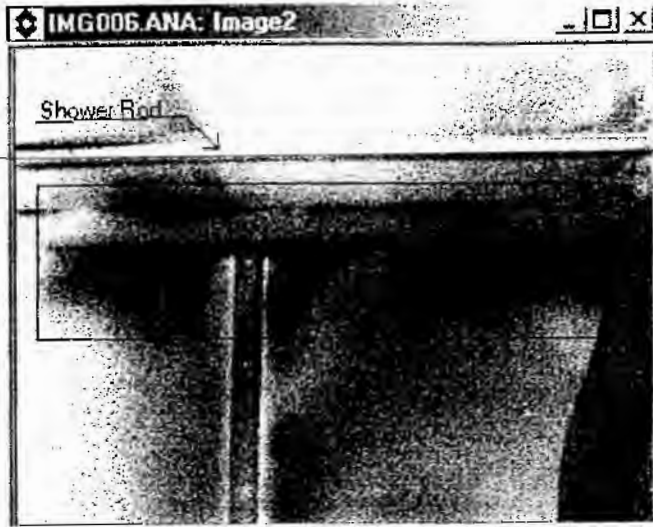
Location: Bathroom Ceiling @ Tub / Shower Wall

Stained ceiling panels represent years of moist air condensing and then dripping back in. The harmful effects of mold spores has been identified and exist in many moisture related building defects. This stain is possible evidence that one such defect is present in this unit.

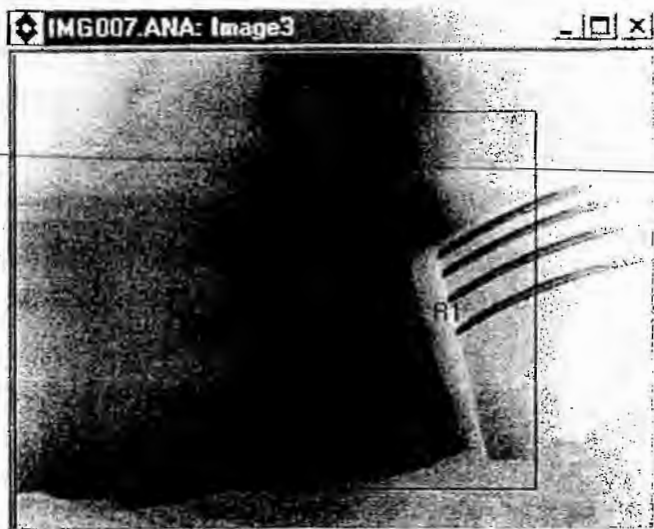
Location: Outside Corner @ Bedroom

Again we found air entering at an interior partition connection with the exterior wall. Temperatures below freezing were commonplace. As important as energy reduction is the comfort of the occupants. Sleeping comfortably could be a challenge.

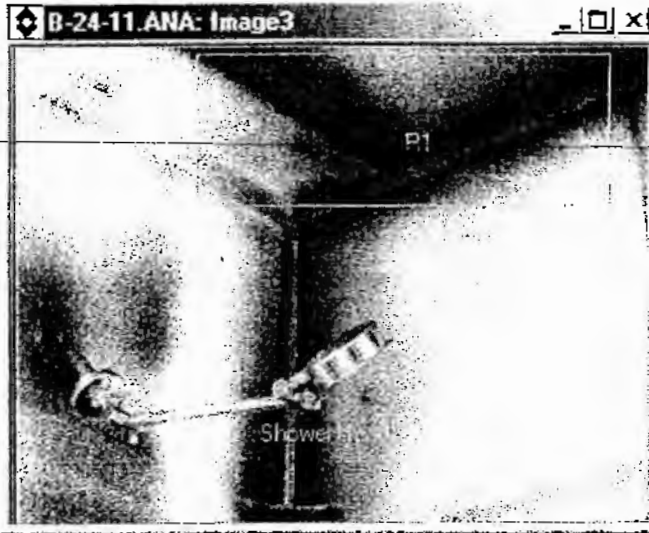
Location: Bathroom @ Shower Upper Wall

To the left is another view of a tub / shower installation showing air leaking in from behind the finished wall surface. Stains above the tub mark the areas where the dewpoint temperature occurs most frequently, causing wetting of the ceiling panels.

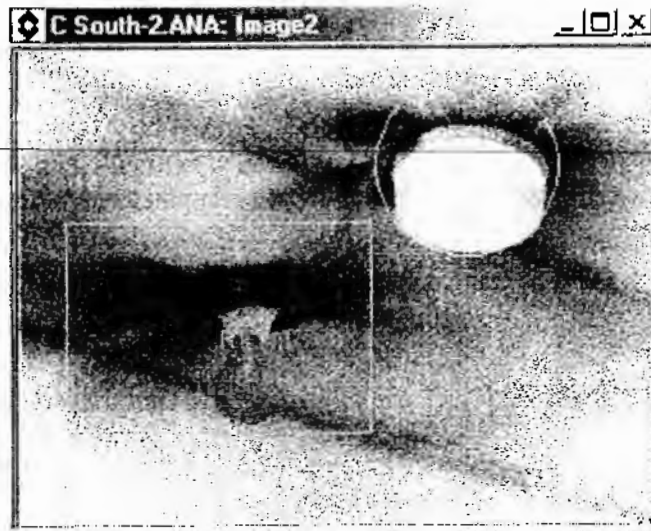
Location: Hallway Ceiling @ Lights & Smoke Alarm

Ceiling light fixtures and smoke alarms were found to be upper envelope leak areas. These are not so cold as other areas indicating infiltrating air is being warmed as it passes through the roof framing and insulation. These are still leaks to outside and need to be sealed.

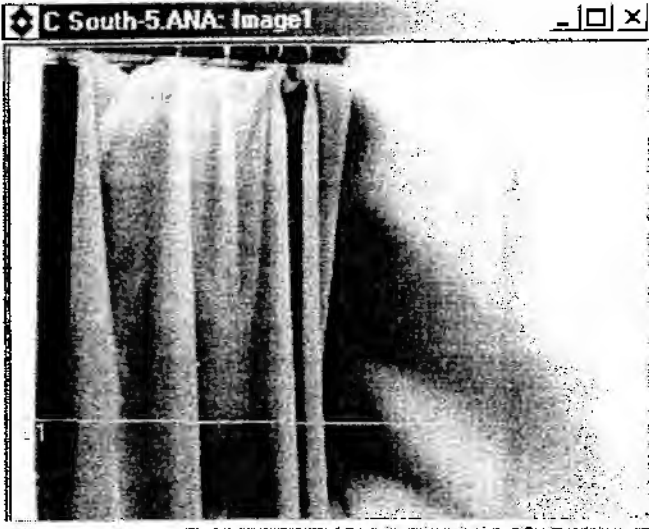
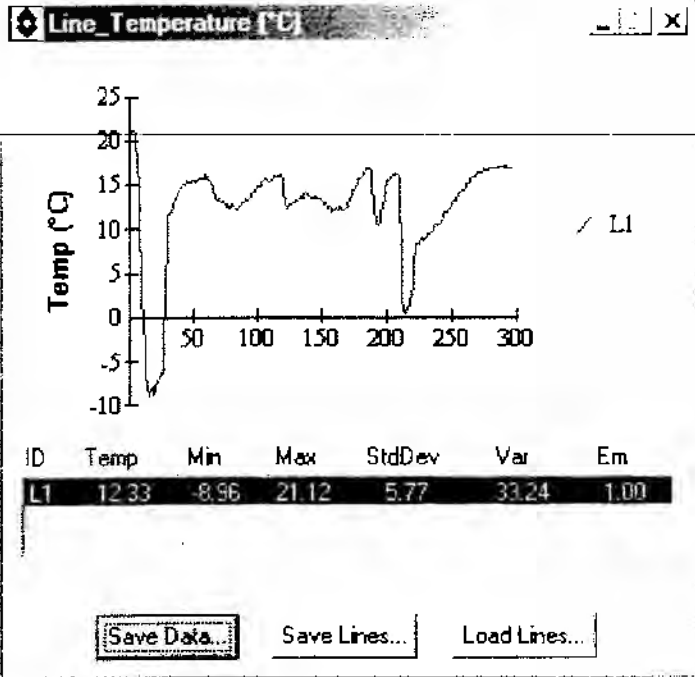
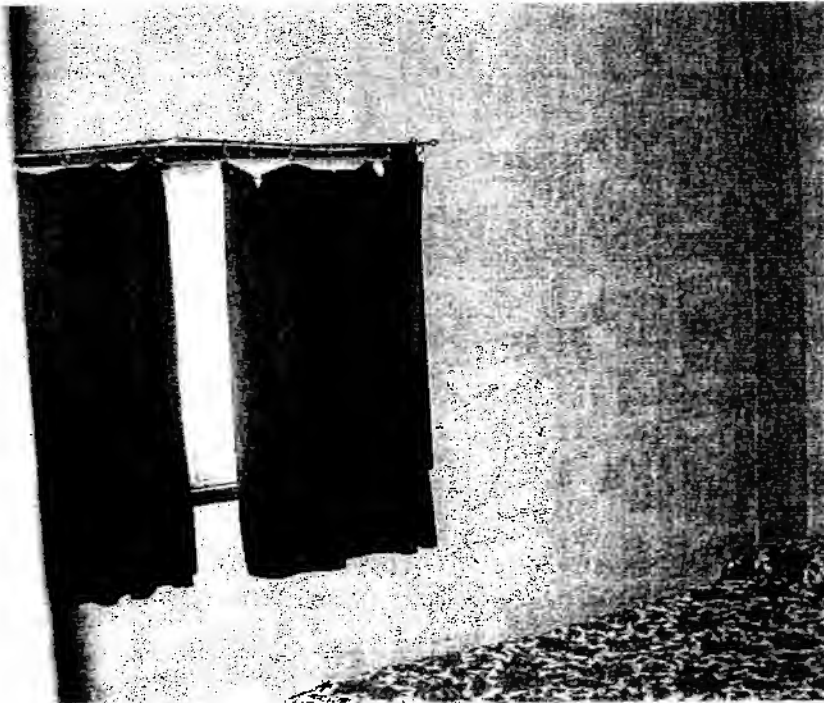
BT-38 - October 15, 2001
101 Mile Motor Inn-Beaver Creek, YT - Building C, South
Location: Bedroom @ Window Installation

One can almost hear the wind blowing just by looking at the thermogram below. Window frame to rough opening gaps are leaking air.
