# YUKON INN ENERGY STUDY

June, 2002

**Yukon Inn**  
4220 4<sup>th</sup> Ave  
Whitehorse, YT, Y1A 1K1

**Sinclair & Associates**  
Suite 2 – 2090 2<sup>nd</sup> Avenue  
Whitehorse, YT, Y1A 1B6  
Tel: 867-667-7205  
Fax: 867-668-7120

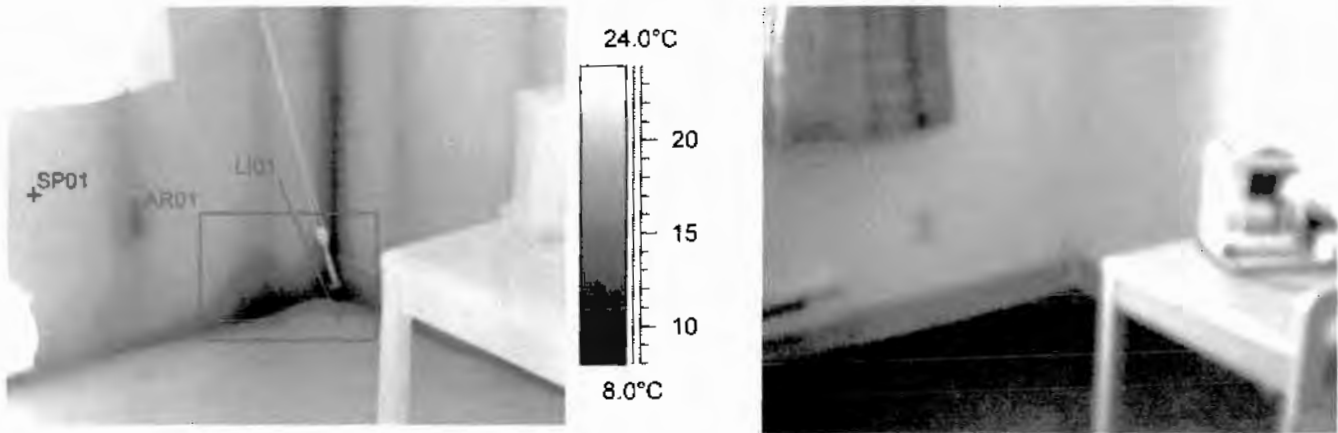
IR Text Comment	Value
Section	Room 231
Equipment	Outside Corner
Additional information	
Fault	Energy loss through framing.
Recommendation	Retrofit Exterior

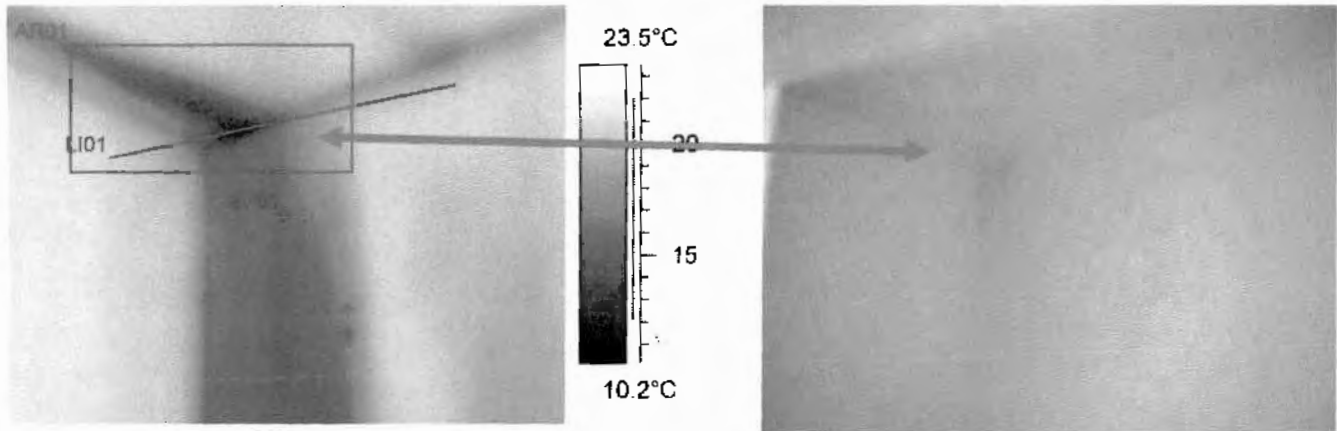
IR Text Comment	Value
Section	Room 231
Equipment	Closet Side Partition
Additional information	
Fault	Air Leakage
Recommendation	Install Air / Vapor Barrier on Exterior

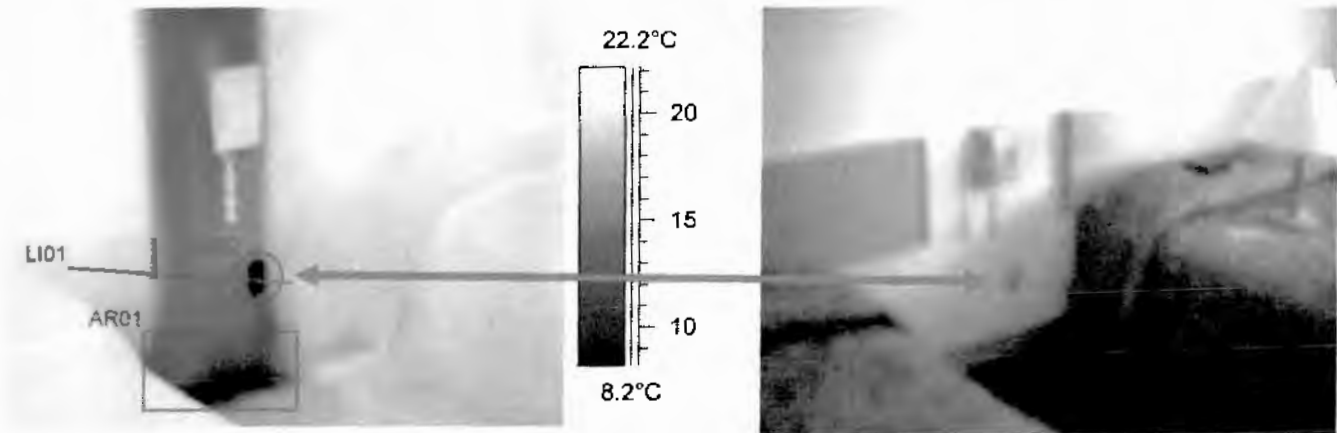
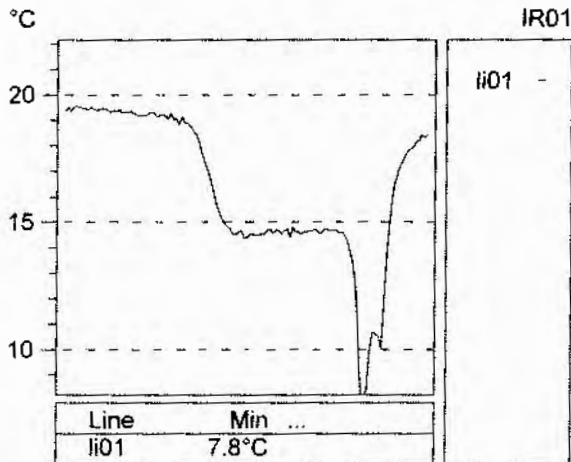
IR Text Comment	Value
Section	Room 231
Equipment	Phone Jack Cavity on Interior Wall
Additional information	Air leakage at interior walls very difficult to seal
...continued	without a majoy exterior retrofit as described in report.
Fault	Air Leakage From Outside
Recommendation	Exterior Retrofit

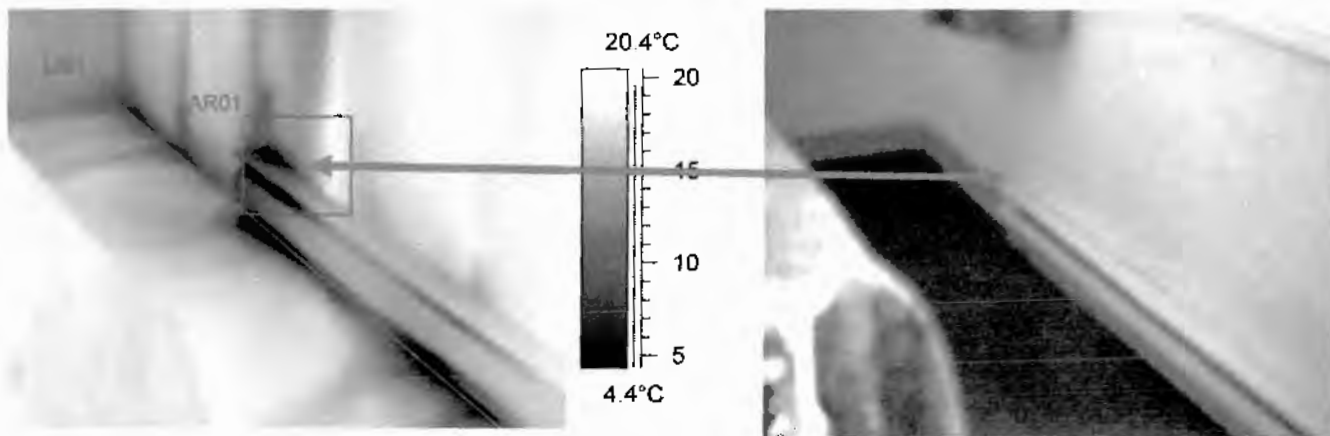
IR Text Comment	Value
Section	Room 231
Equipment	Baseboard and Bottom Plate
Additional information	Plate
Fault	Air Leakage at Bottom Plate
Recommendation	Exterior Retrofit

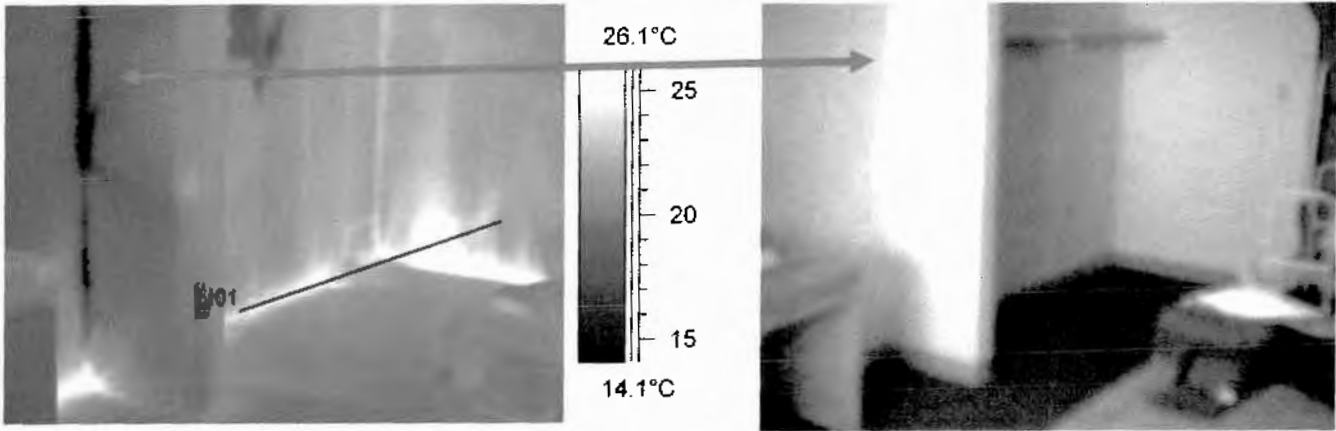
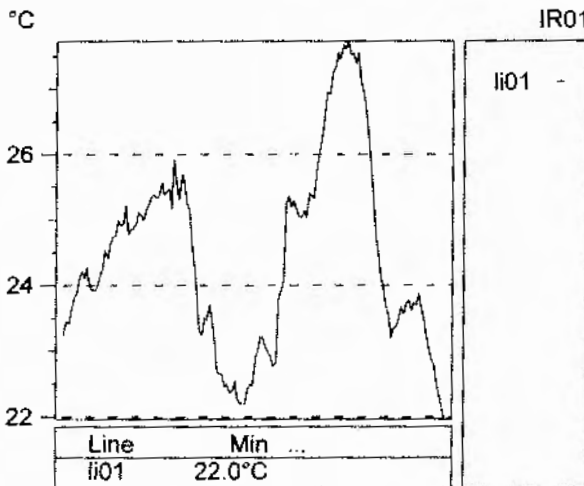
IR Text Comment	Value
Section	Room 231
Equipment	Closet Alcove - Lower
Additional information	
Fault	Hidden Uninsulated Heat Pipe in Wall
Recommendation	Reduce pipe temperature with indoor / outdoor reset aquastat.

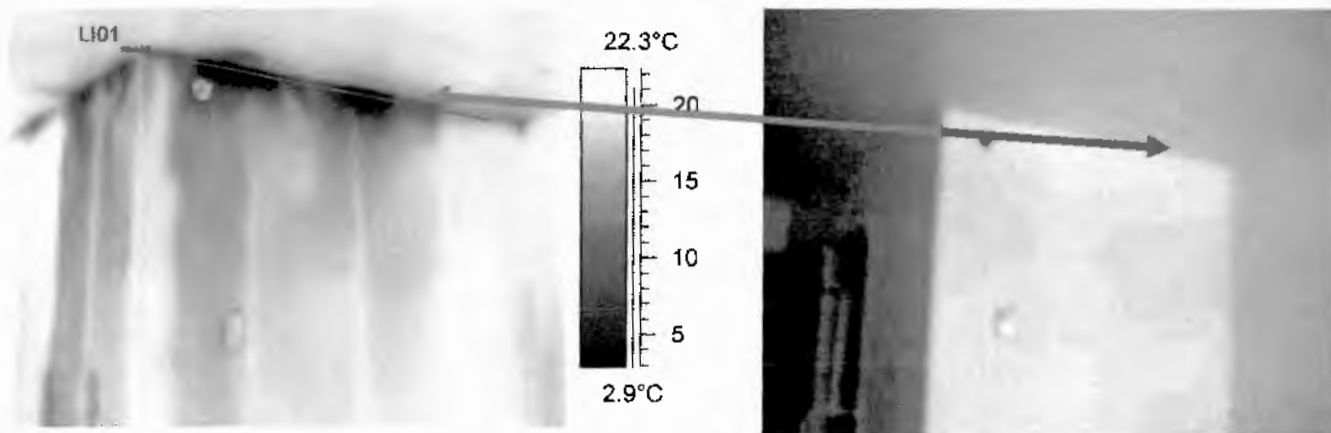
IR Text Comment	Value
Section	Room 231
Equipment	Bathroom Partition
Additional information	
Fault	Air Leakage at top plate
Recommendation	Exterior Retrofit

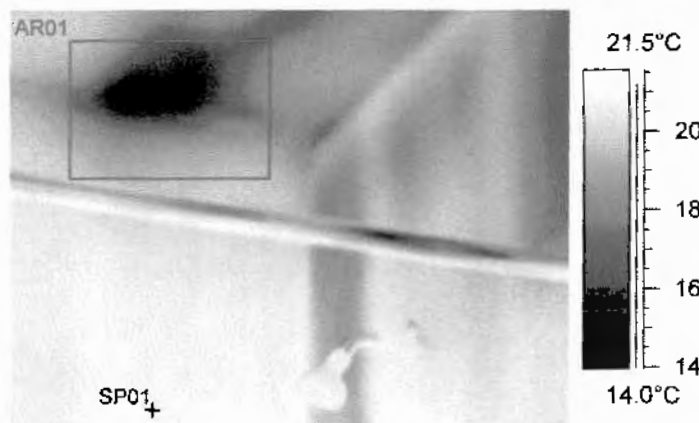
IR Text Comment	Value
Section	Room 231
Equipment	Bathroom Wall Above Towell Rack
Additional information	Towell Rack
Fault	Poorly Installed Insulation and Air Leakage
Recommendation	Exterior Retrofit

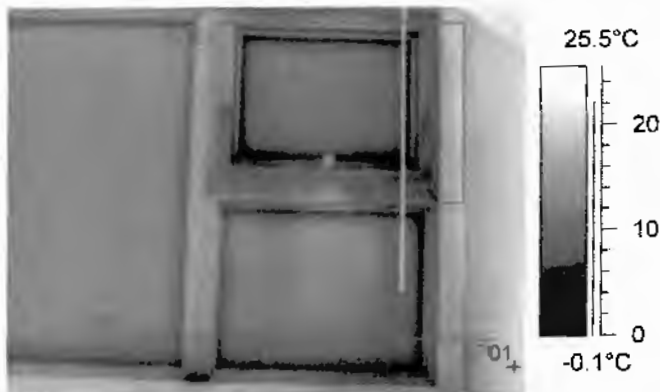
IR Text Comment	Value
Section	Room 143
Equipment	Window
Recommendation	Seal installation air leaks
Additional Information	Remove trim and air seal space between frame and rough opening.

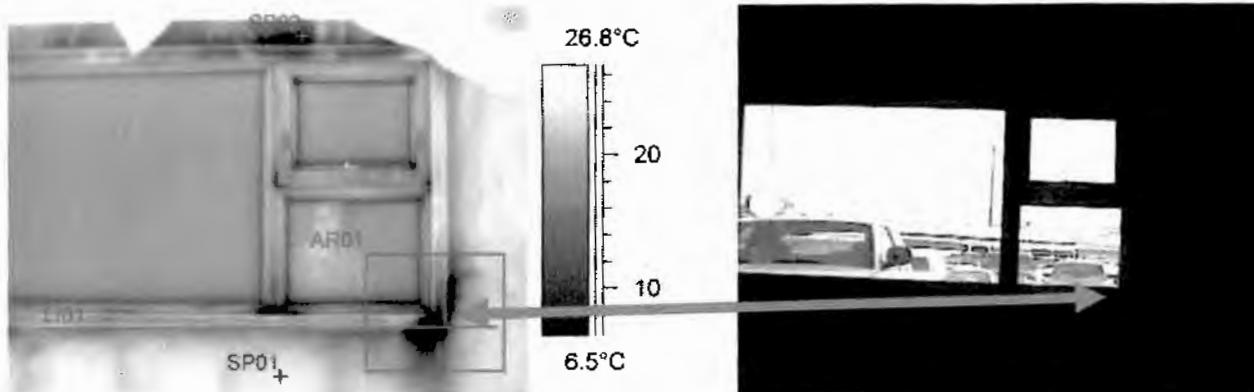
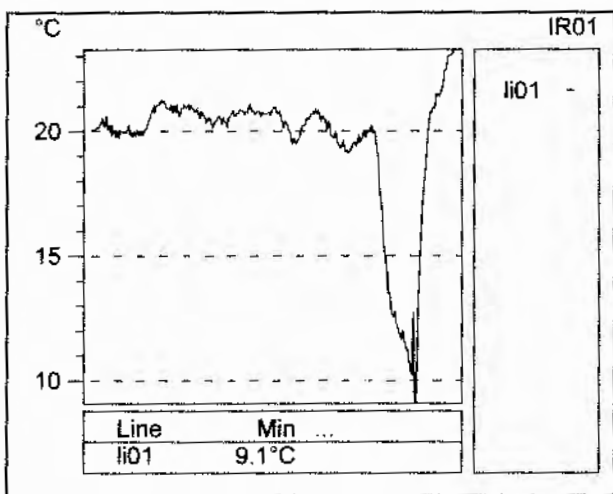
IR Text Comment	Value
Section	Room 141
Equipment	Window
Recommendation	Seal installation leaks
Additional Information	Remove trim and caulk leaks.

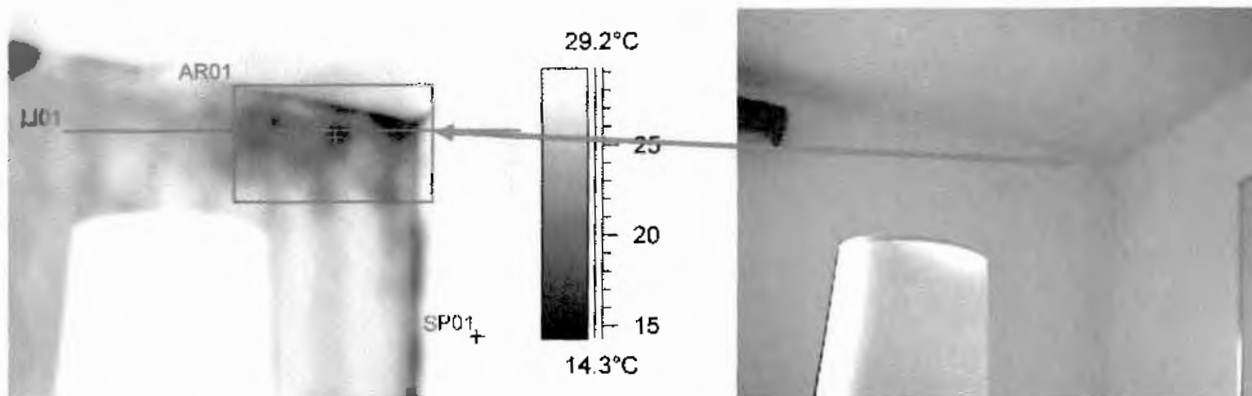
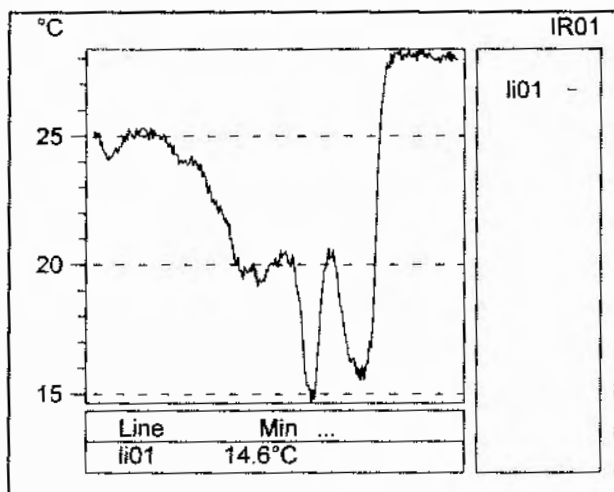
IR Text Comment	Value
Section	Room 143
Equipment	Outside wall upper right corner
Recommendation	Poor insulation
Additional Information	Install rigid foam insulation on exterior & cover w/new siding

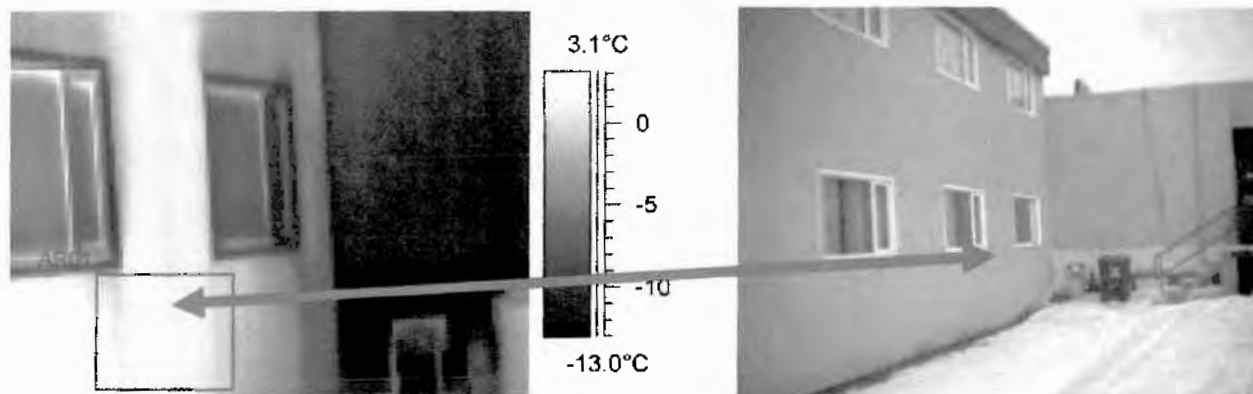
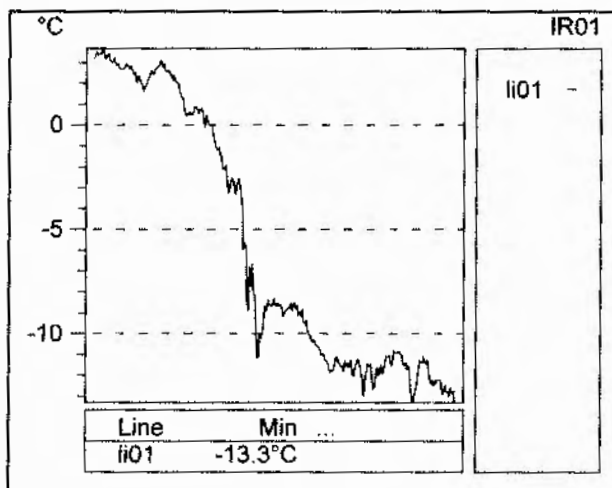
IR Text Comment	Value
Section	Exterior
Equipment	Wall
Recommendation	Insulate on Exterior
Additional Information	Insul. walls on exterior after instal. compl. air/vapour barrie
...continued	Maintain two thirds of the total R-value on the outside.

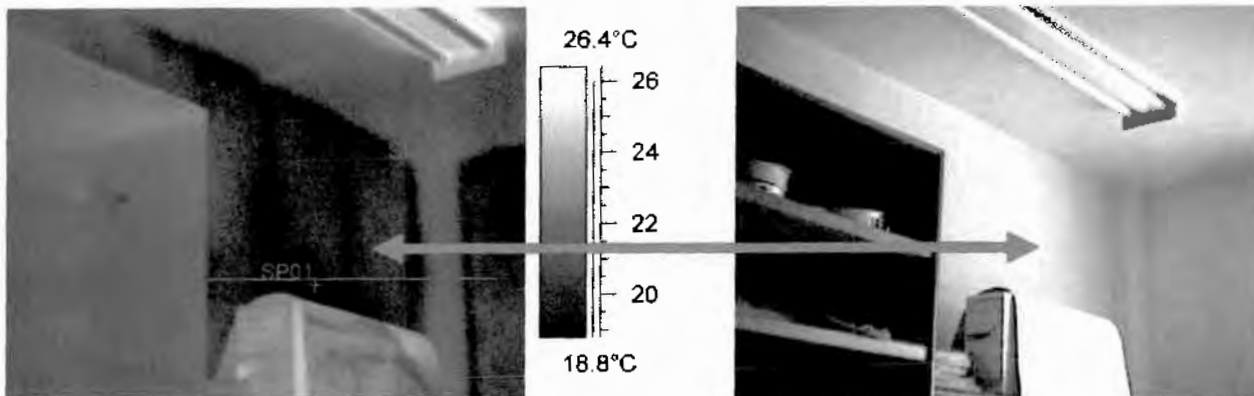
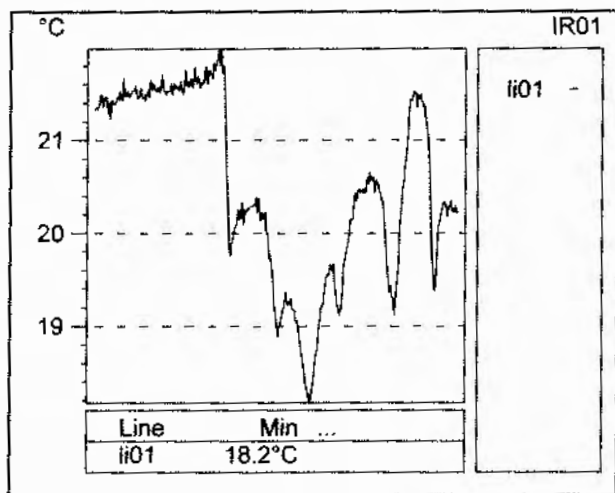
IR Text Comment	Value
Section	Room ?
Equipment	Outside wall
Recommendation	Insulate on Exterior
Additional Information	Install rigid foam insulation on exterior & cover w/ new siding

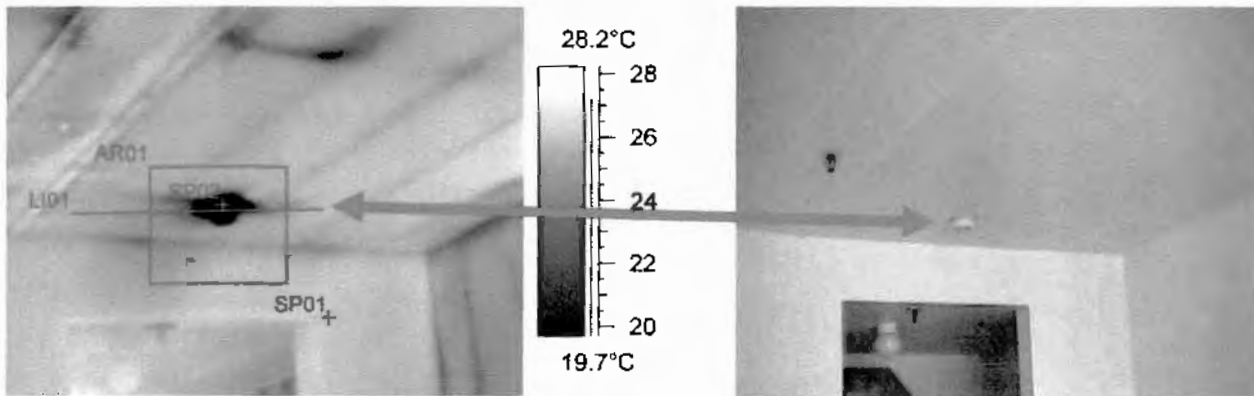
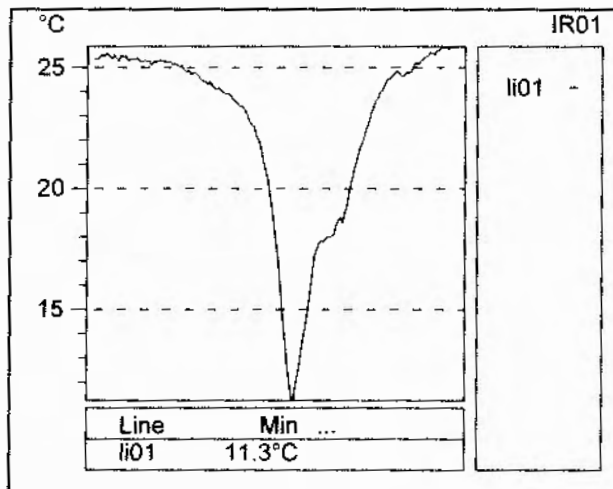
IR Text Comment	Value
Section	Room ?
Equipment	Ceiling
Recommendation	Insulate Attic and Exterior Walls
Additional Information	Blow .3M of cellulose insulation into attic space after sealing
...continued	all air leaks and placing rigid insulation over exterior walls.

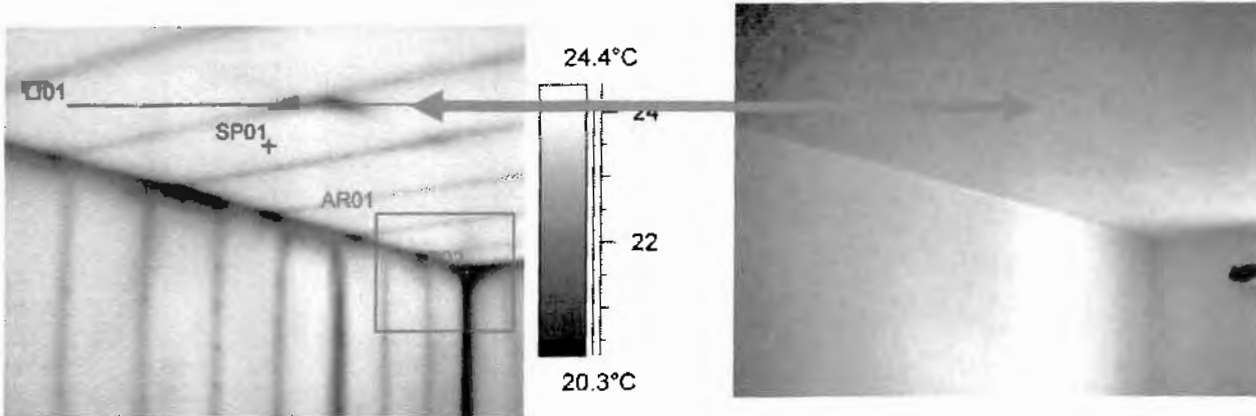
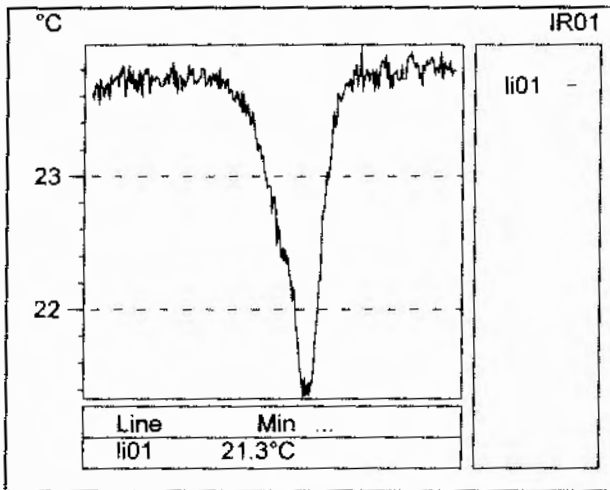
IR Text Comment	Value
Section	Room ?
Equipment	Walls & ceiling
Recommendation	Insulate Attic and Exterior Walls
Additional Information	Blow .3M of cellulose insulation into attic space after sealing
...continued	all air leaks and placing rigid insulatin over exterior walls.

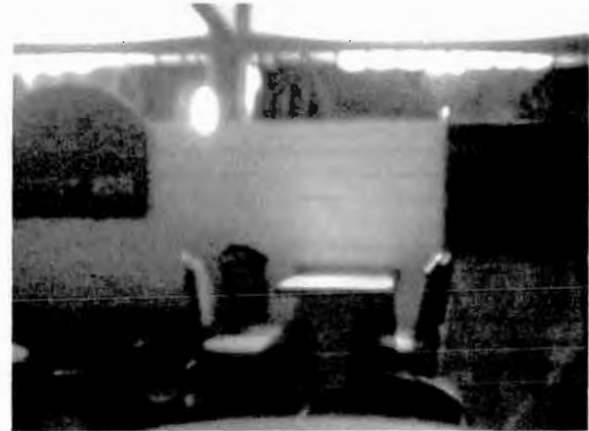
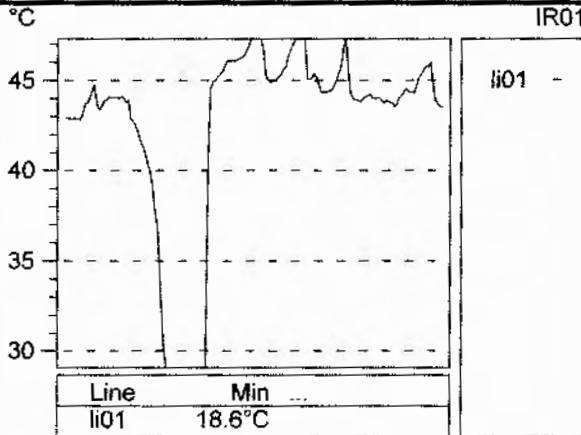
IR Text Comment	Value
Section	Boiler Room Bar
Equipment	Radiant Panel and Windows
Additional information	Room was grossly overheated due to malfunctioning zone valve.
Fault	Heat from panel is lost through double pane windows
Recommendation	Insulate exterior of basement wall and install triple pane glas

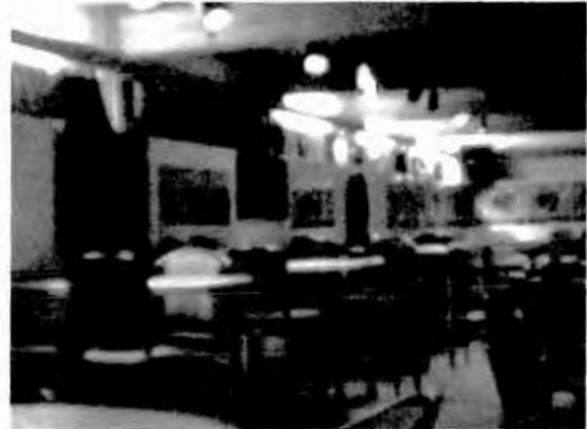
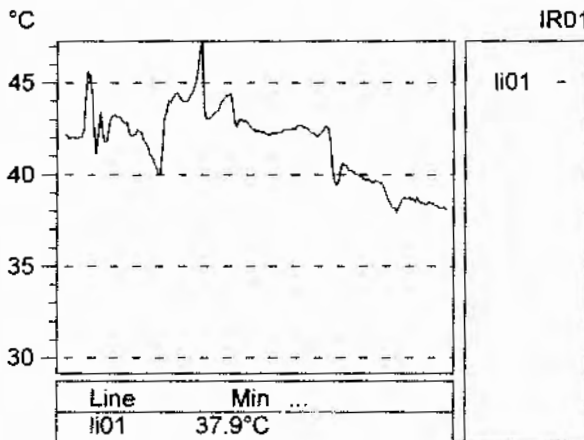
IR Text Comment	Value
Section	Boiler Room Bar
Equipment	View of exterior wall and windows.
Additional information	Room was grossly overheated due to malfunctioning zone valve.
Fault	Heat loss through windows and wall.
Recommendation	Insulate exterior of basement wall and install triple pane glas

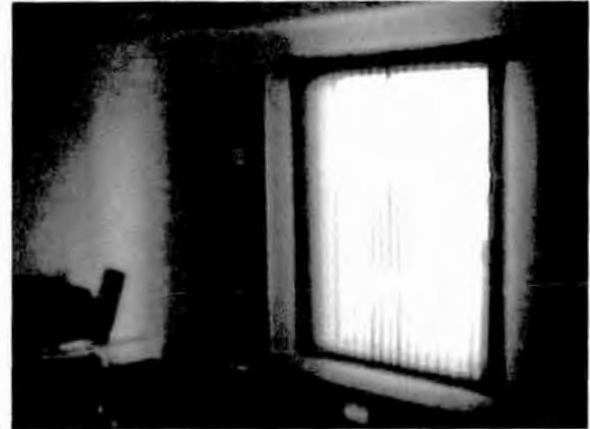
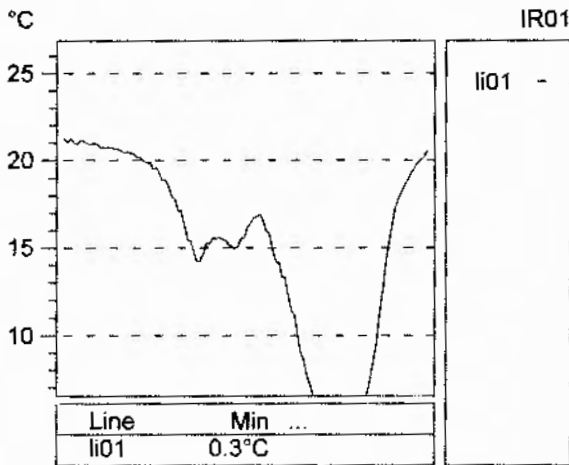
IR Text Comment	Value
Section	Boiler Room Bar
Equipment	Northern Nook and Exterior Door
Additional information	
Fault	High heat loss from air leakage around door.
Recommendation	Install tight fitting weatherstripping around doors.

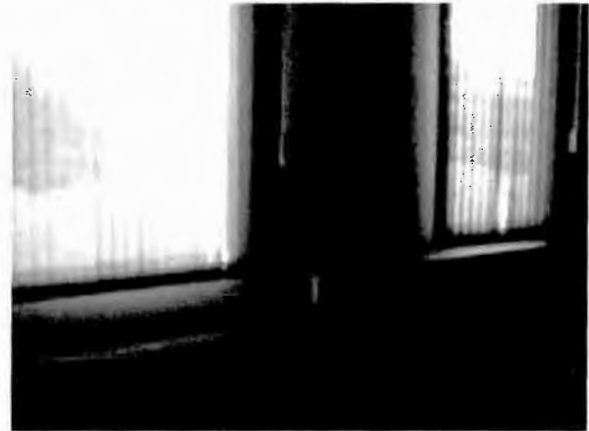
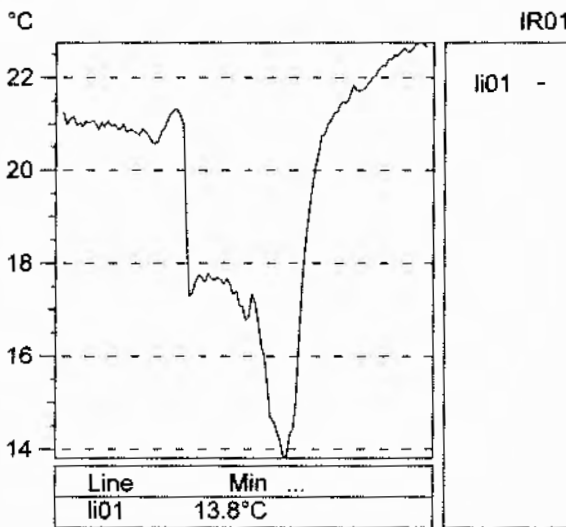
IR Text Comment	Value
Section	Boiler Room Bar
Equipment	Northern Nook Radiation at Wall / Floor
Additional information	
Fault	Elevated heat loss through wall / floor area.
Recommendation	Exterior retrofit.

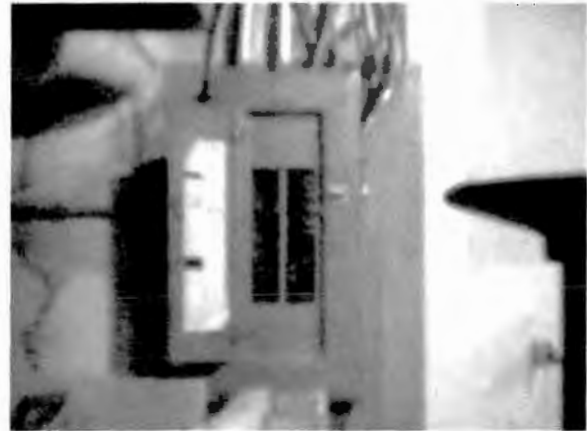
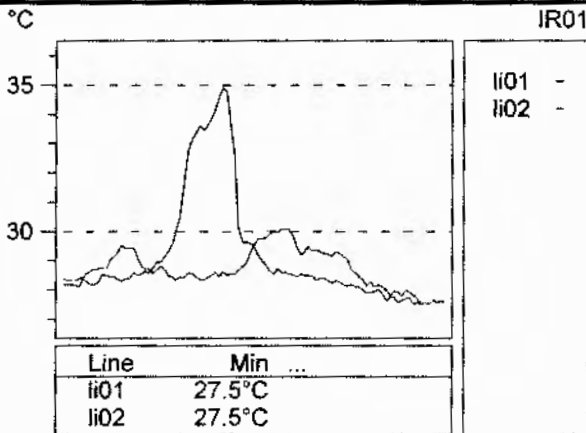
IR Text Comment	Value
Section	Boiler Room Panel
Equipment	Breaker Panel B
Additional information	
Fault	220 V 20 Amp (Freezer)
Recommendation	Increase breaker capacity or reduce load

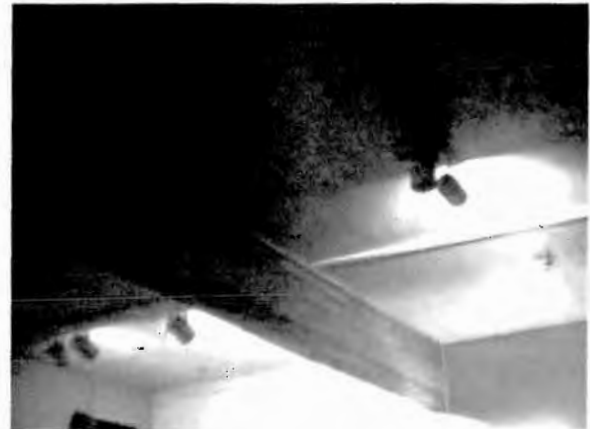
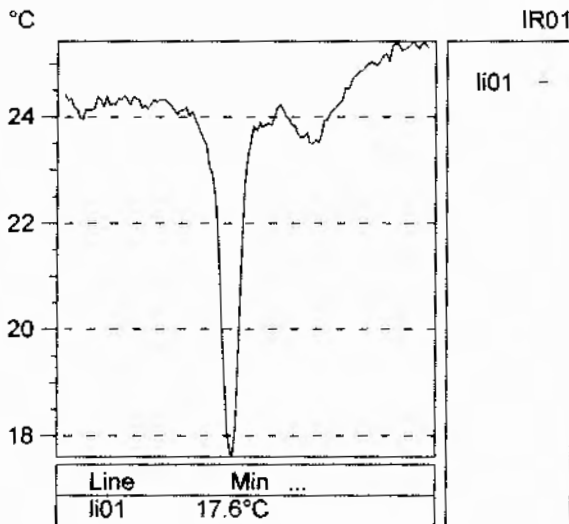
IR Text Comment	Value
Section	Sports Bar
Equipment	Ceiling
Additional information	
Fault	Insulation Flaw in Ceiling
Recommendation	Retrofit ceiling on exterior.

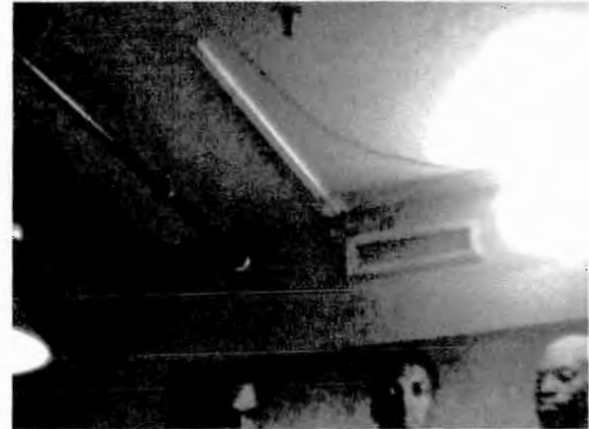
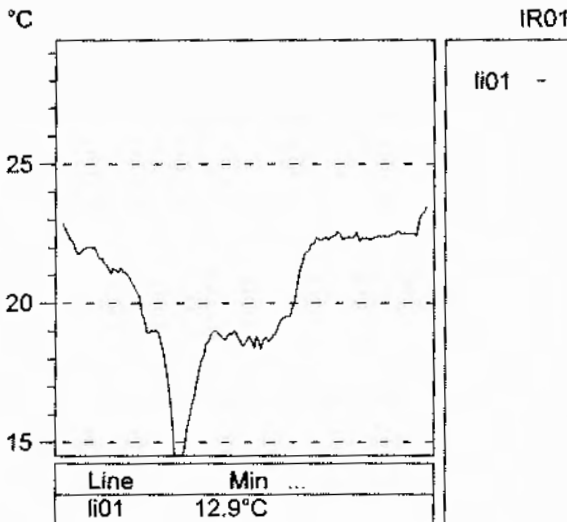
IR Text Comment	Value
Section	Sports Bar
Equipment	Ceiling / Wall Joint
Additional information	
Fault	Poorly installed insulation and air leakage.
Recommendation	Retrofit ceiling on exterior.

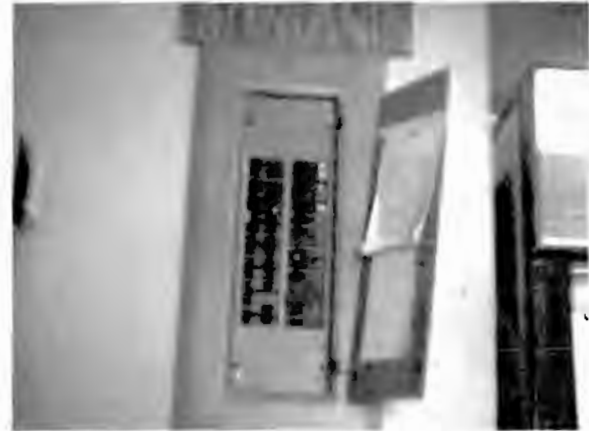
IR Text Comment	Value
Section	Yukon Inn Restaurant
Equipment	Kitchen Breaker Panel R
Additional information	
Fault	Hot Breaker
Recommendation	Replace breaker or reduce load.

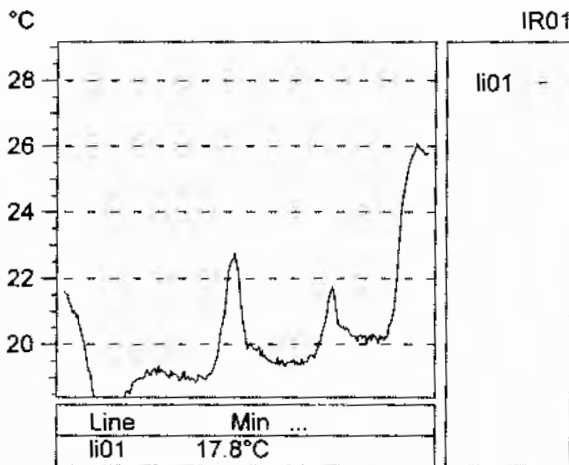
IR Text Comment	Value
Section	Kitchen
Equipment	Staff area ceiling at ventilation grille
Additional information	
Fault	Missing/wet or poorly installed insulation in ceiling.
Recommendation	Perform exterior roof retrofit.

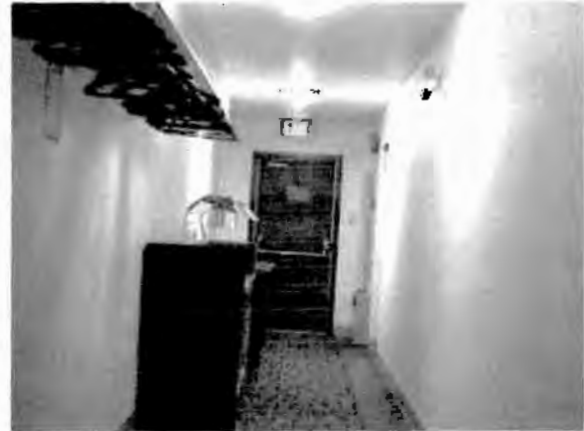
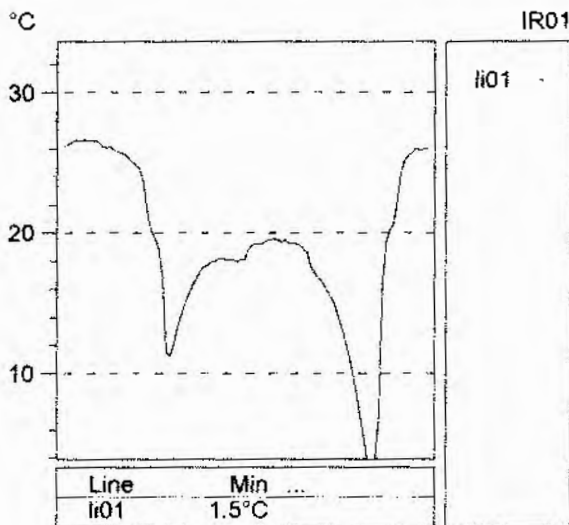
IR Text Comment	Value
Section	Hallway Exit
Equipment	Exterior Door
Additional information	
Fault	Air leakage around door
Recommendation	Adjust or replace weatherstripping.
