GEOLOGICAL SURVEY OF CANADA
BULLETIN 464

FORMATION AND FAILURE OF NATURAL DAMS IN THE CANADIAN CORDILLERA

John J. Clague and Stephen G. Evans

1994

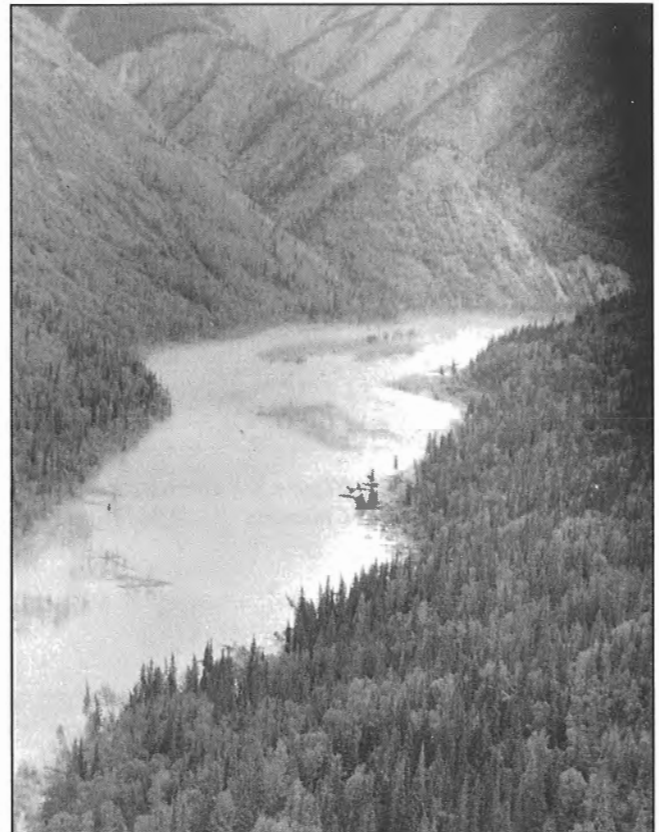
Figure 5. Aerial view of a lake dammed by a landslide in May 1979 in Inklin River valley upstream of Yeth Creek (Fig. 1), northern British Columbia. The landslide occurred in thick Quaternary sediments which form a dissected fill in the valley. (Photograph courtesy of Sandy Johnston, Fisheries Canada).

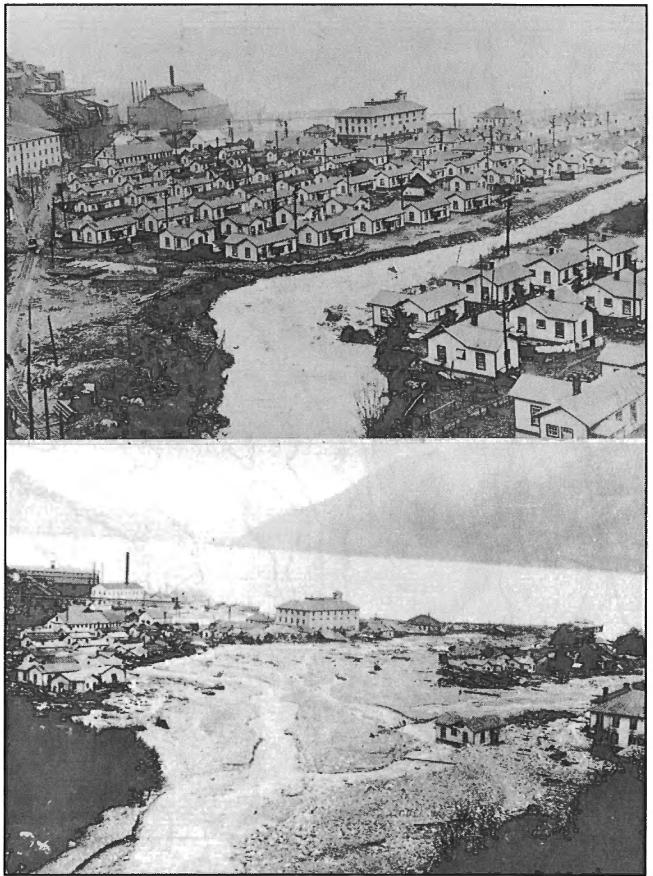
Figure 7. The mining town of Britannia before and immediately after the catastrophic outburst flood of October 28, 1921. The flood, which occurred after several days of heavy rain, resulted from the failure of a landslide dam or an earthfill embankment carrying a mine railway (Eisbacher, 1983; Jackson et al., 1985; Evans, 1986a). Thirty-seven people were killed and about half of the 170 houses in the town destroyed. (Photographs courtesy of Britannia Mining Museum, Browning family collection).

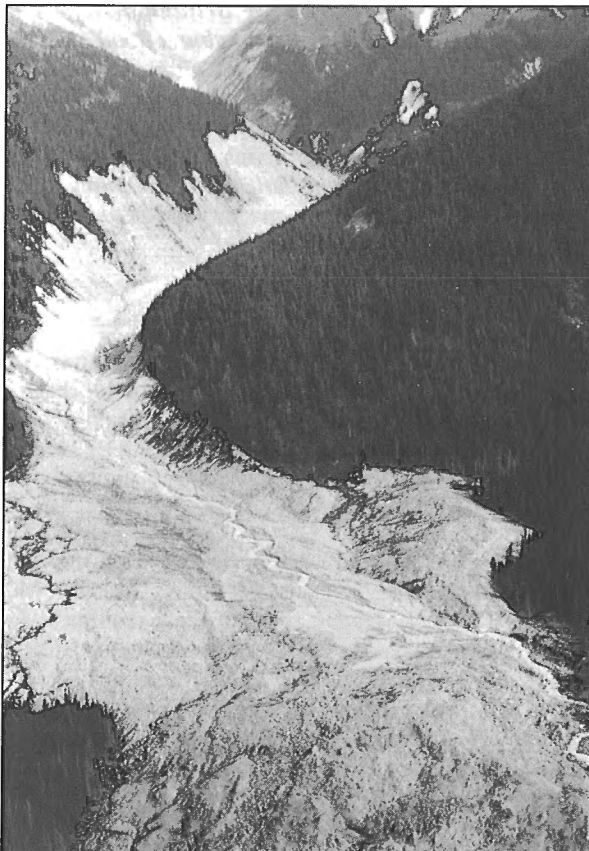
Figure 9. *Aerial view of the valley of Devastator Creek, showing the track of the Devastation Glacier landslide which occurred on July 22, 1975. This landslide is one of many historical failures on the flanks of Quaternary volcanoes in southwestern British Columbia. It dammed a small lake in Meager Creek valley at the mouth of Devastator Creek (see Fig. 10). (GSC 204165-J)*

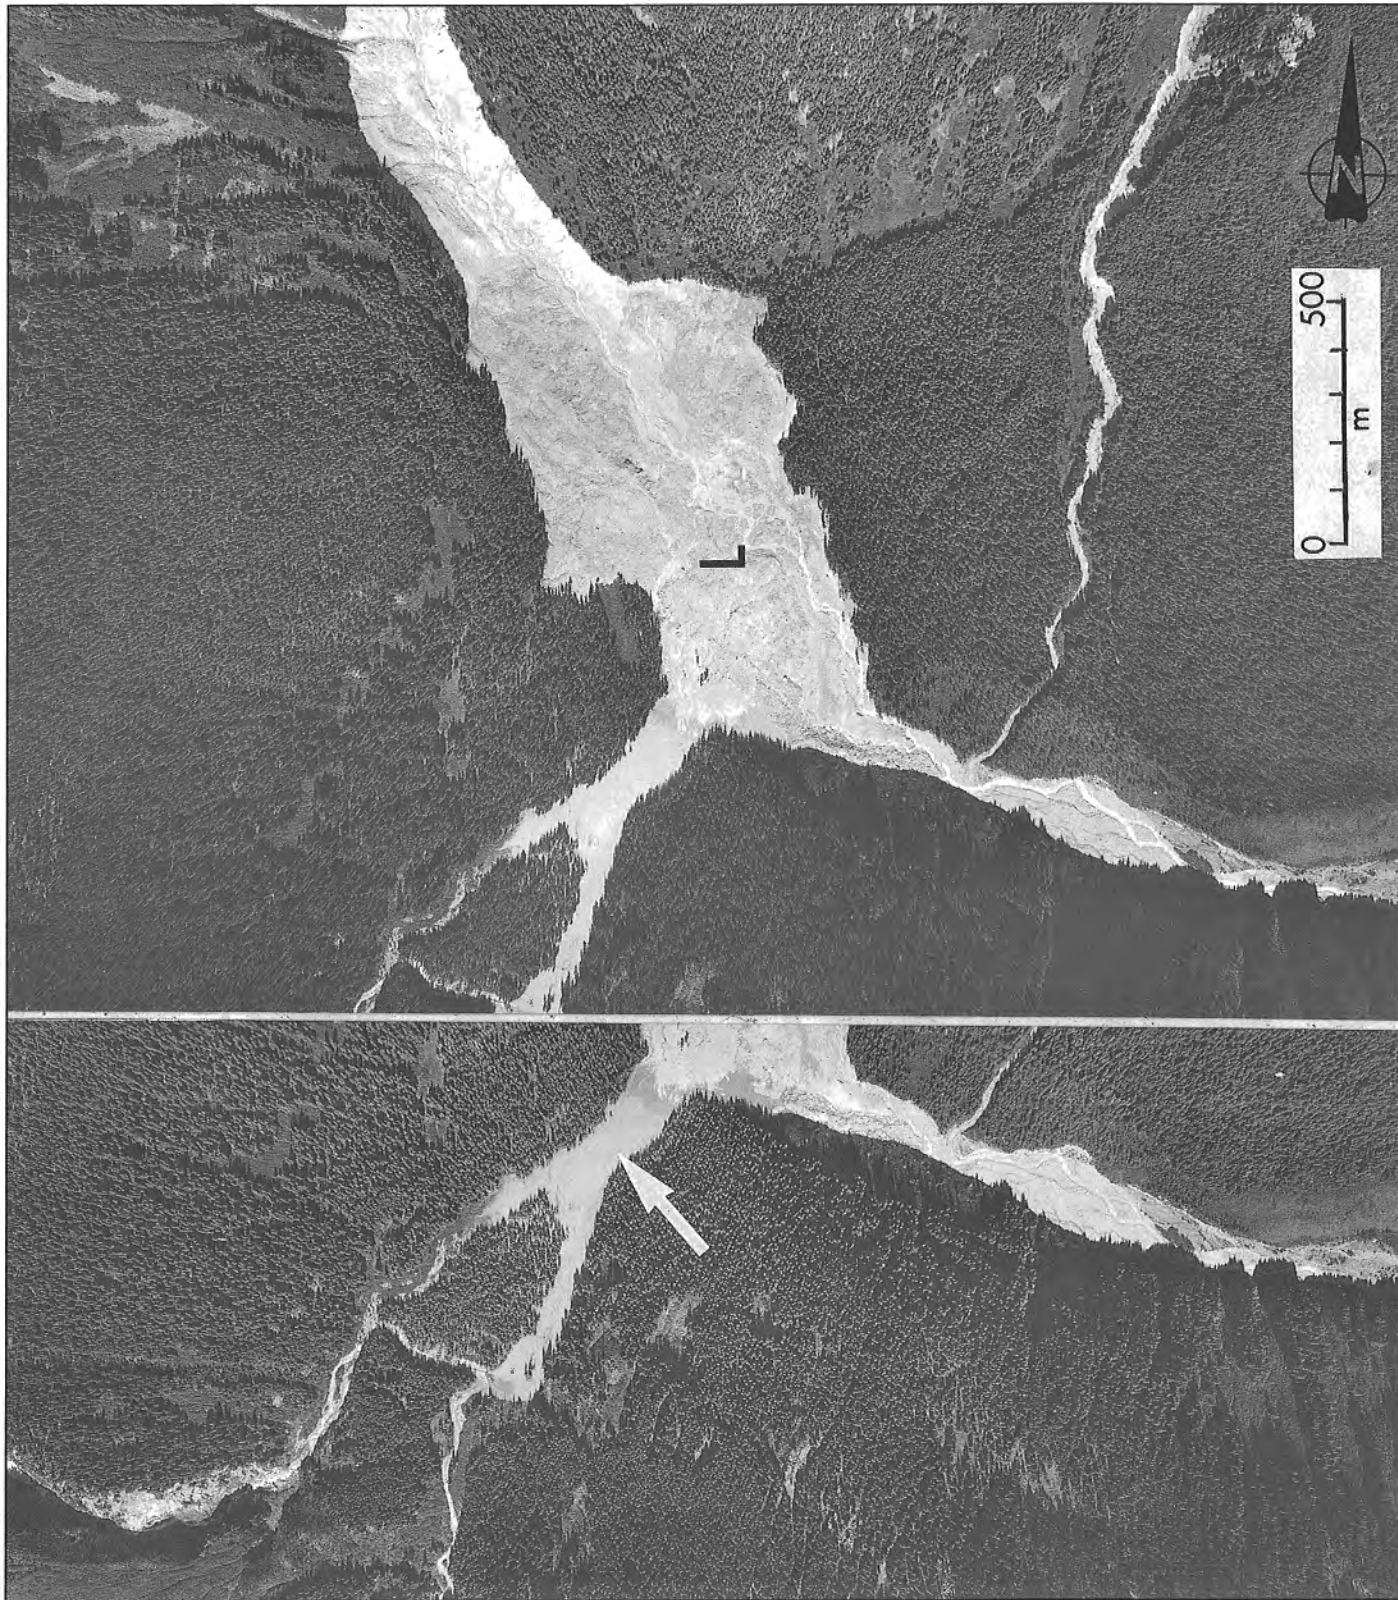
Figure 10. Photostereogram showing the lake (arrow) in Meager Creek valley impounded by the 1975 Devastation Glacier landslide (L). (Province of British Columbia airphotos BC5685-86, -87).

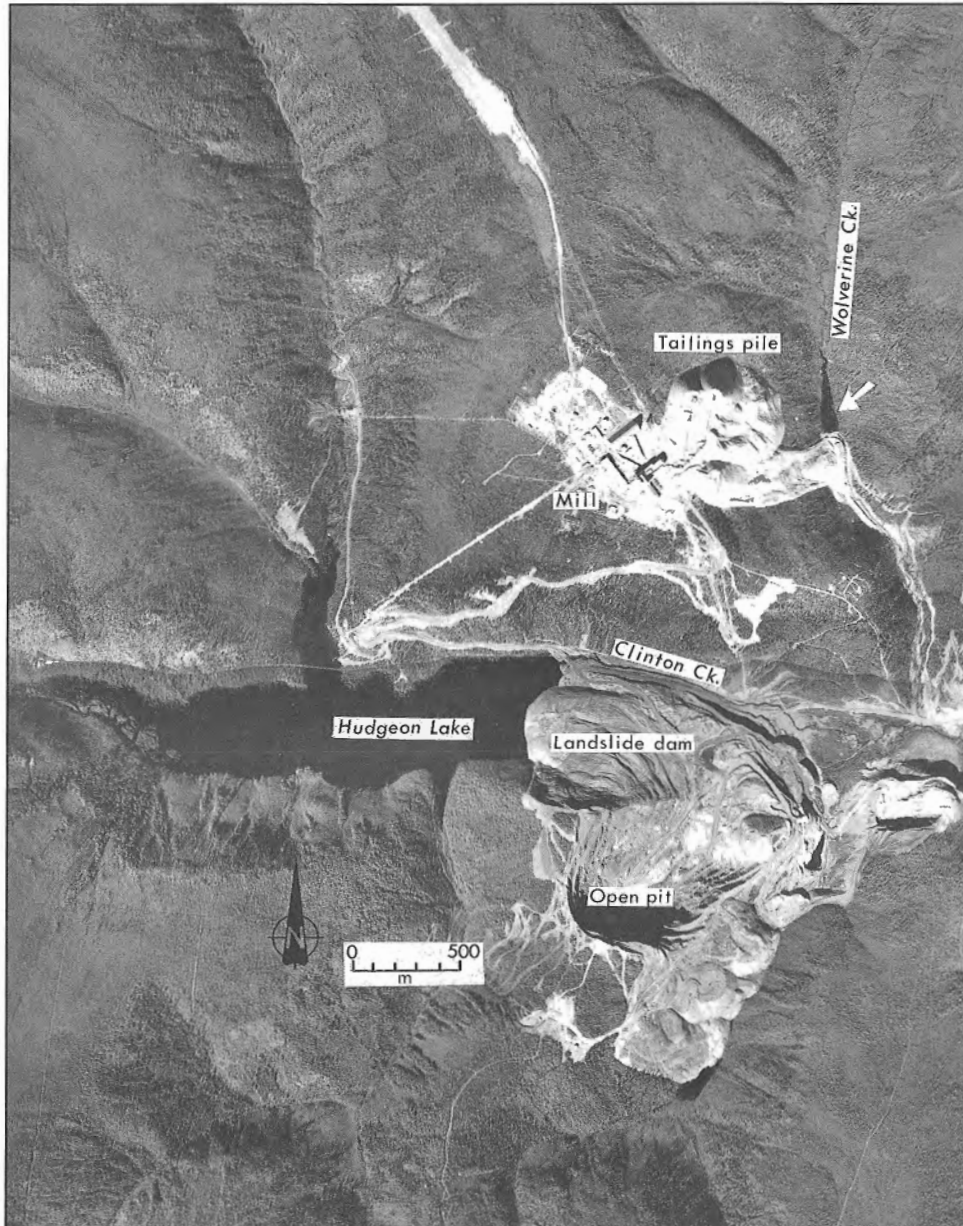
Figure 11. Aerial view of the Clinton Creek mine area in 1976, showing Hudgeon Lake and its dam of failed mine rock waste. A smaller lake, dammed by failed mine tailings, is visible in the upper right (arrow). (Photo courtesy of M. Stepanek, Geo-Engineering (M.S.T.) Ltd.).

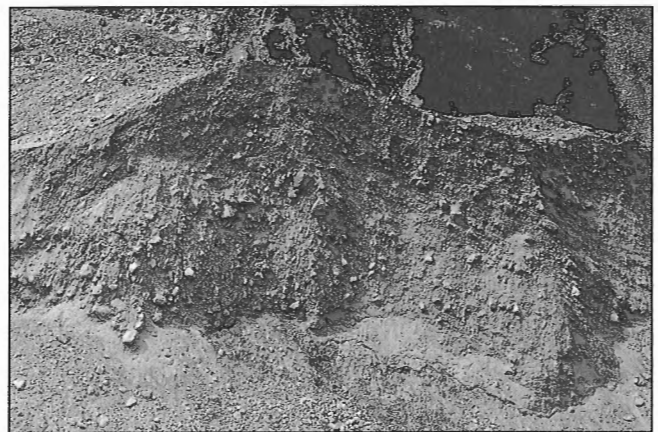
Figure 14. Poorly sorted, bouldery sediments exposed in the breached, Little Ice Age moraine at Nostetuko Lake, British Columbia. Most moraine dams in the Canadian Cordillera are made of similar materials. The height of the exposure is about 40 m.

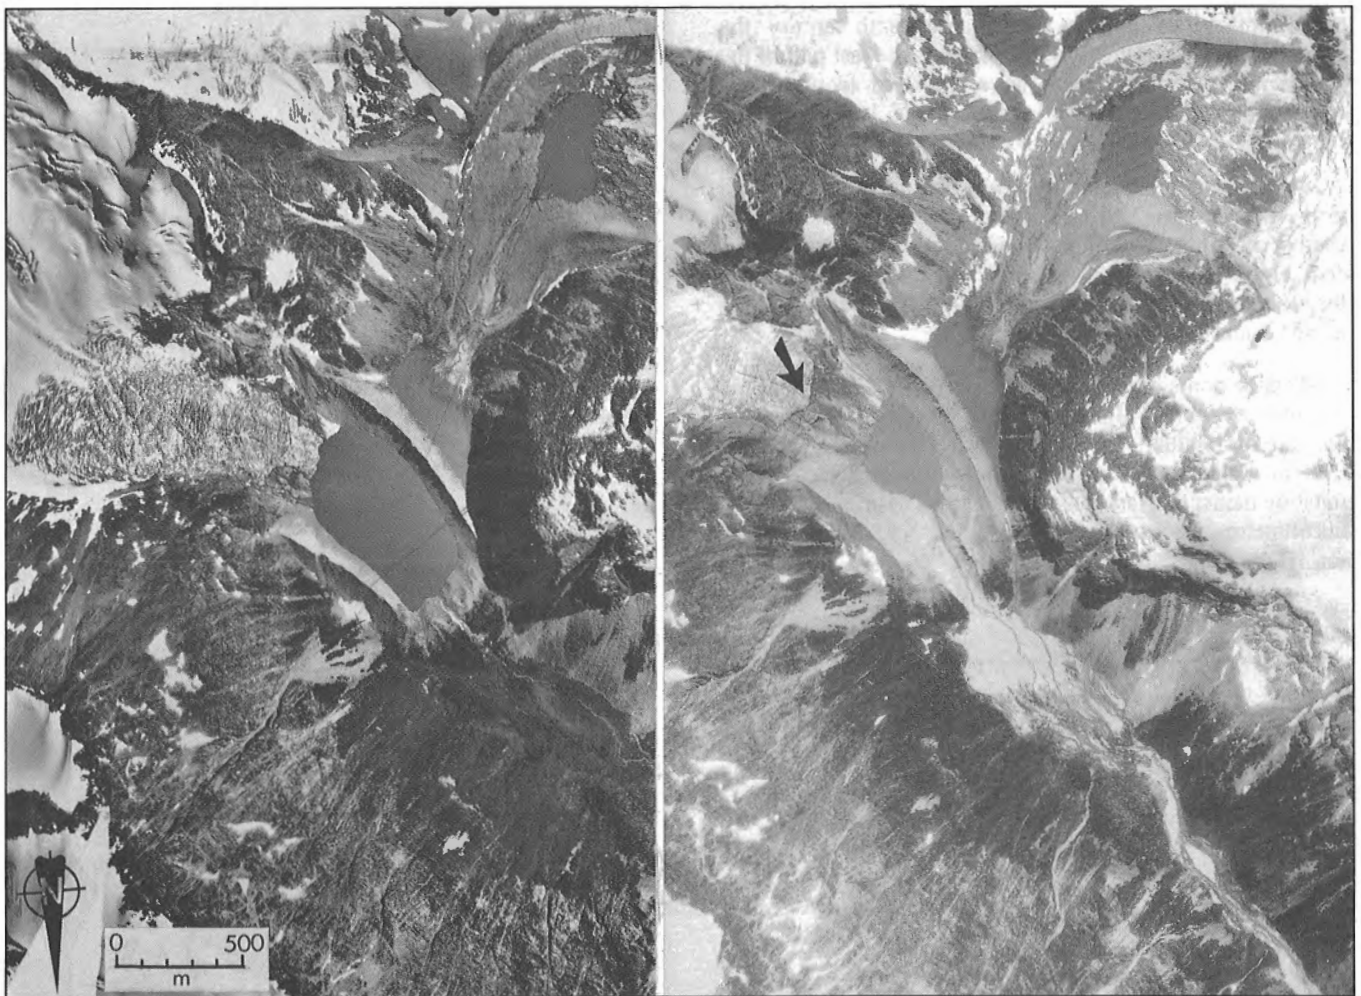
Figure 15. Aerial photographs of Nostetuko Lake before (left) and after (right) the outburst flood of July 19, 1983. Failure occurred when part of the toe of Cumberland Glacier (arrow) collapsed into the lake and generated waves that overtopped the moraine. (Province of British Columbia airphotos BC79069-190, left, and BC86048-147, right).

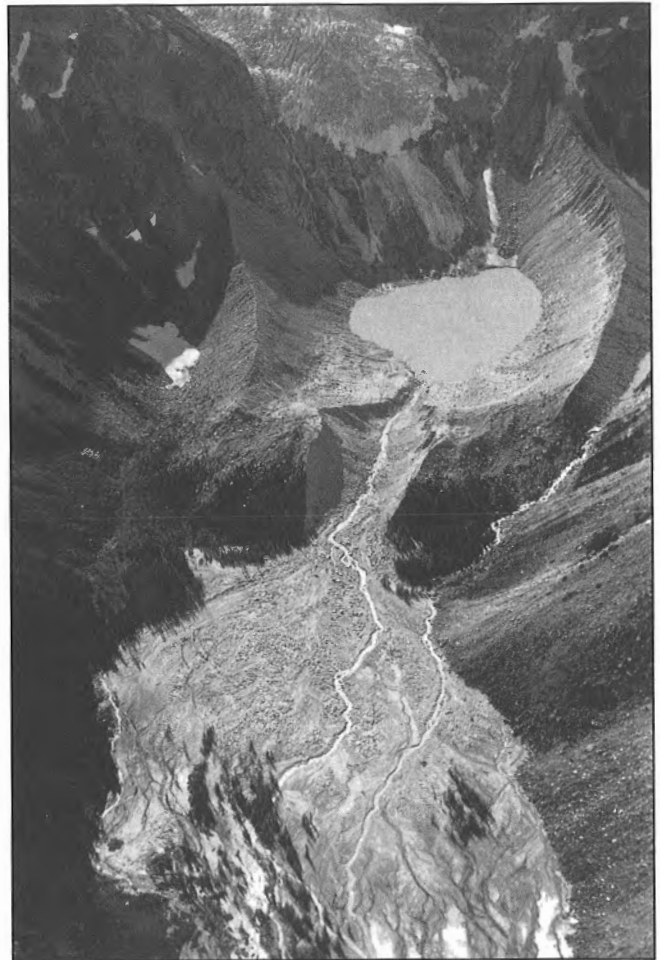
Figure 16. The breached, Little Ice Age moraine of Cumberland Glacier and Nostetuko Lake after the 1983 outburst flood. Note the large fan of bouldery debris in the foreground.

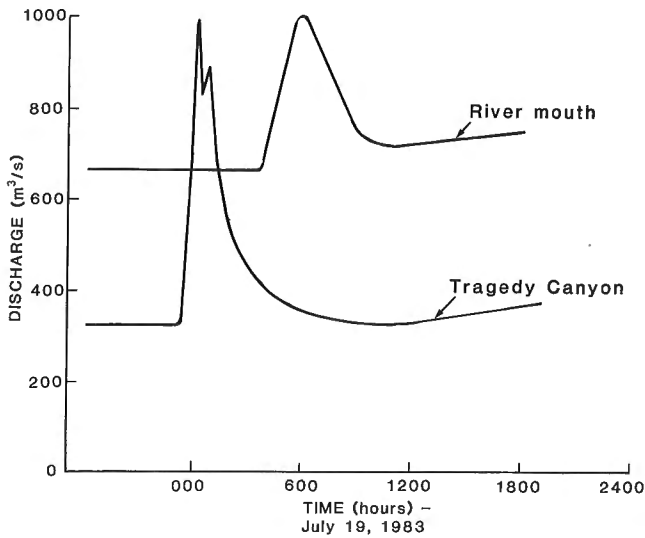
Figure 17. Hydrographs showing the flood that resulted from the failure of the moraine dam at Nostetuko Lake in July 1983. The lower hydrograph is from a site 67 km downstream from the dam and shows an increase in discharge from 330 m³/s to over 900 m³/s in one hour; the upper hydrograph, from a site a further 45 km downvalley, shows a somewhat attenuated flood wave. (Modified from Fig. 4 of British Columbia Hydro and Power Authority, 1983).

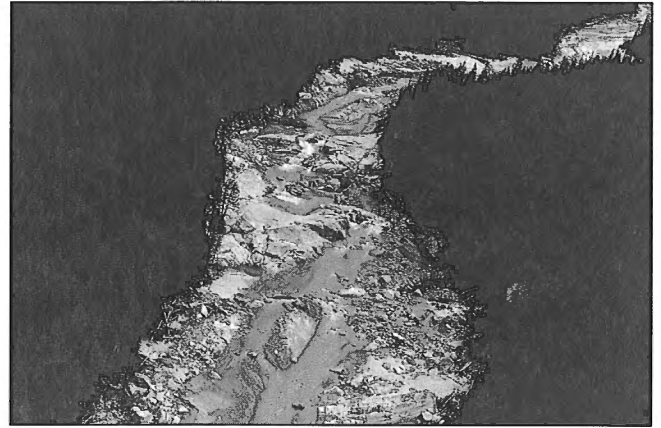
Figure 18. Lower Nostetuko River valley in August 1984, approximately one year after the Nostetuko flood. All sediments and trees were stripped from the valley floor by the floodwaters, which were about 5 m deep here.

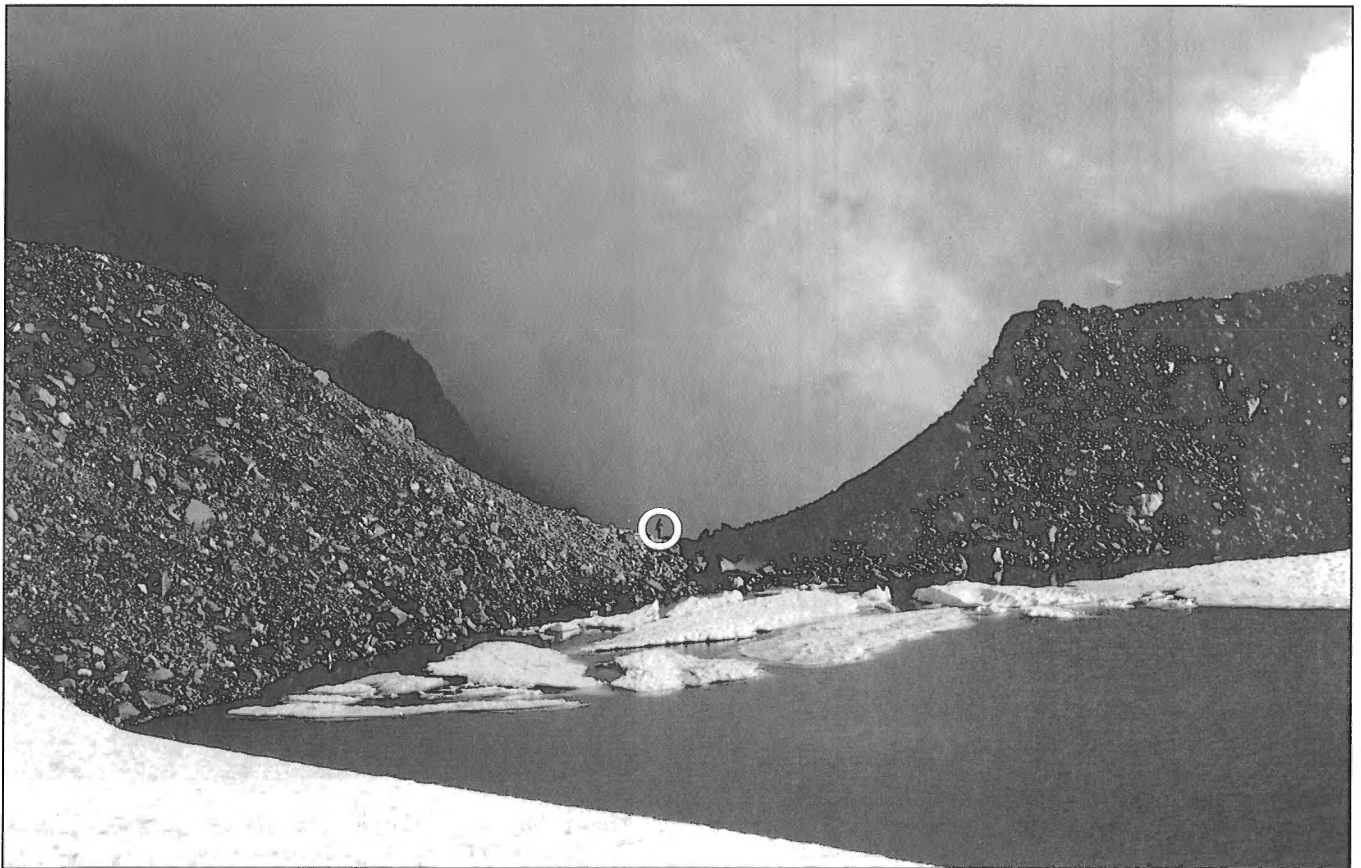
Figure 19. Breached moraine at Klattasine Lake. View to the north through the breach from the shore of Klattasine Lake; person (circled) near outlet provides scale.

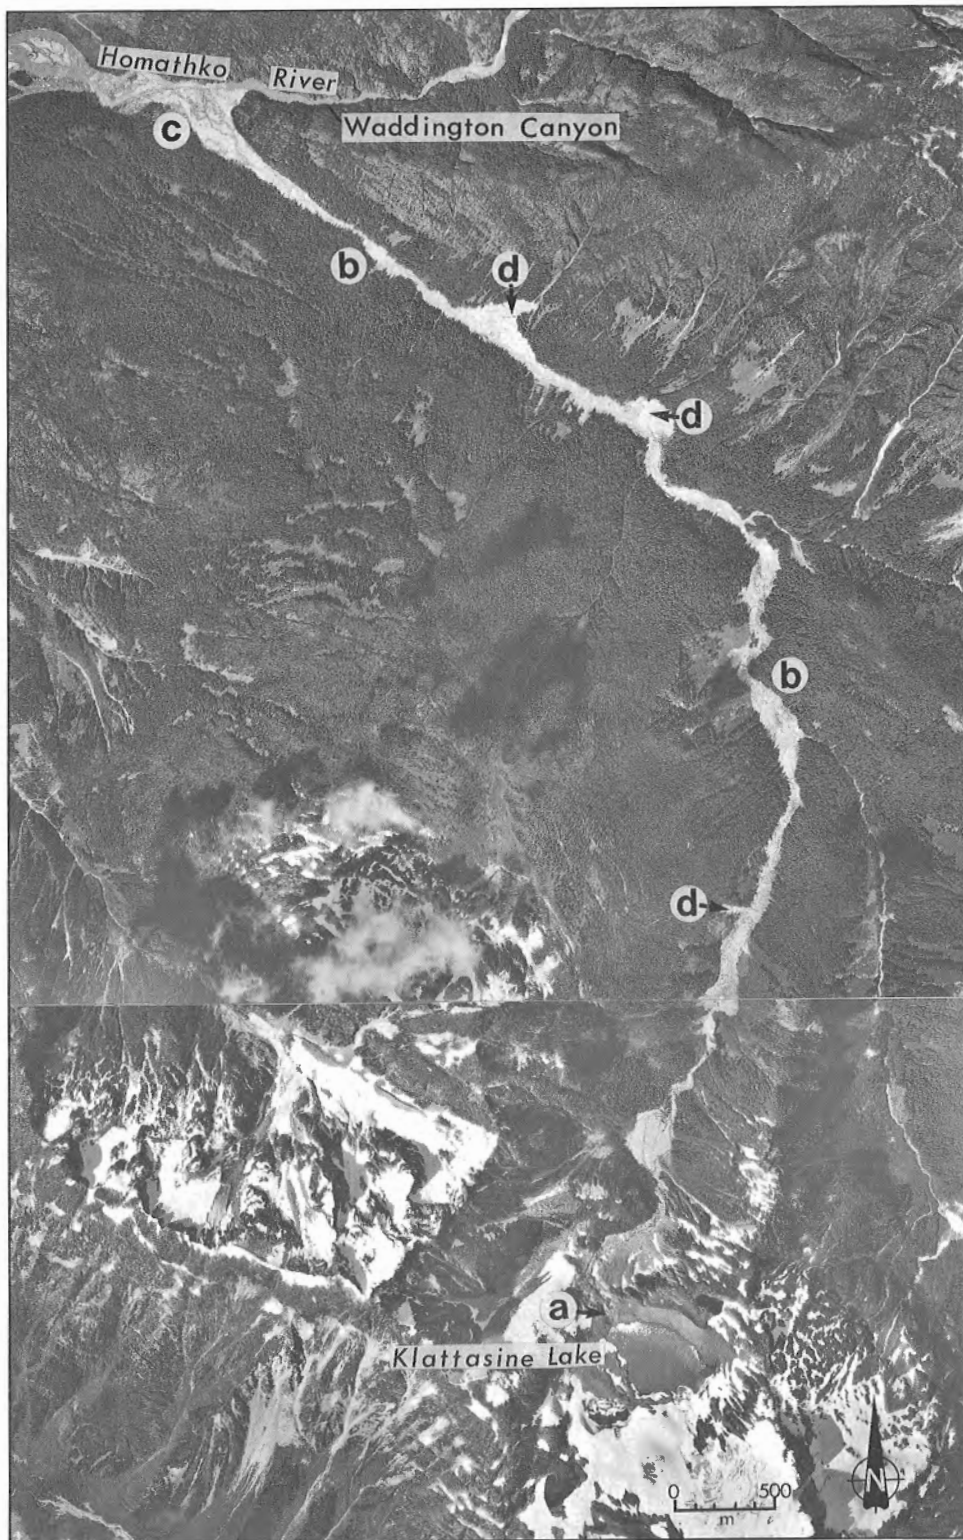
Figure 20. *Photomosaic of the Klattasine Creek debris flow. a, breached moraine at Klattasine Lake; b, unvegetated strip delineating the path of the flow; c, main depositional area at the mouth of the stream; and d, secondary slope failures. (Province of British Columbia airphotos BC79069-235, BC79074-041; Fig. 2 of Clague et al., 1985).*

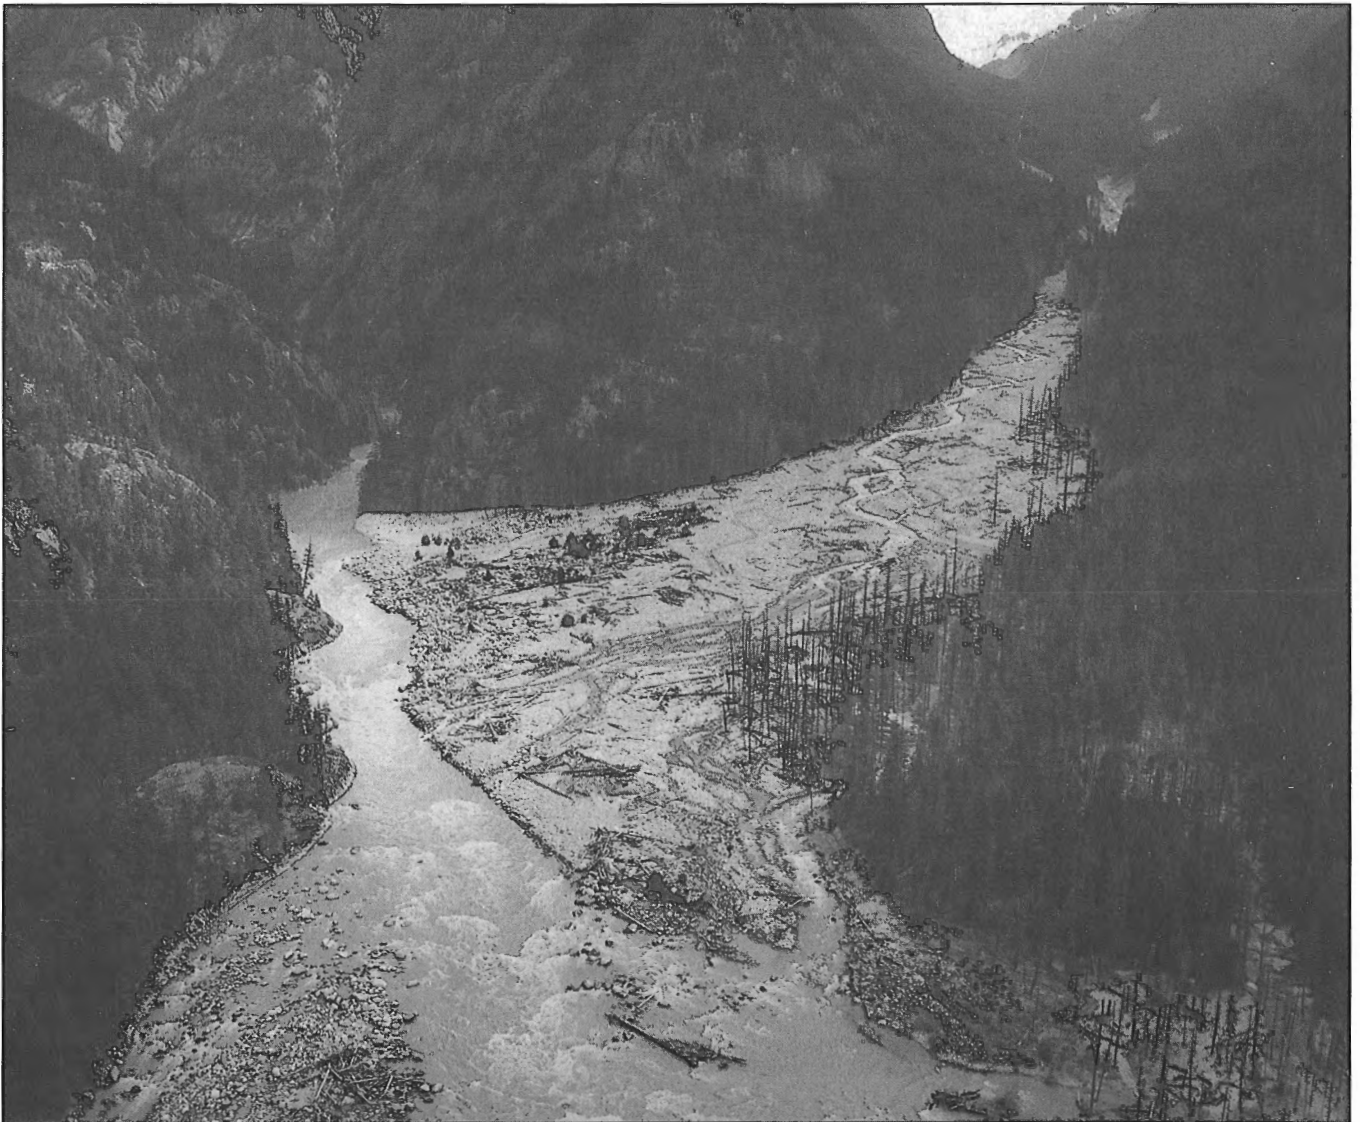
Figure 22. *Fan at the mouth of Klattasine Creek. Bouldery debris deposited by the Klattasine Creek debris flow temporarily blocked Homathko River to form a lake. (Fig. 5 of Clague et al., 1985).*

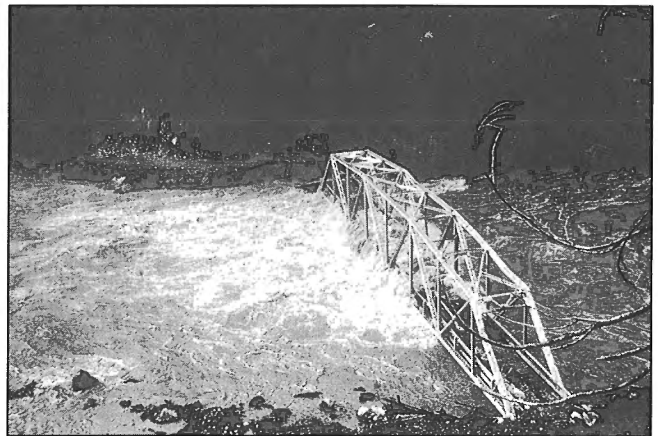
Figure 26. Jökulhlaup from Summit Lake, at Ninemile, Alaska, September 17, 1967. The discharge is almost $3000 \text{ m}^3/\text{s}$, which is 100 times larger than the mean discharge of the stream at this site. The steel bridge was washed away a few hours after this photograph was taken. (Photo by J.J. Plummer).

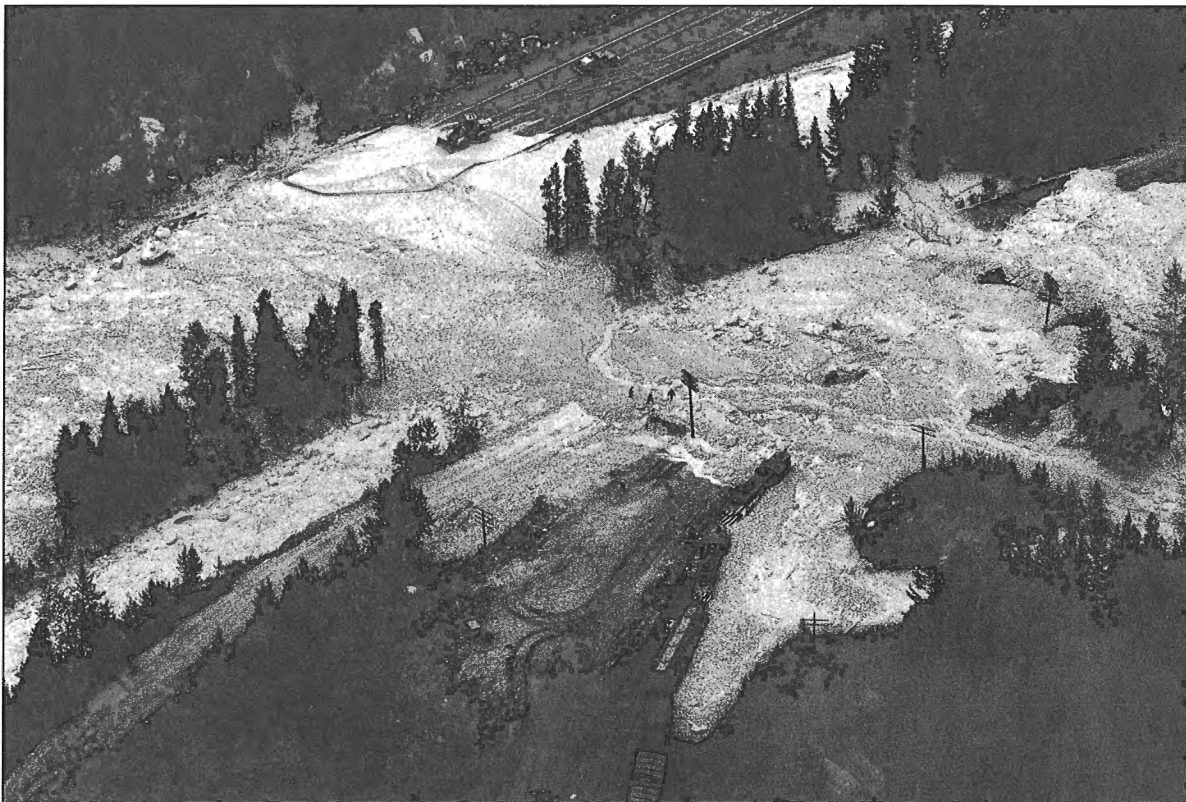
Figure 36. Debris flow deposits covering the Trans-Canada Highway and the Canadian Pacific Railway mainline in Kicking Horse River valley, September 7, 1978. Note the derailed and partially buried locomotives. (Photo by Calgary Herald, courtesy of Glenbow Archives, Calgary, Alberta).
