SMALL PUBLIC WATER SYSTEMS ASSESSMENT  
 NORTHERN REGION

GOVERNMENT OF YUKON  
 HIGHWAYS & PUBLIC WORKS  
 MAYO GRADER STATION  
 BUILDING # 5629  
 SITE LOCATION DIAGRAM  
 WELL ID: 5629

Northern Region – Mayo Grader Station  
Building # 5629

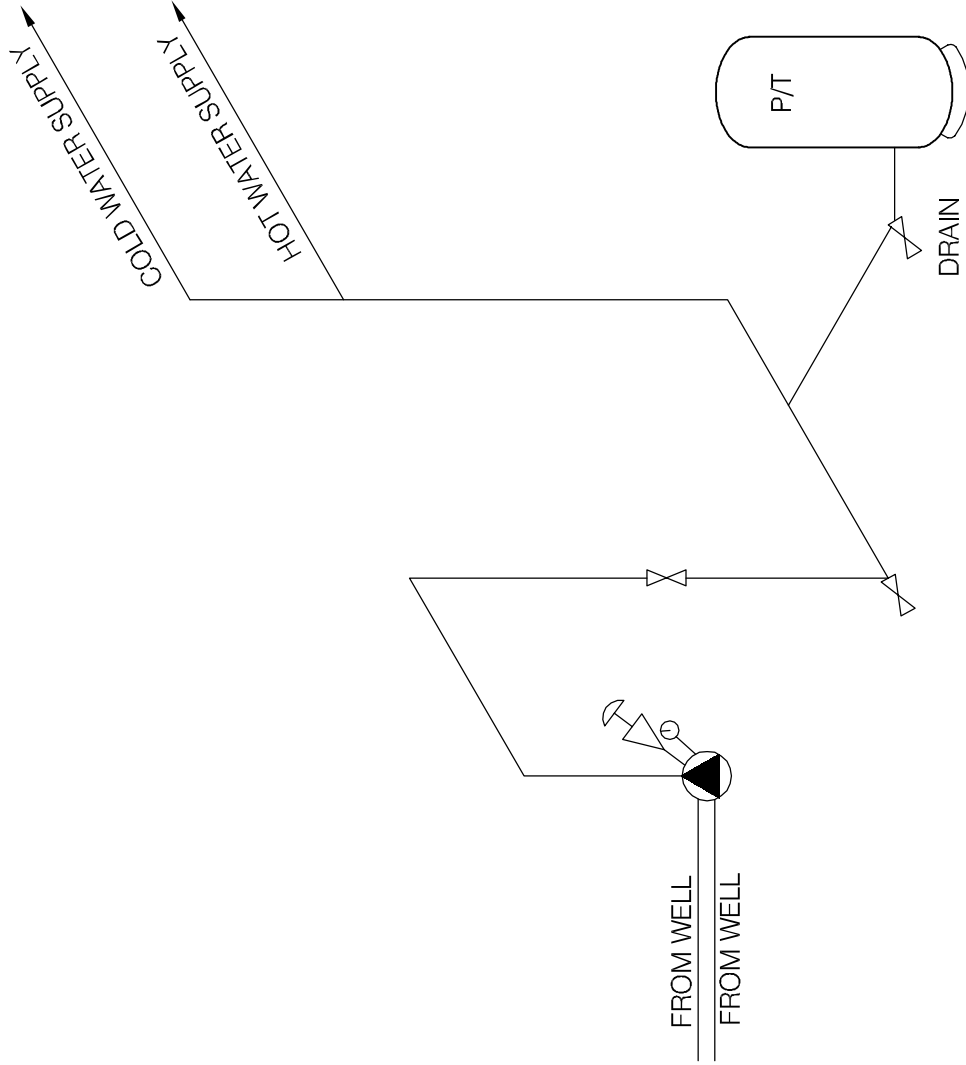
FIGURE 5629-B

THIS IS A OLD STYLE JET PUMP SYSTEM THAT HAS  
A BAD PIPING CONFIGURATION THAT WILL DRIVE  
YOU MAD SHOULD IT EVER LOOSE SUCTION

WHEN WELL HEAD UPGRADES ARE DONE, CHANGE  
THE PUMP TO A SUBMERSIBLE PUMP CONFIGURATION.  
INSTALL 5 MICRON PREFILTER AND 8 GALLON  
PER MINUTE UV SYSTEM (NSF55 CERTIFIED).

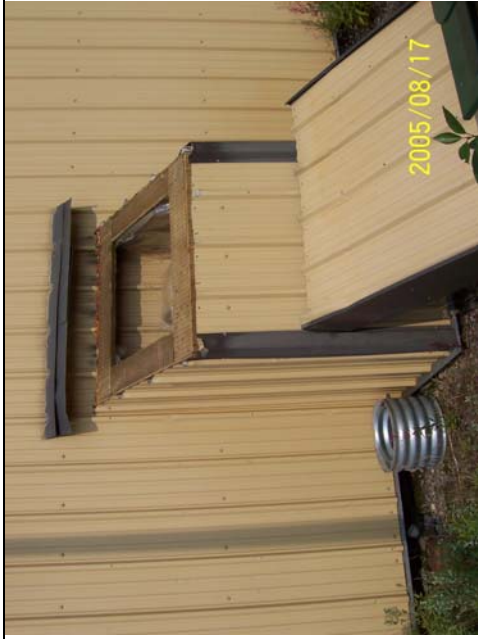
<p>2005/08/17</p>
<p><b>Photo 044:</b> 5629 Wellhead enclosure.</p>	<p><b>Photo 033:</b> 5629 Well enclosure and wellhead in pit.</p>

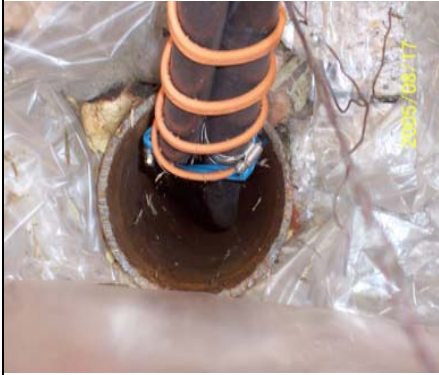
This well is not equipped with a cap

<p>2005/08/17</p>
<p><b>Photo 042:</b> 5629 Wellhead – note that there was no well cap at the time of assessment.</p>	<p><b>Photo 192:</b> 5629 Grader station pressure tank and jet pump.</p>
