PROJECT SMALL PUBLIC WATER SYSTEMS ASSESSMENT NORTHERN REGION	
CLIENT

Northern Region – Mayo Day Use Building  
 Building # 5636

## SMALL PUBLIC WATER SYSTEM ASSESSMENT

WELL ID #	Owner	Location Description
5636	YTG	Mayo ATB Day Use Building

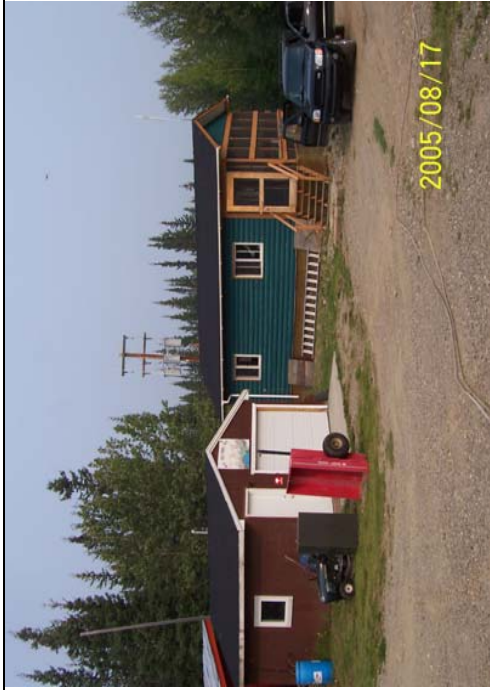
**Photo 033:** 5636 Day use area and garage.

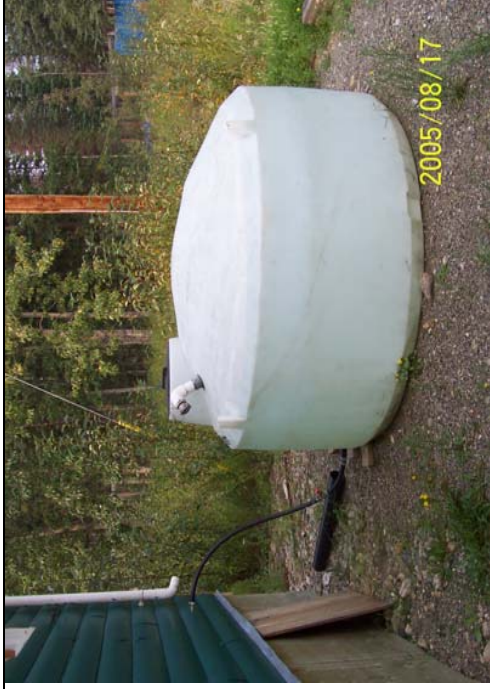
Unauthorized access by humans?  Yes  No *Tank is unlocked, located outside* Entrance by animals?  Yes  No *vermin proof fill. No vent*

Comments: EXPOSED TO DIRECT SUNLIGHT

**Photo 029:** 5636 Seasonal water holding tank.

INSTALL DUPLEX INLINE FILTER 10 AND 1 MICRON  
& 5 GPM NSF55 CERTIFIED UV SYSTEM.

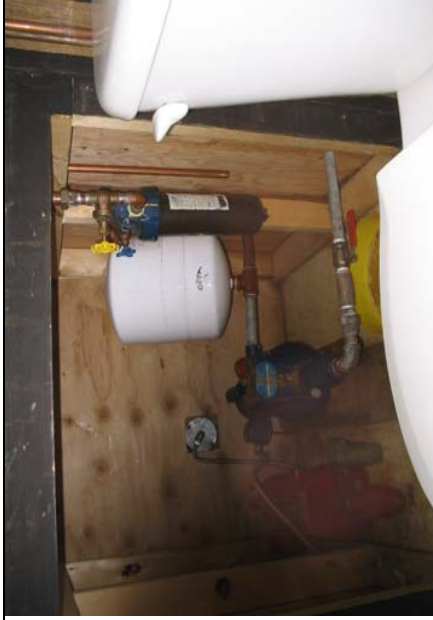
**Photo 190:** 5636 Jet pump and pressure tank.

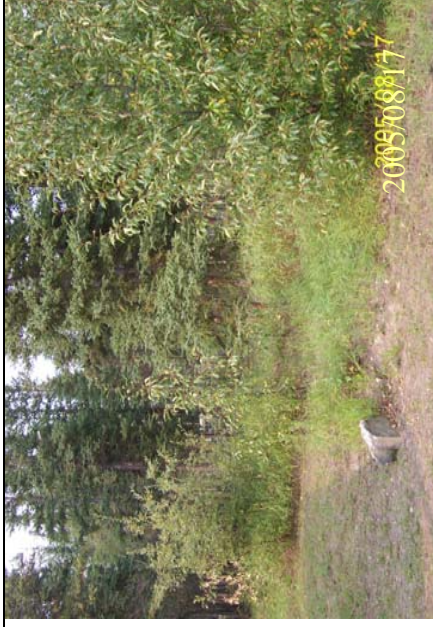
**Photo 036:** 5636 Potential well location to service day use area and crew quarters.
