SMALL PUBLIC WATER SYSTEMS ASSESSMENT
NORTHERN REGION

GOVERNMENT OF YUKON
HIGHWAYS & PUBLIC WORKS
MAYO PMA WORKSHOP
BUILDING # 5640
SITE LOCATION DIAGRAM
WELL ID: 5640

TITLE WATER SYSTEM DISTRIBUTION/TREATMENT
SCHEMATIC SYSTEM ID.: 5640
PMA WORKSHOP - MAYO, YT.

SMALL PUBLIC WATER SYSTEM ASSESSMENT

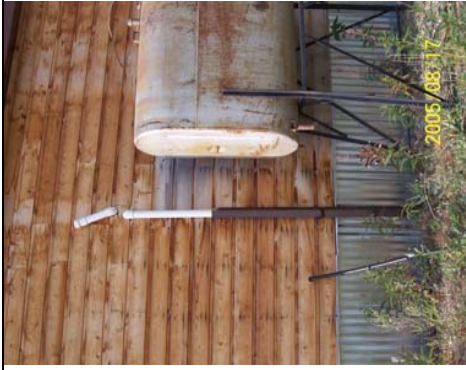
Photo 037: 5640 Water fill and AST.

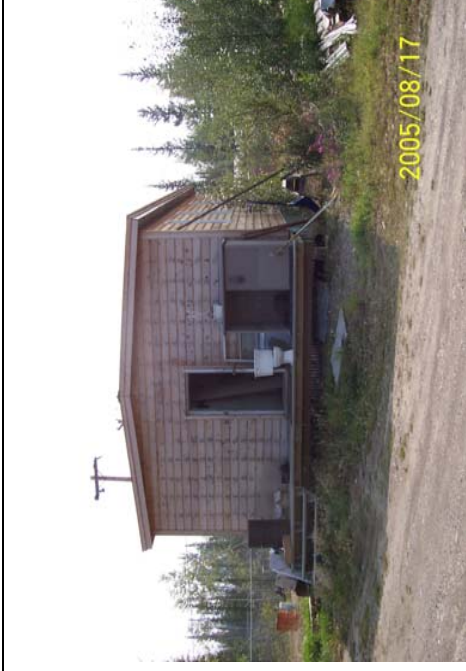
Photo 038: 5640 PMA building.

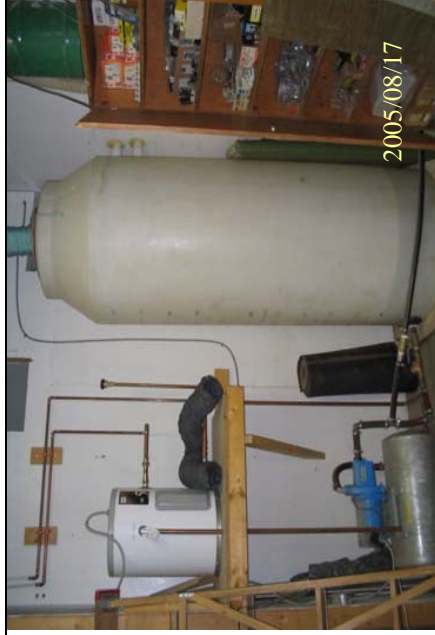
Photo 191: 5640 Water tank and jet pump.

INSTALL DUPLEX INLINE FILTRATION - 30 & 5 MICRON
FOLLOWED BY 5 GPM NSF60 CERTIFIED UV
STERILIZER ON DISCHARGE OF PUMP.
