PROJECT SMALL PUBLIC WATER SYSTEMS ASSESSMENT
WESTERN REGION

Yukon
Highways and Public Works
Property Management Branch

Northern Region – Mayo Wildlife Workshop
Building # 5650

PART A: EBA Site Inspection

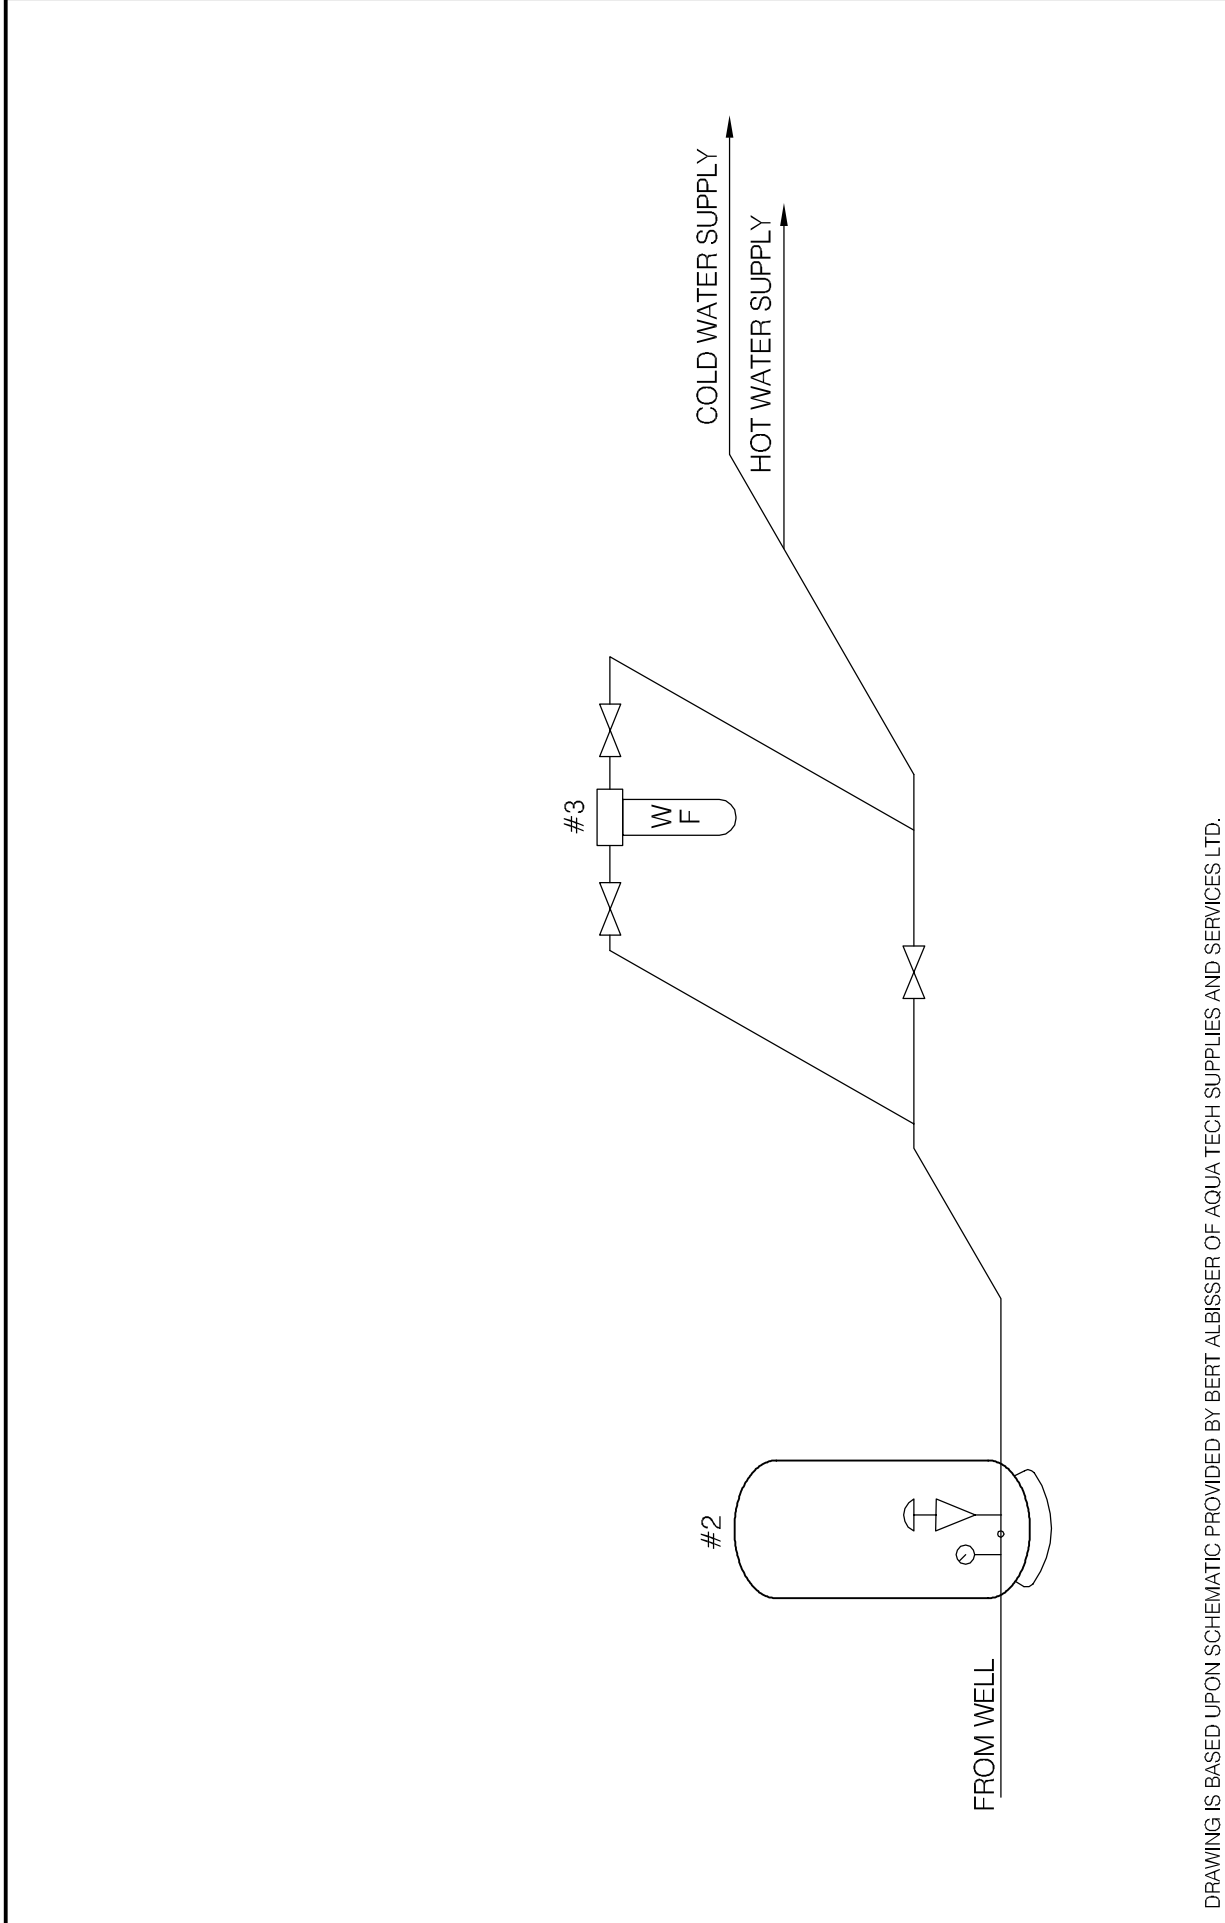
PROJECT SMALL PUBLIC WATER SYSTEMS ASSESSMENT NORTHERN REGION	
CLIENT 		TITLE WATER SYSTEM DISTRIBUTION/TREATMENT SCHEMATIC SYSTEM ID.: 5650 WILDLIFE WORKSHOP - MAYO, YT.	
DATE	SEPT., 2005	FILE NO.	1260002.004
	DWN.	CHKD.	RMM
	JSB		DWG.: FIGURE 5650-B

Item	Description	Manufacturer	Model	Part No.	Serial No.	Size
1	SUB PUMP.	?				?
2	PRESSURE TANK	WEN X TROL	WX-201			
3	INLINE FILTER	AMSTERK	10" BB			10" x 1"
4						
5						
6						
7						
8						
9						
10

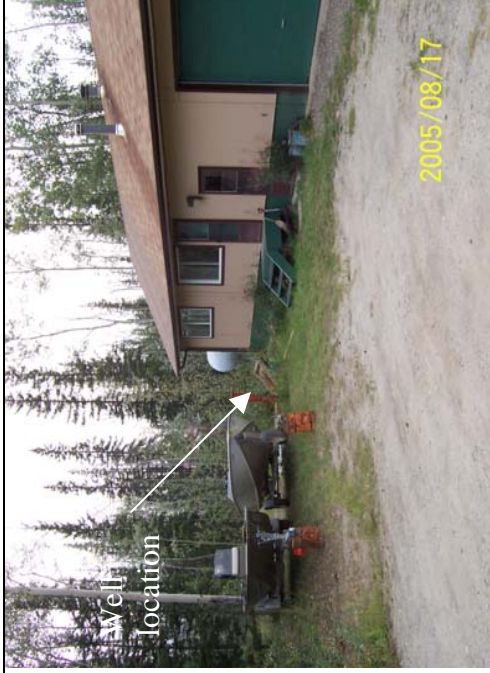
Photo 033: 5650 Wildlife Workshop (northeast side of building).

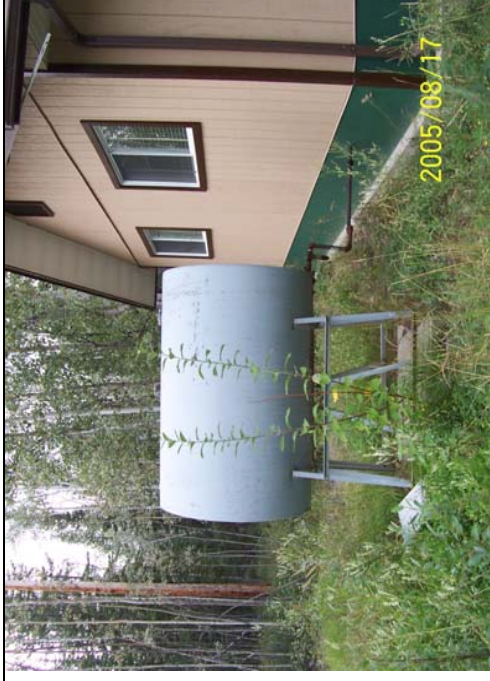
Potential Source 2: AST; Distance from well to Potential Source 2: ~7m

Photo 057: 5650 On site AST.

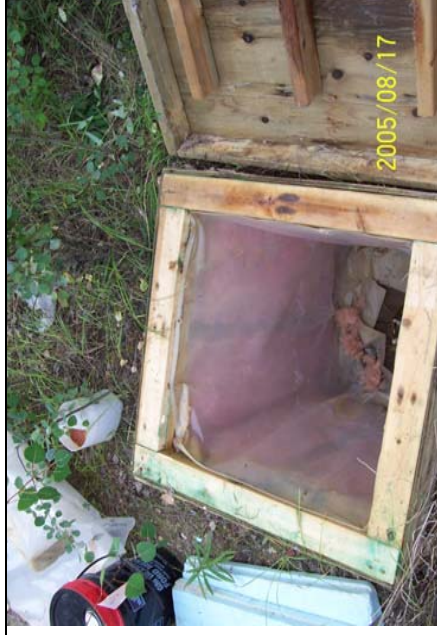
Unauthorized access by humans? Yes No Unlocked enclosure
Entrance by animals? Yes No Access possible

p. Is well site subject to flooding? Yes No enclosure damp

- i. Is the well head below grade? describe in detail ~1.0m bg
- ii. Are there signs of ponding on the enclosure(e.g. water stains, etc.)? Yes No
- iii. Is the wellhead enclosed by fiberglass insulations? Yes No styrofoam
- iv. Any evidence of rodents? Specify Access possible
- v. Does the well casing have a proper seal cap? Yes No
If no, describe condition split gasket cap

Photo 056: 5650 Wellhead enclosure.

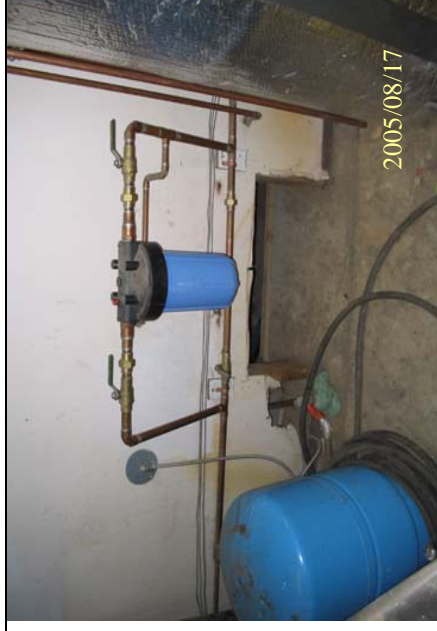
THE INSTALLATION IS SATISFACTORY
THE PRESSURE TANK IS WATER LOGGED - IT NEEDS TO
BE REPLACED.

Photo 194: 5650 Water system. (pressure tank and filter)
