SMALL PUBLIC WATER SYSTEMS ASSESSMENT
 NORTHERN REGION

DAWSON AIR TERMINAL BUILDING
 BUILDING # 2544
 SITE LOCATION DIAGRAM
 WELL ID: 2544

Northern Region – Dawson City Air Terminal Building
 Building # 2544

SMALL PUBLIC WATER SYSTEM ASSESSMENT

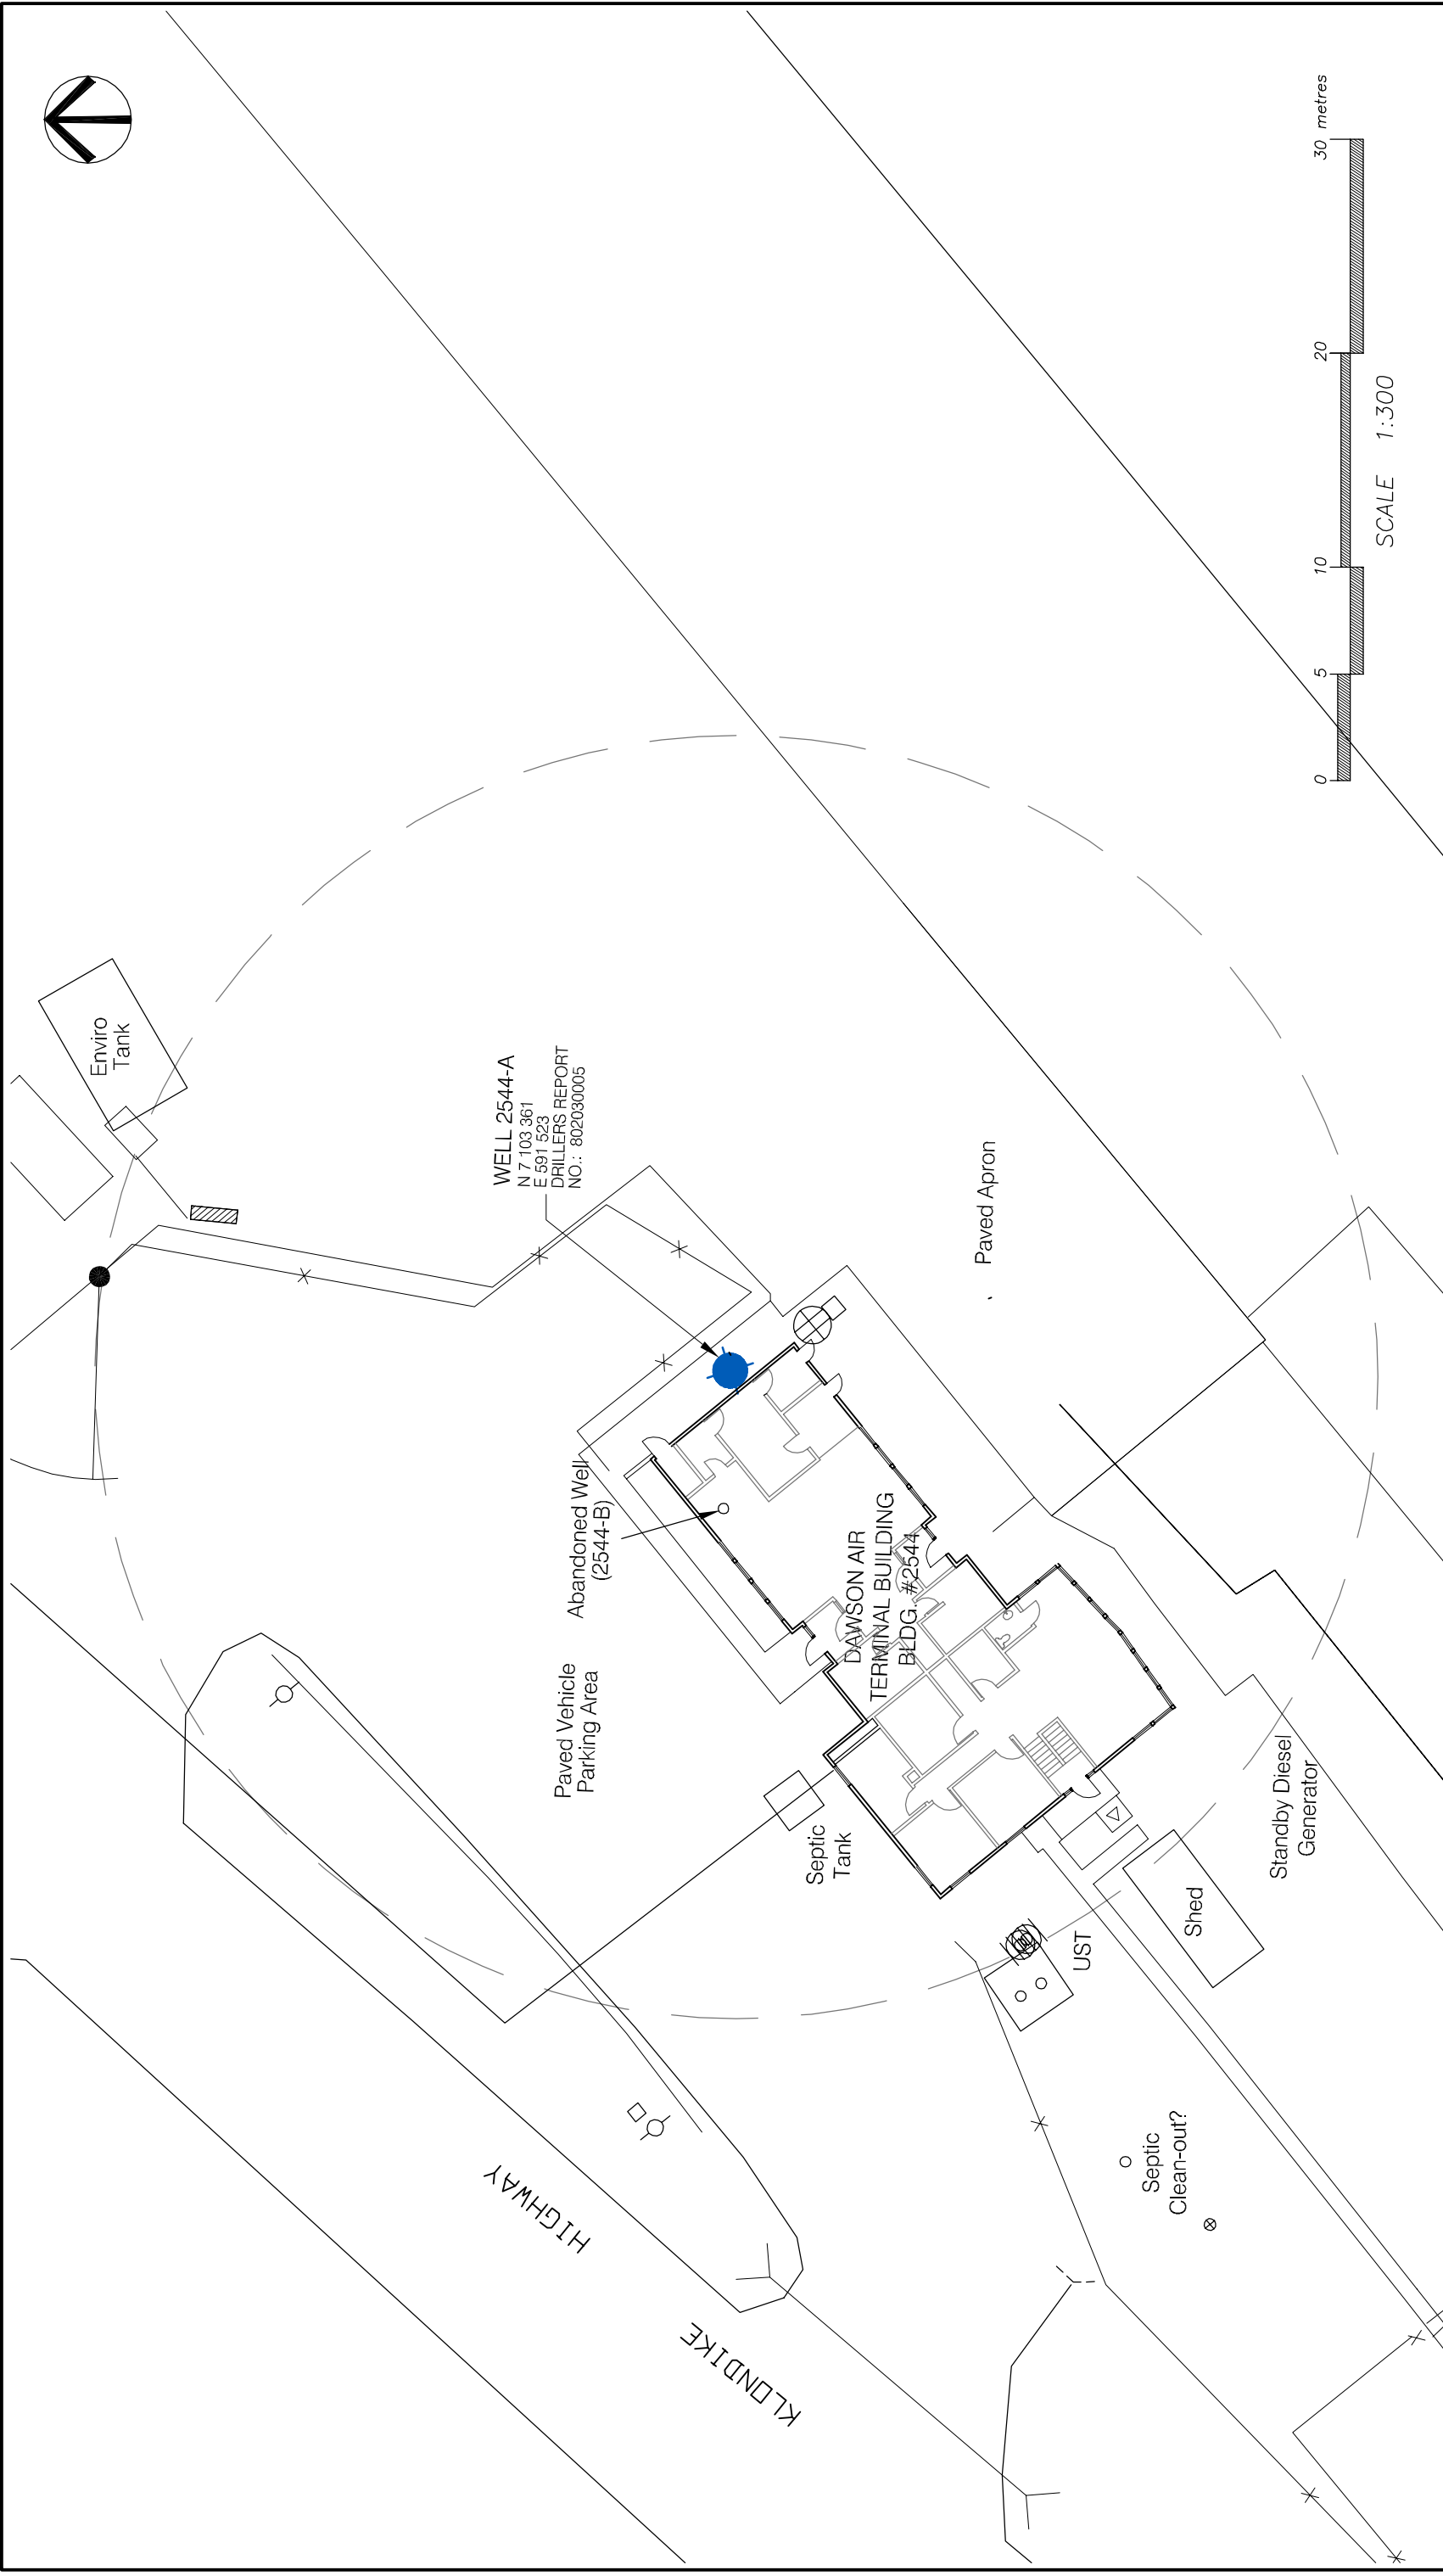
FIGURE No.
 FIGURE 2544-A

○ 30 m RADIUS FROM WATER WELL FOR CONSIDERATION OF PROXIMITY TO POTENTIAL CONTAMINANT SOURCES.

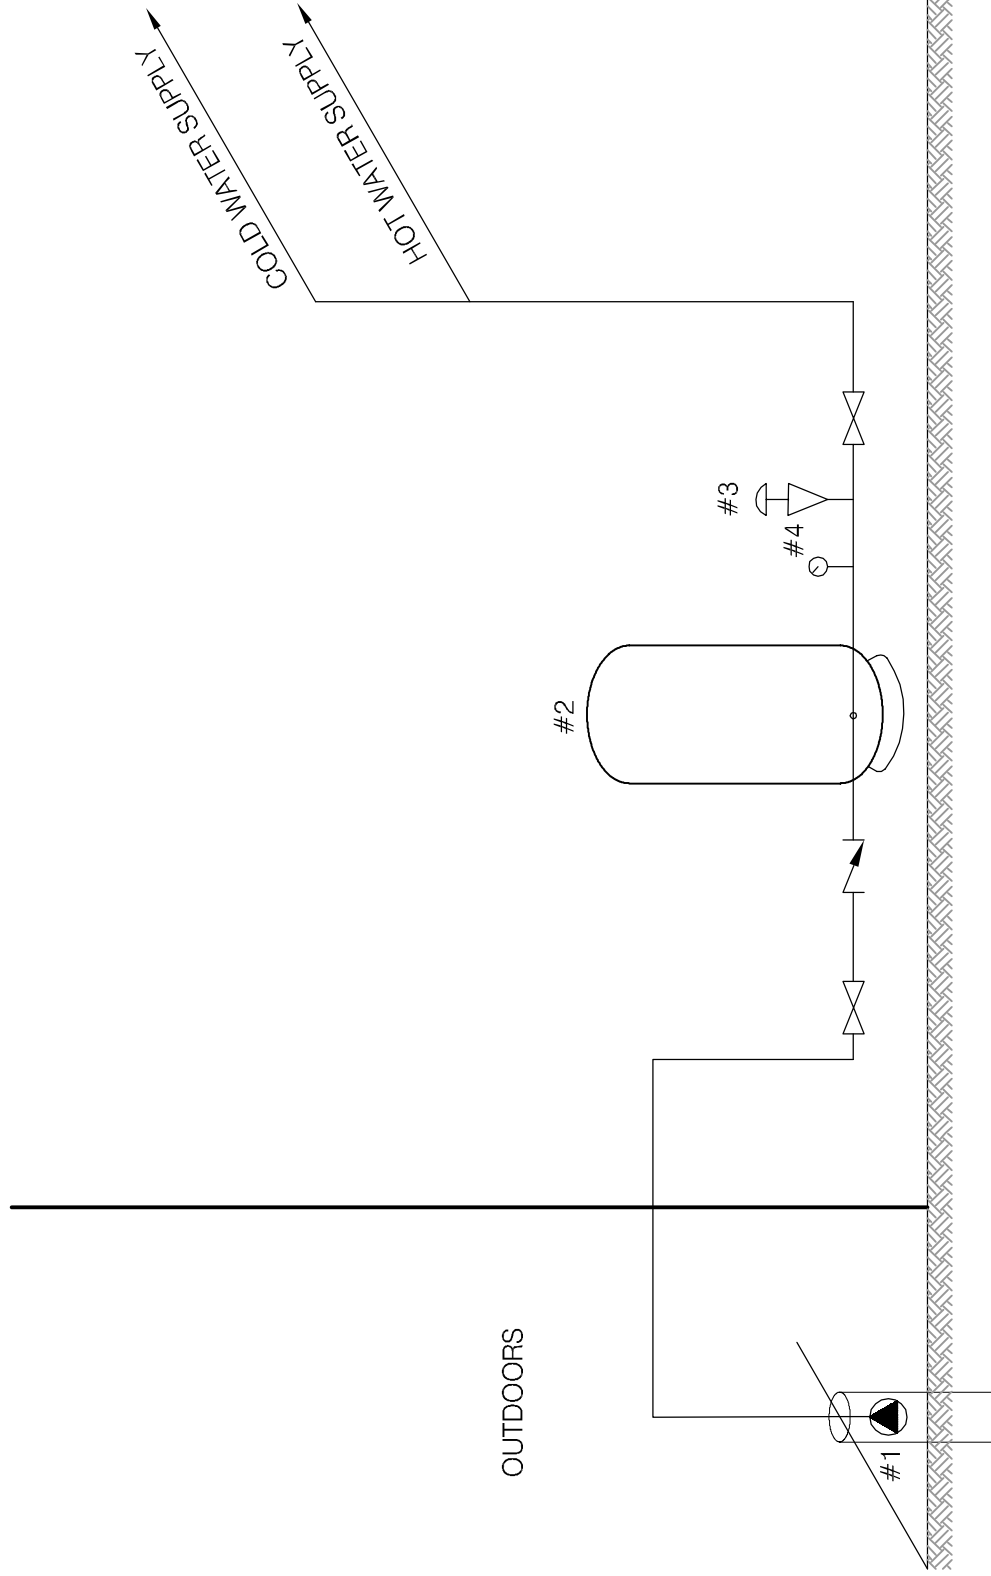
Yukon Highways and Public Works Property Management Branch		TITLE WATER SYSTEM DISTRIBUTION/TREATMENT SCHEMATIC SYSTEM ID.: 2544 AIR TERMINAL BUILDING - DAWSON, YT.	
DATE	SEPT., 2005	FILE NO.	1260002.004
	DWN.	CHKD.	RMM
	JSB		
		DWG.:	FIGURE 2544-B

DRAWING IS BASED UPON SCHEMATIC PROVIDED BY BERT ALBISSER OF AQUA TECH SUPPLIES AND SERVICES LTD.
