DAWSON WILDLIFE
 OFFICE
 BLDG. #2575

SMALL PUBLIC WATER SYSTEMS ASSESSMENT
 NORTHERN REGION

DAWSON WILDLIFE OFFICE
 BUILDING # 2575
 SITE LOCATION DIAGRAM
 WELL ID: 2575

PART A: EBA Site Inspection

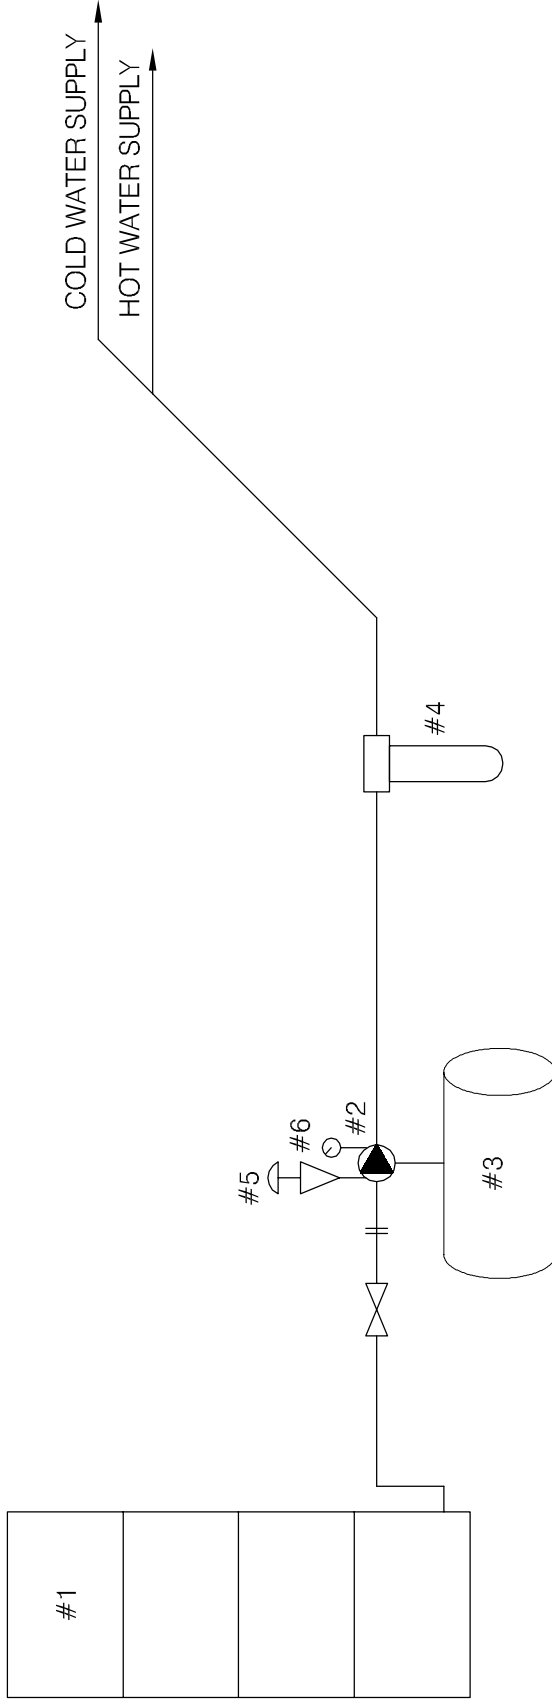
DRAWING IS BASED UPON SCHEMATIC PROVIDED BY BERT ALBISSER OF AQUA TECH SUPPLIES AND SERVICES LTD.

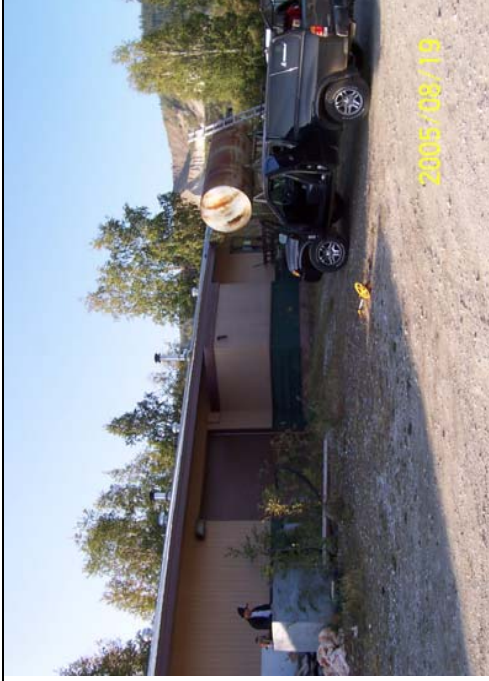
Photo 077: 2575 Environmental office facing south.

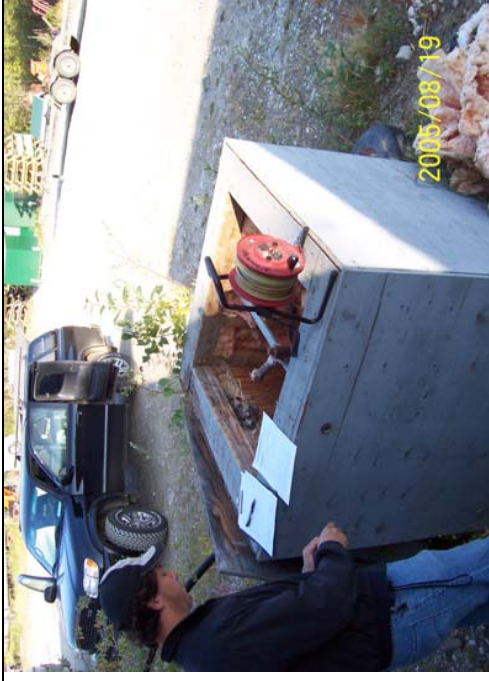
Entrance by animals? Yes No
Access possible. No cap. Evidence of mouse droppings and feathers

- i. Is the well head below grade? describe in detail No, ~0.7m above grade
- ii. Are there signs of ponding on the enclosure(e.g. water stains, etc.)? Yes No
- iii. Is the wellhead enclosed by fiberglass insulations? Yes No
- iv. Any evidence of rodents? Specify Mouse droppings and feathers present
- v. Does the well casing have a proper seal cap? Yes No

If no, describe condition None present

This system is currently on water delivery. There is an abandoned well on the property that is not properly sealed

Photo 075: 2575 Wellhead enclosure.

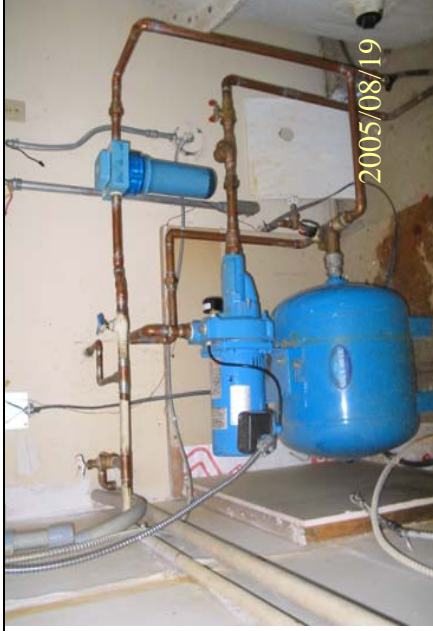
Photo 223: 2575 Jet pump, pump controls and inline filter.

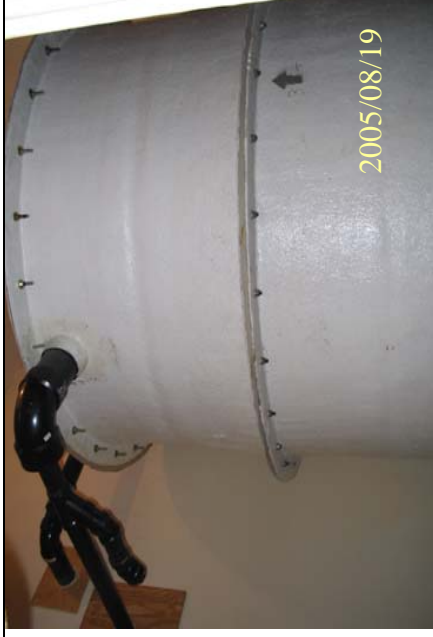
Comments: CLOSED TANK, NO ACCESS

THE INSTALLATION MEETS ALL REQUIREMENT WITH THE EXCEPTION OF ACCESS TO THE TANK FOR INSPECTION & CLEANING.

Photo 225: 2575 Water storage tank.

INSTITUTE REGULAR SCHEDULED FREE CHLORINE TESTING & REPORTING. ASSURE TRUCK DELIVERY RESIDUAL IS 0.5 PPM FREE CHLORINE. INSTALL ACCESS TO TANK FOR INSPECTION & CLEANING. SOURCE FOR WATER DELIVERY SHOULD BE CITY OF DAWSON WATER SYSTEM.
