Northern Region – Dawson City Grader Station
Building # 2599

SMALL PUBLIC WATER SYSTEM ASSESSMENT

PART A: EBA Site Inspection

WELL ID #	Owner	Location Description
2599	YTG	Dawson City Grader Station

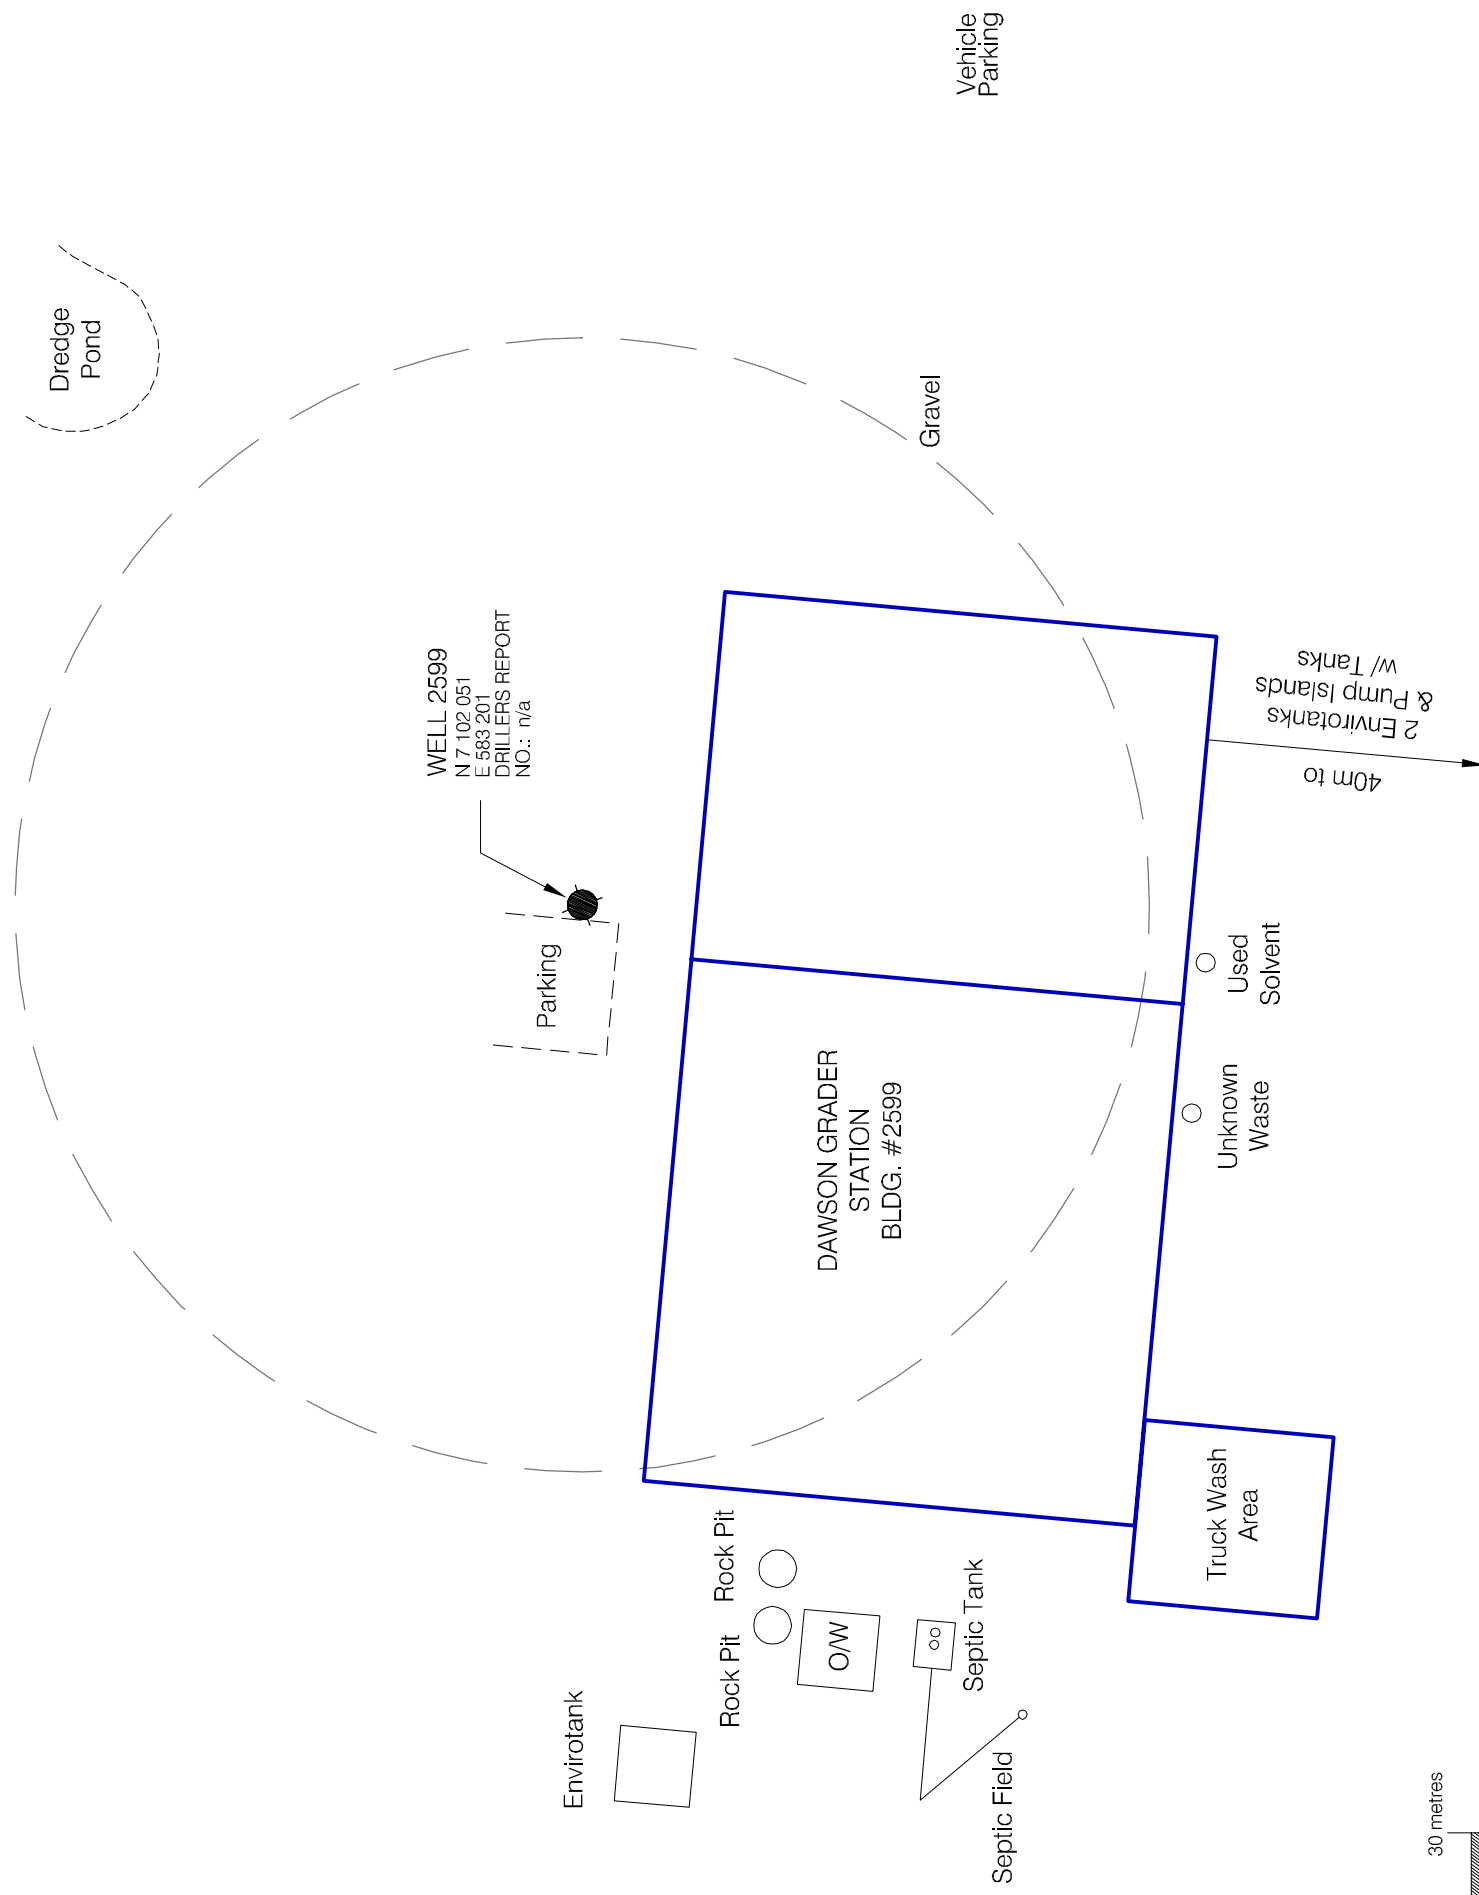
30 m RADIUS FROM WATER WELL FOR CONSIDERATION OF PROXIMITY TO POTENTIAL CONTAMINANT SOURCES.

Tank @ ~42m, Rock pits @ ~36m

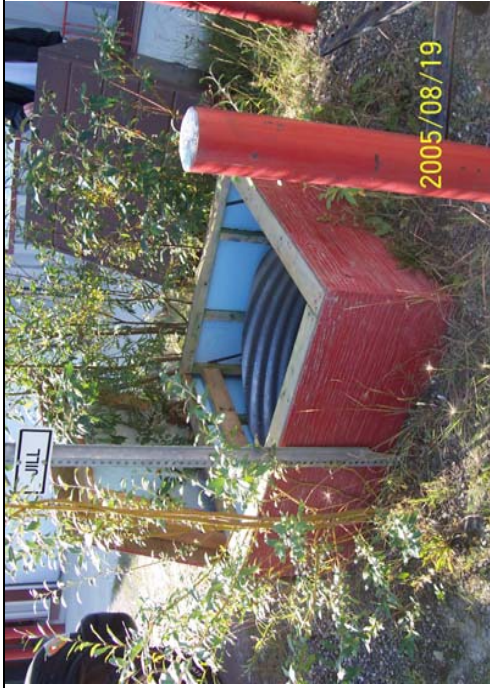
Unauthorized access by humans? Yes No
Unlocked enclosure

Entrance by animals? Yes No
Access possible, but unlikely

Photo 087: 2599 Wellhead enclosure.

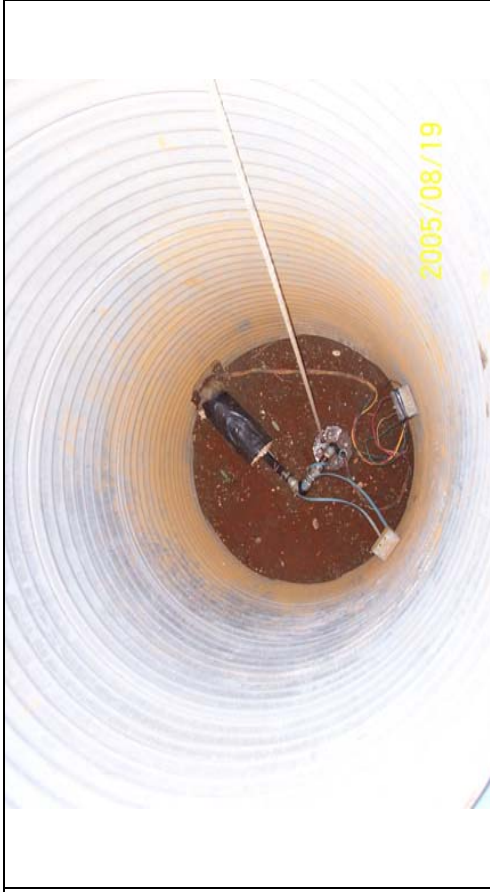
- i. Is the well head below grade? describe in detail ~ 2.3 m below grade
- ii. Are there signs of ponding on the enclosure(e.g. water stains, etc.)? Yes No
- iii. Is the wellhead enclosed by fiberglass insulations? Yes No
- iv. Any evidence of rodents? Specify No.
- v. Does the well casing have a proper seal cap? Yes No
If no, describe condition Split gasket cap

Photo 086: 2599 Wellhead in pit.

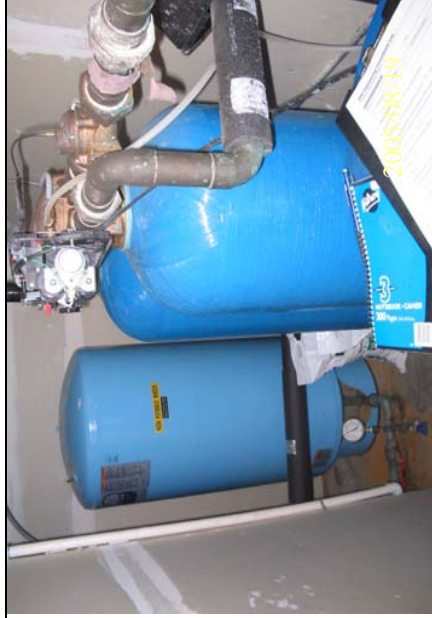
Photo 230: 2599 Pressure tank, pump controls and softener system.

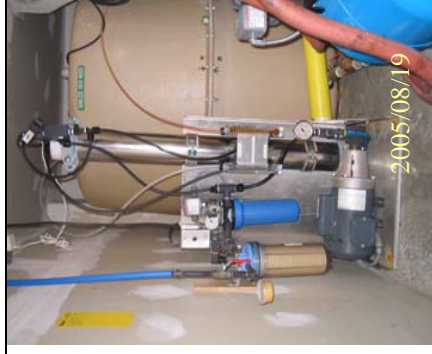
THIS INSTALLATION IS IN GOOD ORDER

Photo 234: 2599 Reverse osmosis system (front) water storage tank (back)

INSTALL FILTRATION AND UV SYSTEM (WFF-55)
ON DOMESTIC LOOP.
