SMALL PUBLIC WATER SYSTEMS ASSESSMENT  
NORTHERN REGION

WATER SYSTEM DISTRIBUTION/TREATMENT  
SCHEMATIC SYSTEM ID.: 2661  
OGILVIE GRADER STATION - DAWSON, YT.

## SMALL PUBLIC WATER SYSTEM ASSESSMENT

WELL ID #	Owner	Location Description
2665	YTG	Ogilvie Grader Station Living Complex

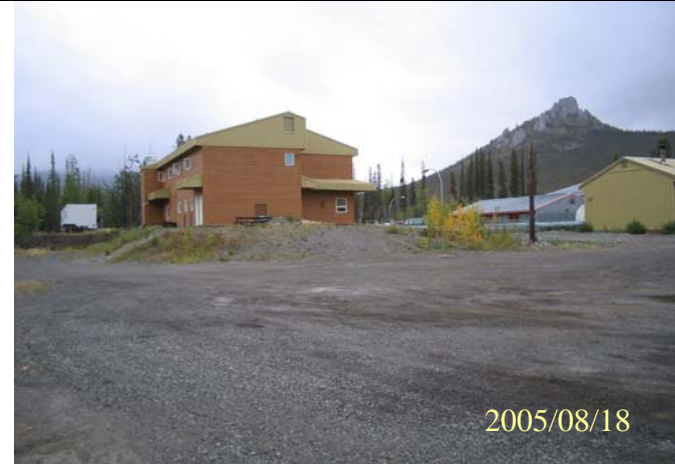
**Photo 205:** 2665 Olgilvie living complex.
