EBA Engineering Consultants Ltd.

SMALL PUBLIC WATER SYSTEMS ASSESSMENT
 NORTHERN REGION

KENO FIRE HALL
BUILDING # 5622
SITE LOCATION DIAGRAM
WELL ID: 5622

Northern Region – Keno Firehall
Building # 5622

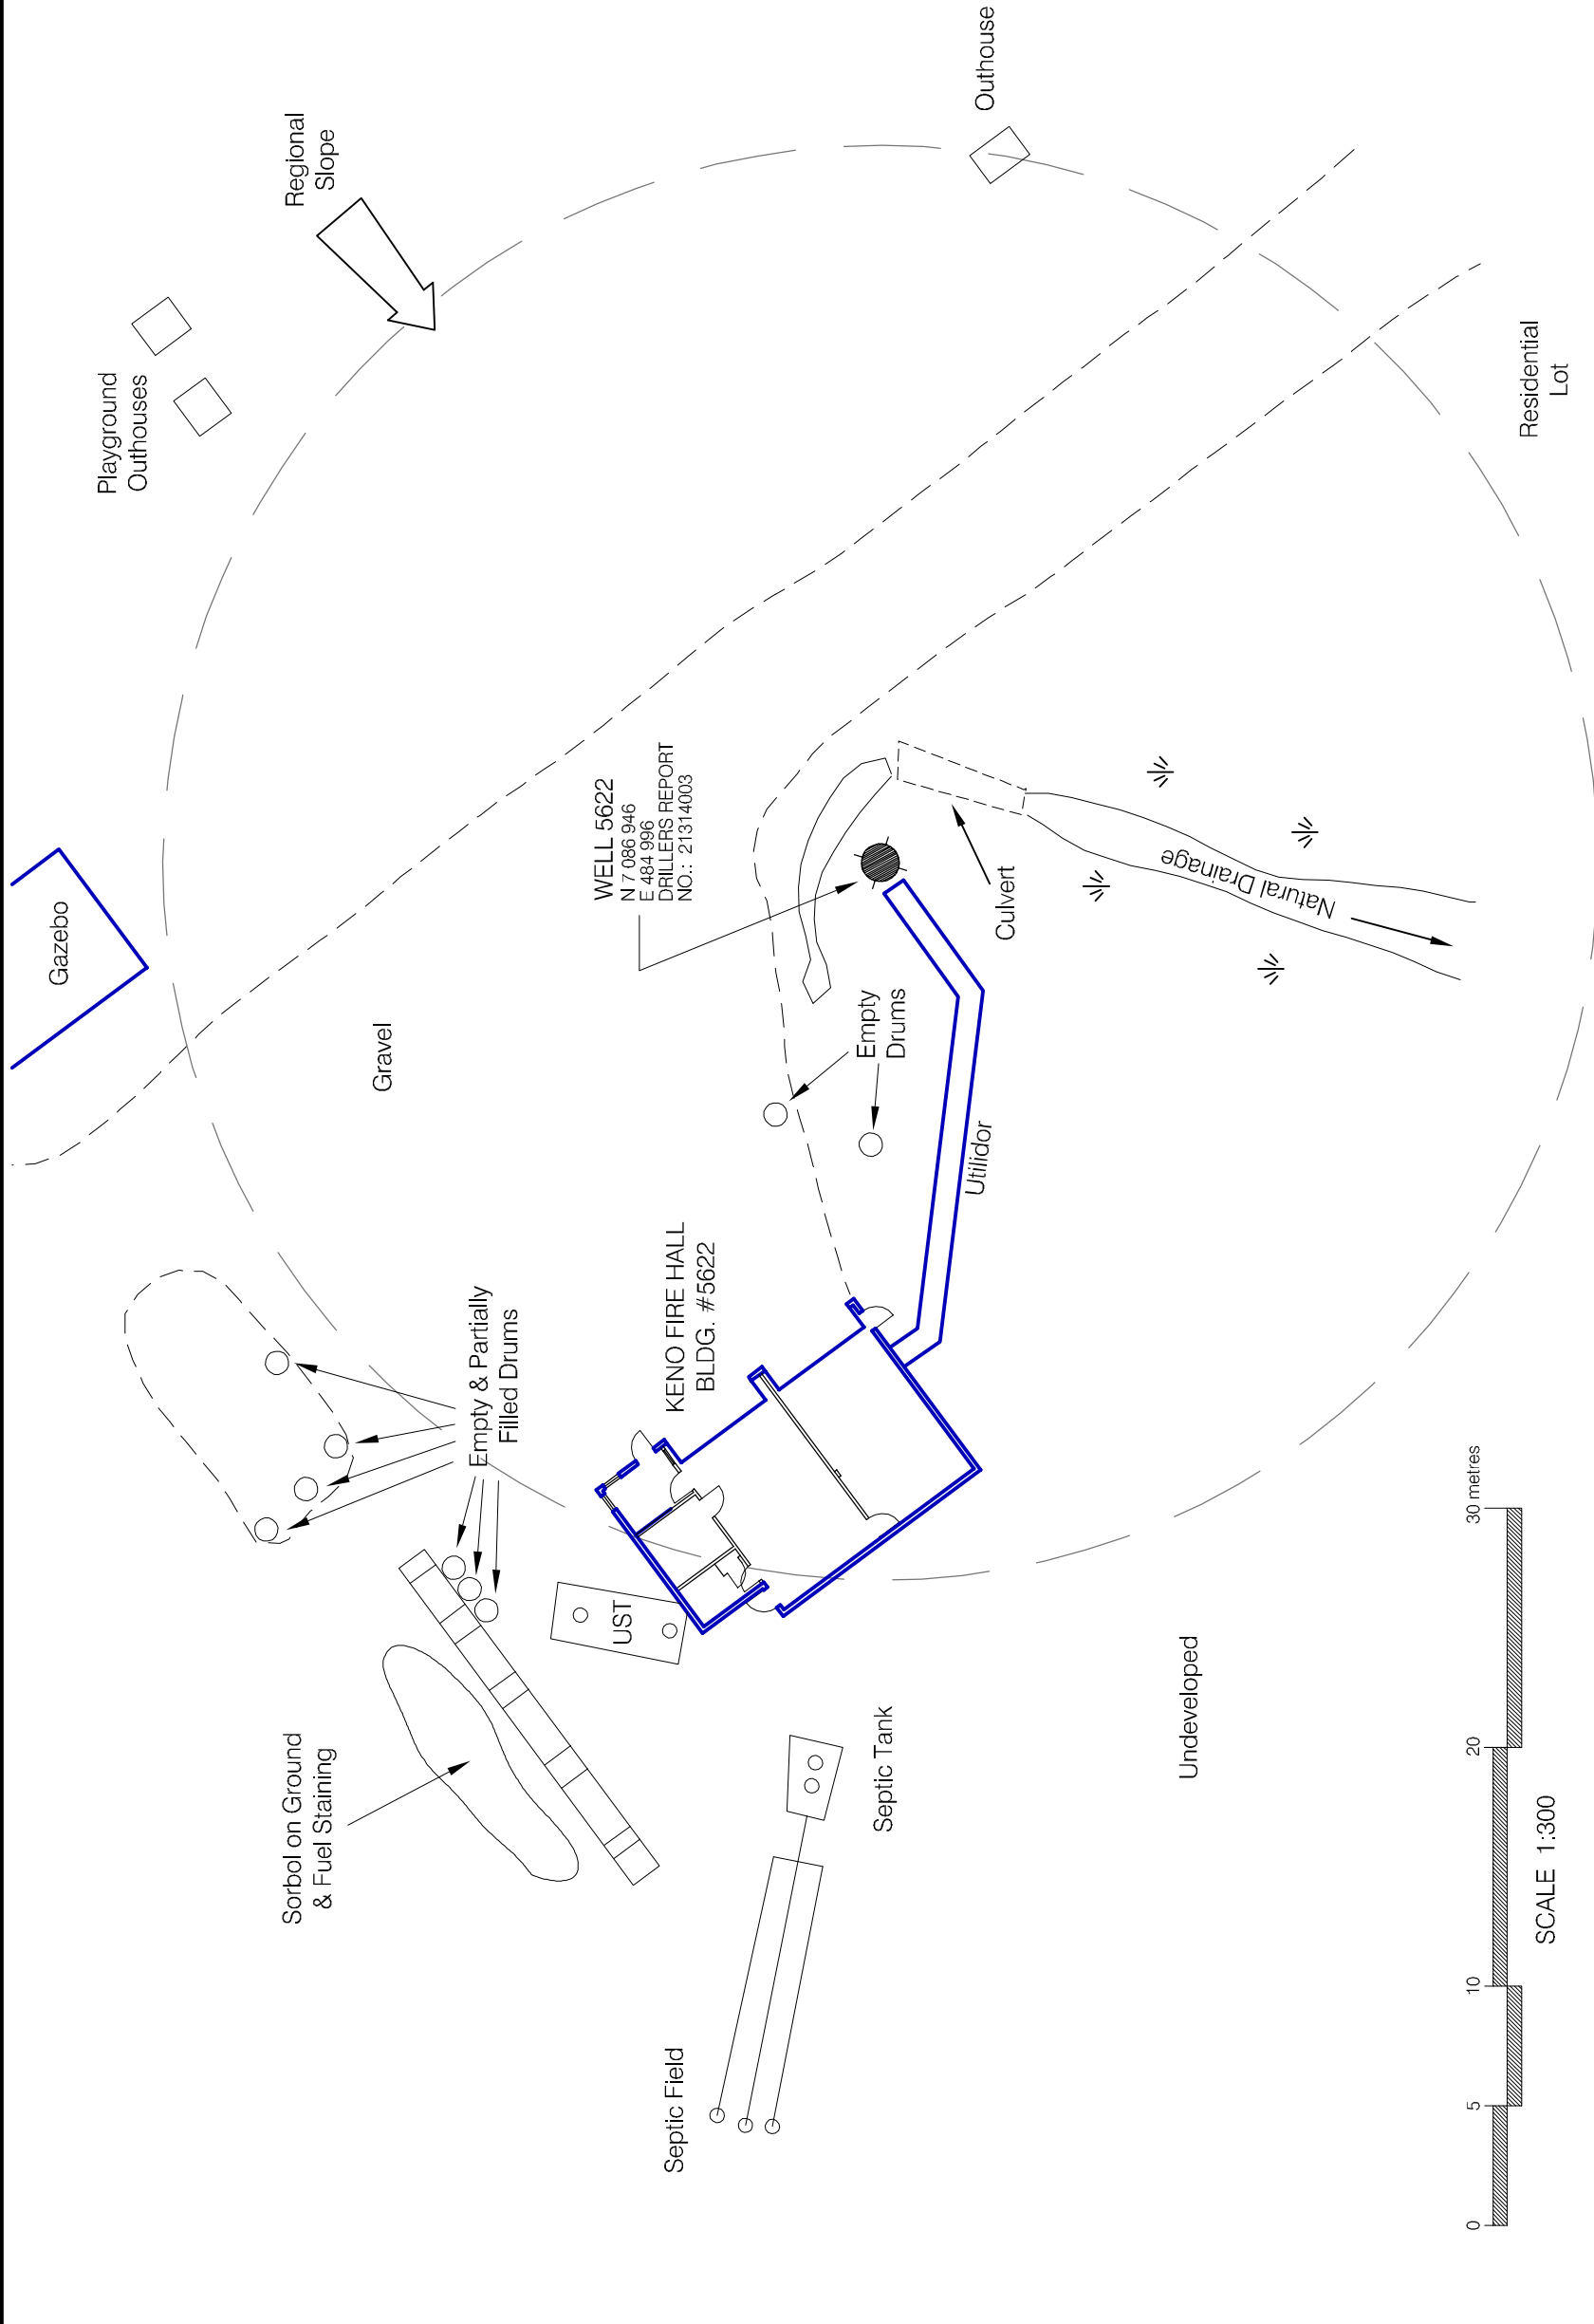
REVISION ISSUE: 0
 FIGURE No.:
FIGURE 5622-A

30 m RADIUS FROM WATER WELL FOR CONSIDERATION OF PROXIMITY TO POTENTIAL CONTAMINANT SOURCES.

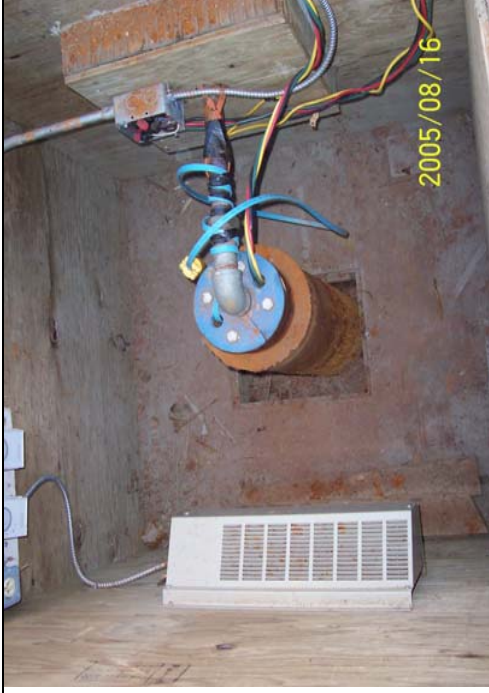
Drainage ditch runs beside wellhead enclosure.

- i. Is the well head below grade? describe in detail No, ~0.25m above grade
- ii. Are there signs of ponding on the enclosure(e.g. water stains, etc.)? Yes No
- iii. Is the wellhead enclosed by fiberglass insulations? Yes No
- iv. Any evidence of rodents? Specify No, access possible
- v. Does the well casing have a proper seal cap? Yes No
If no, describe condition split gasket cap

Photo 017: 5622 Wellhead.

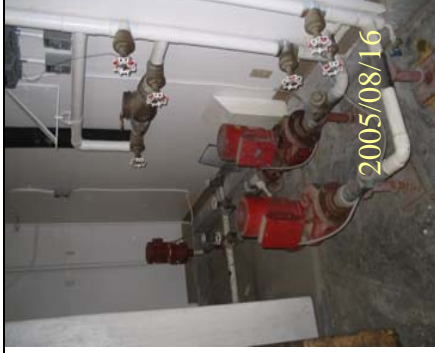
Photo 184: 5622 Booster pumps.
