EBA Engineering Consultants Ltd.	PROJECT SMALL PUBLIC WATER SYSTEMS ASSESSMENT WESTERN REGION			
CLIENT

SMALL PUBLIC WATER SYSTEMS ASSESSMENT
NORTHERN REGION

WATER SYSTEM DISTRIBUTION/TREATMENT
SCHEMATIC SYSTEM ID.: M0026
RCMP - PELLY CROSSING, YT.

Northern Region – Pelly Crossing R.C.M.P. Housing
 Building # ~~M0226~~ M0026

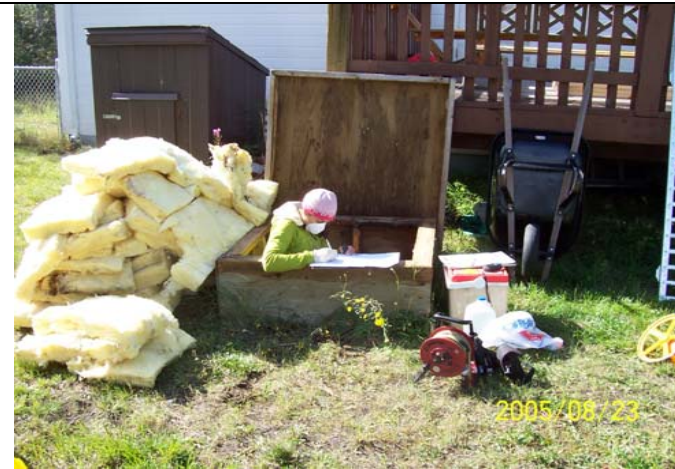
p. Is well site subject to flooding? Yes No *sediment build up in pit*

Photo 386: M0026 Well enclosure.

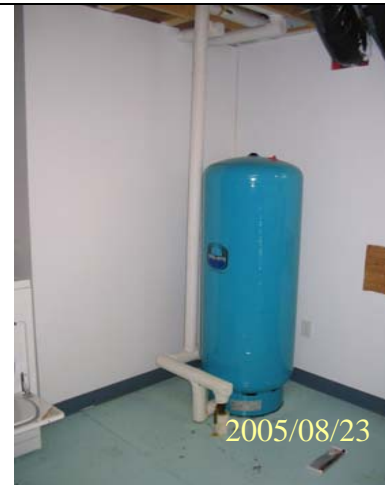
Photo 200: M0227 Pressure tank.
