PROJECT SMALL PUBLIC WATER SYSTEMS ASSESSMENT  
WESTERN REGION

WATER SYSTEM DISTRIBUTION/TREATMENT  
SCHEMATIC SYSTEM ID.: M0156/M0226  
RCMP - PELLY CROSSING, YT.

Northern Region – Pelly Crossing R.C.M.P. Housing  
 Building # ~~M0025~~ M0226

## SMALL PUBLIC WATER SYSTEM ASSESSMENT

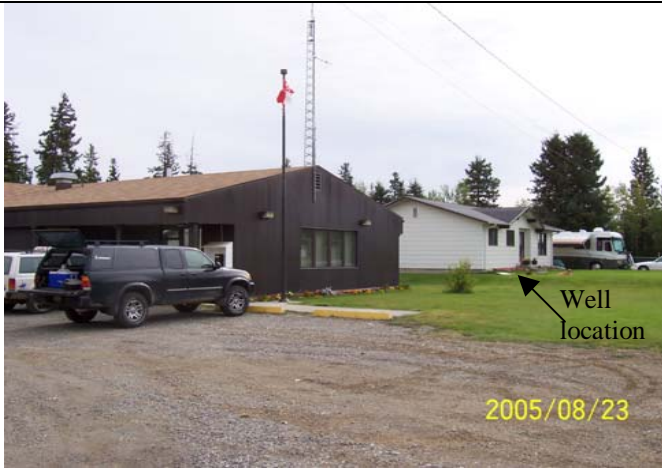
**Photo 381:** M0156 Pelly Crossing RCMP detachment. (left) Residence M0226 on (right).

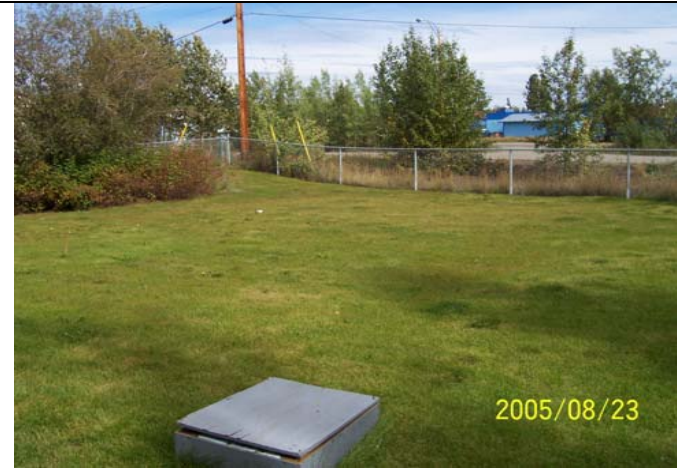
**Photo 381:** M0156/M0226 Well enclosure.

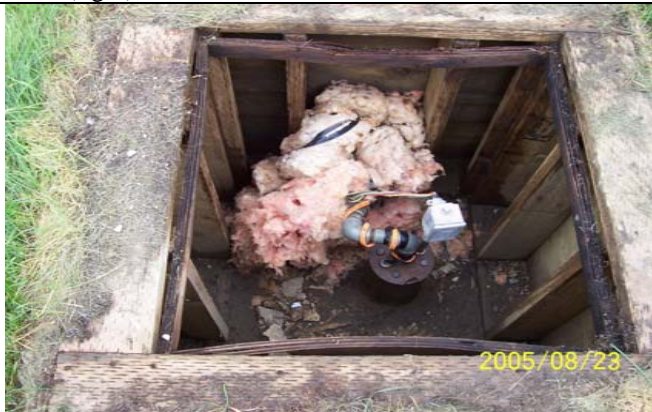
**Photo 379:** M0156/M0226 Well enclosure and wellhead.

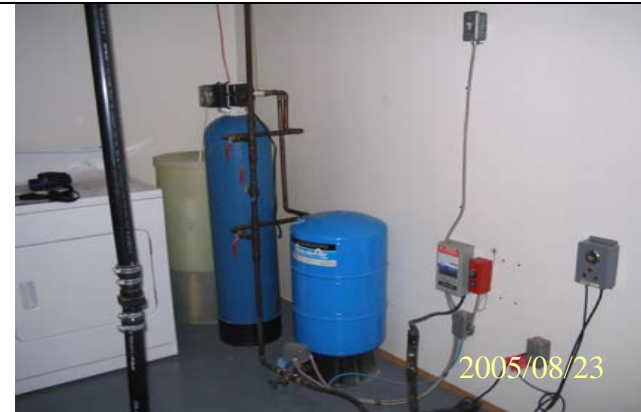
**Photo 199:** M0156/M0226 Water System (pressure tank, pump controls, softener).
