EBA Engineering Consultants Ltd.		PROJECT SMALL PUBLIC WATER SYSTEMS ASSESSMENT NORTHERN REGION							
CLIENT

TITLE WATER SYSTEM DISTRIBUTION/TREATMENT SCHEMATIC SYSTEM ID.: 5672 PELLY CROSSING SWIMMING POOL							
DATE	SEPT. 2005	DWN.	JSB	CHKD.	RMM	FILE NO.	1260002.004	DWG.:	FIGURE 5672-B

Northern Region – Pelly Crossing Swimming Pool
Building # 5672

SMALL PUBLIC WATER SYSTEM ASSESSMENT

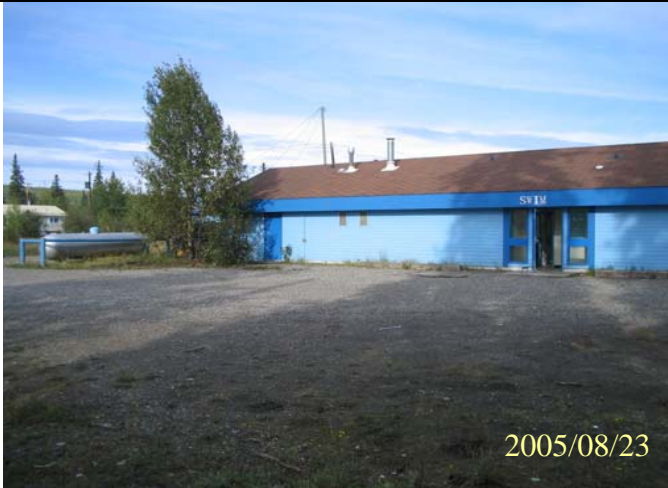
Photo 208: 5672 Pelly Crossing swimming pool. (northeast)

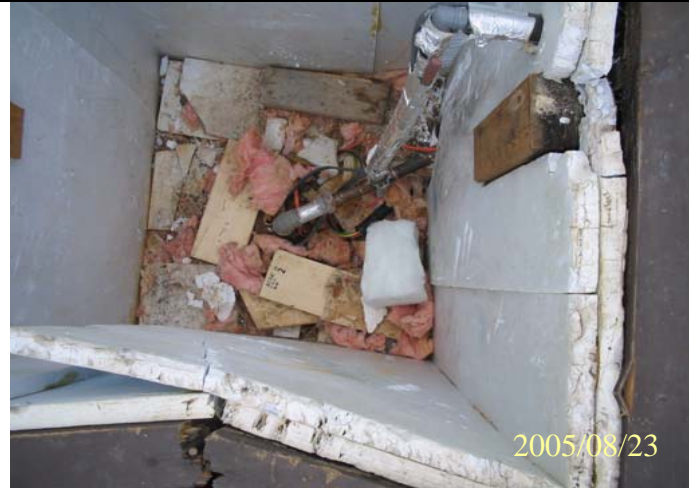
- i. Is the well head below grade? describe in detail Yes.
- ii. Are there signs of ponding on the enclosure(e.g. water stains, etc.)? Yes No
- iii. Is the wellhead enclosed by fiberglass insulations? Yes No
- iv. Any evidence of rodents? Specify No
- v. Does the well casing have a proper seal cap? Yes No

If no, describe condition split gasket cap.

Photo 209: 5672 Well enclosure and wellhead.

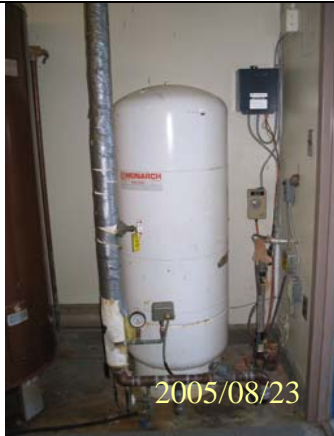
THIS INSTALLATION REQUIRES UPGRADING
THE TEMPORARY LINE IS EXPOSED ABOVE
GROUND

Photo 208: 5672 Water system. (pump controls, pressure tank)

REPAIR PIPING SYSTEM. INSTALL
WATER TREATMENT AS REQUIRED BY
WATER ANALYSIS.
INSTALL PROPORTIONAL CHLORINATION
SYSTEM

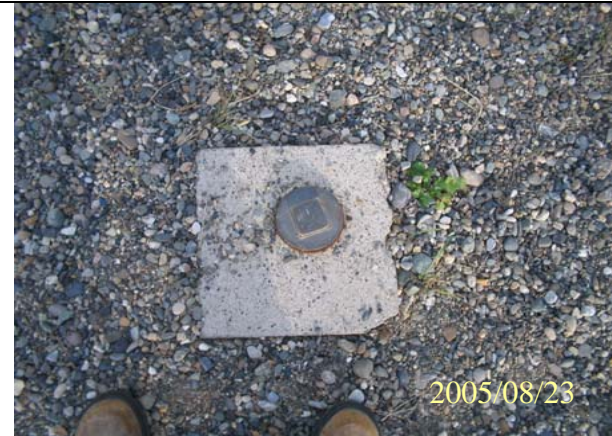
Photo 214: 5672 Potential septic clean out?
