SMALL PUBLIC WATER SYSTEMS ASSESSMENT
 NORTHERN REGION

PELLY CROSSING SCHOOL
 BUILDING # 5676
 SITE LOCATION DIAGRAM
 WELL ID: 5676

Northern Region – Eliza Van Bibber School
Building # 5676

SMALL PUBLIC WATER SYSTEM ASSESSMENT

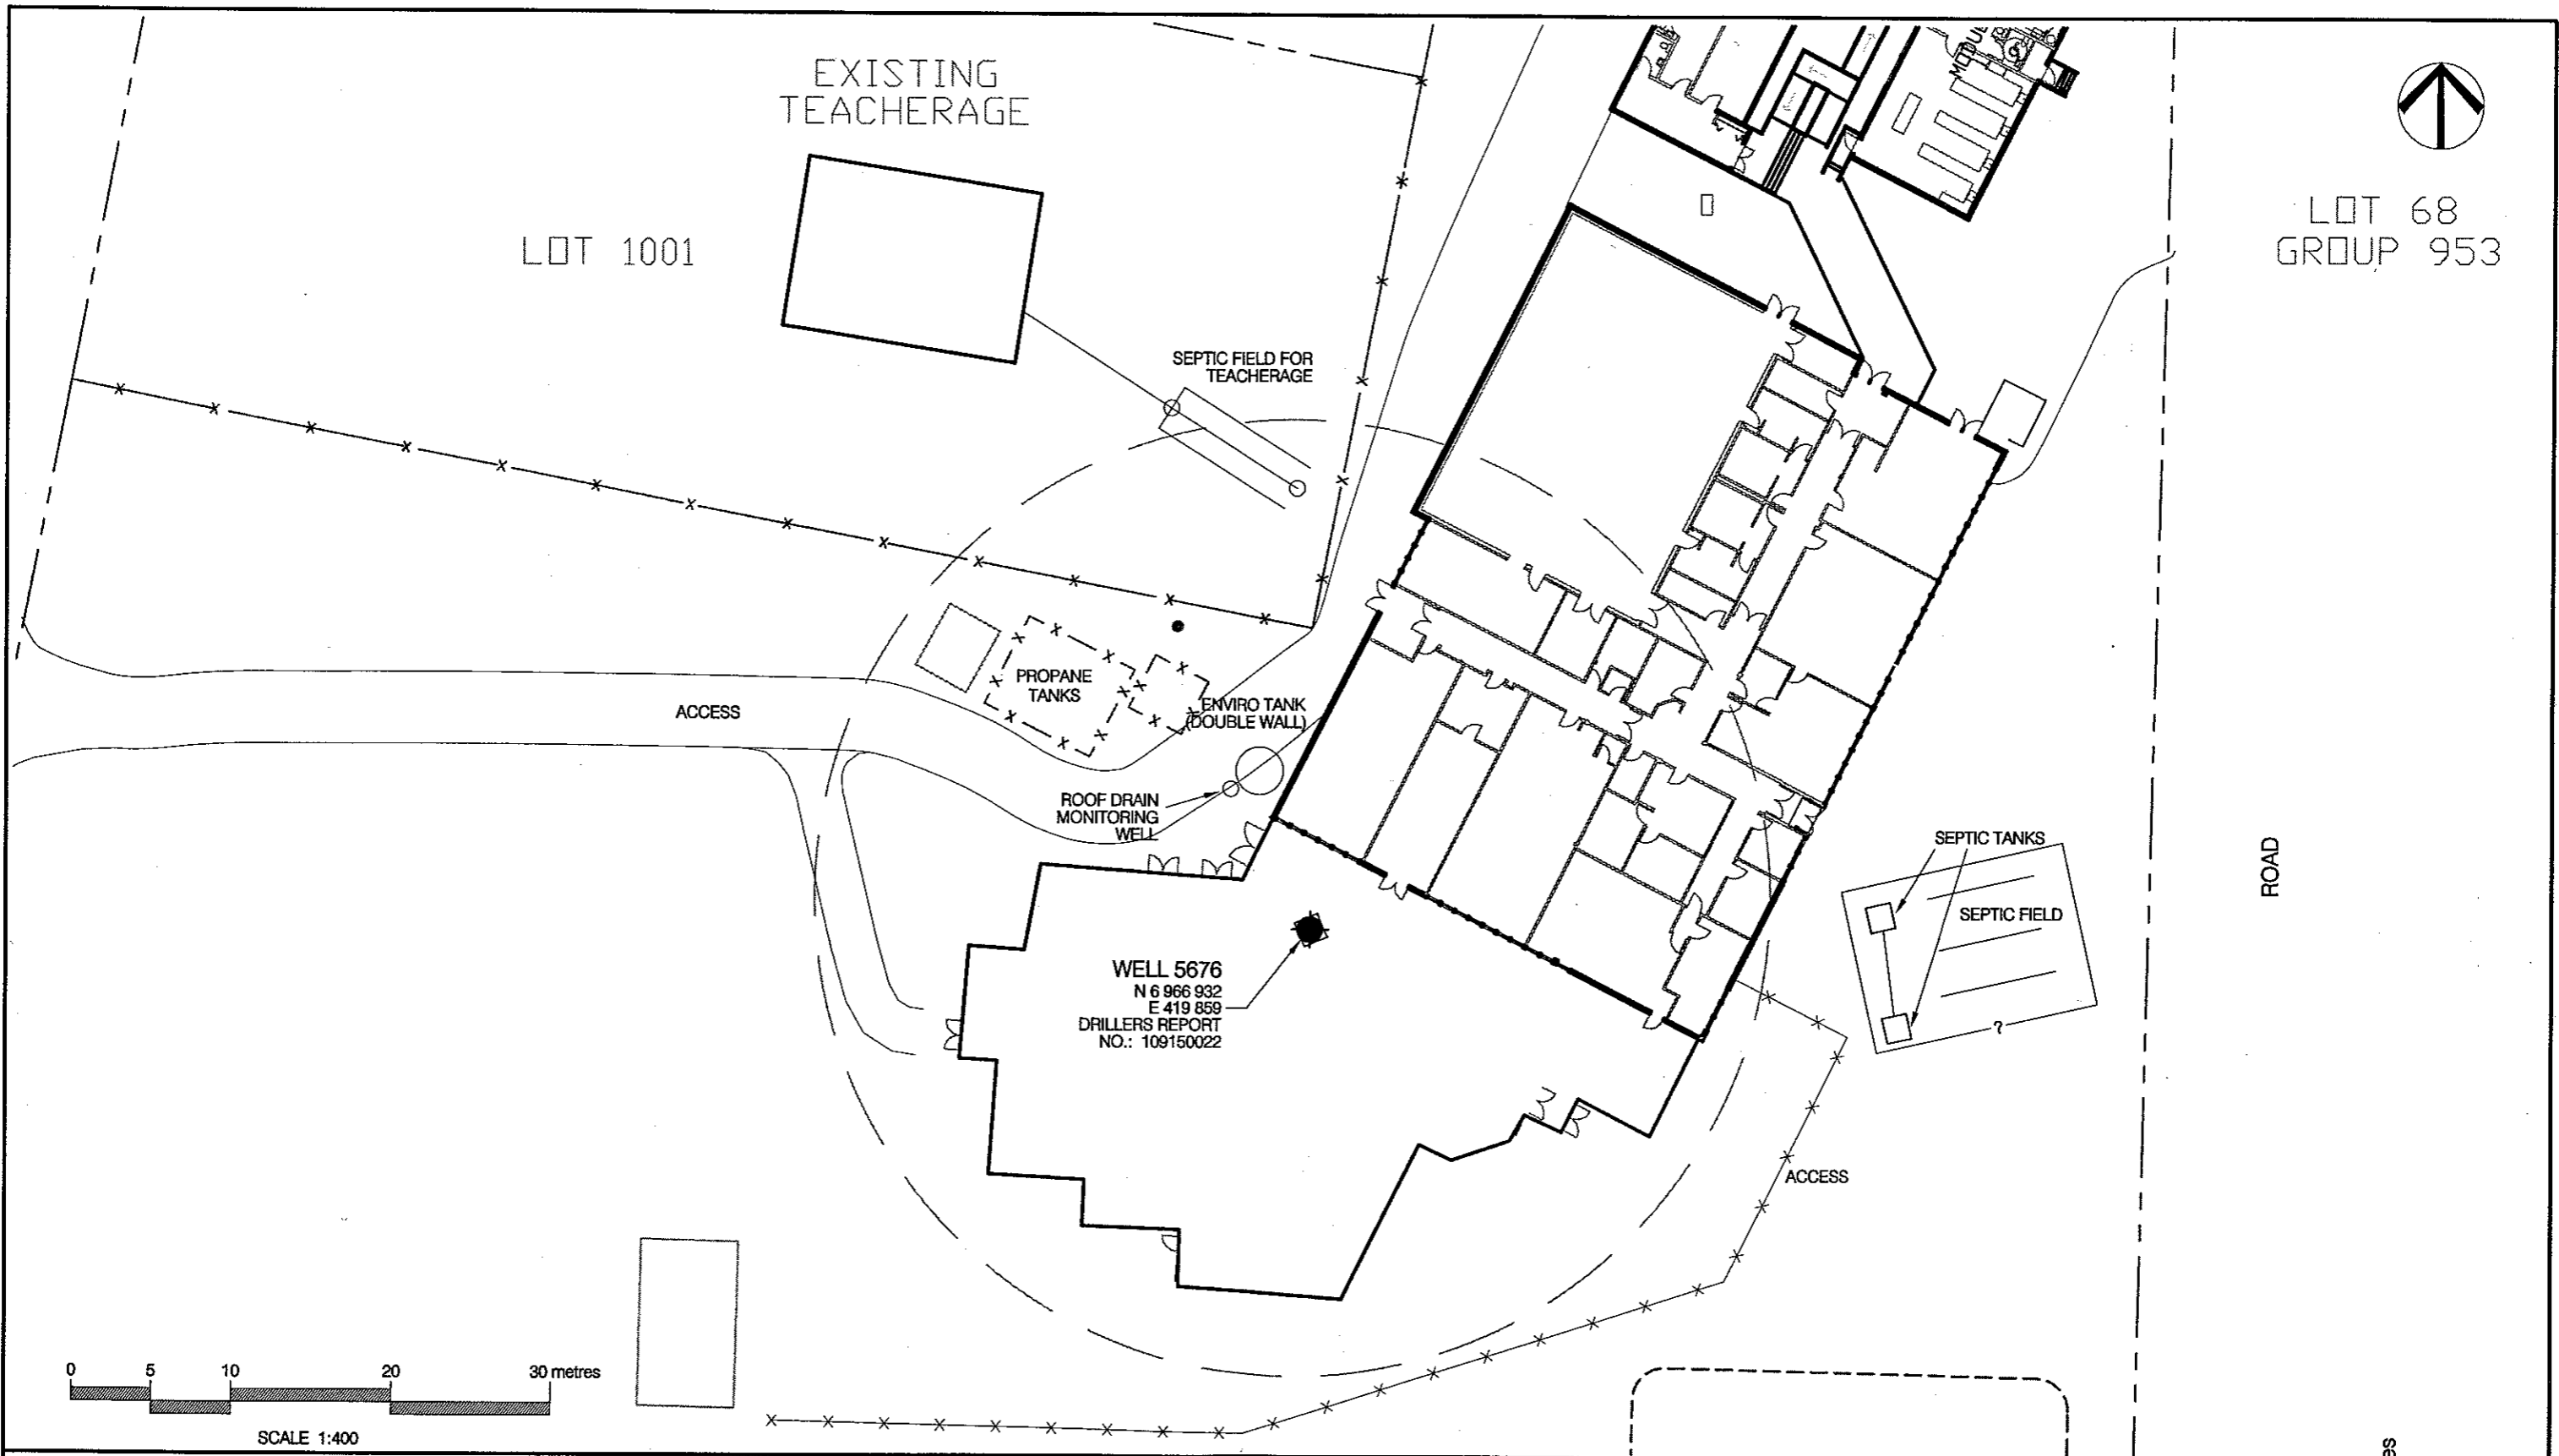
FIGURE No.
 FIGURE 5676-A

30 m RADIUS FROM WATER WELL FOR CONSIDERATION OF PROXIMITY TO POTENTIAL CONTAMINANT SOURCES.

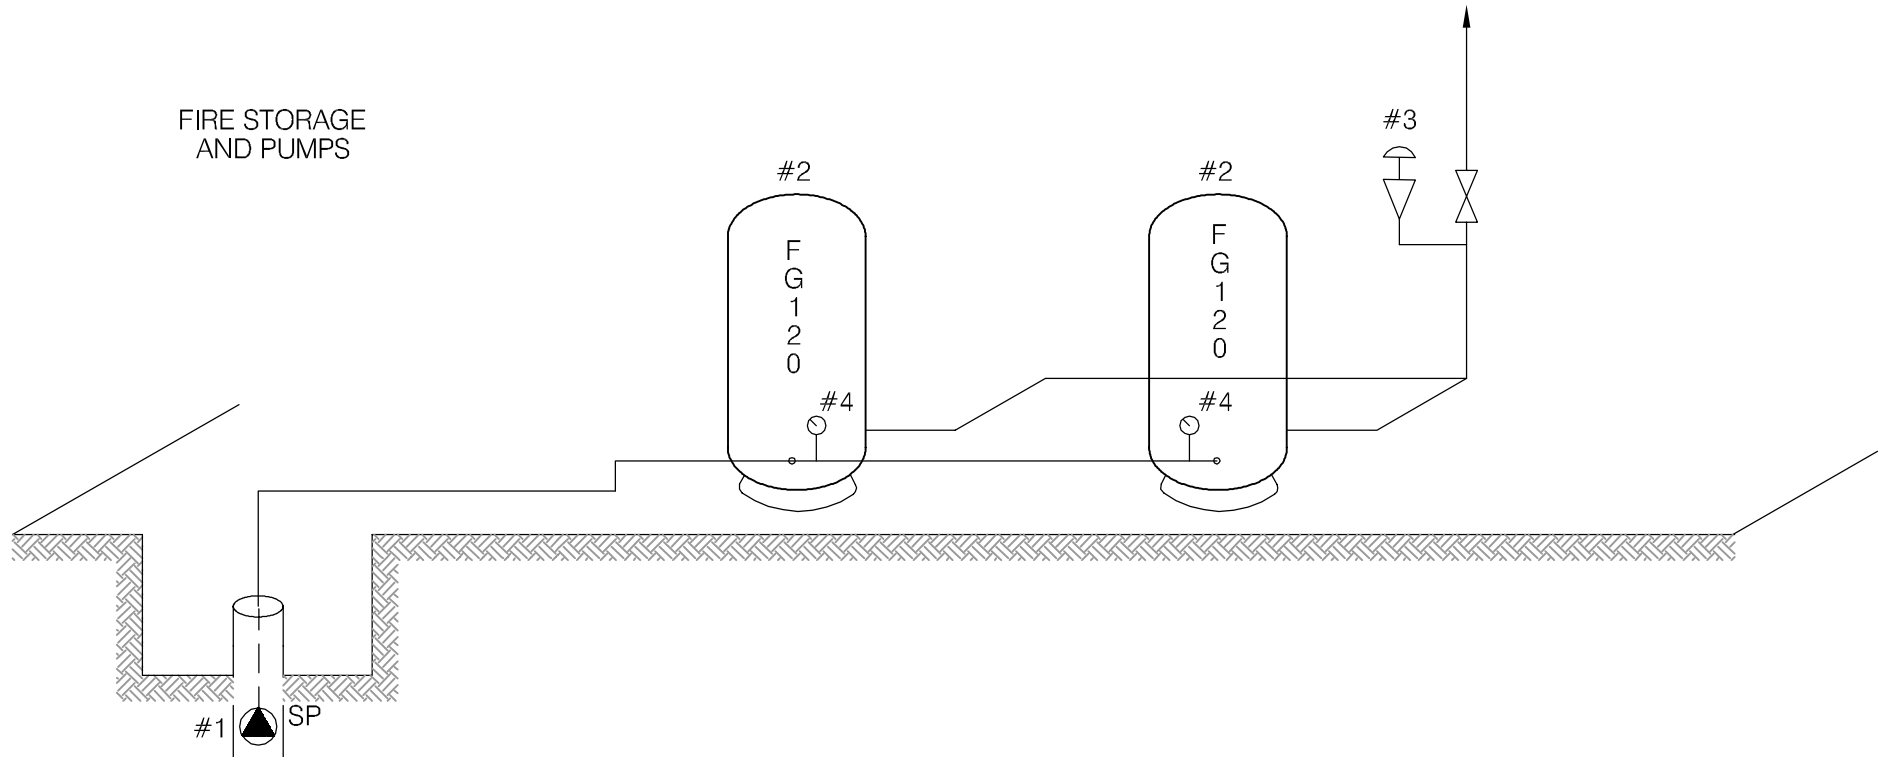
DWG.: FIGURE 5676-B

WATER SYSTEM DISTRIBUTION/TREATMENT
SCHEMATIC SYSTEM ID.: 5676
ELIZA VAN BIBBER SCHOOL - PELLY CROSSING, YT.

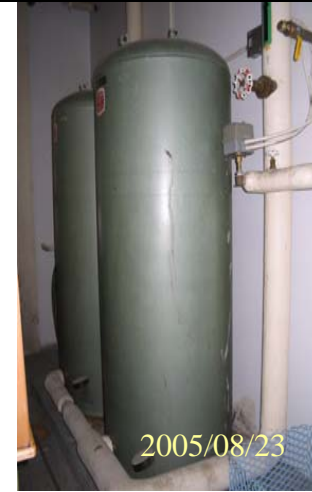
THIS IS A PROFESSIONAL INSTALLATION

Photo 204: 5676 Water System. (pump controls and pressure tanks)

INSTALL PROPORTIONAL CHLORINATION SYSTEM.

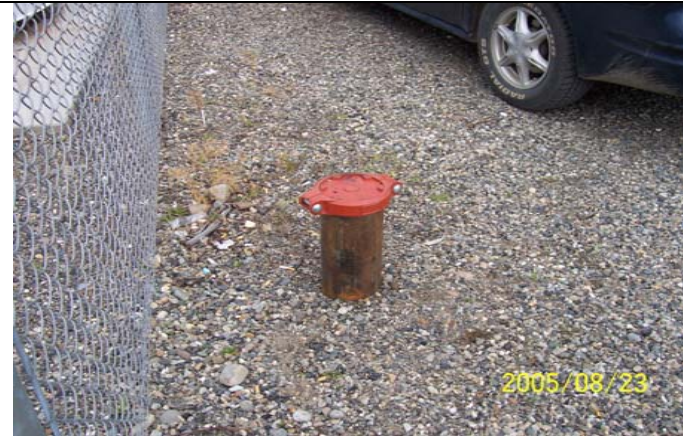
Photo 399: 5676 Monitoring well for rock pit drain.
