PROJECT SMALL PUBLIC WATER SYSTEMS ASSESSMENT
NORTHERN REGION

TITLE WATER SYSTEM DISTRIBUTION/TREATMENT
SCHEMATIC SYSTEM ID.: 5678
PELLY CROSSING FIRE HALL

Northern Region - Pelly Crossing Firehall
Building # 5678

SMALL PUBLIC WATER SYSTEM ASSESSMENT

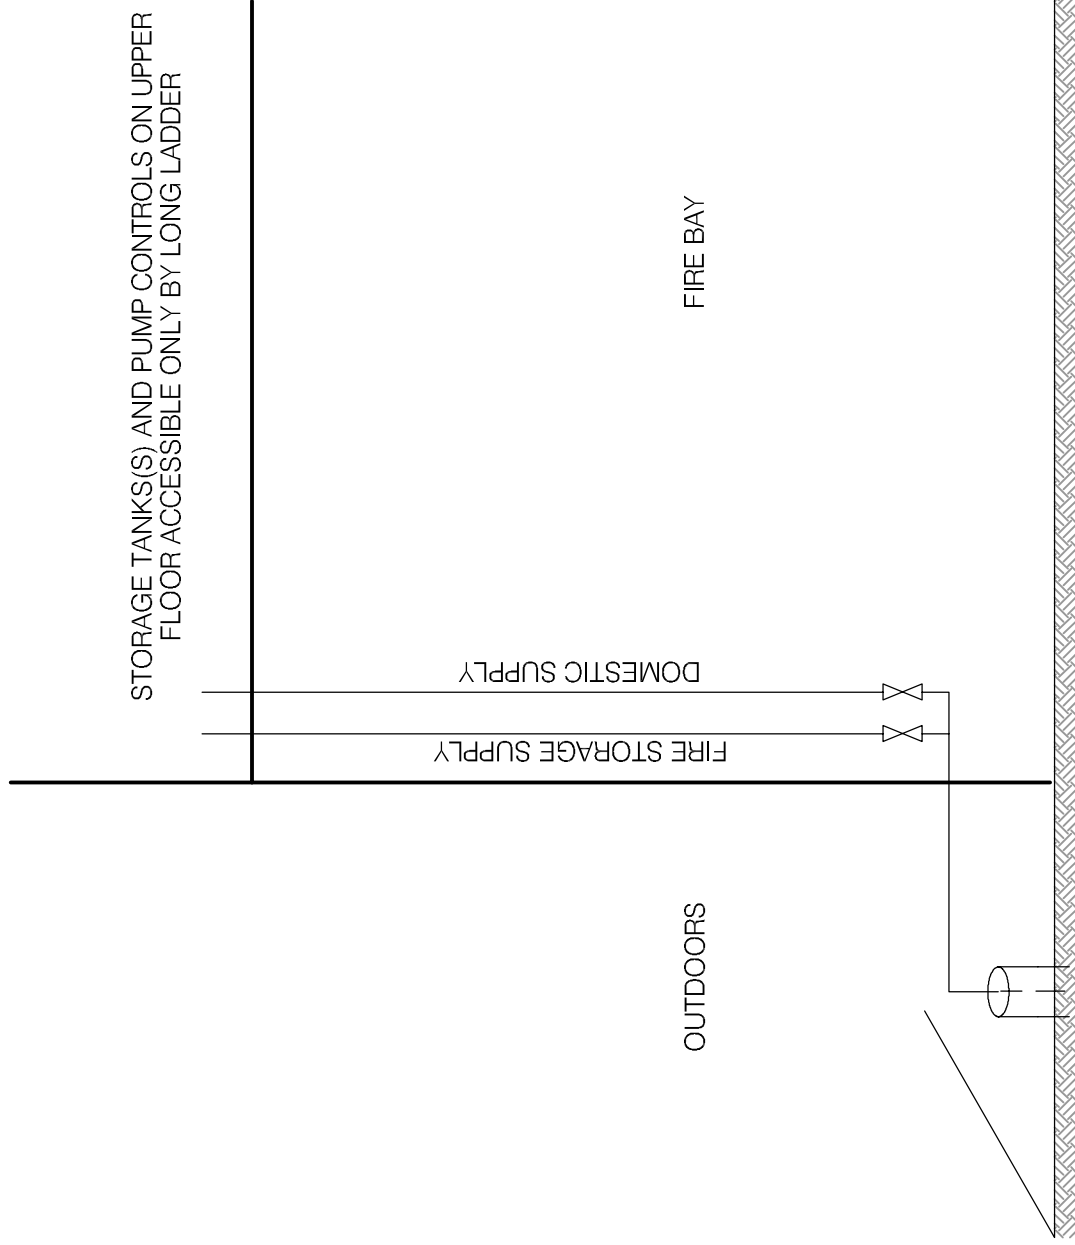
FIGURE 5678-B

STORAGE TANK(S) AND PUMP CONTROLS ON UPPER FLOOR ACCESSIBLE ONLY BY LONG LADDER

INSTALL PROPER ACCESS TO THE WATER STORAGE AREA.
INSTALL WATER TREATMENT AS REQUIRED FOR UV SYSTEM (NSF 55 CERTIFIED)
INSTALL UV SYSTEM.

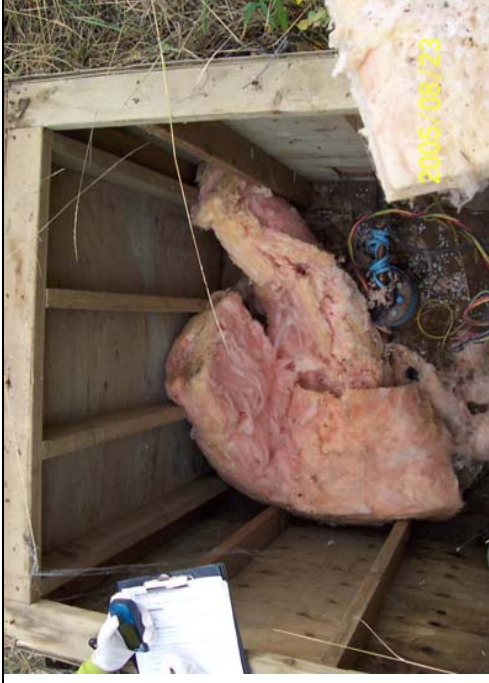
iv. Any evidence of rodents? Specify Yes - significant amounts of mouse feces

If no, describe condition split gasket cap

Photo 402: 5678 Well enclosure and wellhead.
