SMALL PUBLIC WATER SYSTEMS ASSESSMENT
NORTHERN REGION

PELLY NURSING STATION
BUILDING # 5987
SITE LOCATION DIAGRAM
WELL ID: 5987

Northern Region – Pelly Crossing Nursing Station
 Building # 5987

SMALL PUBLIC WATER SYSTEM ASSESSMENT

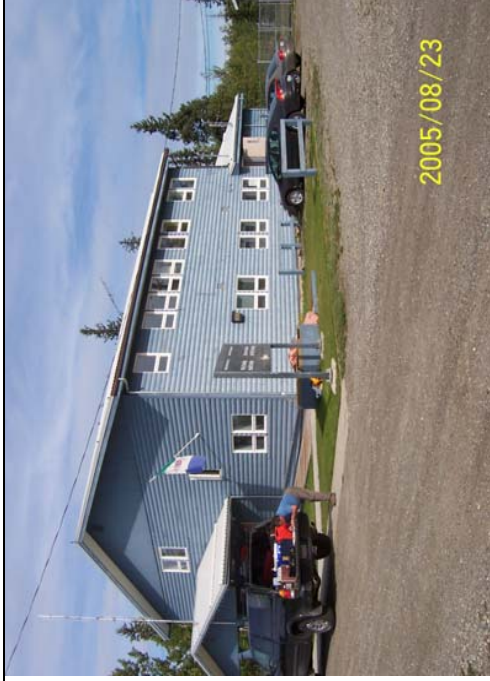
Photo 393: 5987 Pelly Crossing nursing station. (looking northeast)

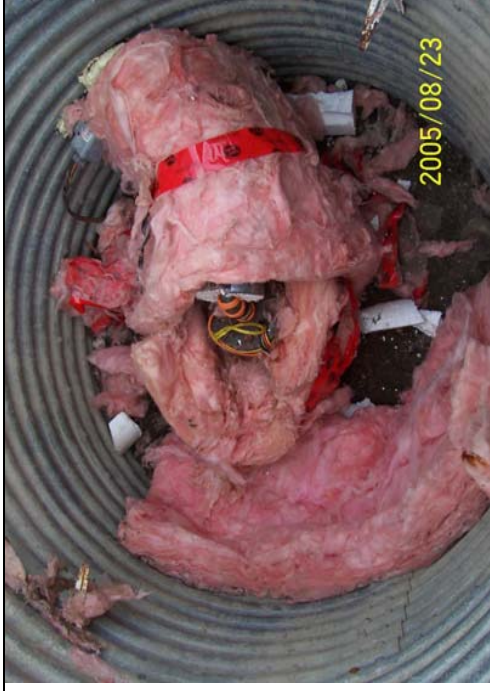
- i. Is the well head below grade? describe in detail Yes (-0.66 m)
- ii. Are there signs of ponding on the enclosure(e.g. water stains, etc.)? Yes No
- iii. Is the wellhead enclosed by fiberglass insulations? Yes No
- iv. Any evidence of rodents? Specify No
- v. Does the well casing have a proper seal cap? Yes No

If no, describe condition Split gasket cap.

no surface seal Yes No farther investigation required.

Photo 394: 5987 Well enclosure and wellhead in pit.

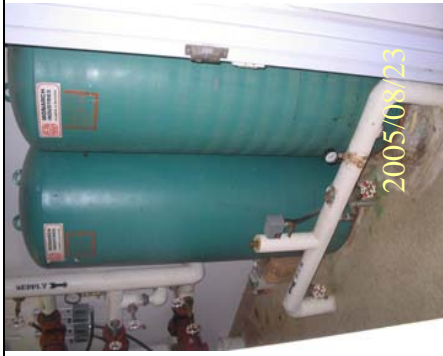
Photo 202: Water system. (pressure tanks & pump controls)

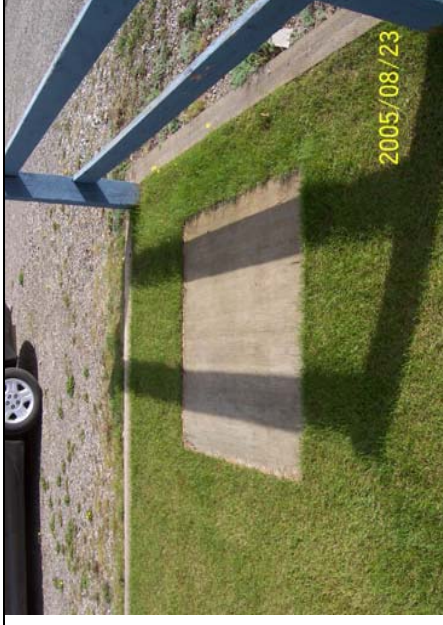
Potential Source 2: Abandoned well; Distance from well to Potential Source 2: 2m.

Photo 396: Potential location of abandoned well.
