**Small Public Water System Assessments  
Yukon Government Maintained Buildings**

***NORTHERN REGION  
DRAFT REPORT***

**EBA Project No. 1260002.004**

**March 2006**

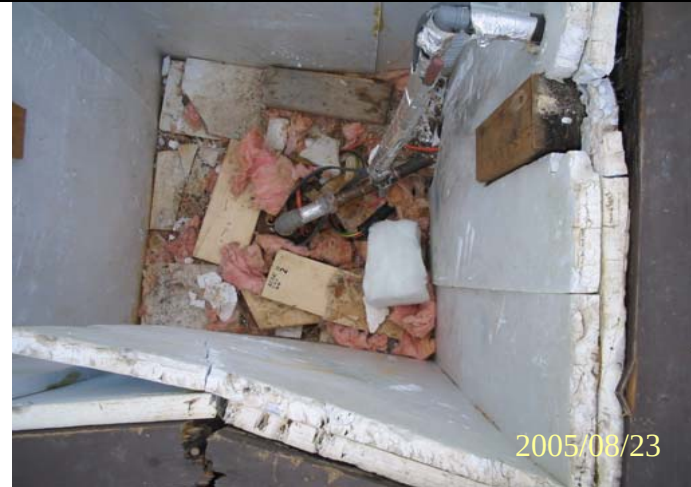
**Photo 209:** 5672 Well enclosure and wellhead.

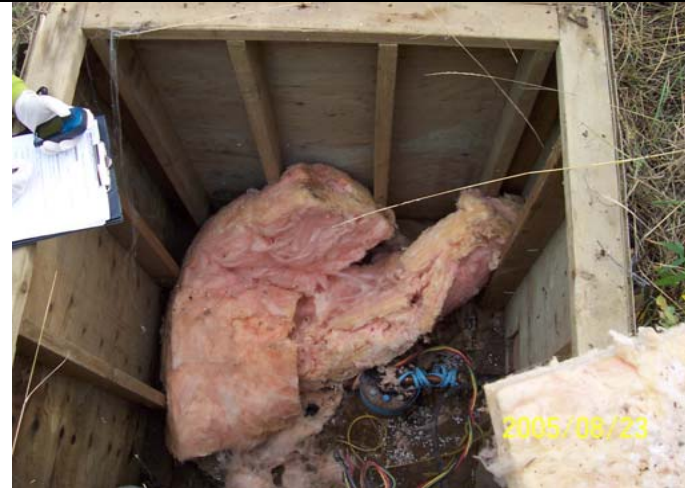
**Photo 402:** 5678 Well enclosure and wellhead.

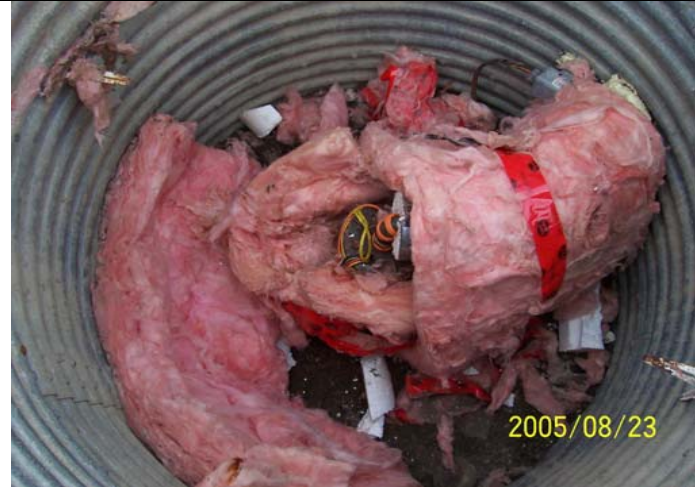
**Photo 394:** 5987 Well enclosure and wellhead in pit.

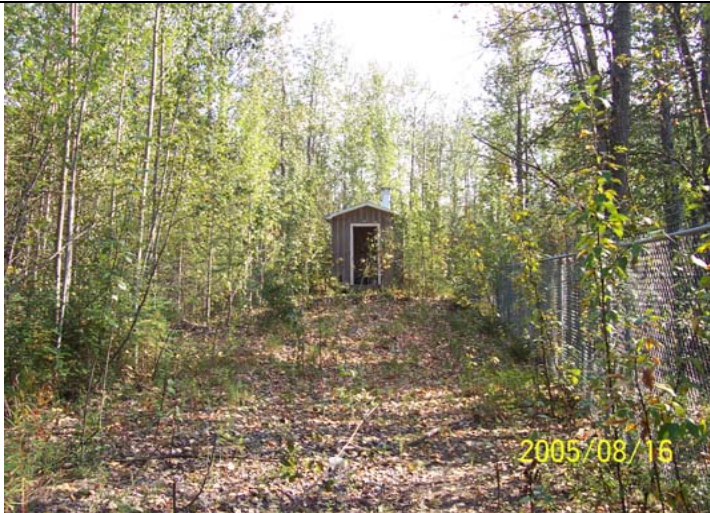
**Photo 001:** Abandoned well enclosure.

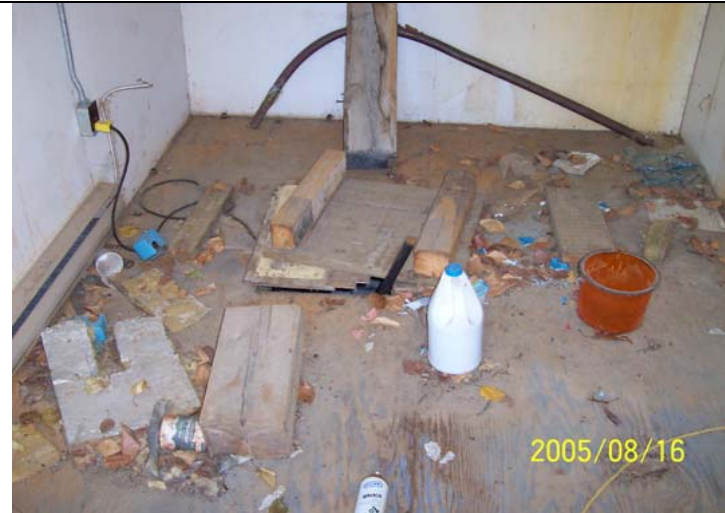
**Photo 002:** Wellhead of abandoned well.

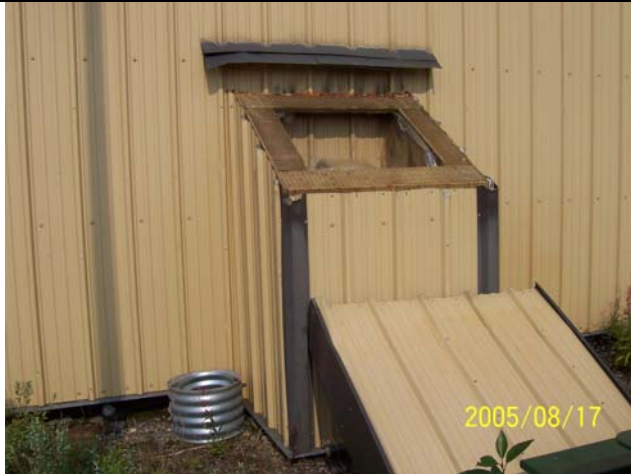
**Photo 044:** 5629 Wellhead enclosure.

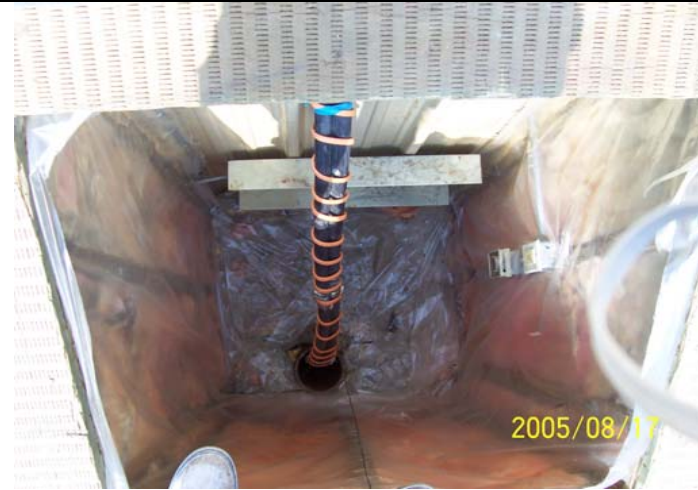
**Photo 033:** 5629 Well enclosure and wellhead in pit.

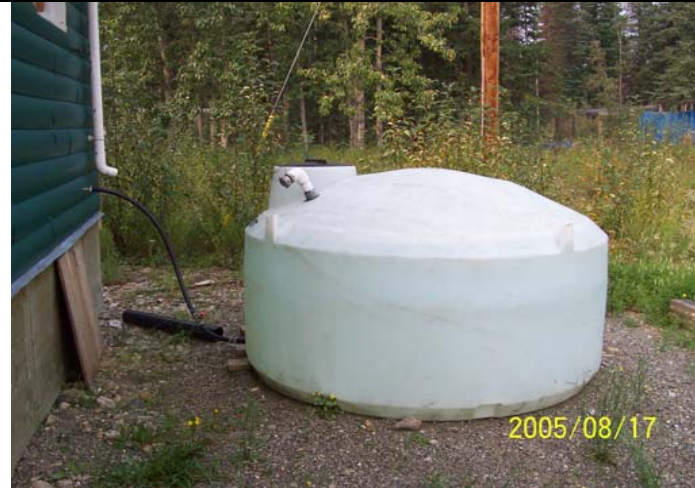
**Photo 029:** 5636 Seasonal water holding tank.

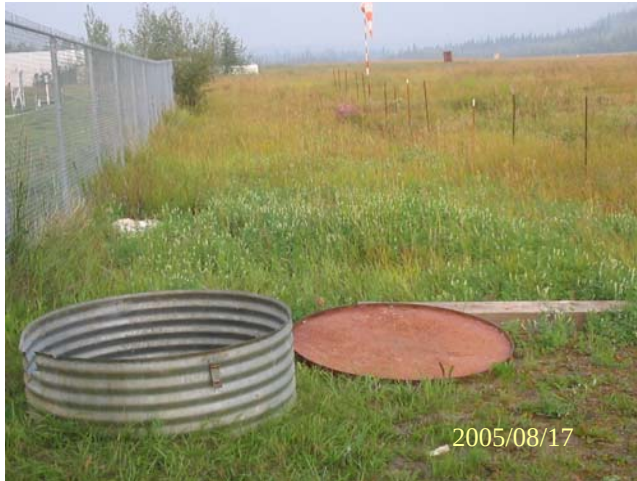
**Photo 0187:** 5653 Mayo Airport wellhead enclosure.

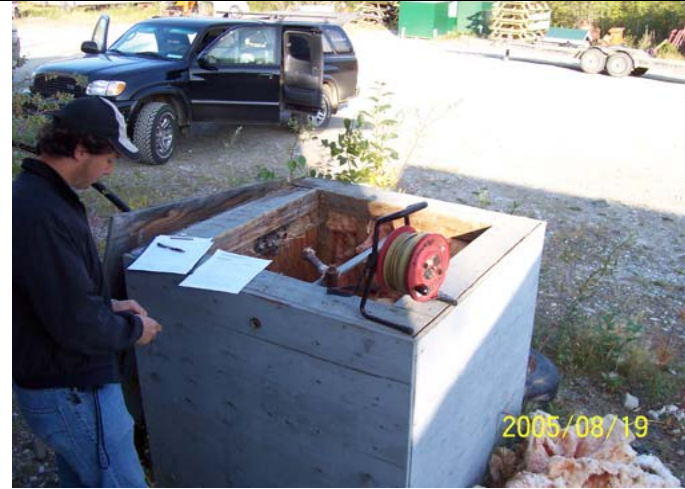
**Photo 075:** 2575 Wellhead enclosure.

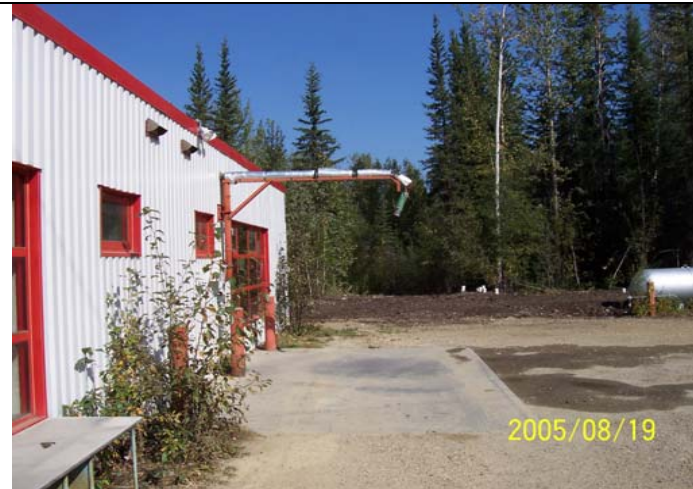
**Photo 096:** 2592 Water filling station.

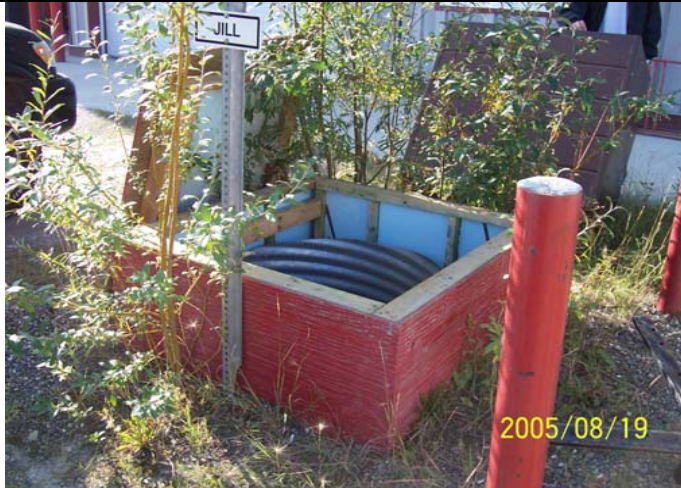
**Photo 087:** 2599 Wellhead enclosure.

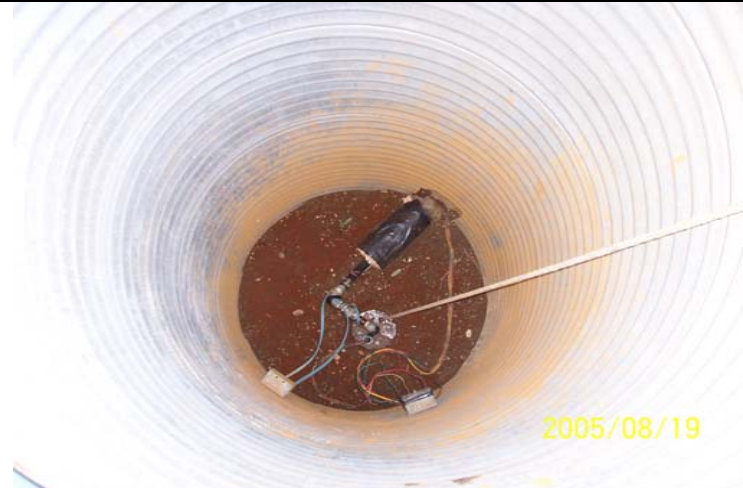
**Photo 086:** 2599 Wellhead in pit.

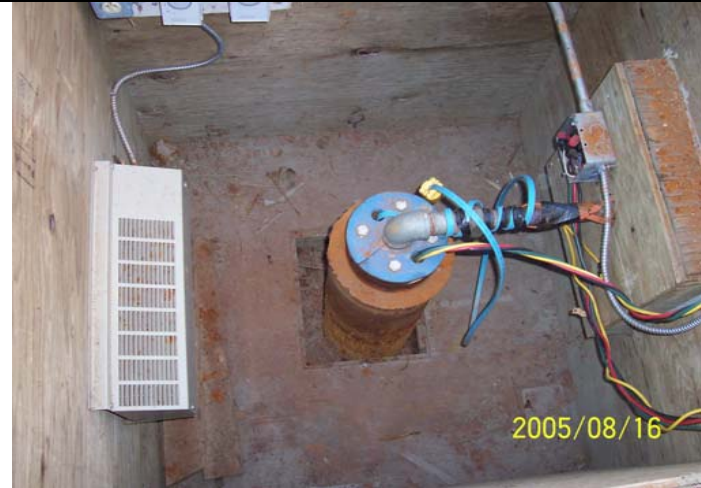
**Photo 017:** 5622 Wellhead.
