PROJECT SMALL PUBLIC WATER SYSTEMS ASSESSMENT
WHITEHORSE REGION

**Whitehorse Region – Mendenhall Firehall
Building # 1421**

SMALL PUBLIC WATER SYSTEM ASSESSMENT

PART A: EBA Site Inspection

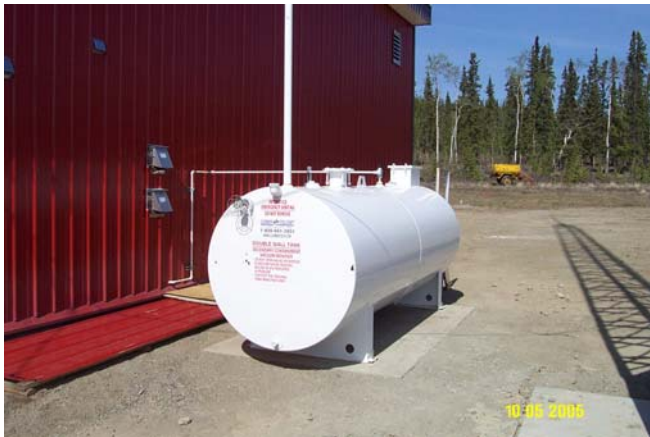
Photo 0093: 1421 Above Ground Storage Tank

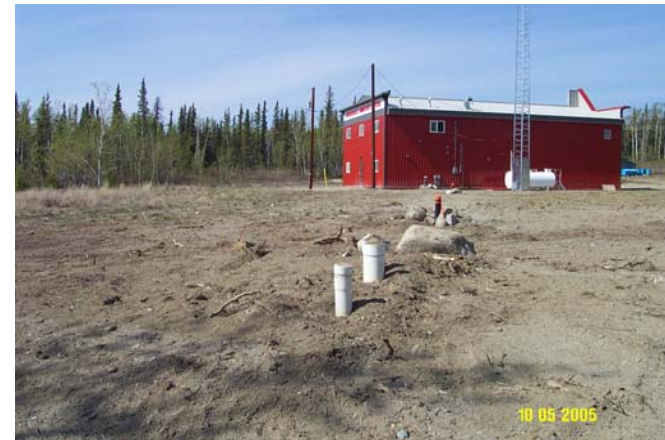
Effluent field/septic tank 50m away

Photo 0094: 1421 Septic Field (front) and Mendenhall Firehall (back)

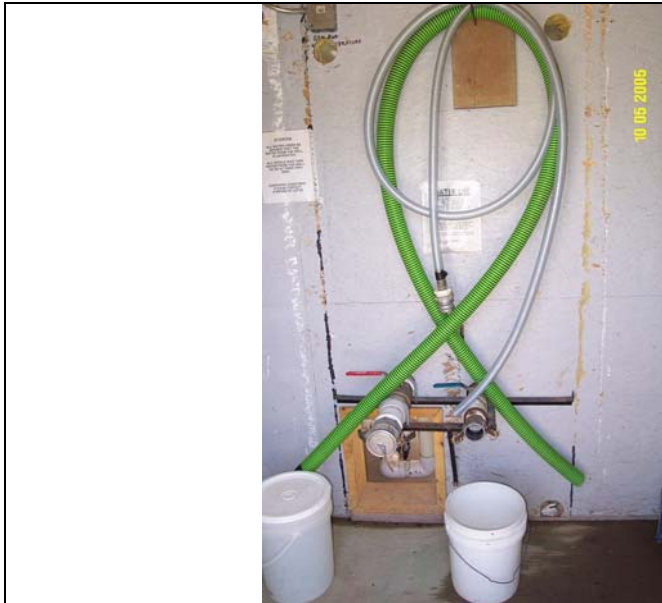
Photo 0089: 1421 Water-Pickup

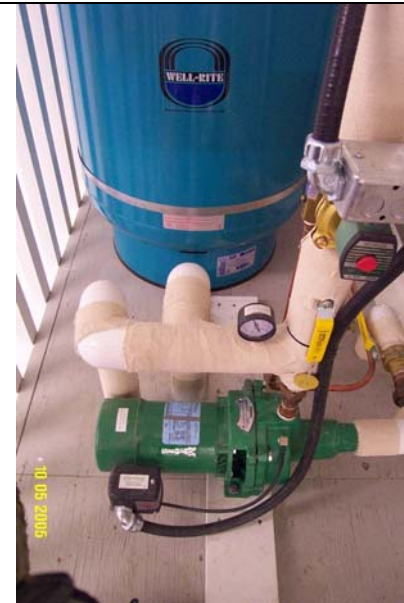
Photo 0098: 1421 Pressure Tank and System

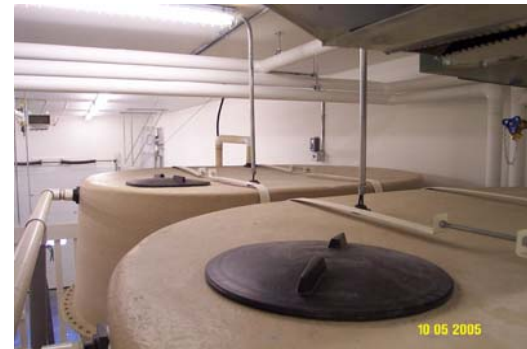
Photo 0097: 1421 Water Storage Tanks (in firehall)
