SMALL PUBLIC WATER SYSTEMS ASSESSMENT
 WHITEHORSE REGION

GOLDEN HORN FIRE HALL
 BUILDING 1924
 SITE LOCATION DIAGRAM
 WELL ID: 1924

**Whitehorse Region – Golden Horn Firehall
Building # 1924**

SMALL PUBLIC WATER SYSTEM ASSESSMENT

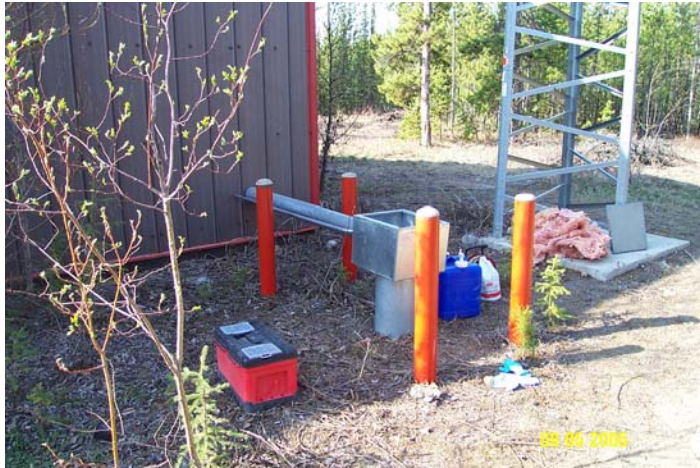
Tank @ 19 m, end of field @ ~40m, field may start before 30m, likely starts within 30m

Photo 0078: 1924 Wellhead (front), Golden Horn Firehall (left) and Septic Field (back)

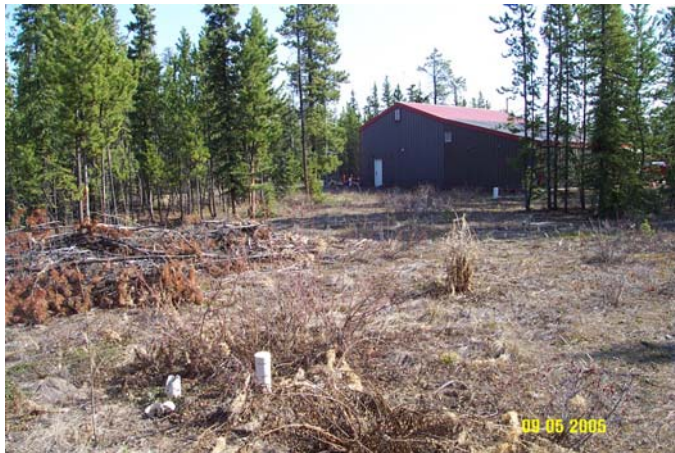
Photo 0080: 1924 Septic Field (fron), Golden Horn Firehall (back)

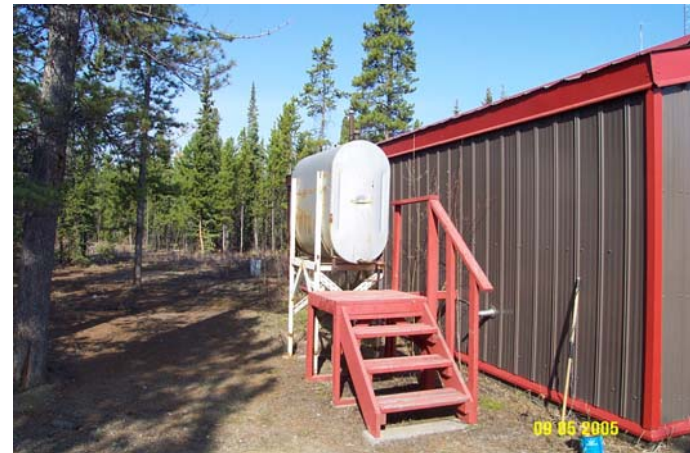
Potential Source 1: Floating Oil Tank; Distance from well to Potential Source 1: 22m

Photo 0077: Above Ground Fuel Storage Tank

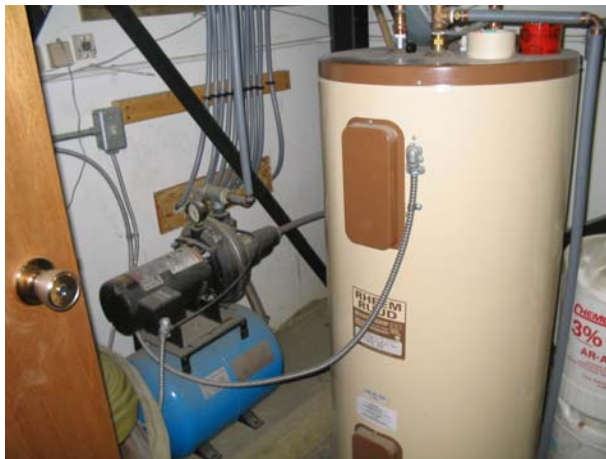
The pump, however, is presently shut down

Photo 0469: 1924 Pump System

INSTALL A PUMP SYSTEM TO SUIT.

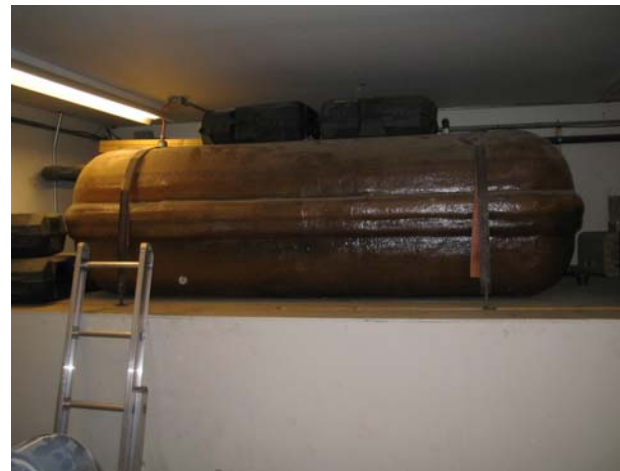
Comments: OVERHEAD ELECTRIC HEATER

Photo 0470: 1924 Water Storage Tank

MODIFY TANK TO ALLOW ACCESS FOR CLEANING.

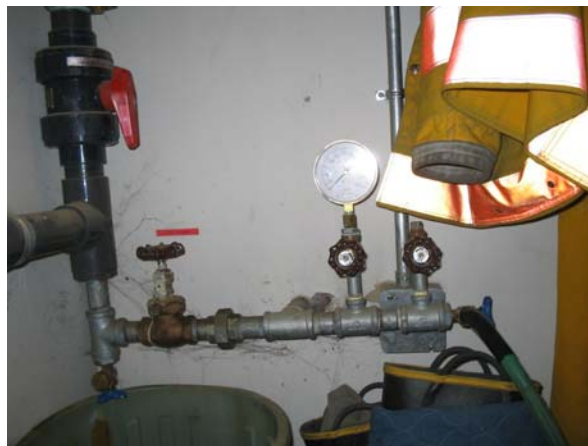
Photo 0465: 1924 Tank Fill Solenoid Valve and Bypass
