SMALL PUBLIC WATER SYSTEMS ASSESSMENT  
WHITEHORSE REGION

IBEX FIRE HALL  
BUILDING 1950  
SITE LOCATION DIAGRAM  
WELL ID: 1950

## SMALL PUBLIC WATER SYSTEM ASSESSMENT

WELL ID #	Owner	Location Description
1950	YTG	Ibex Valley FireHall

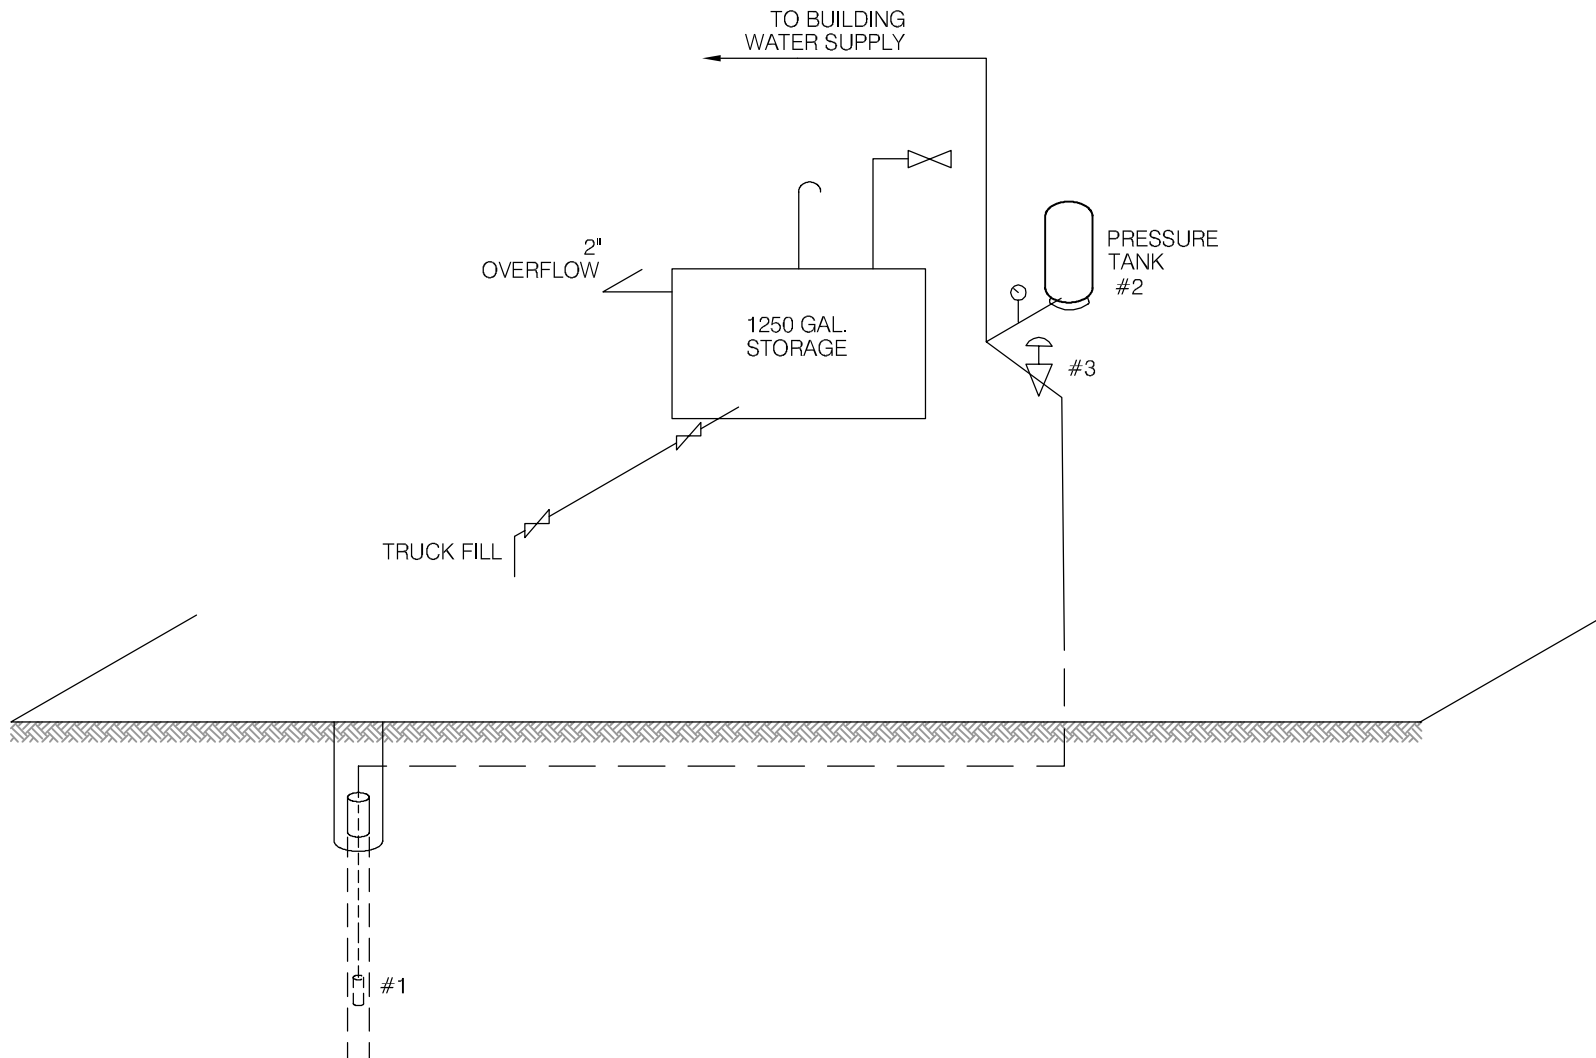
DWG.: FIGURE 1950B

WATER SYSTEM DISTRIBUTION/TREATMENT  
SCHEMATIC SYSTEM ID.: 1950  
IBEX FIRE HALL

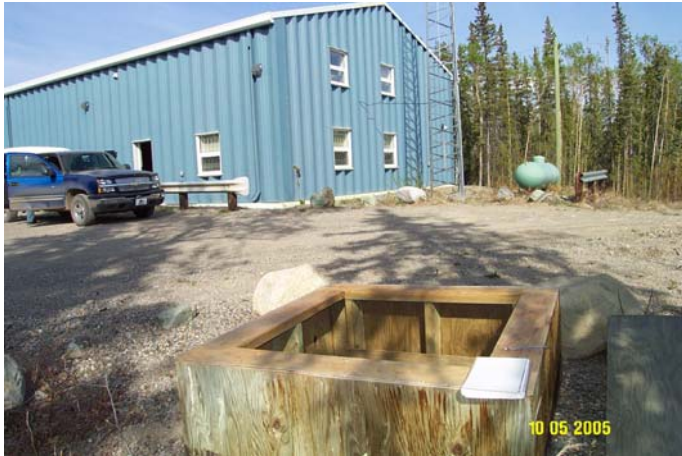
- m. Is the well head:  in pumphouse  in pit  pitless adaptor  in a building  
*An insulated pit w/pwf exterior casing (plywood and 2x6 studs)*  
 in a wooden enclosure other, describe \_\_\_\_\_

- i. Is the well head below grade? describe in detail The well head is 1.75m below grade
- ii. Are there signs of ponding on the enclosure(e.g. water stains, etc.)?  Yes  No
- iii. Is the wellhead enclosed by fiberglass insulations?  Yes  No
- iv. Any evidence of rodents? Specify There is a little amount of mouse droppings in the upper section
- v. Does the well casing have a proper seal cap?  Yes  No  
If no, describe condition Although there is a <sup>plastic</sup> cap, there are open holes for the heat trace and power lines to go down

**Photo 0100:** 1950 Well-Enclosure – Pit (front), Ibex Valley Firehall (back)

- b. Recommendations:  
The well should be installed in a concrete pit with a cover.  
The pump should be installed in a concrete enclosure with a cover.

NEW CASING TO BE EXTENDED ABOVE GROUND LEVEL & SURFACE SEAL INSTALLED. INSTALL PROPORTIONAL CHLORINATOR AND SURTAGE RETENTION TANK. POTABLE WATER IS TAKEN OFF BEFORE FIRE STORAGE TANK.

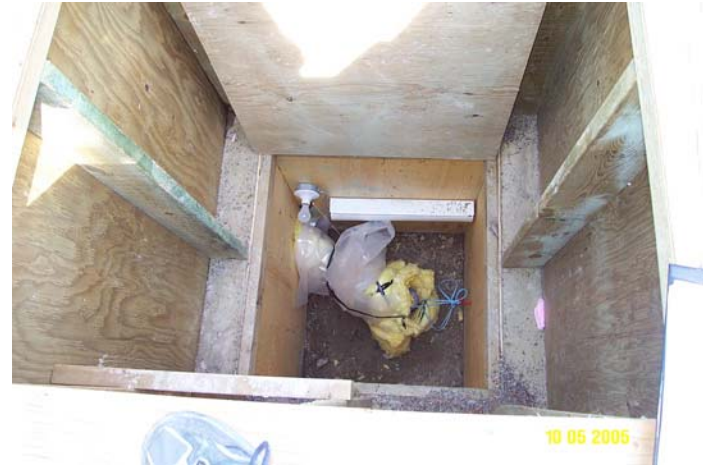
**Photo 0099:** 1950 Wellhead

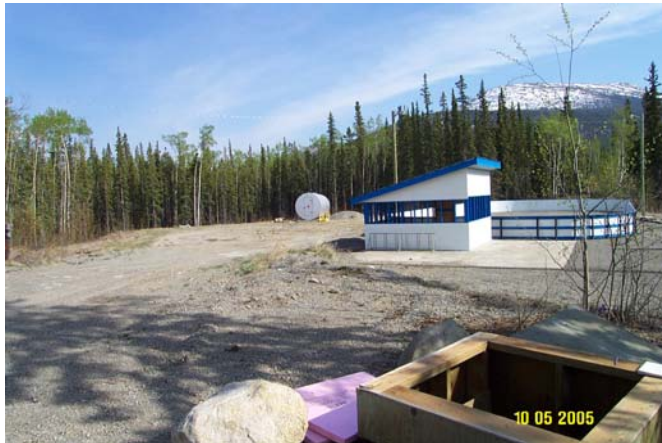
48368  
674217  
753m (16m) ← Potential Source 1: AST ; Distance from well to Potential Source 1: >60m

**Photo 0101:** 1950 Well (front), Skating Rink and Above Ground Oil Storage Tank (back)

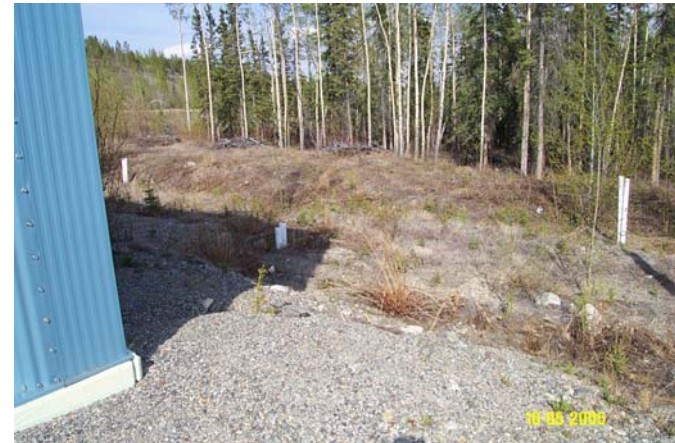
The septic tank/effluent field is down the likely water-level gradient from the well

**Photo 0102:** 1950 Septic Field

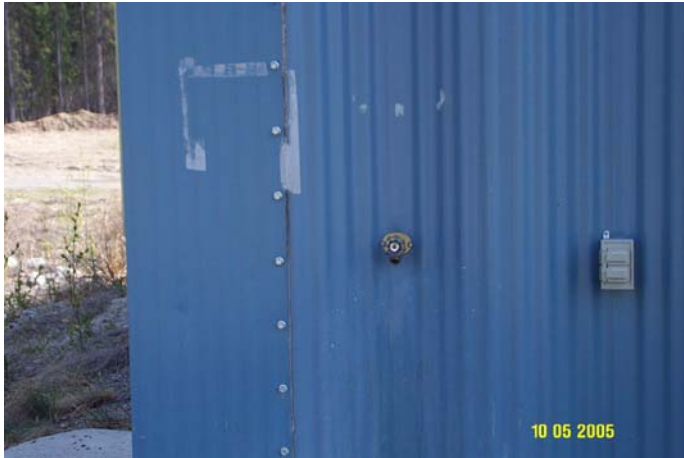
15 or more service connections to a piped distribution system? If so how many Supplies the Fire Hall however, there is an outside hose bib that the public sometimes uses

**Photo 0104:** 1950 Outside Water Tap Accessable to Public for Water Pickup

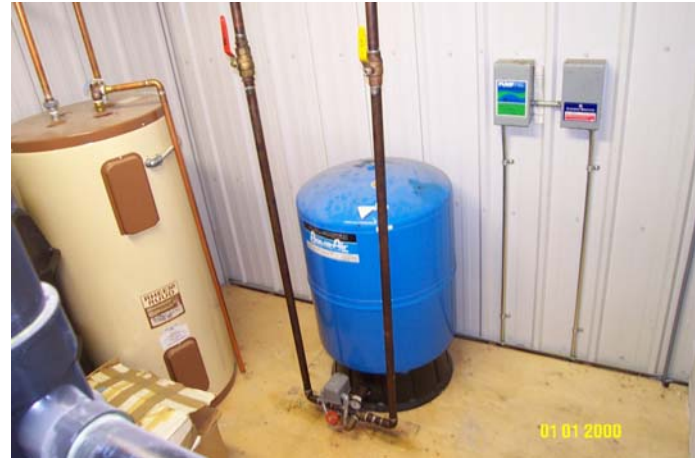
**Photo 0106:** 1950 Pressure Tank

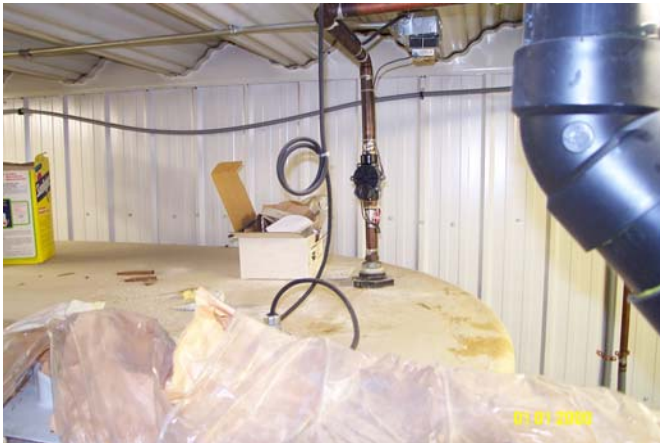
**Photo 0107:** 1950 Solenoid and Water Storage Tank

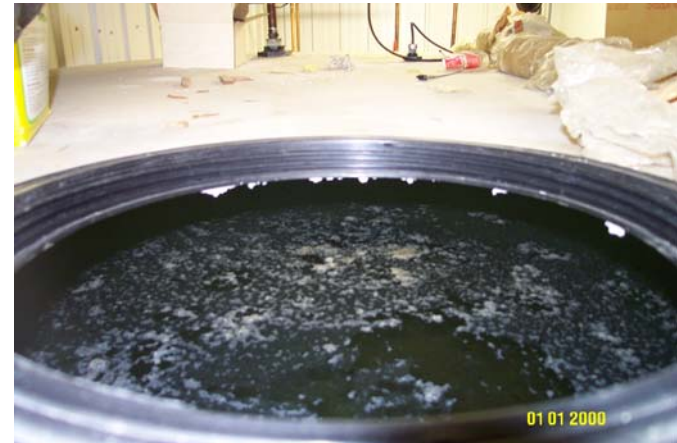
THE BASIC INSTALLATION IS GOOD. THE TANK NEEDS TO BE CLEANED.

**Photo 0105:** 1950 Scum on Surface of Well Water Storage Tank
