EBA Engineering Consultants Ltd.		PROJECT SMALL PUBLIC WATER SYSTEMS ASSESSMENT EASTERN REGION	
CLIENT

Whitehorse Region – Mount Lorne Firehall
Building # 1955

SMALL PUBLIC WATER SYSTEM ASSESSMENT

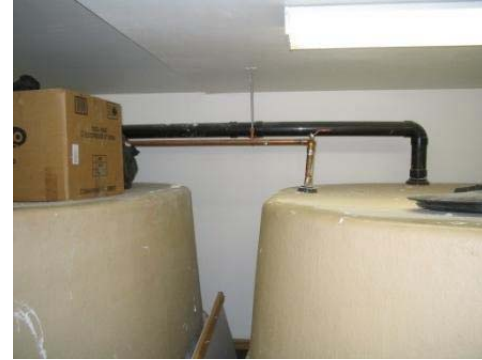
REASONABLY GOOD INSTALLATION.
TANK OVERFLOW IS ABOVE TANKS - TANKS
WILL OVERFLOW INTO BUILDING.

Photo 0021: 1955 Water Storage Tanks

INSTALL IN LINE COMMERCIAL FILTER
ON LINE FROM WELL PUMP. INSTALL
CHLORINATOR BETWEEN FILTER &
PRESSURE TANK.
LOWER OVERFLOW LINE TO TOP OF
TANK LEVEL, AND EXTEND OVERFLOW
LINE TO GROUND LEVEL. SCREEN
OVERFLOW PIPE
