SMALL PUBLIC WATER SYSTEMS ASSESSMENT
 WHITEHORSE REGION

YUKON WILDLIFE PRESERVE
 BUILDING YWP-B
 SITE LOCATION DIAGRAM
 WELL ID: YWP-B

SMALL PUBLIC WATER SYSTEM ASSESSMENT

PART A: EBA Site Inspection

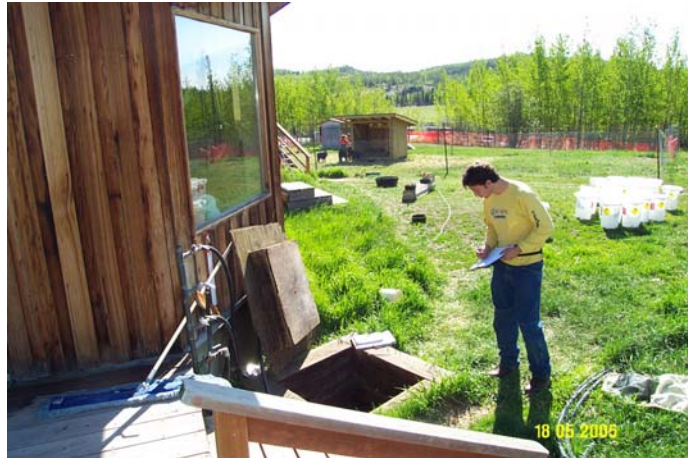
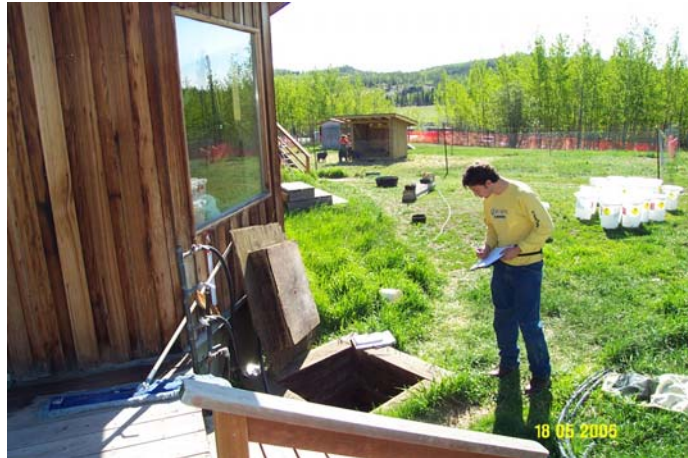
Potential Source 2: Baby Muskox pen; Distance from well to Potential Source 2: ~12m

Photo 0174: YWP-A Main Office (left), Well Head Enclosure (center) and Baby Muskox Pen (back right)

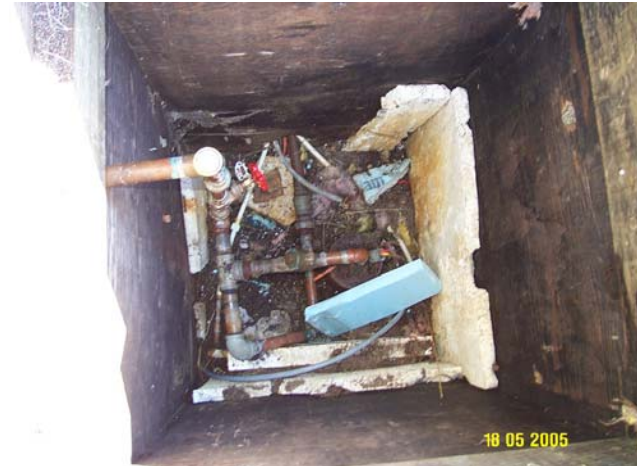
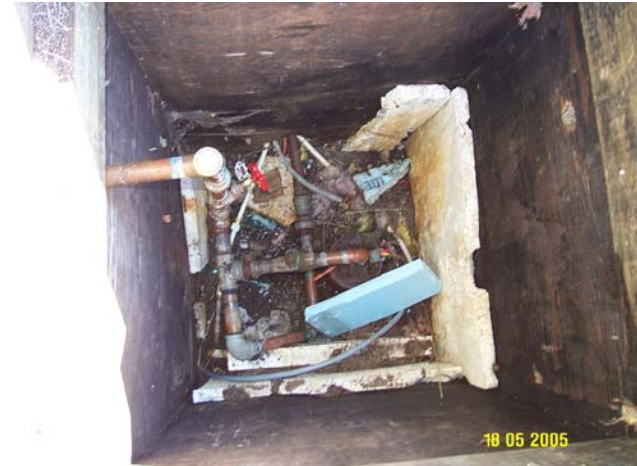
- i. Is the well head below grade? describe in detail Yes, 1.4m below grade
- ii. Are there signs of ponding on the enclosure(e.g. water stains, etc.)? Yes No
water staining and dampness
- iii. Is the wellhead enclosed by fiberglass insulations? Yes No
There is styrofoam insulation in enclosure walls and
wd. No insulation directly inside enclosure
- iv. Any evidence of rodents? Specify No evidence, access is likely
- v. Does the well casing have a proper seal cap? Yes No

Photo 0173: YWP-A Well Head

INSTALL SURFACE SEAL ON WELL, EXTEND CASING ACCORDINGLY. REPIPE THE COMPLETE SYSTEM. INSTALL SUITABLE DUPLEX WATER CONDITIONER OF APPROPRIATE SIZE FOR NEW DEMAND. INSTALL UV SYSTEM AFTER SOFTNER FOLLOWED BY AUXILIARY CHLORINATION SYSTEM FOR PROTECTION OF THE PIPING SYSTEM. INSTALL BACKFLOW PREVENTION OF APPROPRIATE SIZE.

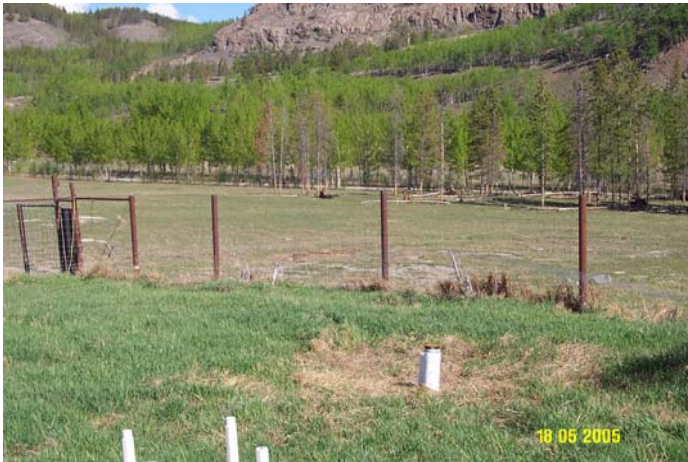
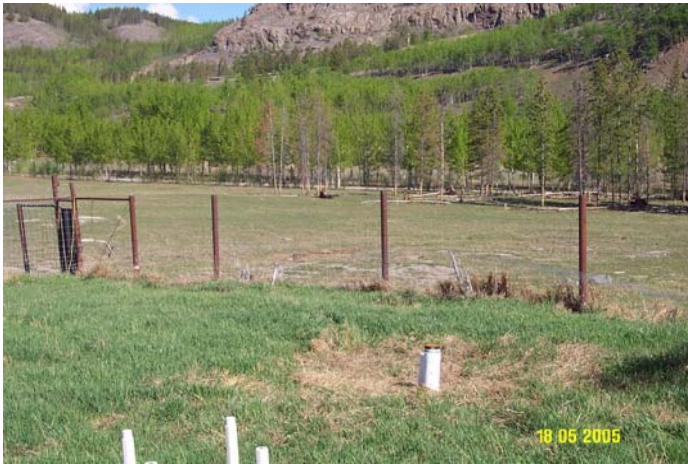
Septic tank ~20m away, downslope, septic field begins >40m away, downslope

Photo 0175: YWP-A Septic Field (front) and Muskox Pen (Back)

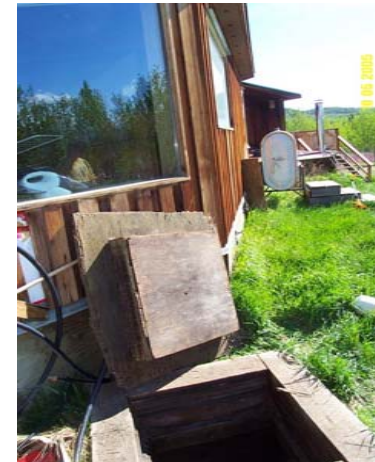
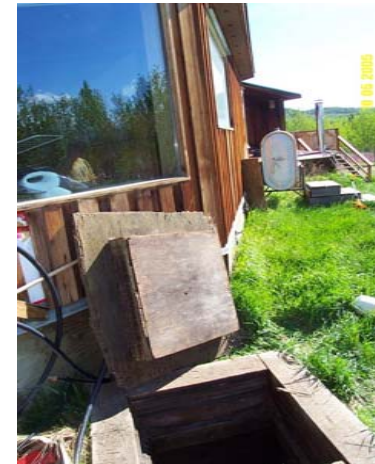
Potential Source 1: AST; Distance from well to Potential Source 1: ~6m

Photo 0178: YWP-A Well Head Enclosure (front), Main Office (left) and Above ground Fuel Storage Tank (right)

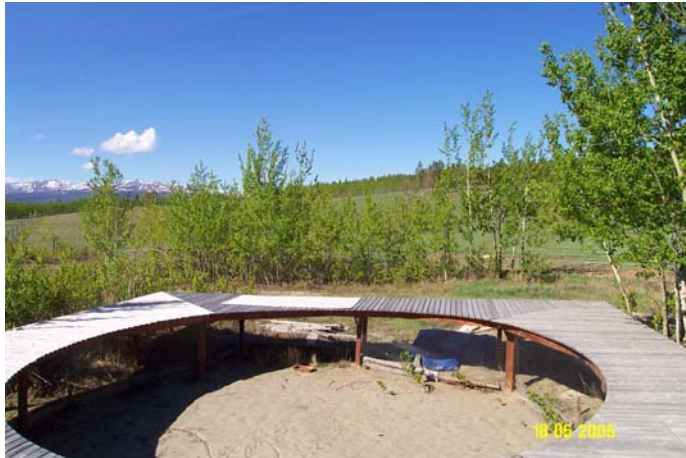
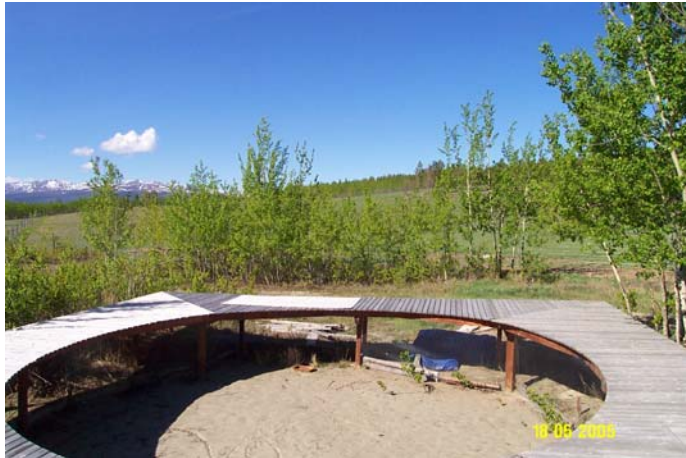
Potential Source 3: Muskox pen; Distance from well to Potential Source 3: 25m

Photo 0176: YWP-A Muskox Pen (back)

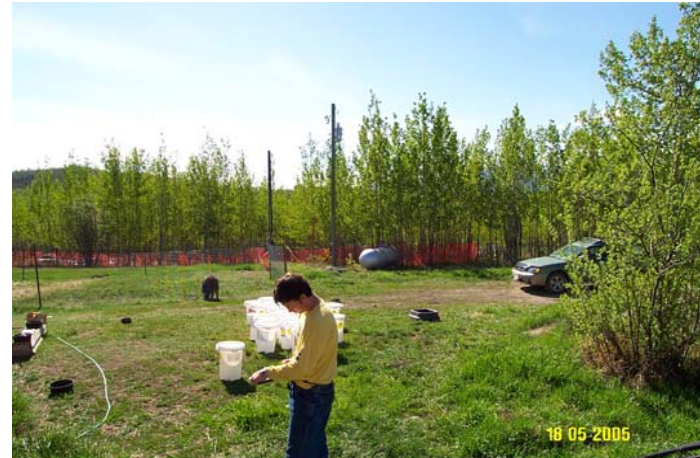
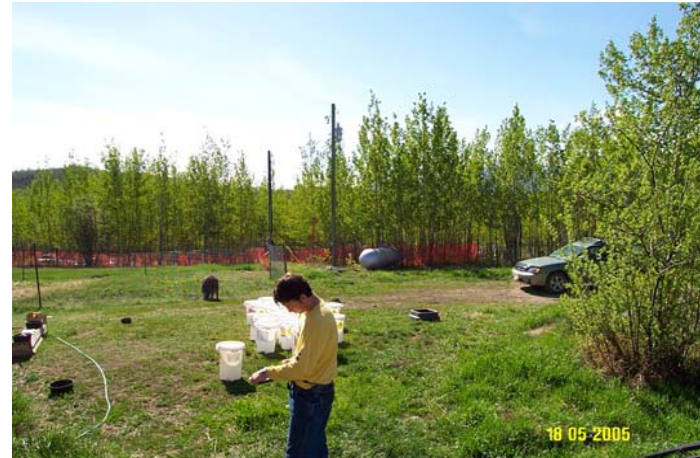
Photo 0177: YWP-A Baby Muskox Pen (left), Animal Feed Storage Area (behind)

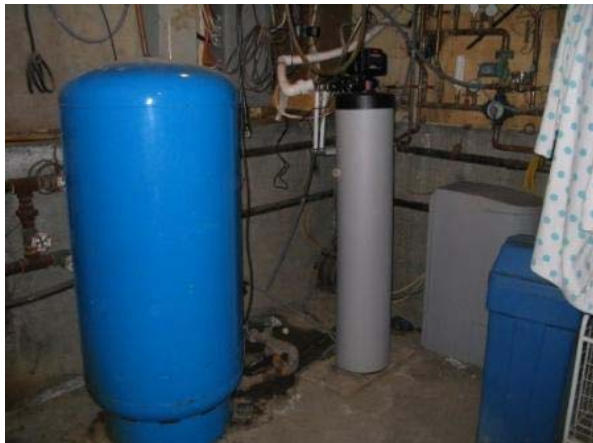
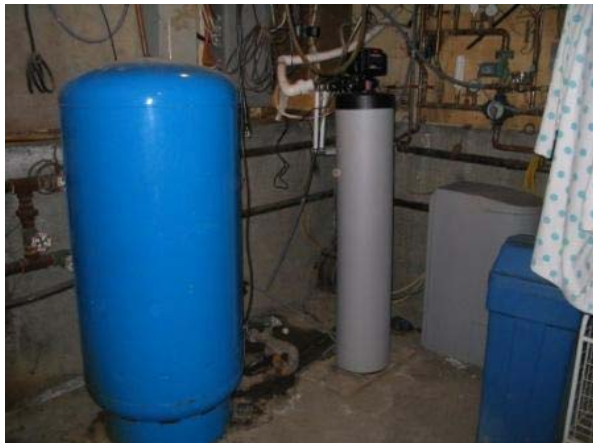
SYSTEM NEEDS TO BE COMPLETELY RE-PIPED FROM WELL TO HOUSE TIE IN. SOFTNER IS ONLY SIZED FOR 4 PEOPLE MAXIMUM. A LARGER SOFTNER WILL HAVE TO BE INSTALLED TO GET UNINTERRUPTED SOFT WATER SUPPLY.

Photo 0004: YWP-A Pressure Tank (left) and Water Softener (right)

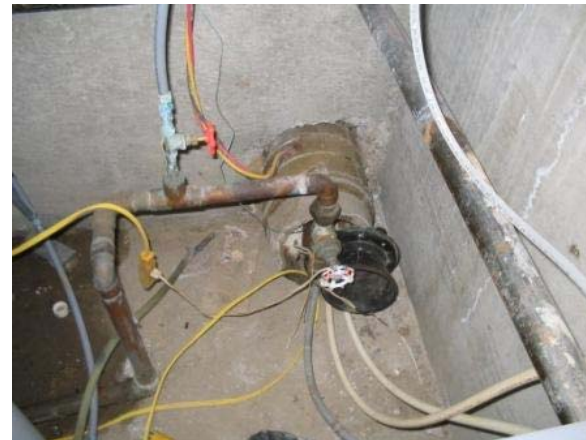
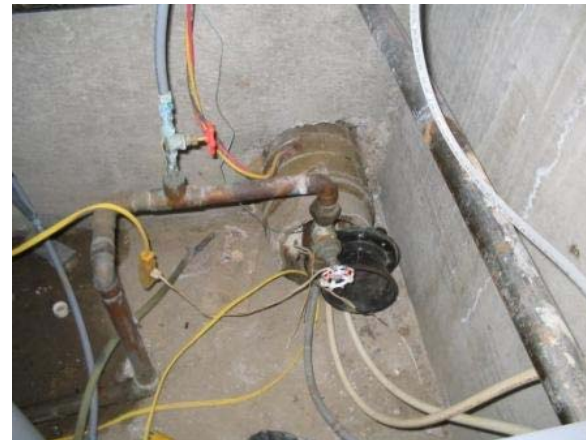
Photo 0001: YWP-A Piping in Building from Wellhead

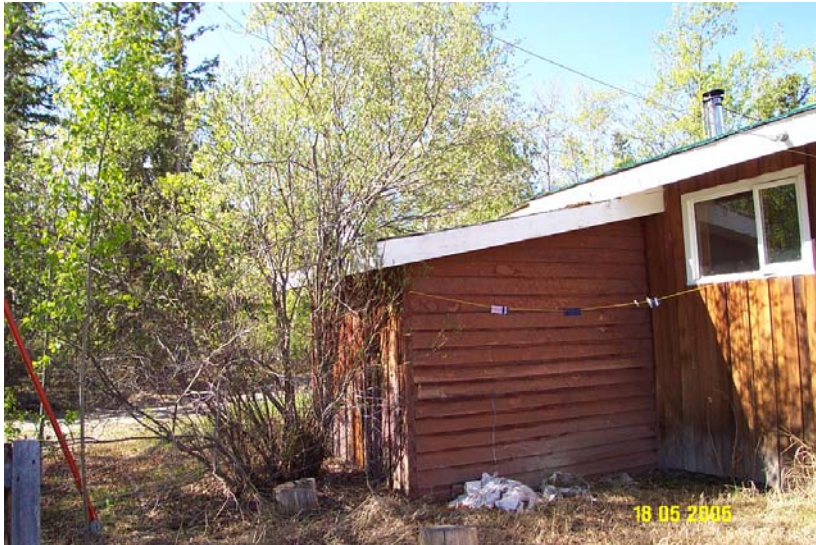
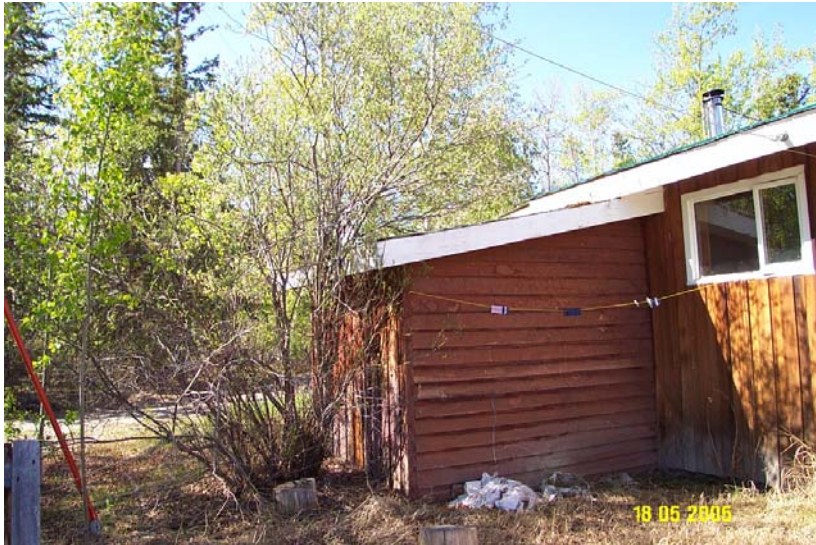
Photo 0183: YWP-B Preserve Staff Building and Well House Addition

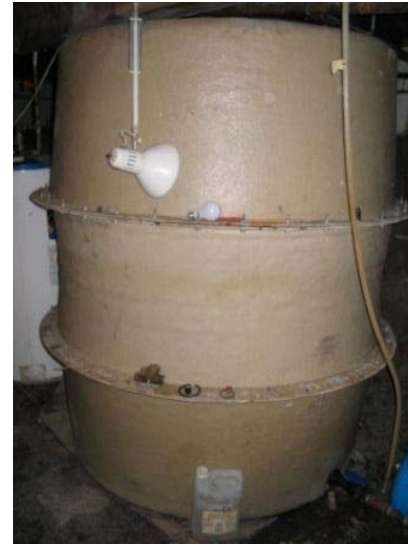
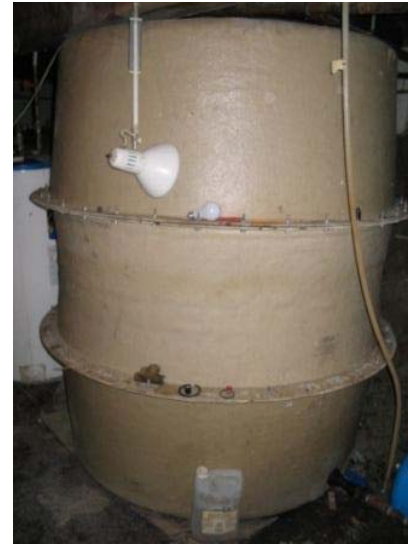
Photo 0006: YWP-B Trucked Water Storage Tank

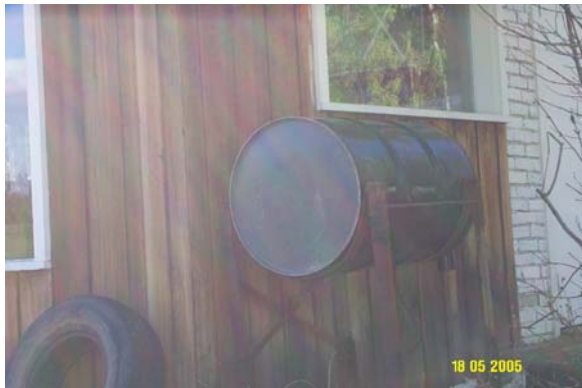
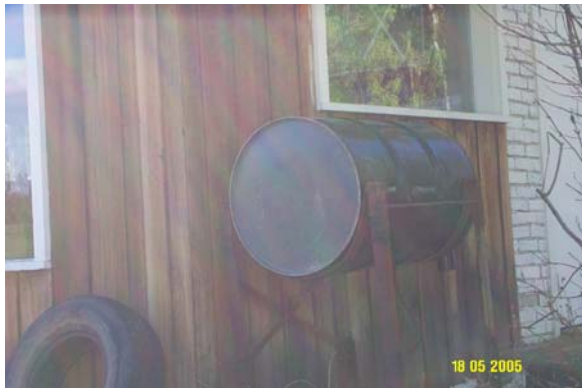
Photo 0182: YWP-B Above Ground Fuel Storage Tank

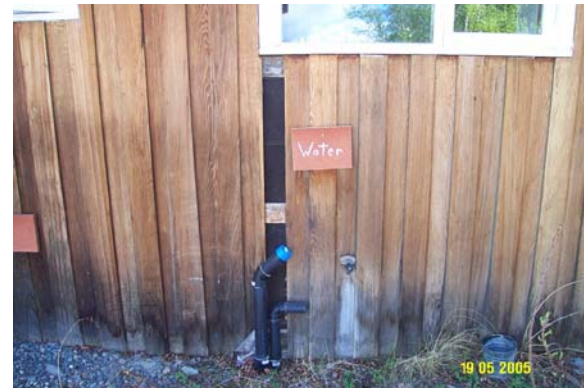
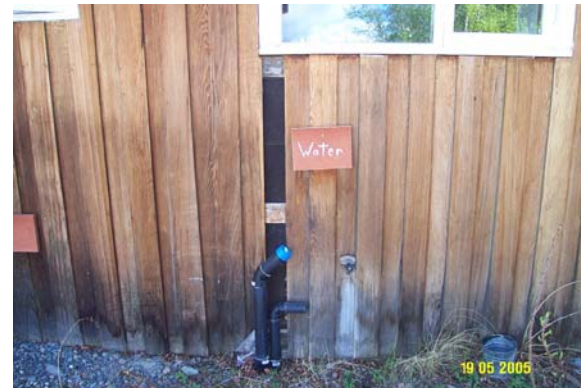
Photo 0184: YWP-B Trucked Water Intake

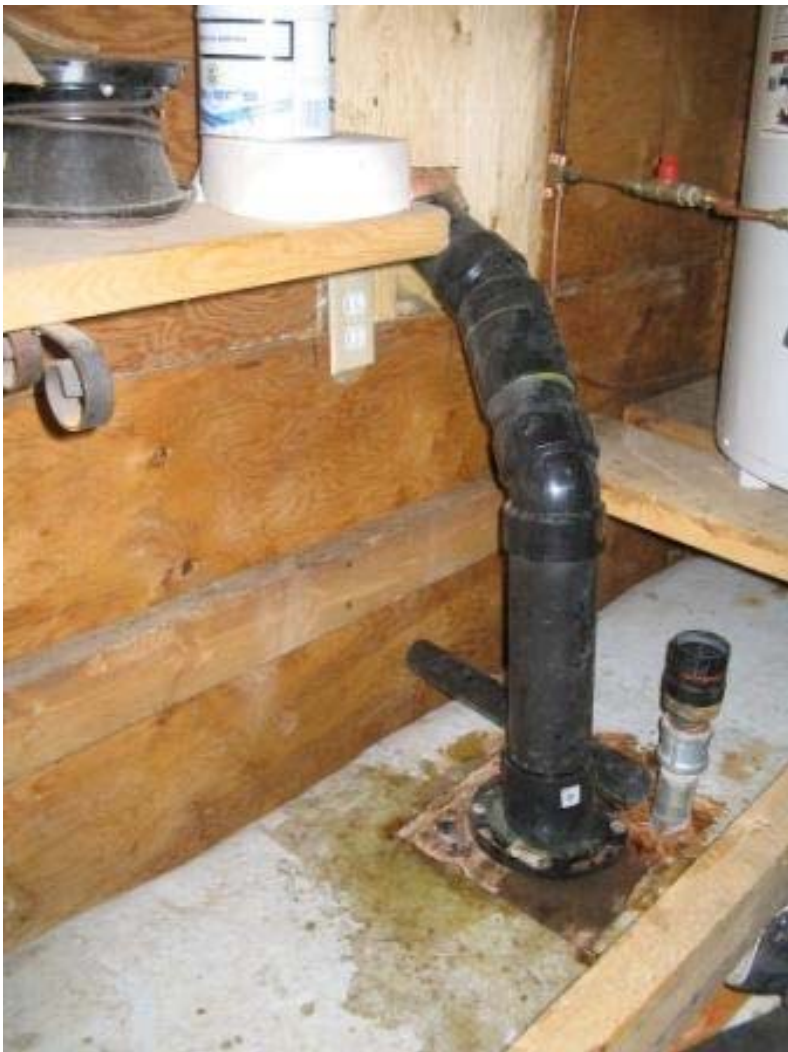
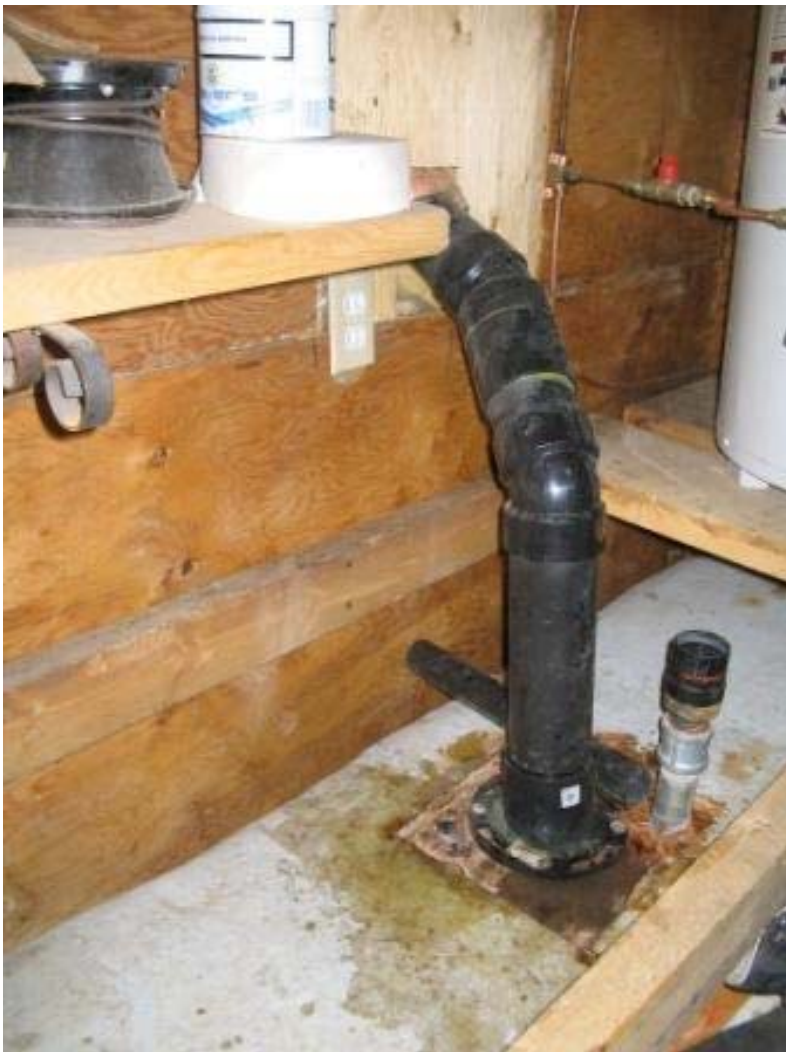
Photo 0182: YWP-D Piping

REPLACE THE COMPLETE SYSTEM, INCLUDING THE STORAGE TANK. THERE IS ADEQUATE ROOM FOR A NEW SYSTEM IN THE SHOP AREA.

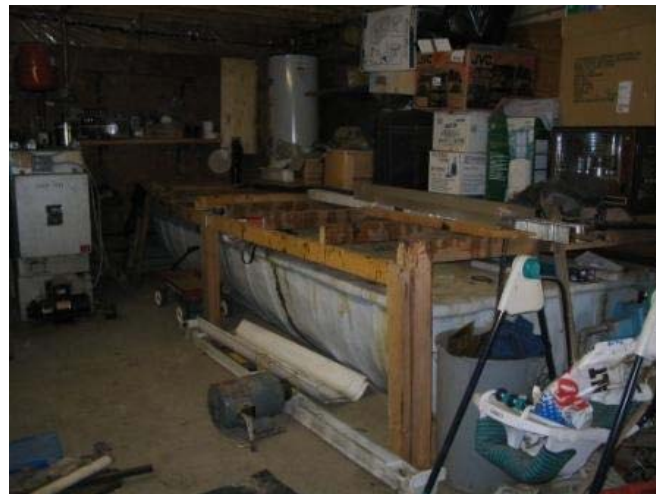
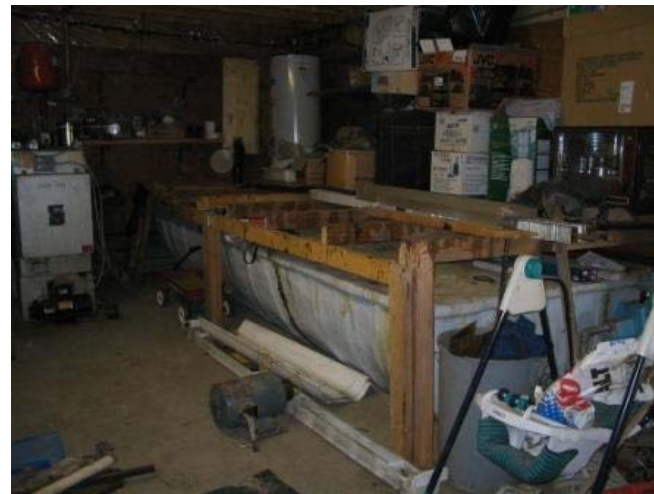
Photo 0006: YWP-D Water Storage Tank

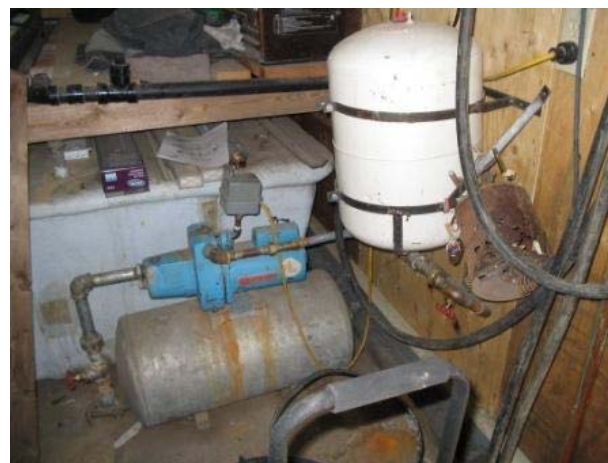
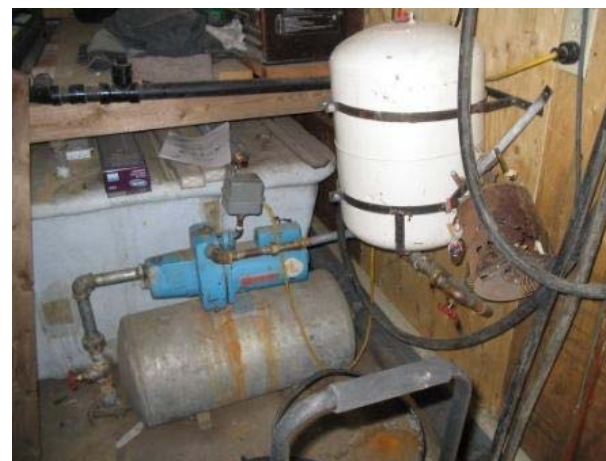
Photo 0184: YWP-D Jet Pump and Pressure Tank
