PROJECT SMALL PUBLIC WATER SYSTEMS ASSESSMENT
WHITEHORSE REGION

TITLE WATER SYSTEM DISTRIBUTION/TREATMENT SCHEMATIC SYSTEM ID.: M0093 CARMACKS RCMP DETACHMENT WELL			
DATE APRIL 2006	DWN. JSB	CHKD. RMM	FILE NO. 1260002.001	DWG.: FIGURE M0093B

Whitehorse Region – R.C.M.P. Detachment
Building # MO093

SMALL PUBLIC WATER SYSTEM ASSESSMENT

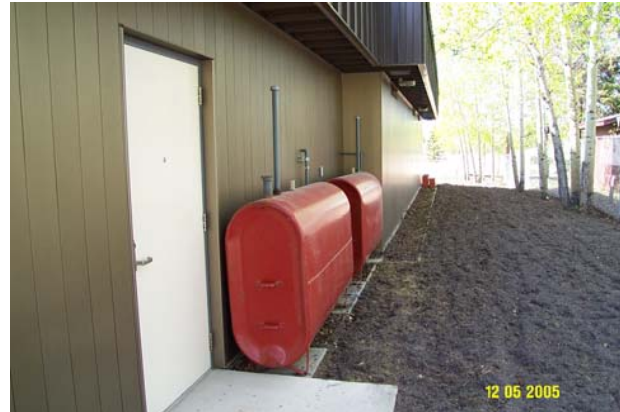
Potential Source 1: AST 1 + AST 2; Distance from well to Potential Source 1: ~9m

Photo 0146: M0093 Two Above Ground Storage Tanks

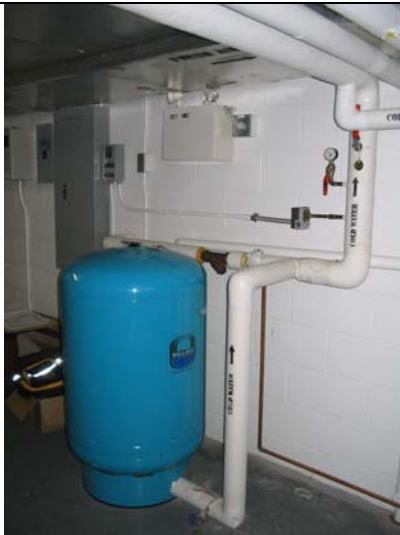
Is there a water tank? Yes No Details: *PRESSURE TANK.*

Comments: *BASEMENT.*

Photo 0008: M0093 Pressure Tank

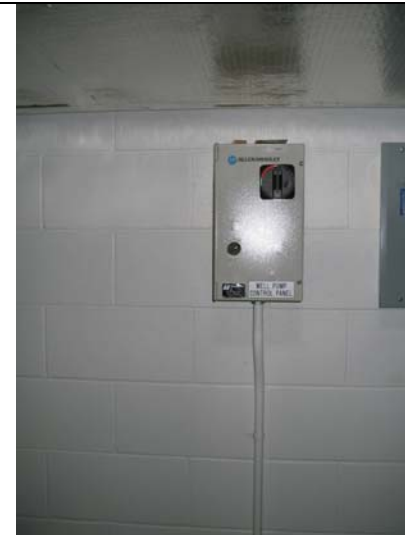
Photo 0010: M0093 Pump Control Panel
