<b>EBA Engineering Consultants Ltd.</b>	PROJECT SMALL PUBLIC WATER SYSTEMS ASSESSMENT WHITEHORSE REGION
CLIENT <div style="text-align: center; margin-top: 10px;">

TITLE WATER SYSTEM DISTRIBUTION/TREATMENT SCHEMATIC SYSTEM ID.: M0201 RCMP HOUSING	
DATE	APRIL 2006	DWN.	JSB
CHKD.	FMM	FILE NO.	1260002.001
		DWG.:	FIGURE M0201B

Whitehorse Region – R.C.M.P. Housing  
Building # MO201

## SMALL PUBLIC WATER SYSTEM ASSESSMENT

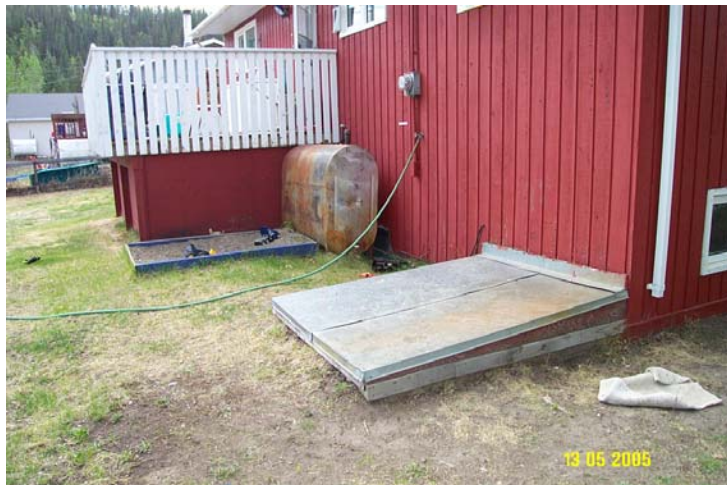
- i. Is the well head below grade? describe in detail Yes, ~0.5m below grade
- ii. Are there signs of ponding on the enclosure (e.g. water stains, etc.)?  Yes  No  
There is some wetness and water stains near and on the ground. Rusting on wellhead
- iii. Is the wellhead enclosed by fiberglass insulations?  Yes  No
- iv. Any evidence of rodents? Specify There is some evidence of mouse droppings and cobwebs
- v. Does the well casing have a proper seal cap?  Yes  No  
split seal gasket  
If no, describe condition \_\_\_\_\_

**Photo 0166:** M0201 Wellhead (front below paneling), R.C.M.P. Residence (behind) and Above Ground Storage Tank (center)

SYSTEM SHOULD BE UPGRADED WITH  
PROPER PUMP & PRESSURE TANK  
INSTALLATION. THE SOFTNER SHOULD  
BE PUT BACK IN SERVICE AND  
A UV SYSTEM SHOULD BE INSTALLED.  
THE WELL HEAD SHOULD BE UPGRADED  
TO THE NEW REGS UP COMING.

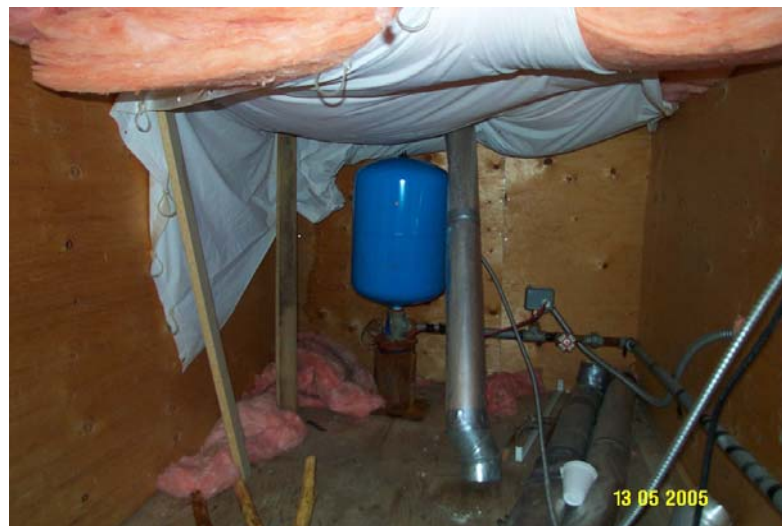
THIS SYSTEM IS A BARELY ADEQUATE SETUP.  
THE SOFTNER APPEARS TO BE NEGLECTED  
AS THERE IS NO SALT IN THE BRINE  
TANK. NO FILTRATION OR BACTERIAL  
TREATMENT IS IN PLACE. THE PUMP  
IS VERY NOISY AND MAY FAIL SOON

**Photo 0167:** M0201 Wellhead and Pressure Tank
