SMALL PUBLIC WATER SYSTEMS ASSESSMENT
 WHITEHORSE REGION

TANTALUS SCHOOL
 BUILDING 6511
 SITE LOCATION DIAGRAM
 WELL ID: 6511

**Whitehorse Region – Tantalus School
Building # 6511**

SMALL PUBLIC WATER SYSTEM ASSESSMENT

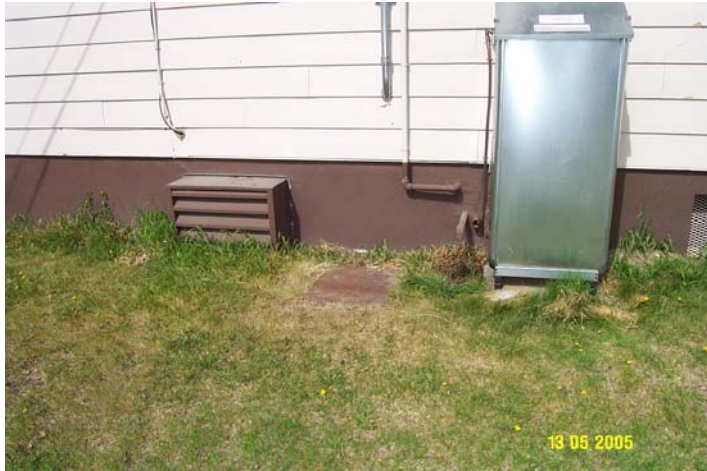
Potential Source 1: AST; Distance from well to Potential Source 1: ~1m

Photo 0162: 6511-A Main School Wellhead (underneath panel at center) and Above Ground Fuel Storage Tank (right)

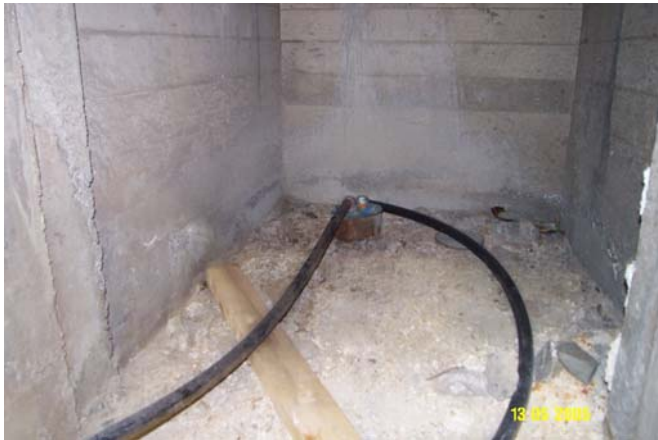
- i. Is the well head below grade? describe in detail The well head is 1.6m below grade
- ii. Are there signs of ponding on the enclosure(e.g. water stains, etc.)? Yes No
- iii. Is the wellhead enclosed by fiberglass insulations? Yes No
- iv. Any evidence of rodents? Specify no apparent evidence
- v. Does the well casing have a proper seal cap? Yes No

THE INSTALLATION MUST BE UPGRADED.
THE WELL HEAD MUST BE SEALED BETTER.
A DUPLEX PUMP SYSTEM FOR CONTINUOUS
WATER SUPPLY MUST BE PROVIDED.

Photo 0160: 6511-A Wellhead

INSTALL A NEW DUPLEX WATER SUPPLY.
INSTALL FILTRATION AND PROPORTIONATE
CHLORINATION SYSTEM. CHECK THE
FILTER SYSTEM AND UP GRADE
AS NECESSARY.

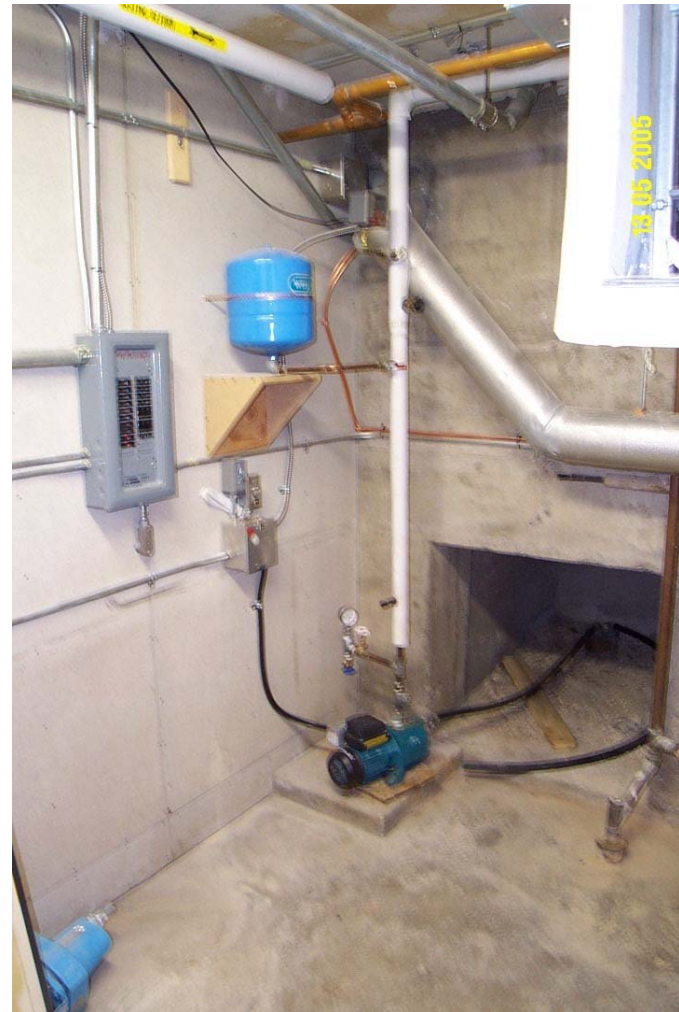
i. Is there provision for taking water samples before water reaches storage? Yes No
Although these raw sample are filthy, Deep Brown coloration to the water due to sagrant pipe

Photo 0161: 6511-A Jet Pump and Pressure Tank

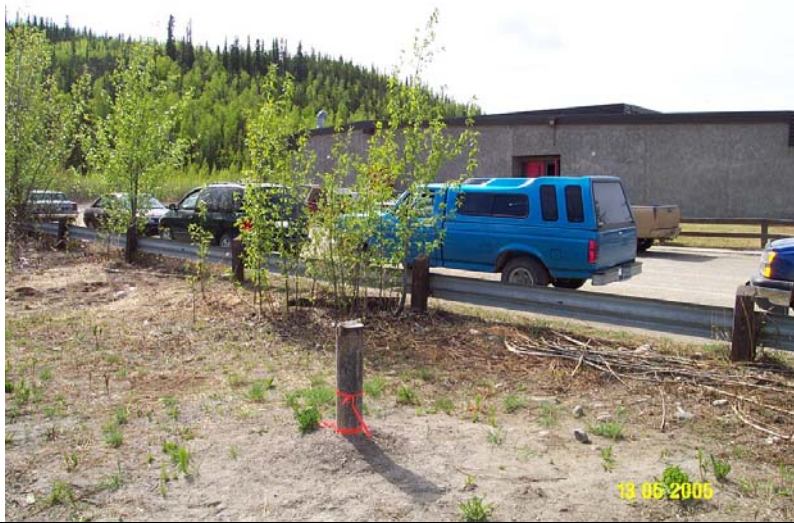
Photo 0159: 6511-C New Well Wellhead

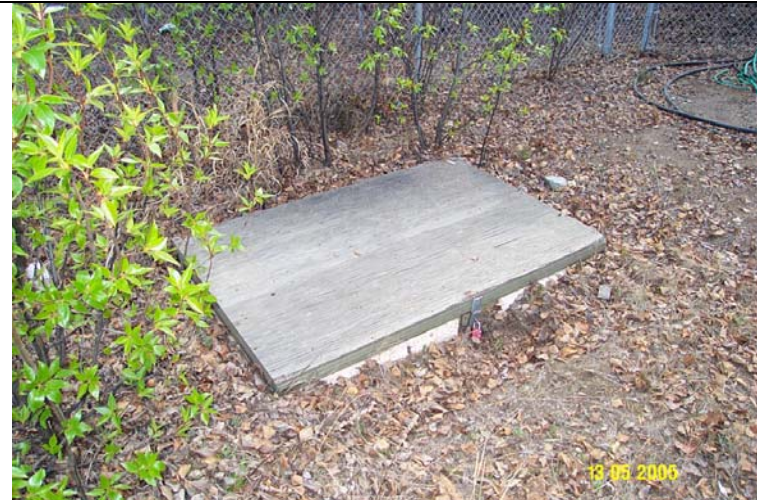
Photo 0158: 6511-C Irrigation Well Wellhead
