SMALL PUBLIC WATER SYSTEMS ASSESSMENT
 WHITEHORSE REGION

GOVERNMENT OF YUKON
 HIGHWAYS & PUBLIC WORKS
 CARMACKS GRADER STATION
 BUILDING 6912
 SITE LOCATION DIAGRAM
 WELL ID: 6912

SMALL PUBLIC WATER SYSTEM ASSESSMENT

WELL ID #	Owner	Location Description
6512	YTS	Carmacks Grader Station

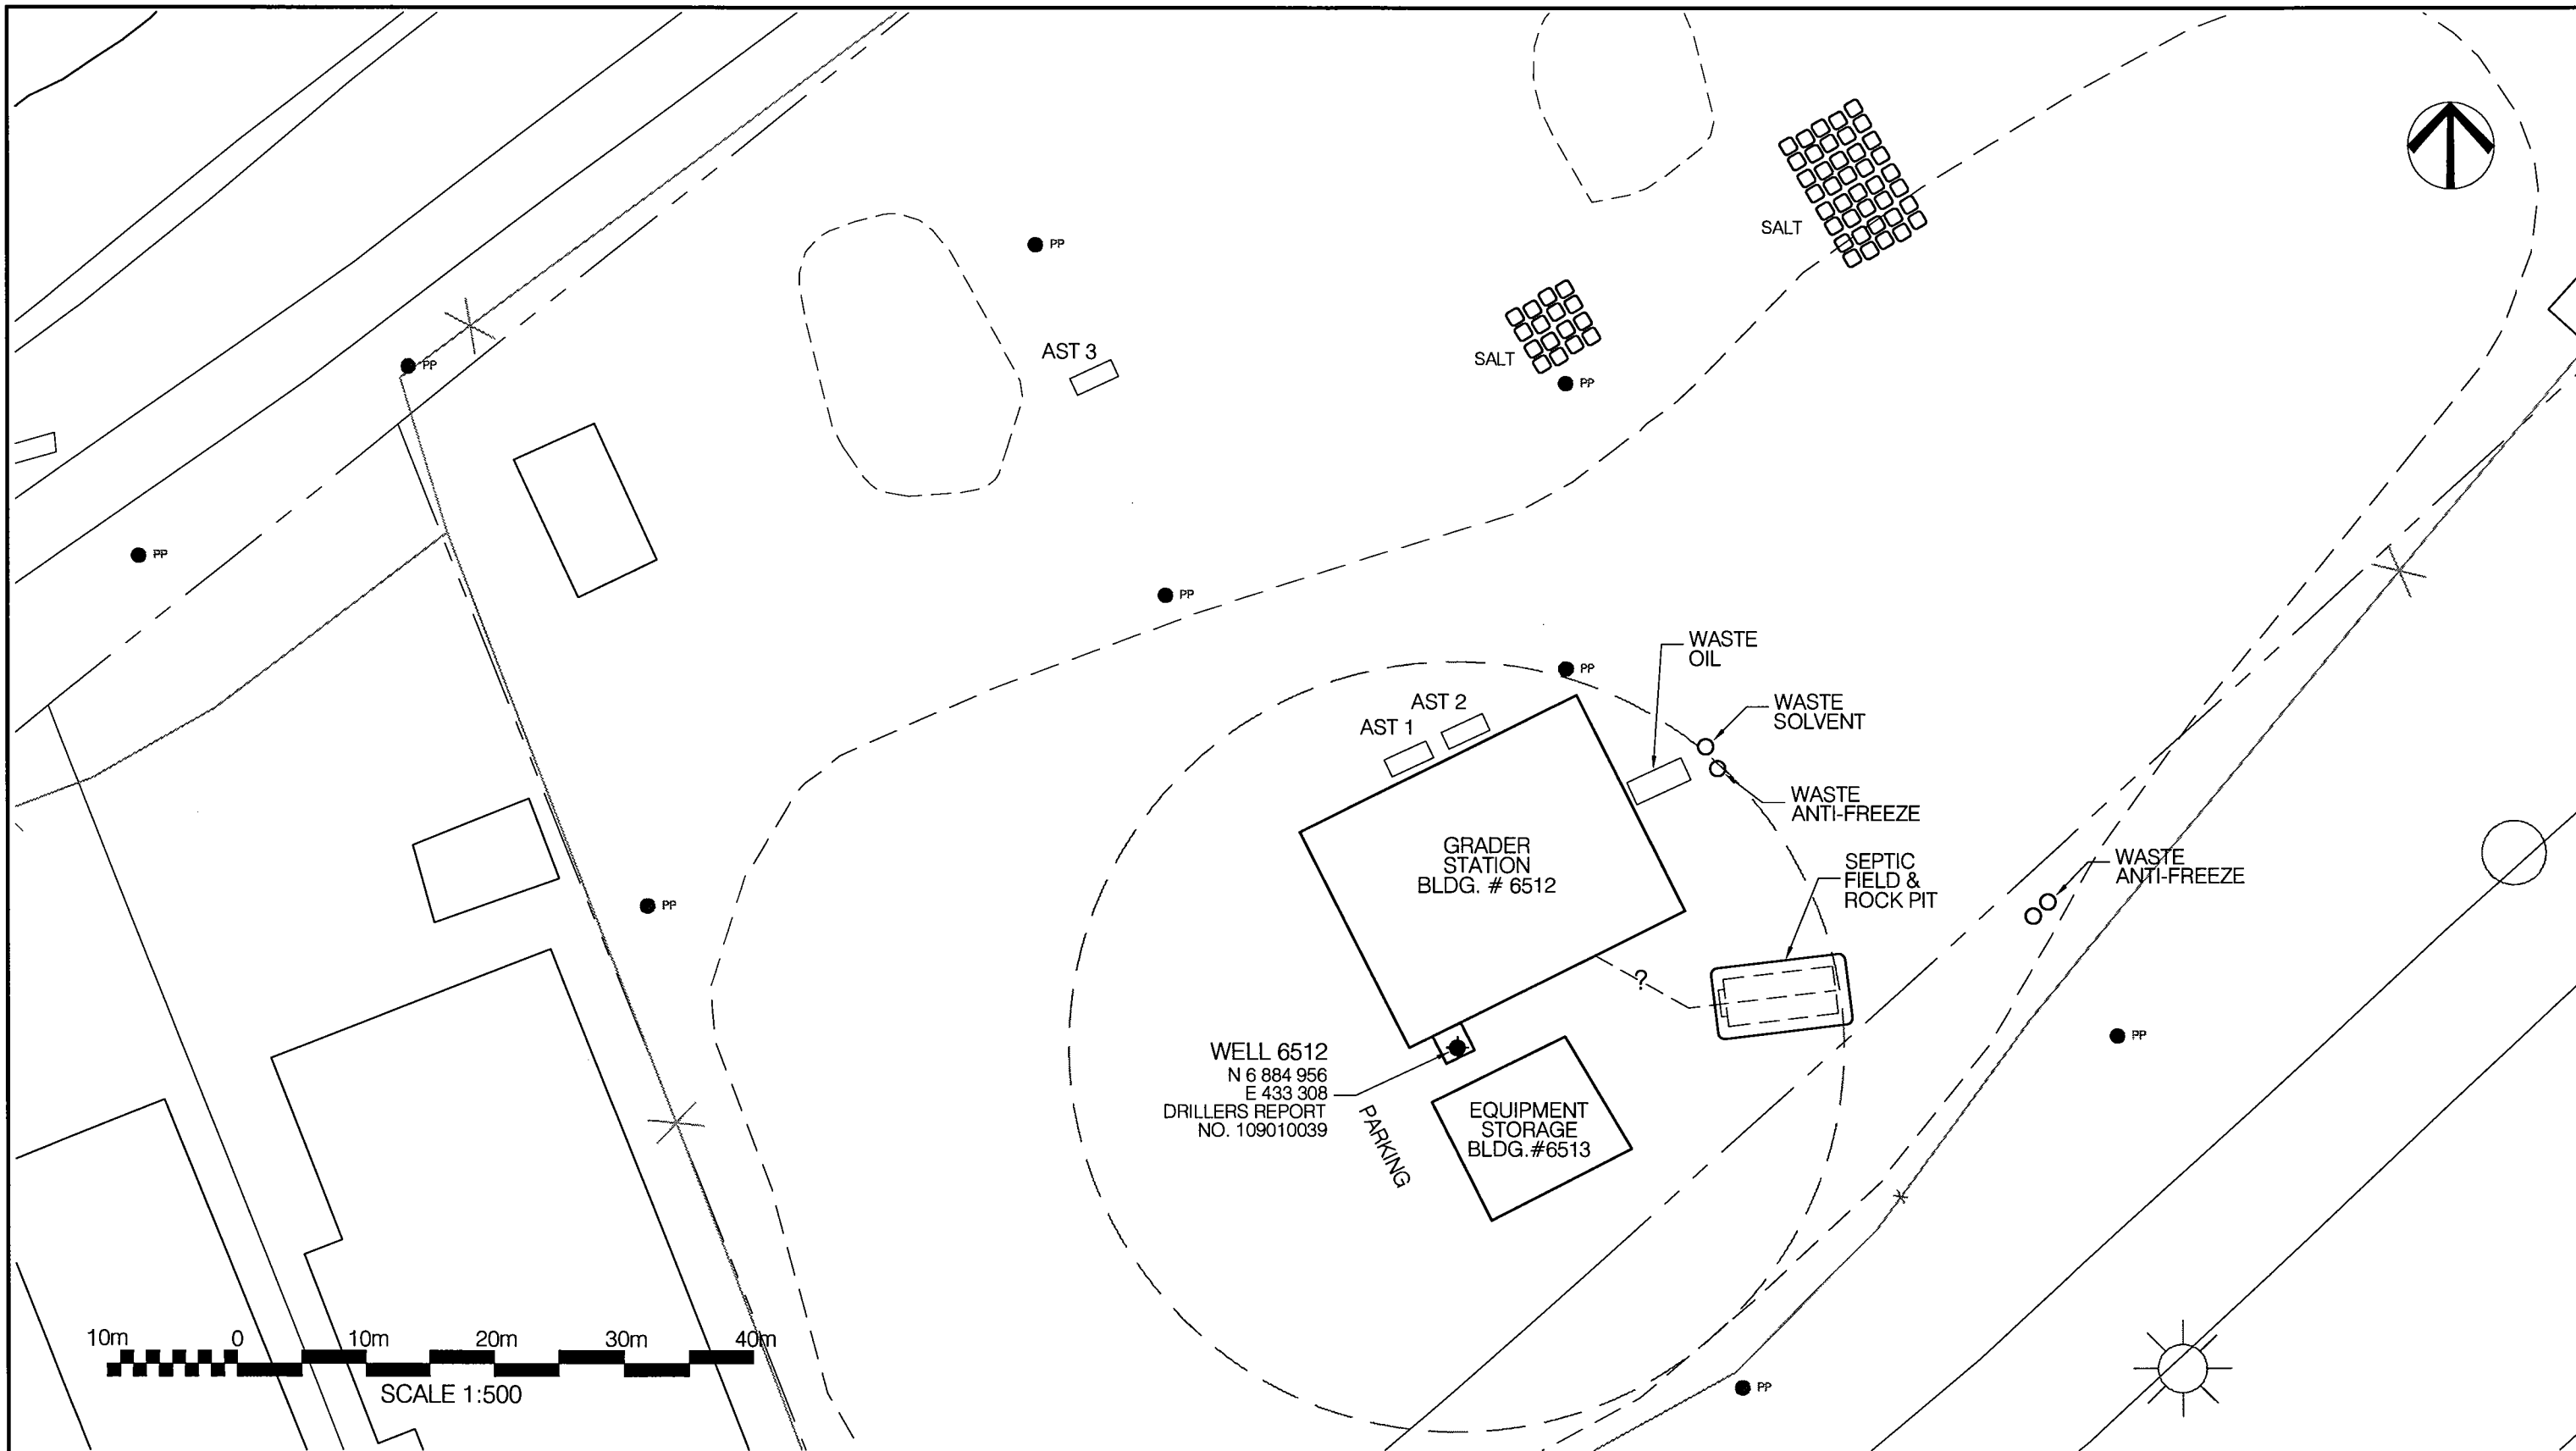
REVISION ISSUE
 0
 DRAWING No.
 FIGURE 6512A

30 m RADIUS FROM WATER WELL FOR CONSIDERATION OF PROXIMITY TO POTENTIAL CONTAMINANT SOURCES.

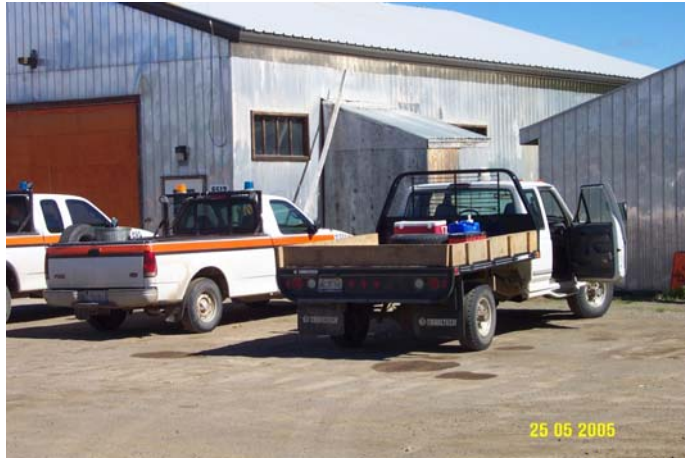
No Some evidence of mouse droppings. Entrance can be easily gained by animals. There are spaces between the walls of the wellhouse and dike and the grader station, as well as cracks in the cement floor

Photo 0196: 6512 Carmacks Grader Station and Well house Addition (back), Parking (front)

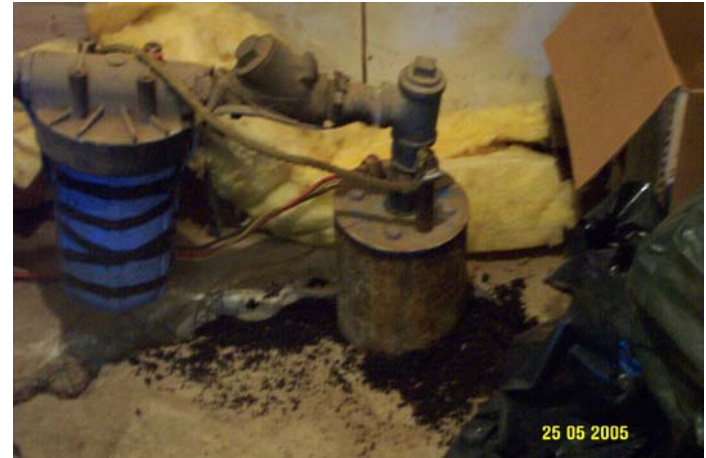
- i. Is the well head below grade? describe in detail No ~ 0.3 m above grade
- ii. Are there signs of ponding on the enclosure(e.g. water stains, etc.)? Yes No
- iii. Is the wellhead enclosed by fiberglass insulations? Yes No
The well is inside ~~semi~~ insulated addition, there are however major cracks in concrete floor and spaces between addition and grader str walls
- iv. Any evidence of rodents? Specify Access is possible, some mouse droppings
- v. Does the well casing have a proper seal cap? Yes No
split seal cap
If no, describe condition _____

Comments: CONCRETE CRACKED AROUND WELL CASING, FILLED WITH COLD MIX (PAVEMENT)

Photo 0197: 6512 Wellhead (center) and Filter (left)

- ① REPAIR CRACKS IN CONCRETE FLOOR IN WELL HOUSE.
- ② RAISE CASING - CASING IS ONLY 7" ABOVE WELL HOUSE FLOOR AND IS APP. 13" ABOVE FLOOR OF SHOP.
- ③ TO CLEAN WELL (REDEVELOP) YOU WOULD HAVE TO REMOVE ROOF OR REMOVE THE WHOLE ADD ON WELL ROOM BUILDING, IN ORDER TO GET EQUIPMENT OVER HOLE.

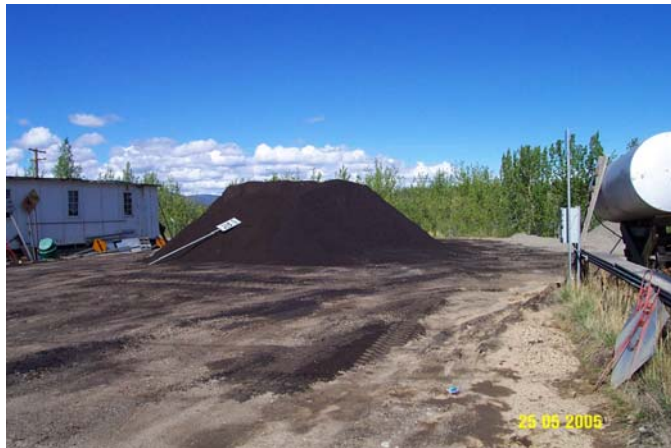
Photo 0200: 6512 Ash Fault Pile
