SMALL PUBLIC WATER SYSTEMS ASSESSMENT
WHITEHORSE REGION

CARMACKS FORESTRY CREW QUARTERS
BUILDING 6536
SITE LOCATION DIAGRAM
WELL ID: 6536

SMALL PUBLIC WATER SYSTEM ASSESSMENT

PART A: EBA Site Inspection

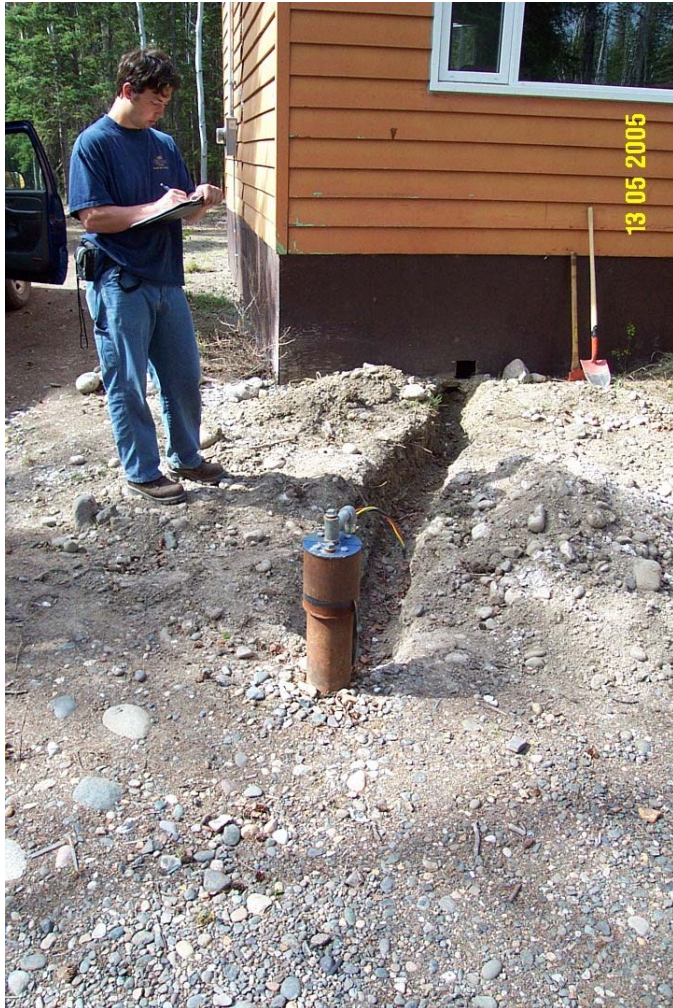
The well head is outside at the front of the crew quarters

The well is directly outside

Photo 0163: 6536 Wellhead (front) and Forestry Crew Quarters (back)

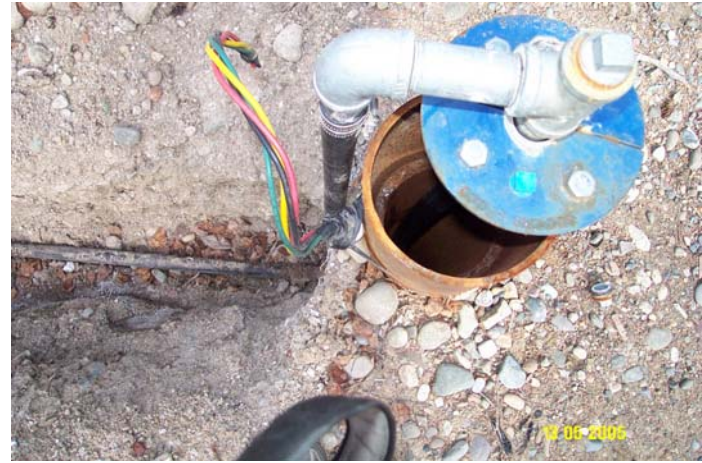
- i. Is the well head below grade? describe in detail no, well is 0.5m above grade
- ii. Are there signs of ponding on the enclosure(e.g. water stains, etc.)? Yes No
There is no enclosure
- iii. Is the wellhead enclosed by fiberglass insulations? Yes No
- iv. Any evidence of rodents? Specify Likely, the well is outside
- v. Does the well casing have a proper seal cap? Yes No
If no, describe condition split cap gasket

k. Is the pump and piping protected from freezing? Yes No
The well is directly outside with no head trace, no insulation, no encasing. The well appears to be under construction.
If yes, describe: _____

Photo 0164: 6536 Wellhead

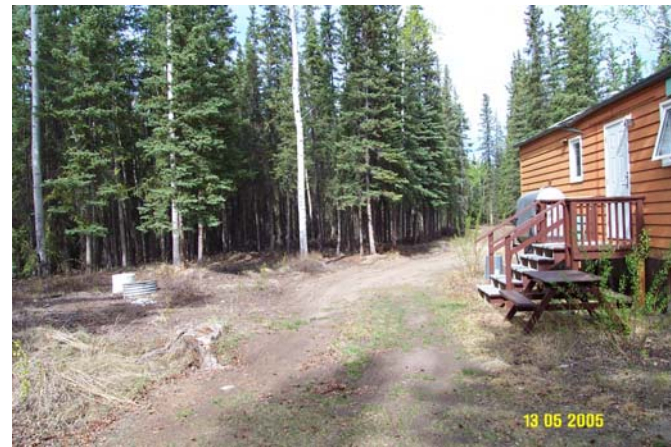
septic is ~ 20m from the well

Photo 0165: 6536 Septic Field (left) and Forestry Crew Quarters (right)
