SMALL PUBLIC WATER SYSTEMS ASSESSMENT
 WHITEHORSE REGION

CARMACKS FORESTRY OFFICE
 BUILDING 6542
 SITE LOCATION DIAGRAM
 WELL ID: 6542

Whitehorse Region – District Office
Building # 6542

SMALL PUBLIC WATER SYSTEM ASSESSMENT

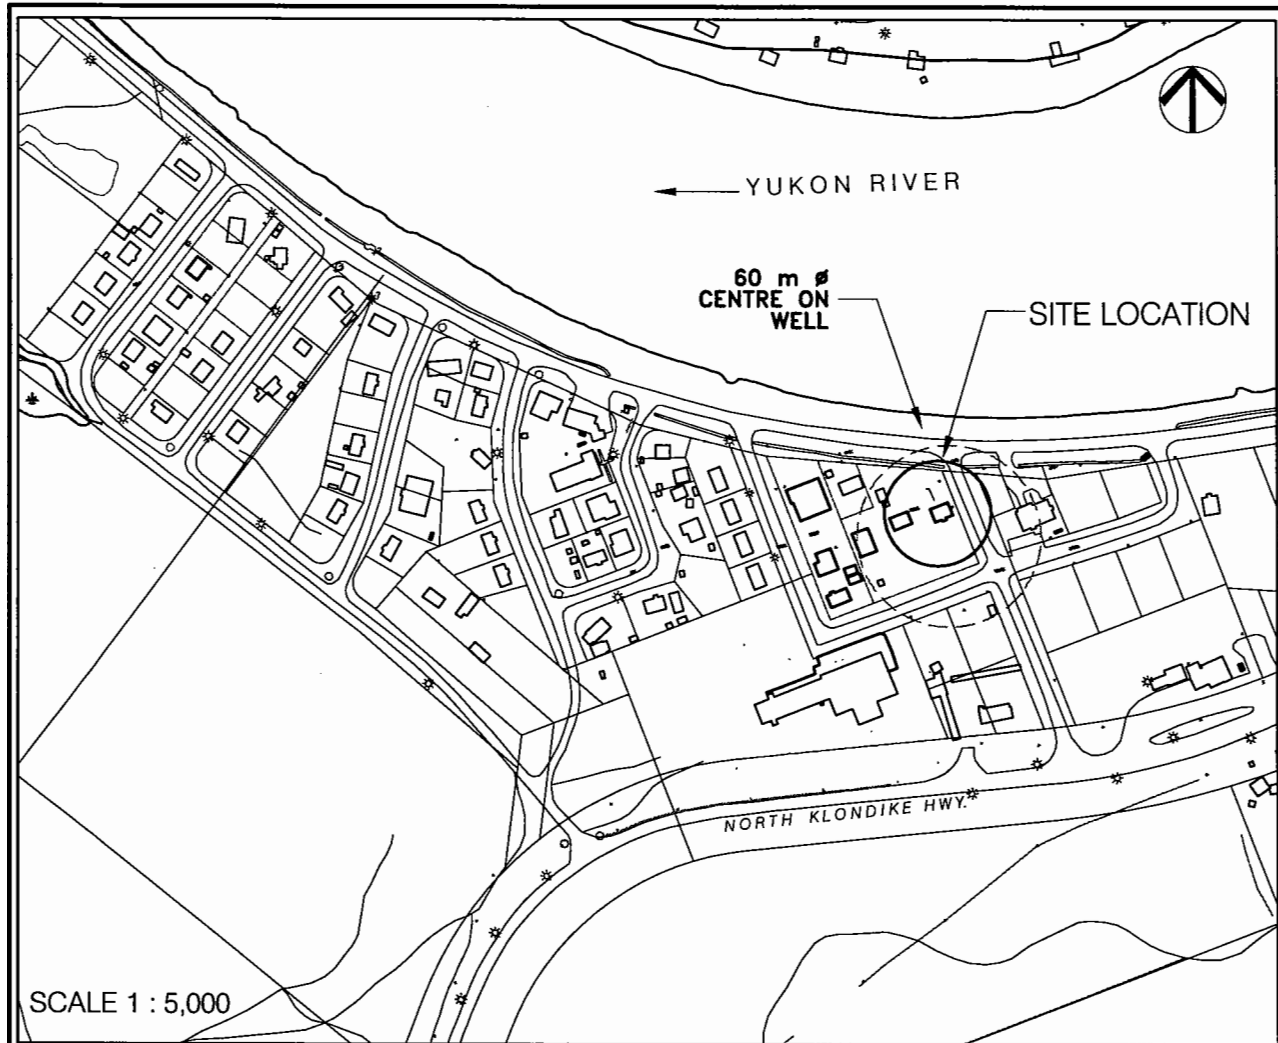
REVISION	ISSUE
0	0
DRAWING No.	
FIGURE 6542A

○ 30 m RADIUS FROM WATER WELL FOR CONSIDERATION OF PROXIMITY TO POTENTIAL CONTAMINANT SOURCES.

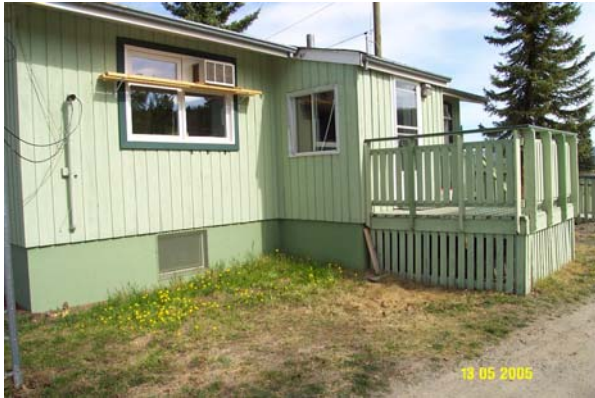
Photo 0155: 6542 Forestry District Office (wellhead located inside underneath)

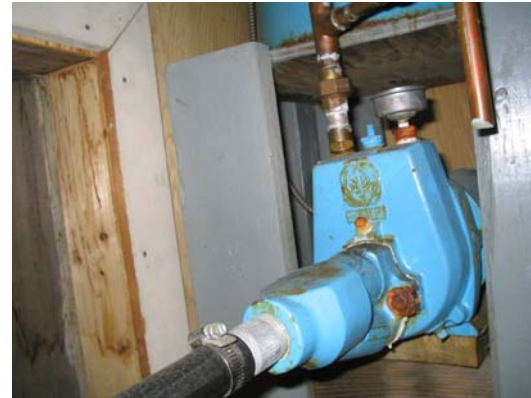
THIS SYSTEM IS TOTALLY OBSOLETE. THE EQUIPMENT IS 20 YEARS +, THE WELL IS NOT ACCESSIBLE FOR SERVICING.

Photo 0023: 6542 Jet Pump

DRILL A NEW WELL AND REPLACE THE WATER SYSTEM TO SUIT NEW REGS.

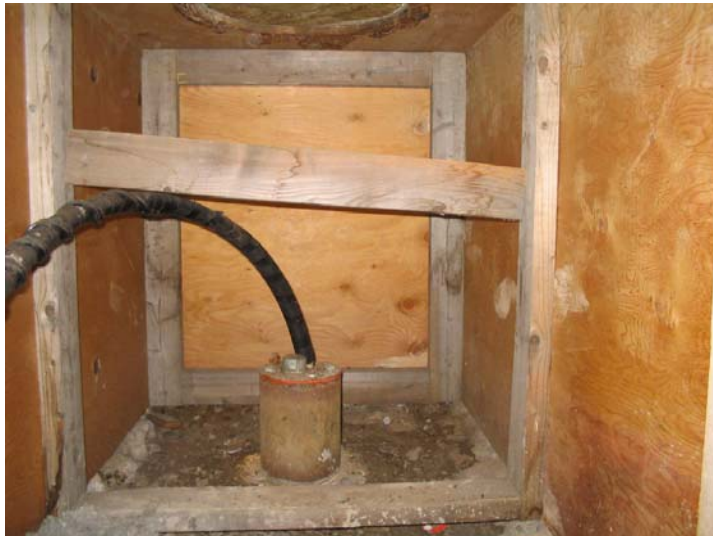
- i. Is the well head below grade? describe in detail AT PERMANENT 4 FT BELOW
- ii. Are there signs of ponding on the enclosure(e.g. water stains, etc.)? Yes No
- iii. Is the wellhead enclosed by fiberglass insulations? Yes No
- iv. Any evidence of rodents? Specify No
- v. Does the well casing have a proper seal cap? Yes No

k. Is the pump and piping protected from freezing? Yes No
The well is located in the basement of a heated building, however there is no insulation or heat trace on the piping or well
If yes, describe: well

Photo 0020: 6542 Wellhead

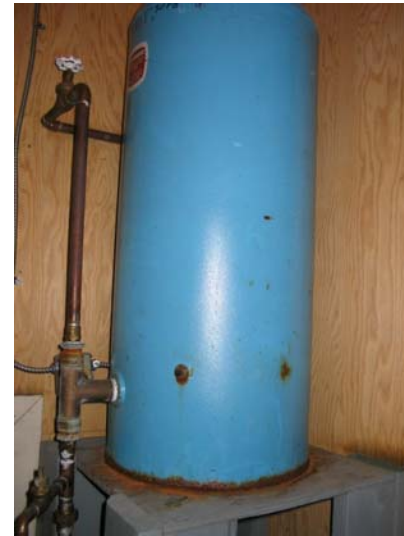
Is there a water tank? Yes No Details: *PRESSURE TANK 30FG*

Where is it located?
Comments: *BASEMENT*

Photo 0022: 6542 Pressure Tank
