PROJECT SMALL PUBLIC WATER SYSTEMS ASSESSMENT  
WHITEHORSE REGION

TITLE WATER SYSTEM DISTRIBUTION/TREATMENT SCHEMATIC SYSTEM ID.: 6975 CARMACKS HEALTH CENTRE	
DATE	APRIL 2006	DWN.	JSB
CHKD.	FMM	FILE NO.	1260002.001
		DWG.:	FIGURE 6975B

## SMALL PUBLIC WATER SYSTEM ASSESSMENT

### PART A: EBA Site Inspection

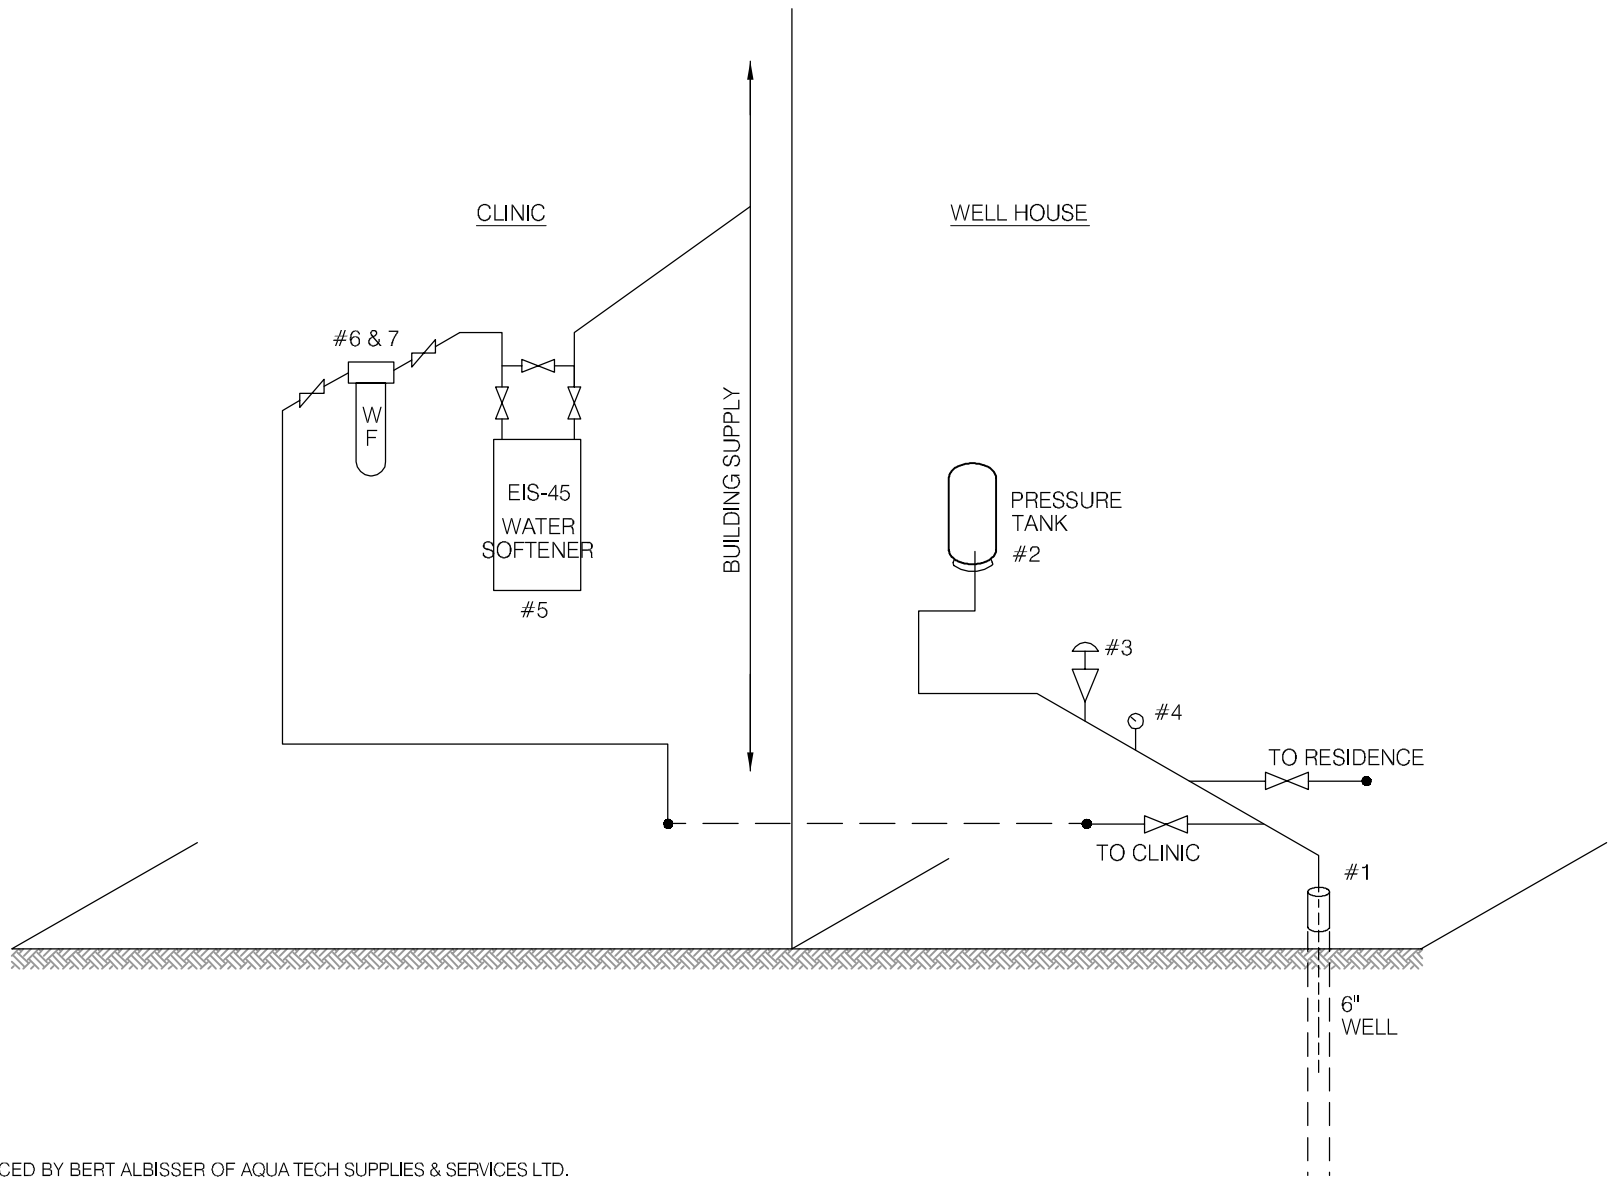
SCHEMATIC PRODUCED BY BERT ALBISSER OF AQUA TECH SUPPLIES & SERVICES LTD.

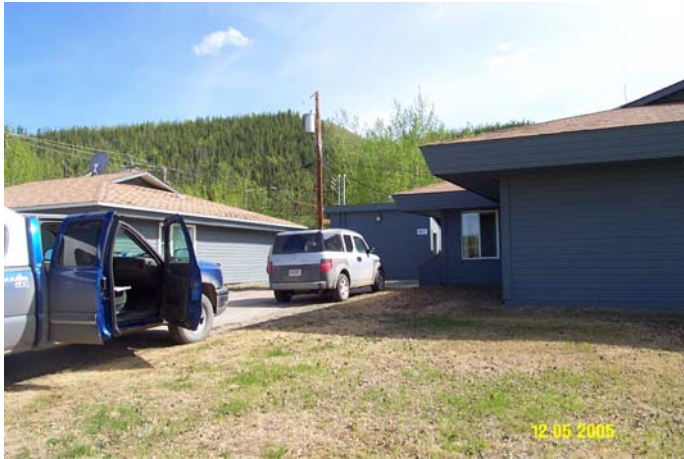
**Photo 0137:** 6975 Health Center (right), Wellhouse (center) and Nursing Residence (left)

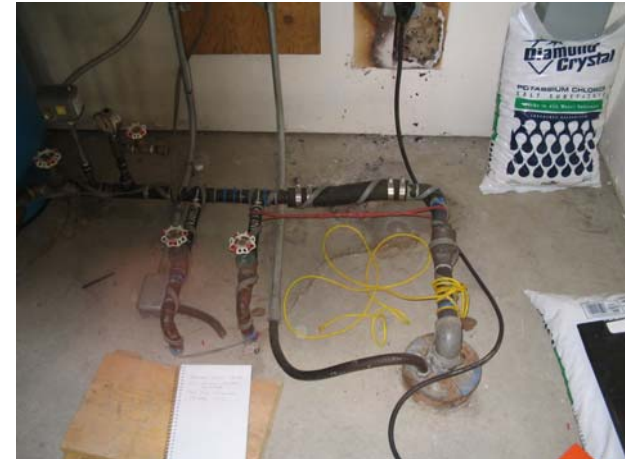
- f. Well casing: Diameter 15cm Material:  steel  plastic  concrete  
and rope (?) split casing, There is an open hole for heat trace
- \*g. Depth of well: 17.68m  measured (if possible)  reported  from log

- i. Is the well head below grade? describe in detail no; it is 6cm above grade
- ii. Are there signs of ponding on the enclosure(e.g. water stains, etc.)?  Yes  No  
well area seems very clean
- iii. Is the wellhead enclosed by fiberglass insulations?  Yes  No  
The well head is within a heated, insulated building
- iv. Any evidence of rodents? Specify no evidence of rodents
- v. Does the well casing have a proper seal cap?  Yes  No

**Photo 0002:** 6975 Wellhead

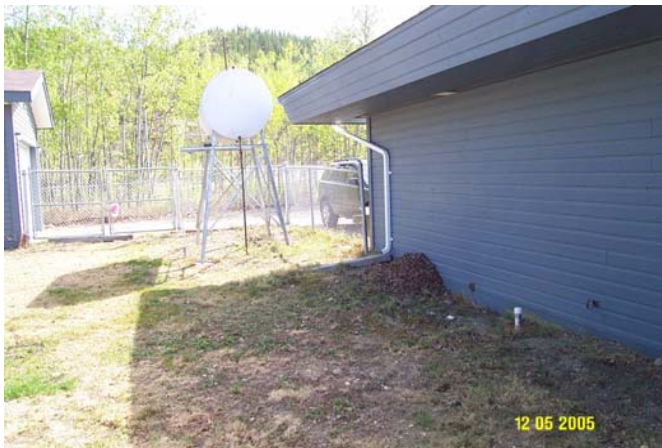
q. Is there a buried fuel tank on the property?  Yes  No unlikely  
There is, however, a buried fuel line that has leaked hydrocarbons and contaminated the soil ~ 6m from the well & see report - contaminated soil was relocated

There was a leak from the AST in the line running to the station. Some soil contamination

**Photo 0138:** 6975 Above Ground Fuel Storage Tank and Hydrocarbon Spill Site

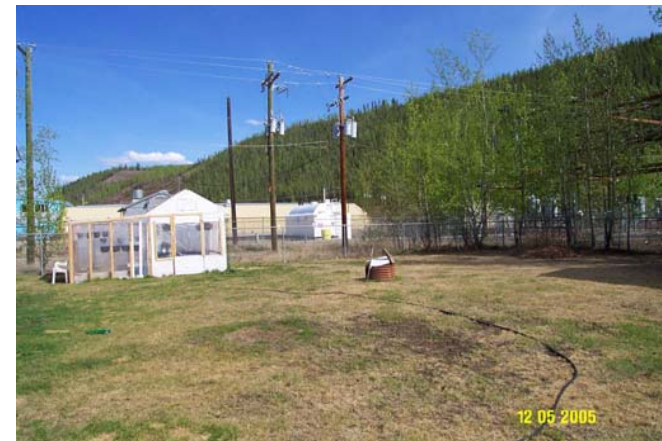
**Photo 0139:** Substation and Above Ground Fuel Storage Tank (back)

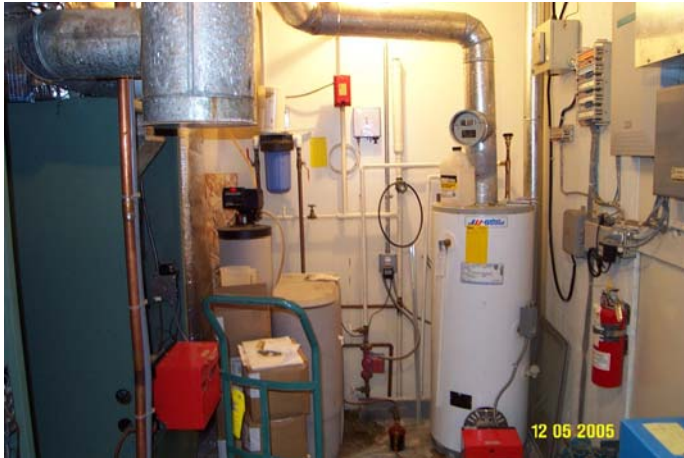
**Photo 0142:** 6975 Health Center Water Treatment System

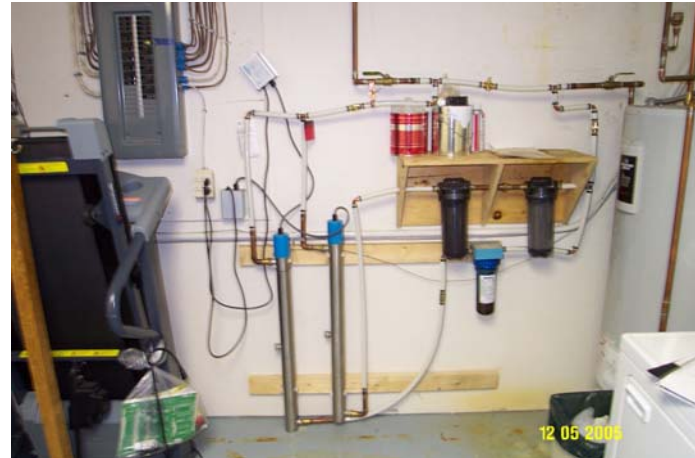
UV SYSTEM INSTALLATION REQUIRES ATTENTION. THE TWO UV REACTORS DO NOT HAVE FLOW RESTRICTORS INSTALLED TO ASSURE FULL UV EXPOSURE, NO UV MONITOR IS PRESENT TO MEASURE UV STRENGTH. THE PIPING FEEDING THE REACTORS PROMOTES UNEVEN FLOW DISTRIBUTION AGGRAVATING THE ABOVE PROBLEM.

**Photo 0143:** 6975 Nursing Residence Water Treatment System

RENEW THE PIPING SYSTEM. INSTALL ONE FILTER SYSTEM TO HANDLE THE FULL FLOW. INSTALL UV MONITORS ON BOTH REACTORS ALONG WITH THE APPROPRIATE FLOW RESTRICTORS.  
INSTALL PRETREATMENT IF REQUIRED  
THIS SYSTEM IS AN ACCIDENT WAITING TO HAPPEN.

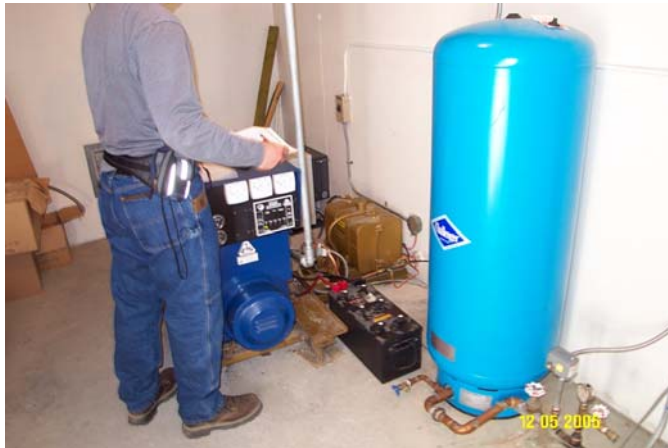
**Photo 0141:** 6975 Pressure Tank (right) and Backup Electrical Generator

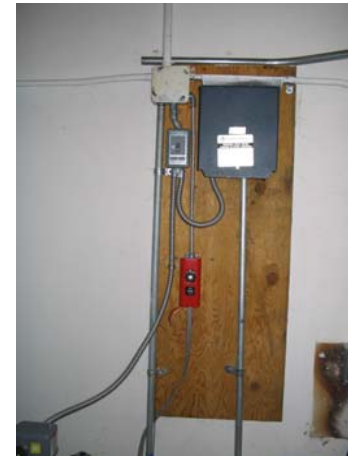
**Photo 0001:** 6975 Pump Control Box
