EBA Engineering Consultants Ltd.	PROJECT ADDITIONAL ASSESSMENT EASTERN REGION			
CLIENT

TITLE WATER SYSTEM DISTRIBUTION/TREATMENT SCHEMATIC SYSTEM ID.: 1131 CARCROSS SEARCH & RESCUE BUILDING			
DATE APRIL 2006	DWN. JSB	CHKD. RMM	FILE NO. 1260002.005	DWG.: FIGURE 1131-B

**Whitehorse Region – Carcross Search and Rescue
Building # 1131**

SMALL PUBLIC WATER SYSTEM ASSESSMENT

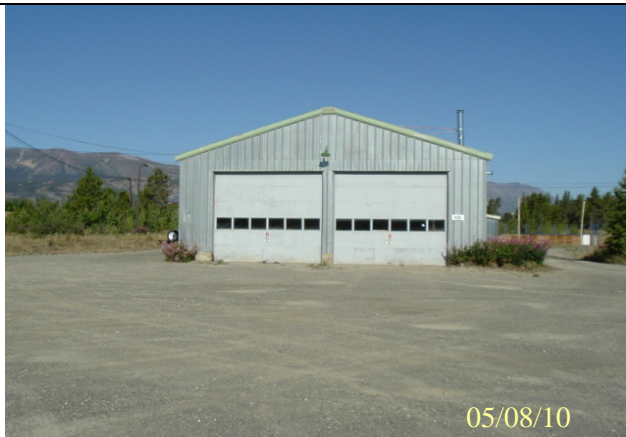
Photo 029: 1131 Carcross search and rescue building (former grader station).
