PROJECT SMALL PUBLIC WATER SYSTEMS ASSESSMENT
WHITEHORSE REGION

TITLE WATER SYSTEM DISTRIBUTION/TREATMENT SCHEMATIC SYSTEM ID.: 1134 CARCROSS SCHOOL	
DATE	APRIL 2006	DWN.	JSB
CHKD.	FMM	FILE NO.	1260002.001
		DWG.:	FIGURE 1134B

Whitehorse Region – Carcross School
Building # 1134

SMALL PUBLIC WATER SYSTEM ASSESSMENT

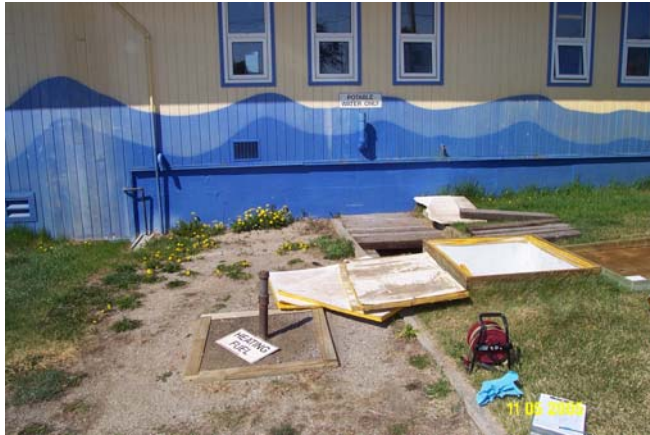
Photo 0115: 1134 Wells 1 and 2, Water Fill, Underground Fuel Storage Tank

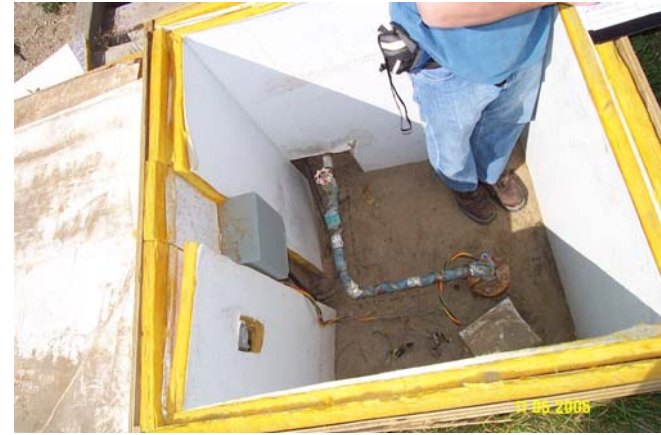
If no, describe condition both have split seal gasket caps, though
rusty, W2 has 2 missing bottom plates
and may not be properly sealed.

Photo 0120: 1134 Well 2 Well Head in Pit

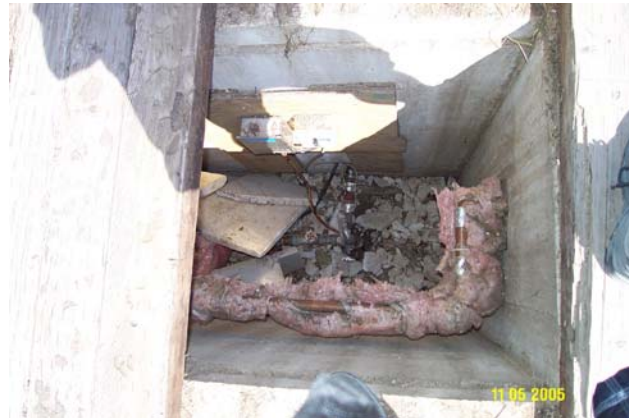
- i. Is the well head below grade? describe in detail Yes W1 180cm, W2 84cm
- ii. Are there signs of ponding on the enclosure (e.g. water stains, etc.)? Yes No
W1 has serious signs of flooding and water stains
W2 has no evidence of ponding
- iii. Is the wellhead enclosed by fiberglass insulations? Yes No
In both cases
- iv. Any evidence of rodents? Specify W2 is clean, no evidence of rodents
W1 has some mouse droppings
- v. Does the well casing have a proper seal cap? Yes No

Photo 0121: 1134 Well 1 Well Head in Pit

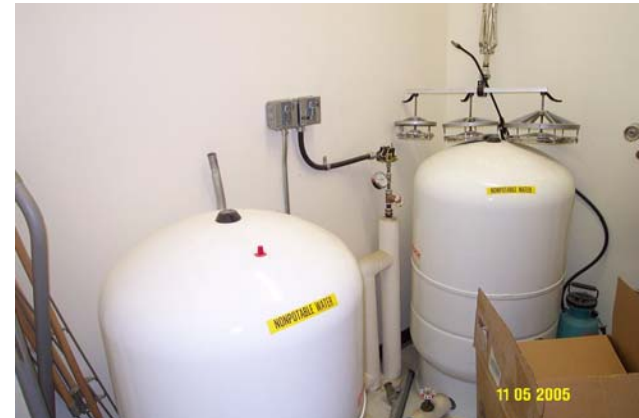
Photo 122: 1134 Pressure Tanks and Flow Switch

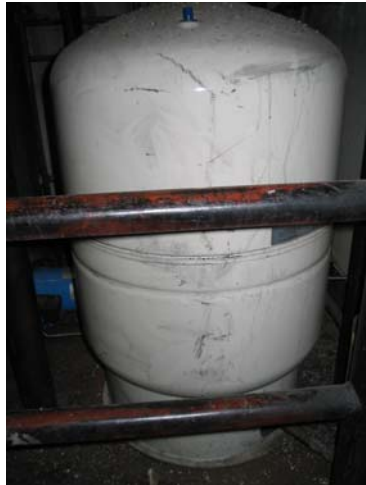
Photo 0497: 1134 Heating Expansion Tank

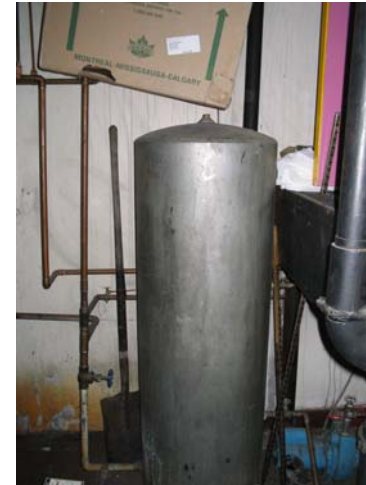
Photo 0498: 1134 Potable Water Pressure Tank

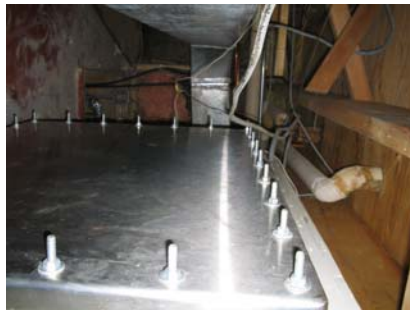
Comments: TANK HAS TO BE DRAINED ACCESS ON SIDE OF TANK.

Photo 0500: 1134 Storage Tank

COMPLEX PIPING SYSTEM MUST BE CODED
TO IDENTIFY NON POTABLE & POTABLE
SOURCES. SYSTEM NEEDS TO BE CHECKED
TO ASSURE NO CROSS CONNECTION EXISTS.
POTABLE STORAGE TANK SHOULD BE IN
A LOCATION THAT ALLOWS EASY INSPECTION
AND CLEANING. CHLORINATION EQUIPMENT
MUST BE INSTALLED TO EFFECT PROPER
CHLORINE RESIDUALS & CONTACT TIME.
SYSTEM COMPONENTS SHOULD BE
IDENTIFIED.

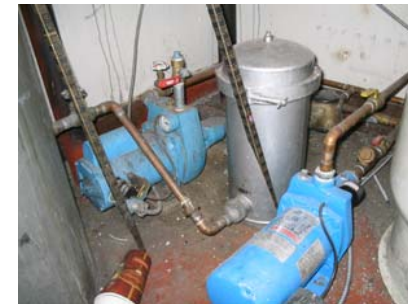
Photo 0495: 1134 Jet Pumps and Tank
