EBA Engineering Consultants Ltd.

SMALL PUBLIC WATER SYSTEMS ASSESSMENT
 WHITEHORSE REGION

CARCROSS FIRE HALL
 BUILDING 1137
 SITE LOCATION DIAGRAM
 WELL ID: 1137

SMALL PUBLIC WATER SYSTEM ASSESSMENT

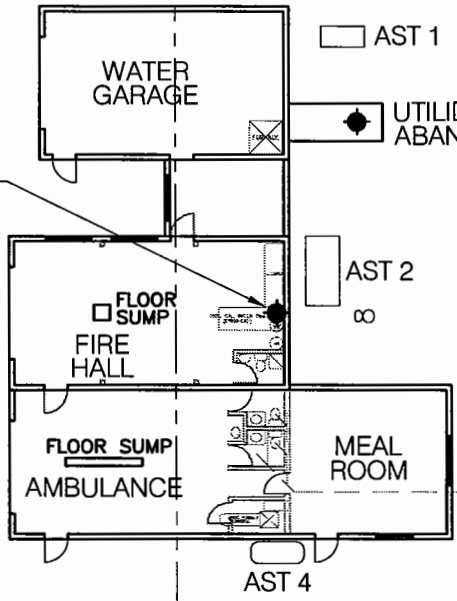
DRAWING No.
 FIGURE 1137A

DOMESTIC FUEL OIL STORAGE - GASOLINE & OIL (JERRY CANS, QUARTS OF OIL & MISC. HYDROCARBON SOURCES)

30 m RADIUS FROM WATER WELL FOR CONSIDERATION OF PROXIMITY TO POTENTIAL CONTAMINANT SOURCES.

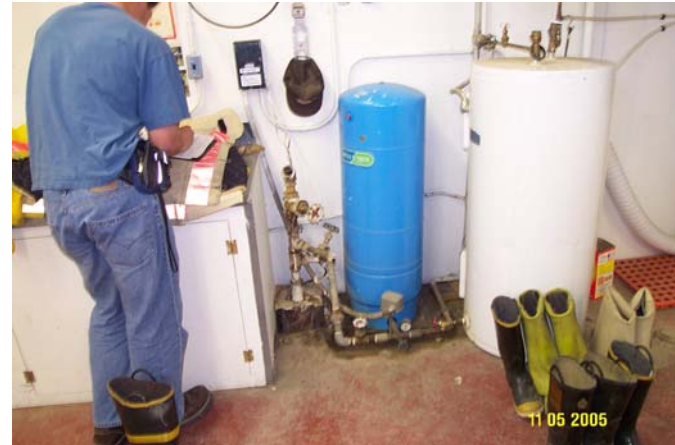
- i. Is the well head below grade? describe in detail 12cm above grade
- ii. Are there signs of ponding on the enclosure(e.g. water stains, etc.)? Yes No
There are mineral deposits from pipe leakage
- iii. Is the wellhead enclosed by fiberglass insulations? Yes No
It is, however, within the firehall
- iv. Any evidence of rodents? Specify There is no evidence of rodents
- v. Does the well casing have a proper seal cap? Yes No
The condition of it, however, is poor due to water leakage as there are mineral deposits and rust present.
If no, describe condition _____

The well is located in a garage where oil and other automotive
chemicals can potentially leak around the wellhead

Photo 0129: 1137 Well, Pressure Tank and Pump Controls

ABANDON THE WELL, PUMP WATER
SUPPLY FROM ATTACHED COMMUNITY
WATER SYSTEM WHICH IS FILTERED
AND CHLORINATED.

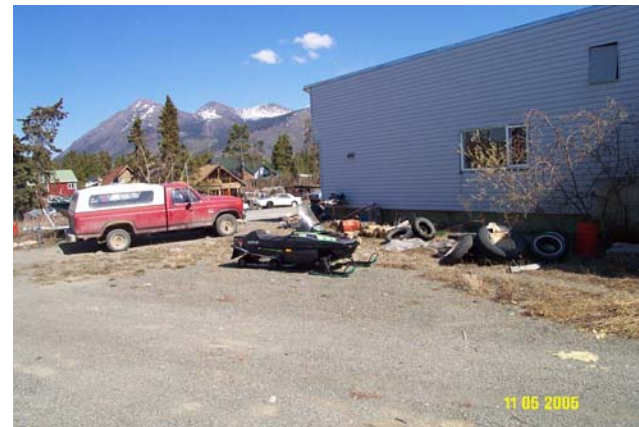
the well is ~50m from a junkyard and ~10m from a residential home with various old vehicles, fuel/oil storage tanks

Photo 0125: 1137 Neighbouring Building with Mechanical Equipment, Fuel and Oil Storage (foreground), Commercial Junkyard (background)
