EBA Engineering Consultants Ltd.	PROJECT SMALL PUBLIC WATER SYSTEMS ASSESSMENT WHITEHORSE REGION
CLIENT <div style="text-align: center; margin-top: 10px;">

TITLE WATER SYSTEM DISTRIBUTION/TREATMENT SCHEMATIC SYSTEM ID.: 1334 LAKEVIEW FIRE HALL - MARSH LAKE	
DATE	APRIL 2006	DWN.	JSB
CHKD.	RMM	FILE NO.	1260002.001
		DWG.:	FIGURE 1334B

Whitehorse Region – Lakeview Firehall
Building # 1334

SMALL PUBLIC WATER SYSTEM ASSESSMENT

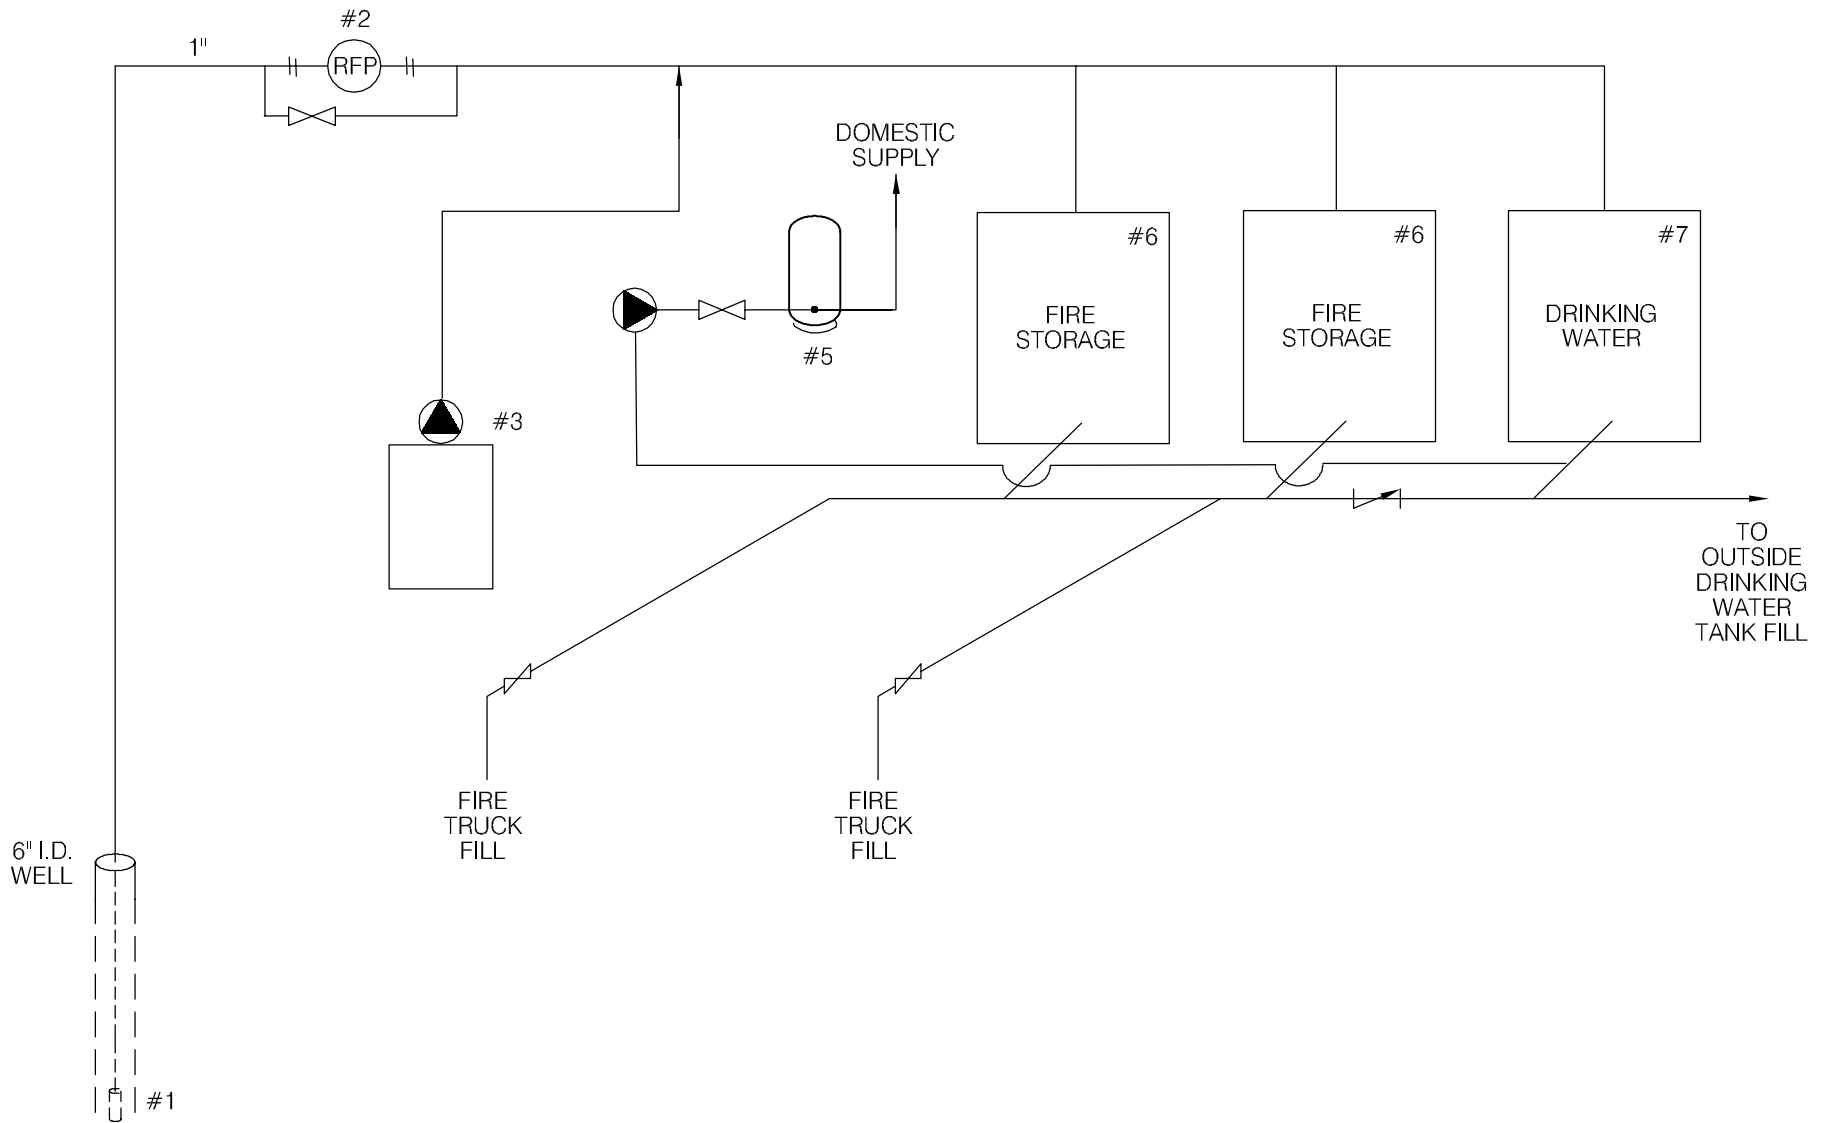
TANK FIRE SOLENOID VALVE SHOULD BE MOVED TO THE TANK AREA. 3/4" DOMESTIC WATER PIPE S/B INSTALLED AT A POINT PRIOR TO THE SOLENOID TO SUPPLY FRESH CHLORINATED WATER TO THE BUILDING.

PRESENT PIPING CONFIGURATION PRESENTS A HEALTH RISK FROM CONTAMINATED WATER OF FIRE TANK. CL2 INJECTION VALVE CRACKED.

MOVE SOLENOID.

DISCONNECT PRESENT FEED TO DOMESTIC PUMP.

INSTALL 1" FEED LINE TO PUMP SYSTEM.

INSTALL BACKFLOW PREVENTER IN FIREMAN SUPPLY LINE.

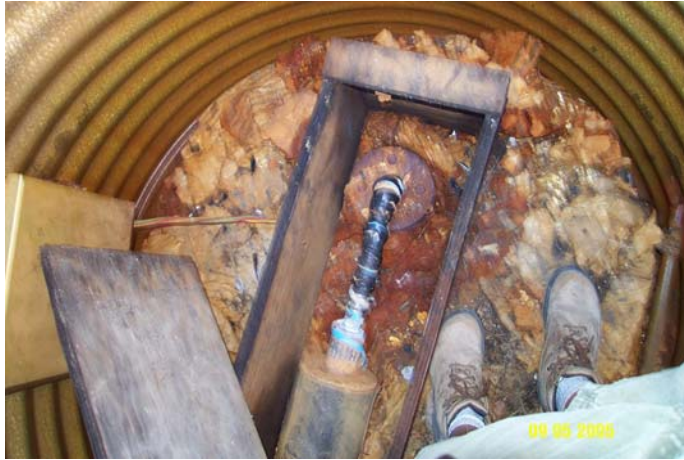
Unauthorized access by humans? Yes No
There is only a broken lock and a large flower pot on top

o. Is well site subject to flooding? Yes No
It is located in a pit

- i. Is the well head below grade? describe in detail 1.8m below grade
- ii. Are there signs of ponding on the enclosure(e.g. water stains, etc.)? Yes No
Evidence of water stains on culvert and the pit is in a generally unsanitary condition
- iii. Is the wellhead enclosed by fiberglass insulations? Yes No
- iv. Any evidence of rodents? Specify There is no direct evidence of rodents, despite general unsanitary condition of pit
- v. Does the well casing have a proper seal cap? Yes No

Photo 0071: 1334 Wellhead

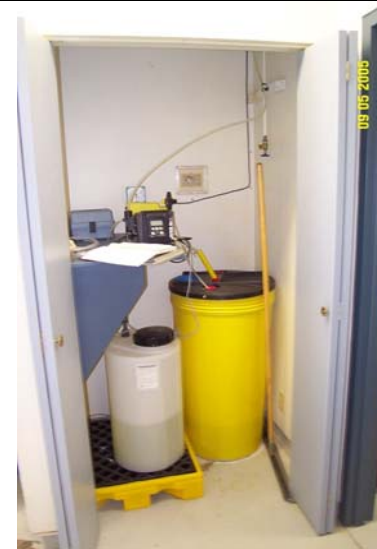
Photo 0072: 1334 DME Chlorinator and LMI Chlorinator back-up system.

INSTALL NEW INJECTION VALVE RIGHT AWAY.

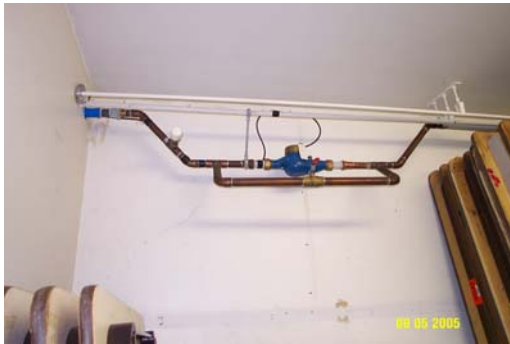
Photo 0073: 1334 Flow Meter

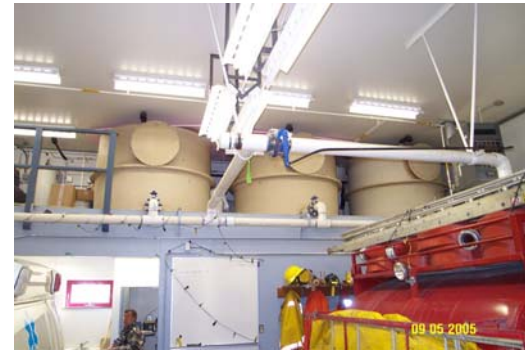
Does the lid have a tight seal and is it watertight when closed? YES (NO) ~~N/A~~

Is the water tank drain accessible? YES (NO) ~~N/A~~ NO DRAIN.

Are there signs of staining or biofouling? (YES) NO

Photo 0074: 1334 Tanks and Truck Fill (domestic tank far right)

PIPE OVERFLOW TO OUTSIDE PIPING TO PREVENT INDOOR FLOODING.
