**Small Public Water System Assessment  
Yukon Government Maintained Buildings**

***WHITEHORSE REGION***

**EBA Project No. 1260002.001**

**March 2006**

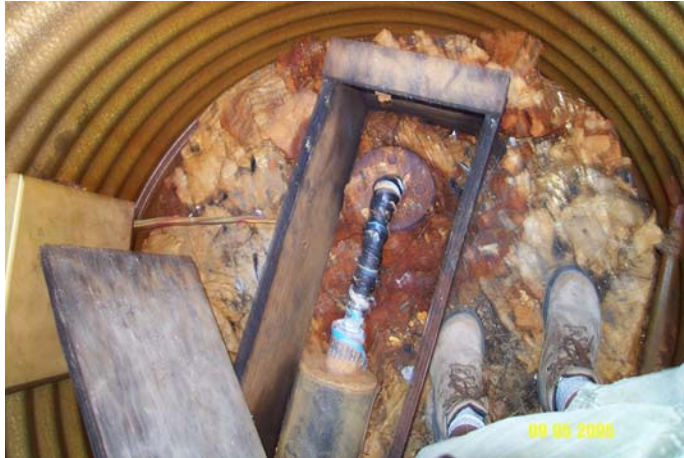
**Photo 0071:** 1334 Wellhead

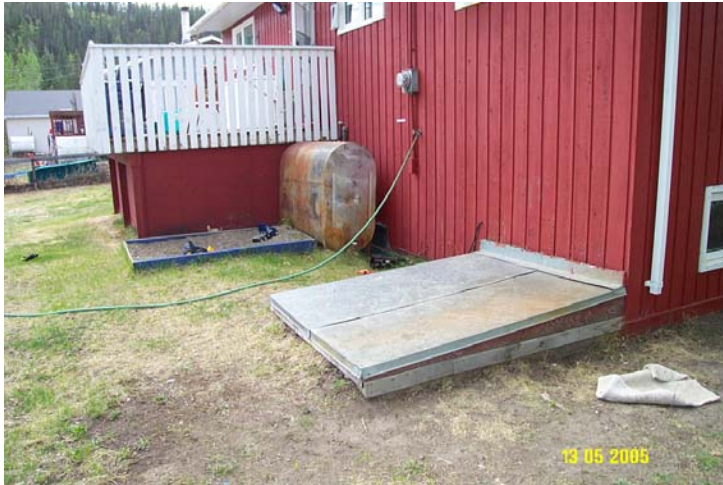
**Photo 0166:** M0201 Wellhead (front below paneling), R.C.M.P. Residence (behind) and Above Ground Storage Tank (center)

SYSTEM SHOULD BE UPGRADED WITH  
PROPER PUMP & PRESSURE TANK  
INSTALLATION. THE SOFTNER SHOULD  
BE PUT BACK IN SERVICE AND  
A UV SYSTEM SHOULD BE INSTALLED.  
THE WELL HEAD SHOULD BE UPGRADED  
TO THE NEW REGS UP COMING.

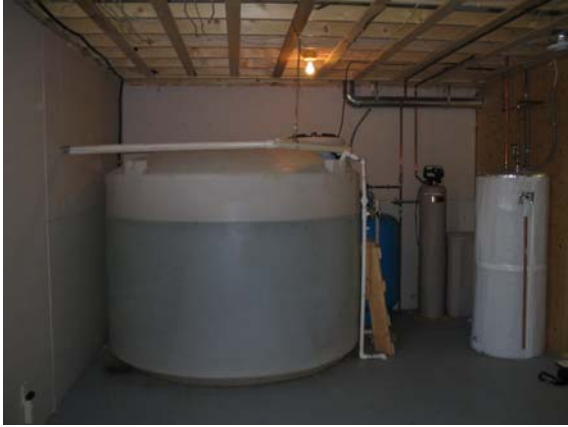
**Photo 0015:** M0064 Water System

ADD UV SYSTEM & FILTRATION

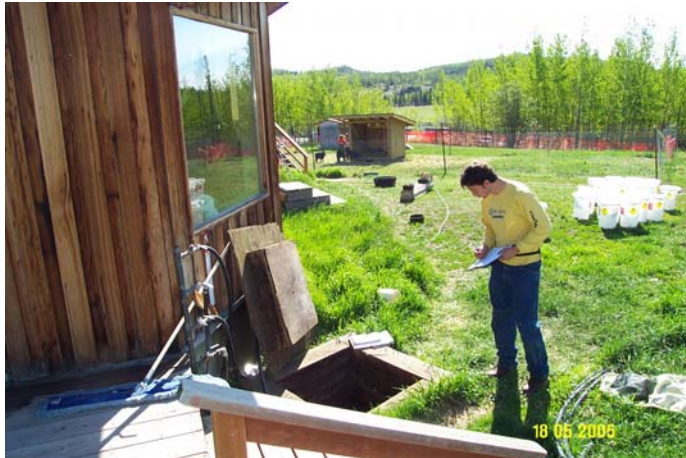
**Photo 0174:** YWP-A Main Office (left), Well Head Enclosure (center) and Baby Muskox Pen (back right)

REPLACE THE COMPLETE SYSTEM, INCLUDING THE STORAGE TANK. THERE IS ADEQUATE ROOM FOR A NEW SYSTEM IN THE SHOP AREA.

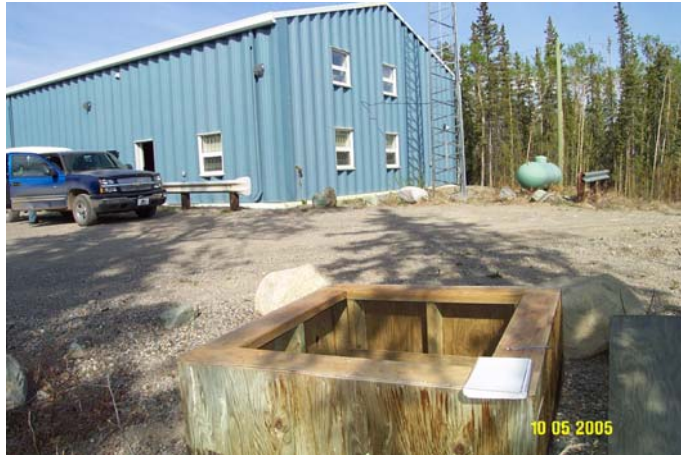
**Photo 0100:** 1950 Well-Enclosure – Pit (front), Ibex Valley Firehall (back)

WELL CASING TO BE EXTENDED ABOVE GROUND  
LEVEL & SURFACE SEAL INSTALLED. INSTALL  
PROPORTIONAL CHLORINATOR AND SURFACE RETENTION  
TANK. POTABLE WATER IS TAKEN OFF BEFORE  
FIRE STORAGE TANK.

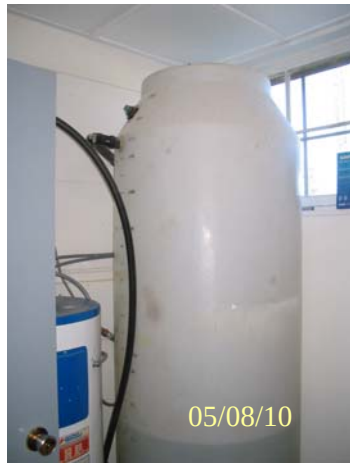
**Photo 141:** 1131 Water storage tank.
