March 3, 2023

ISSUED FOR REVIEW
FILE: 704-ENG.WARC04345-01.001
Via Email: matt.ball@yukon.ca

Subject: Updated Geohazard Study
5th Avenue and Rogers Street – Whitehorse, Yukon

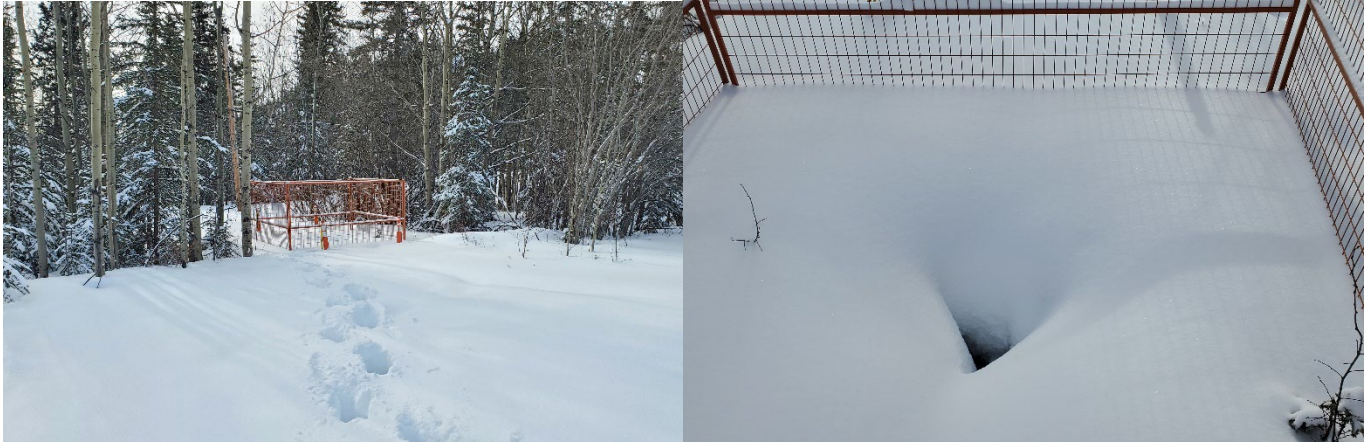
YG has advised that a potential sinkhole is present at the site. Tetra Tech completed a site visit on March 2, 2023 to observe the potential sinkhole and review its origin. The hole is located in a stand of trees, approximately in the centre of the parcel. The hole was mostly obscured by snow at the time of the site visit and was surrounded by fencing, as shown in the photos below.

Photo 1 (left): Potential sinkhole area in stand of trees near centre of the parcel, surrounded by fencing.
Photo 2 (right): Potential sinkhole mostly obscured by snow during the site visit on March 2, 2023.

The sinkhole should be checked in snow-free conditions to confirm its depth, which is likely no deeper than the maximum depth of ground disturbance from previous site developments.

New development at the subject site should include a geotechnical site investigation to determine the depth of potentially unstable soil, and site preparation procedures should be implemented to eliminate the risk of uncontrolled

soil subsidence. Site preparation procedures generally consist of excavation to remove uncontrolled fill, old foundations, abandoned underground utilities, and other potentially deleterious materials. These should be replaced with fill that is placed in lifts and compacted to suit site development requirements.

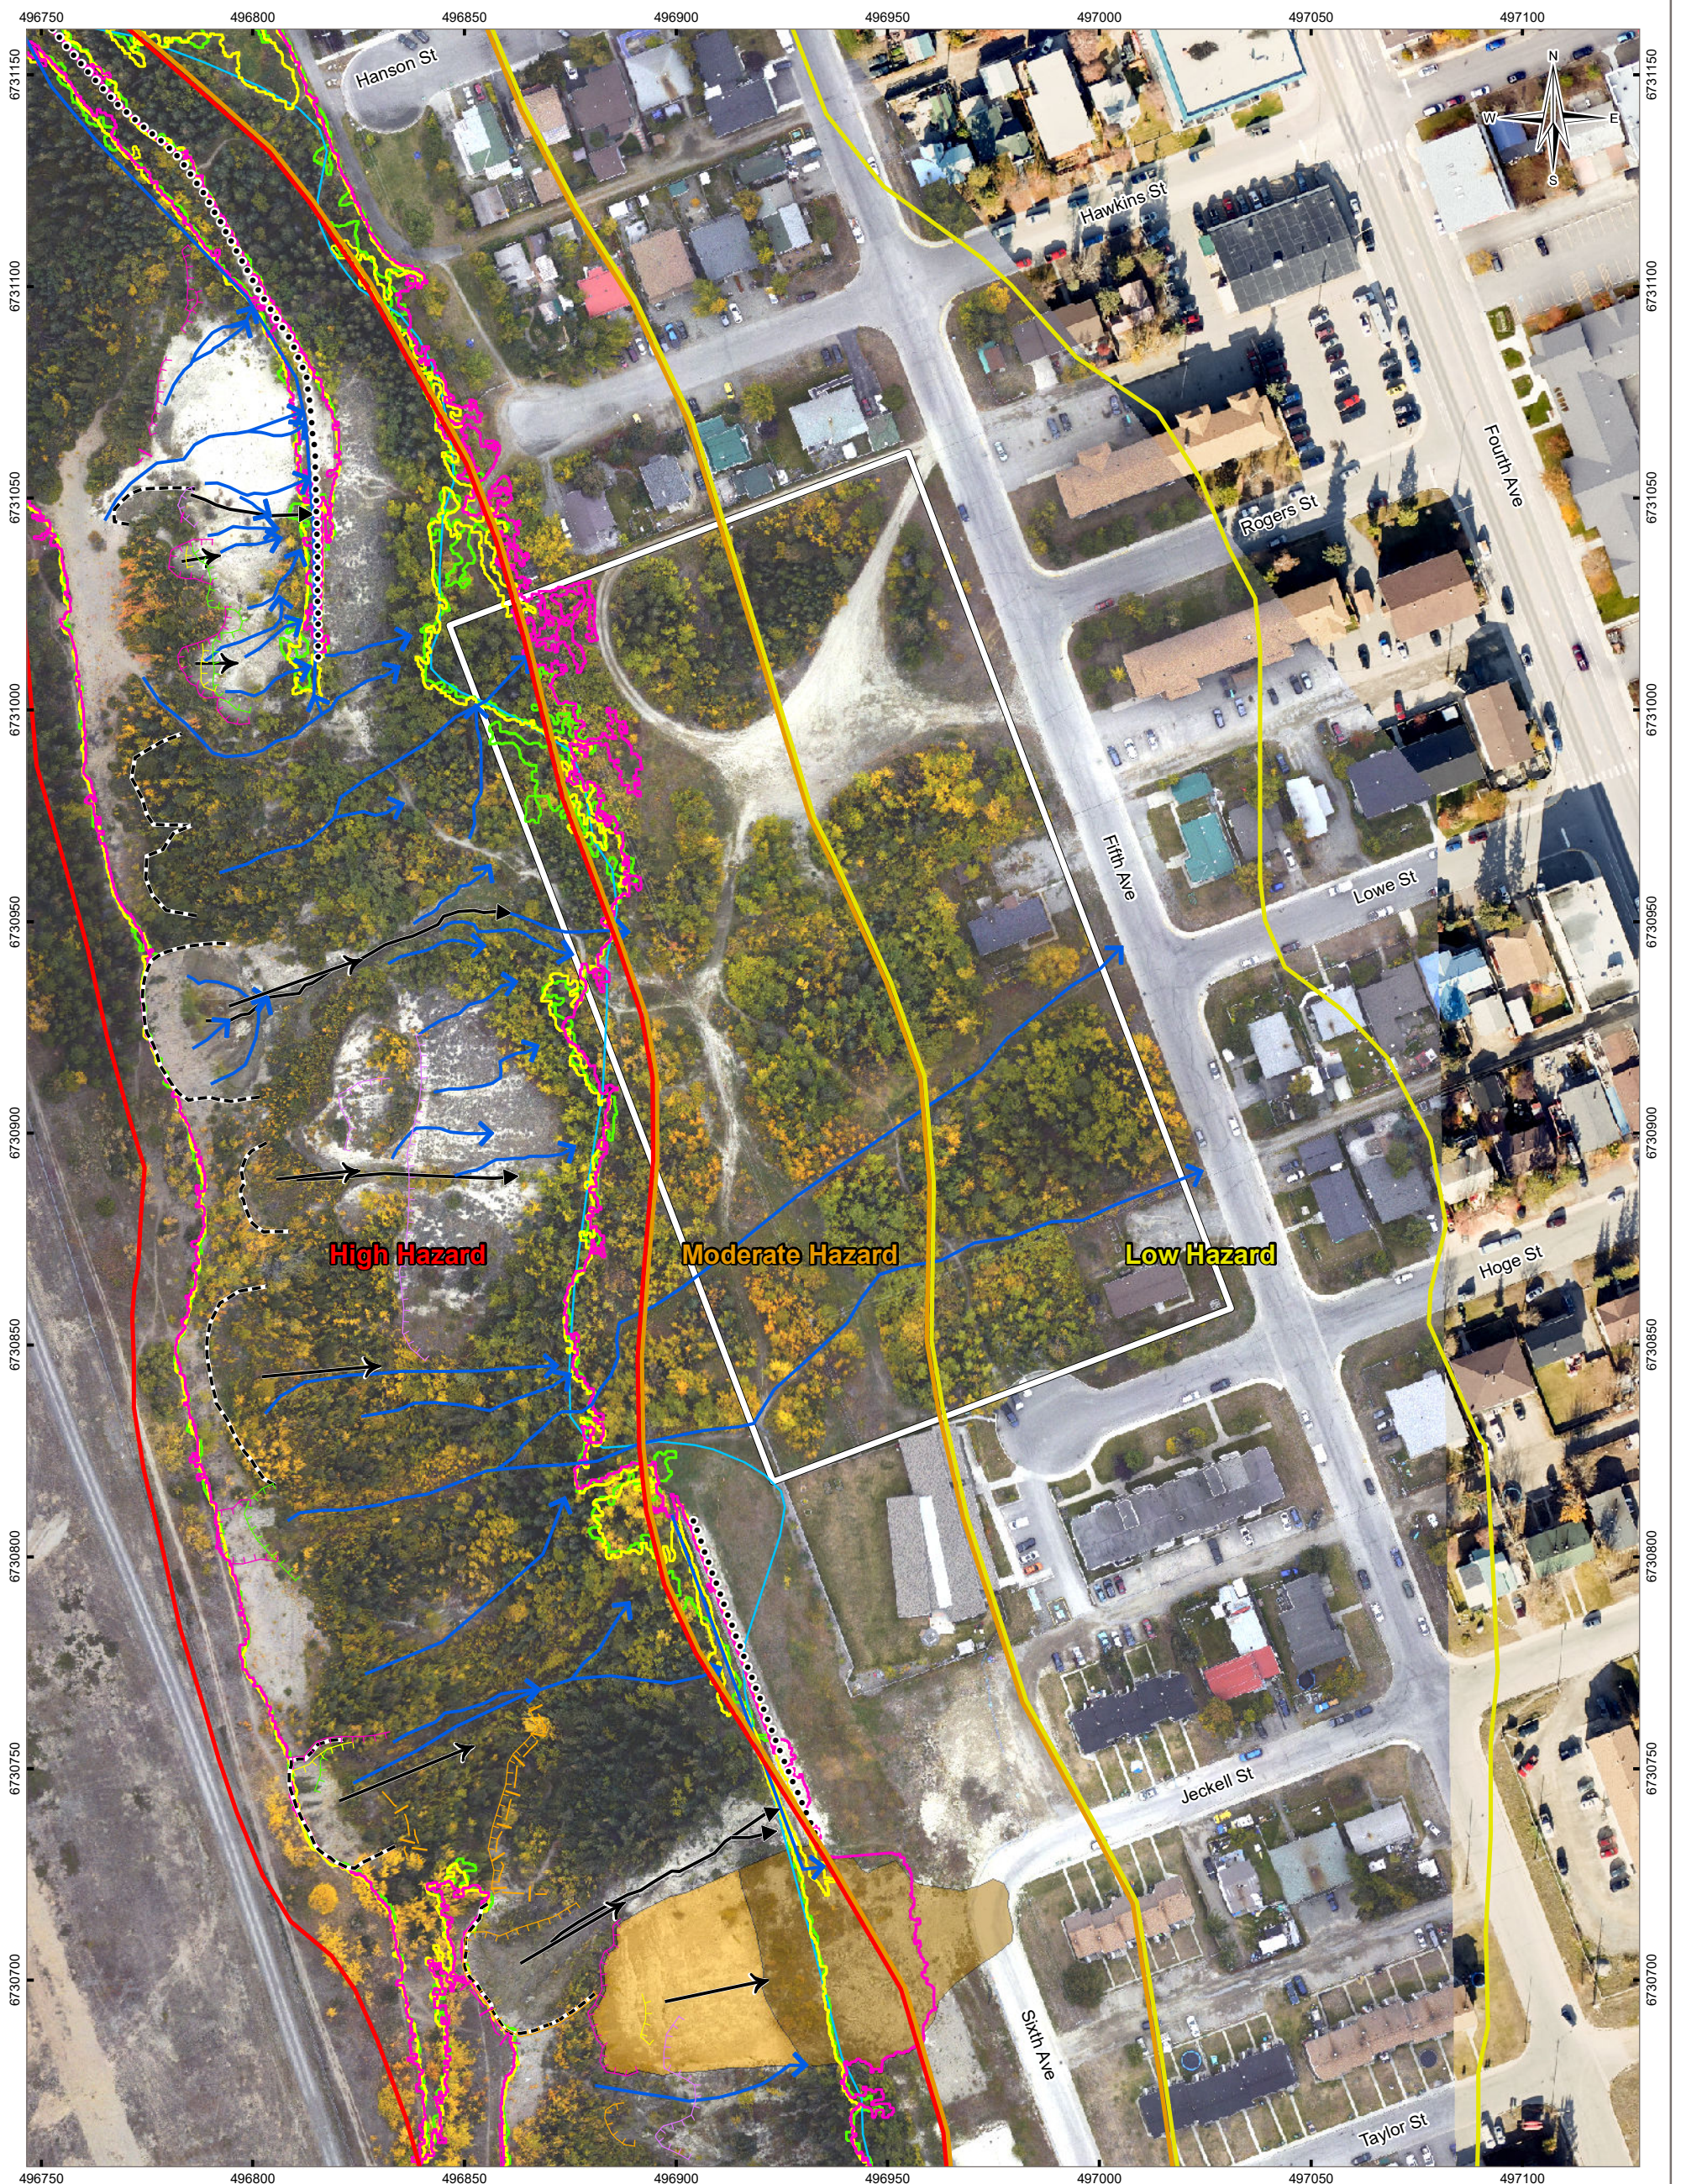
Figure 1

Backscarp regression of approximately 2.6 m (between 2013 to 2019) and 5.7 m (between 2019 to 2022) was identified through historical LiDAR and air photo analysis, approximately halfway upslope at the northwestern edge of the parcel, above the former east airport access road, which is currently used as a recreational walking path (Figures 1 and 2). This analysis also determined that the Escarpment toe at this location has transitioned eastwards by up to approximately 50 m since 2019. Although the area is still vegetated, given the nature of the process and texture of the material, the fan is accumulating material by continual seepage from upslope backscarp faces. Significant flow of sediment-laden water is visible flowing down the slope and into the west side of the subject site during the spring. Significant precipitation events may have the potential to increase the volume of material and possibly cause damage to property.

As with Tetra Techs 2012 study, this historical air photo and LiDAR interpretation study coupled with elevation change detection analysis have determined that no changes are warranted to the 2002 Landslide Hazard zones at the 5th and Rogers parcel. The escarpment slopes continue to show expected active thaw-flow slides and erosion and mass movement are ongoing at a manageable and predictable rate that reflects the landslide hazard zone and land use guidelines developed by EBA in 2002.

The parcel at 5th and Rogers is located mostly within the Low Hazard Zone (50%) and Moderate Hazard Zone (46%), with the exception of the northwestern corner that is at the boundary of the High Hazard Zone (4%).

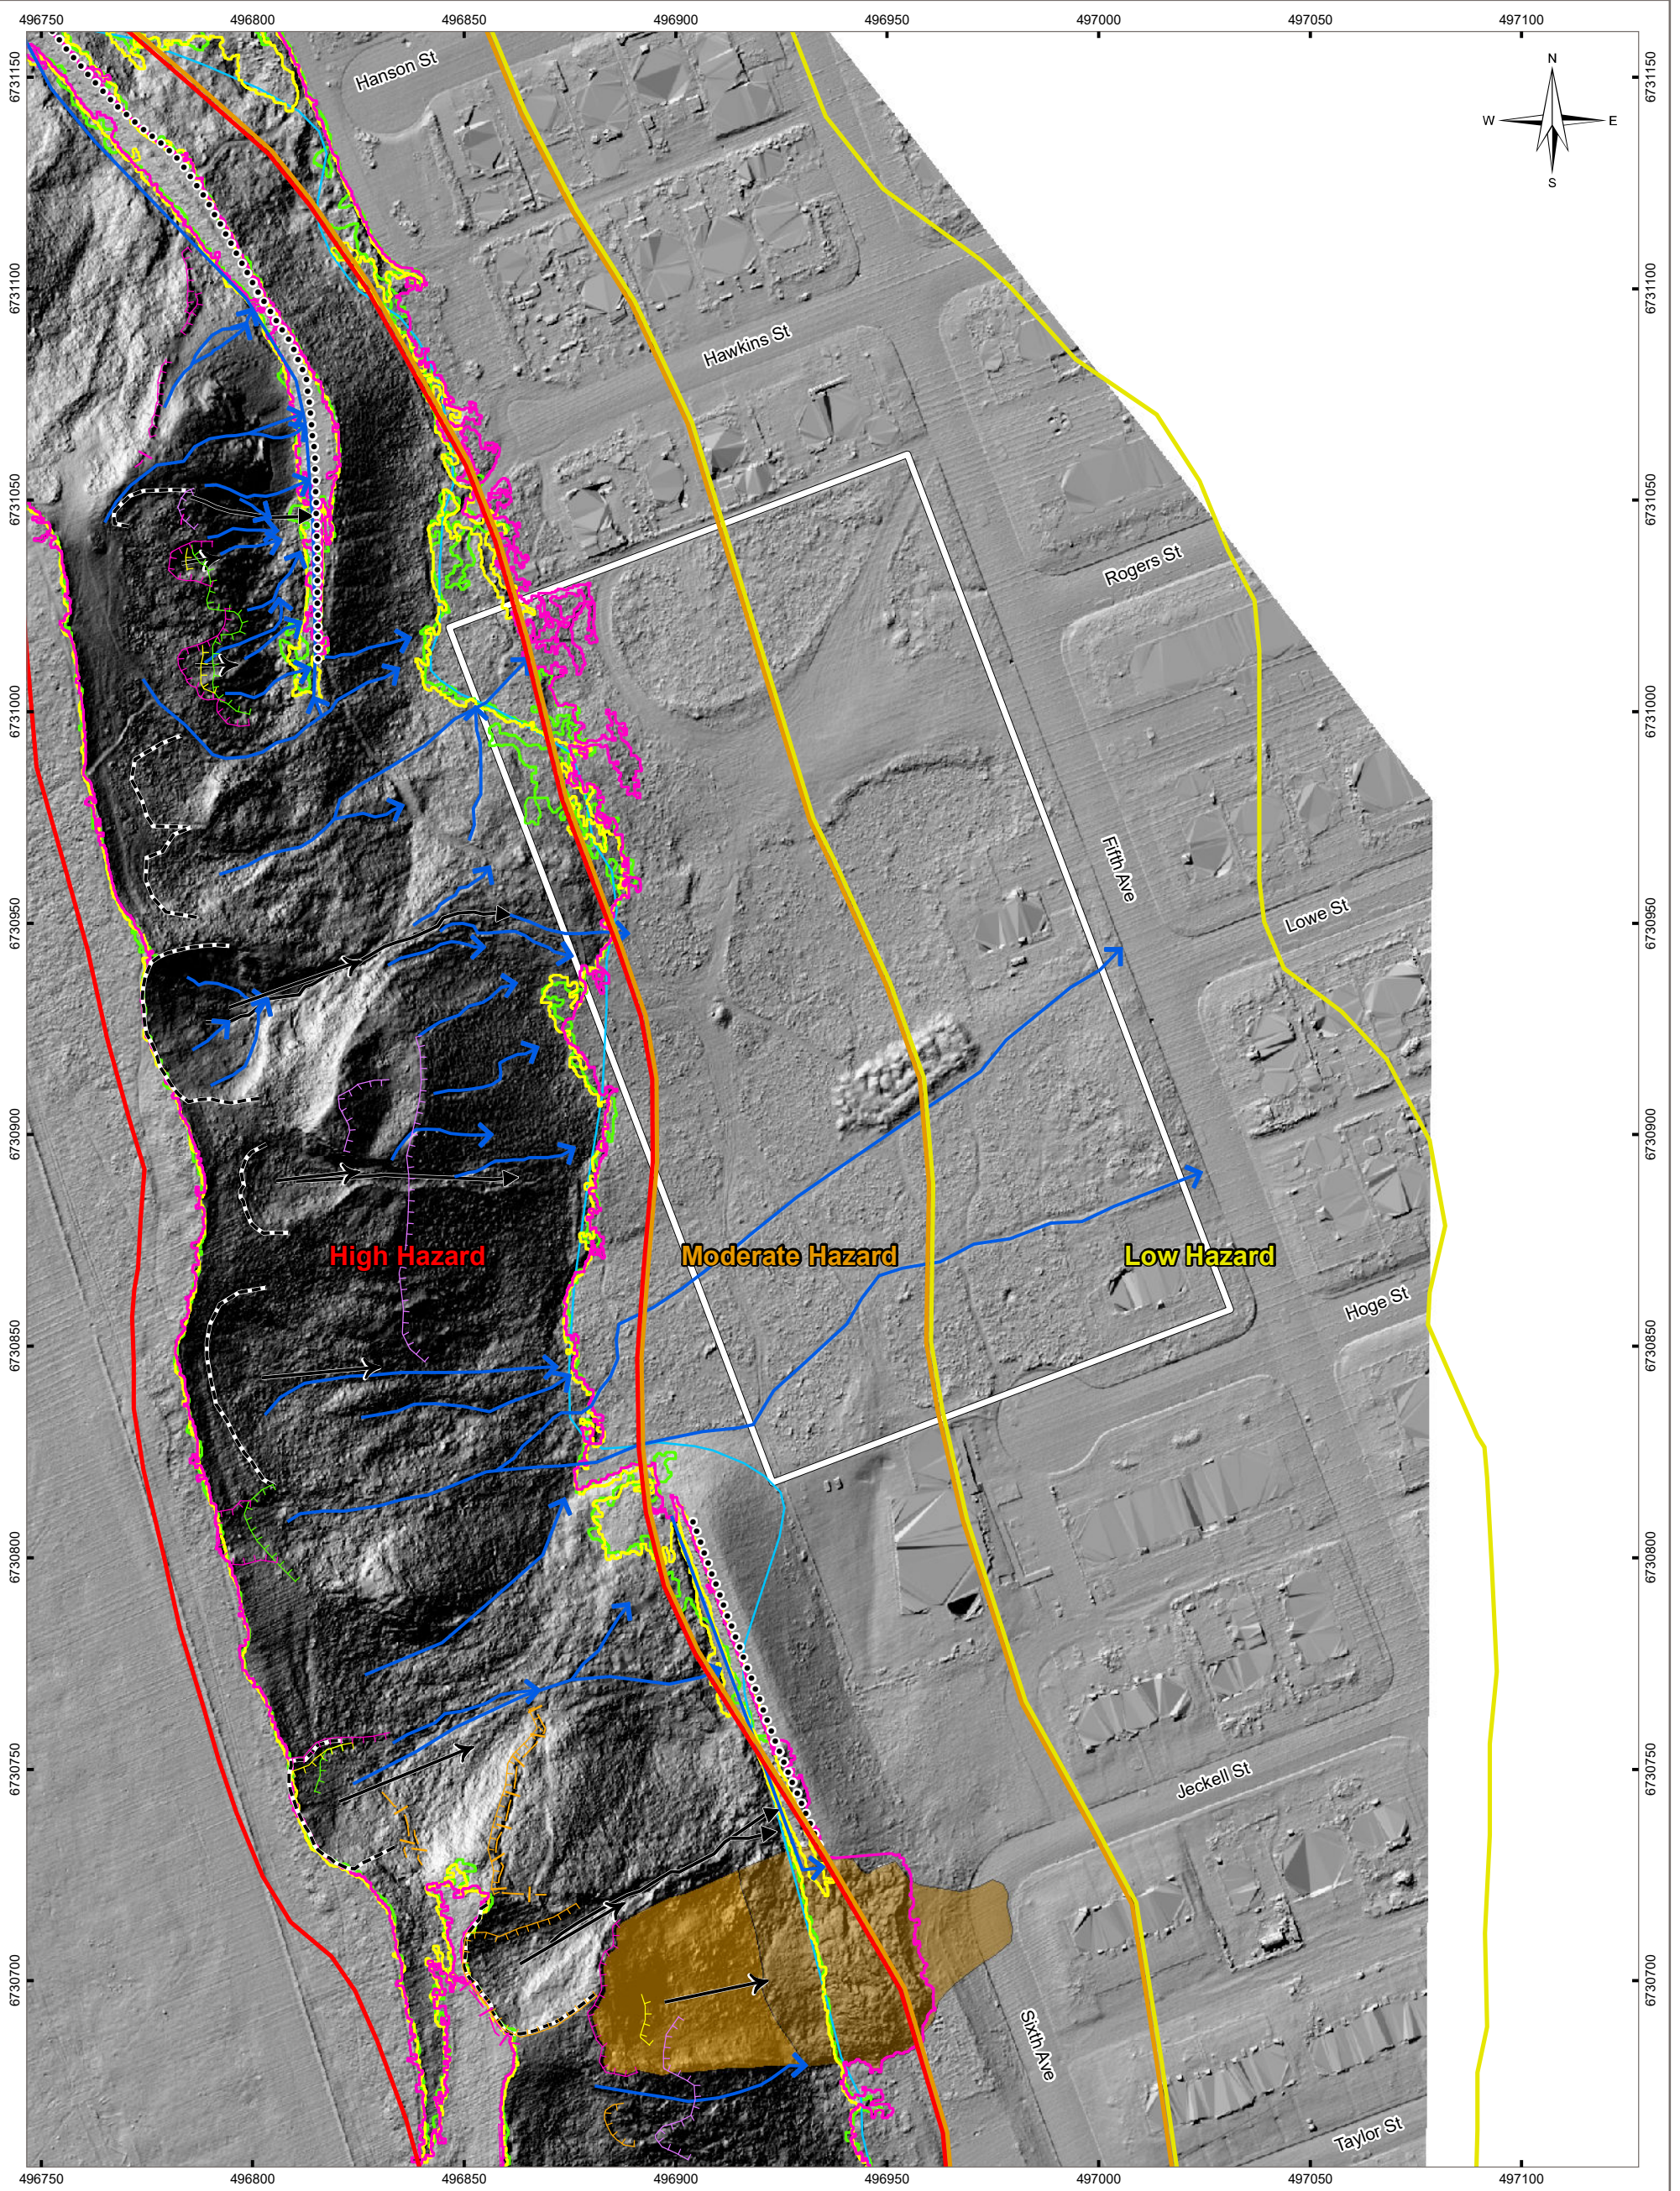
PROJECTION UTM Zone 8	DATUM NAD83	CLIENT
Scale: 1:1,500 20 10 0 20 Metres		
FILE NO. WARC04345-01_Figure02_HazardsDEM.mxd		
OFFICE Tl-EDM	DWN MRB	CKD SL
DATE February 17, 2023	APVD EP	REV 0
PROJECT NO. ENG.WARC04345-01		Figure 2

The 2022 LiDAR and orthoimagery data (5 cm) was provided to Tetra Tech by Pioneer in October 2022. Tetra Tech reclassified the data to fine-tune the ground classification parameters and created a 20-cm-resolution Digital Elevation Model (DEM). The orthoimagery is seen on Figure 1 and hillshade DEM on Figure 2.

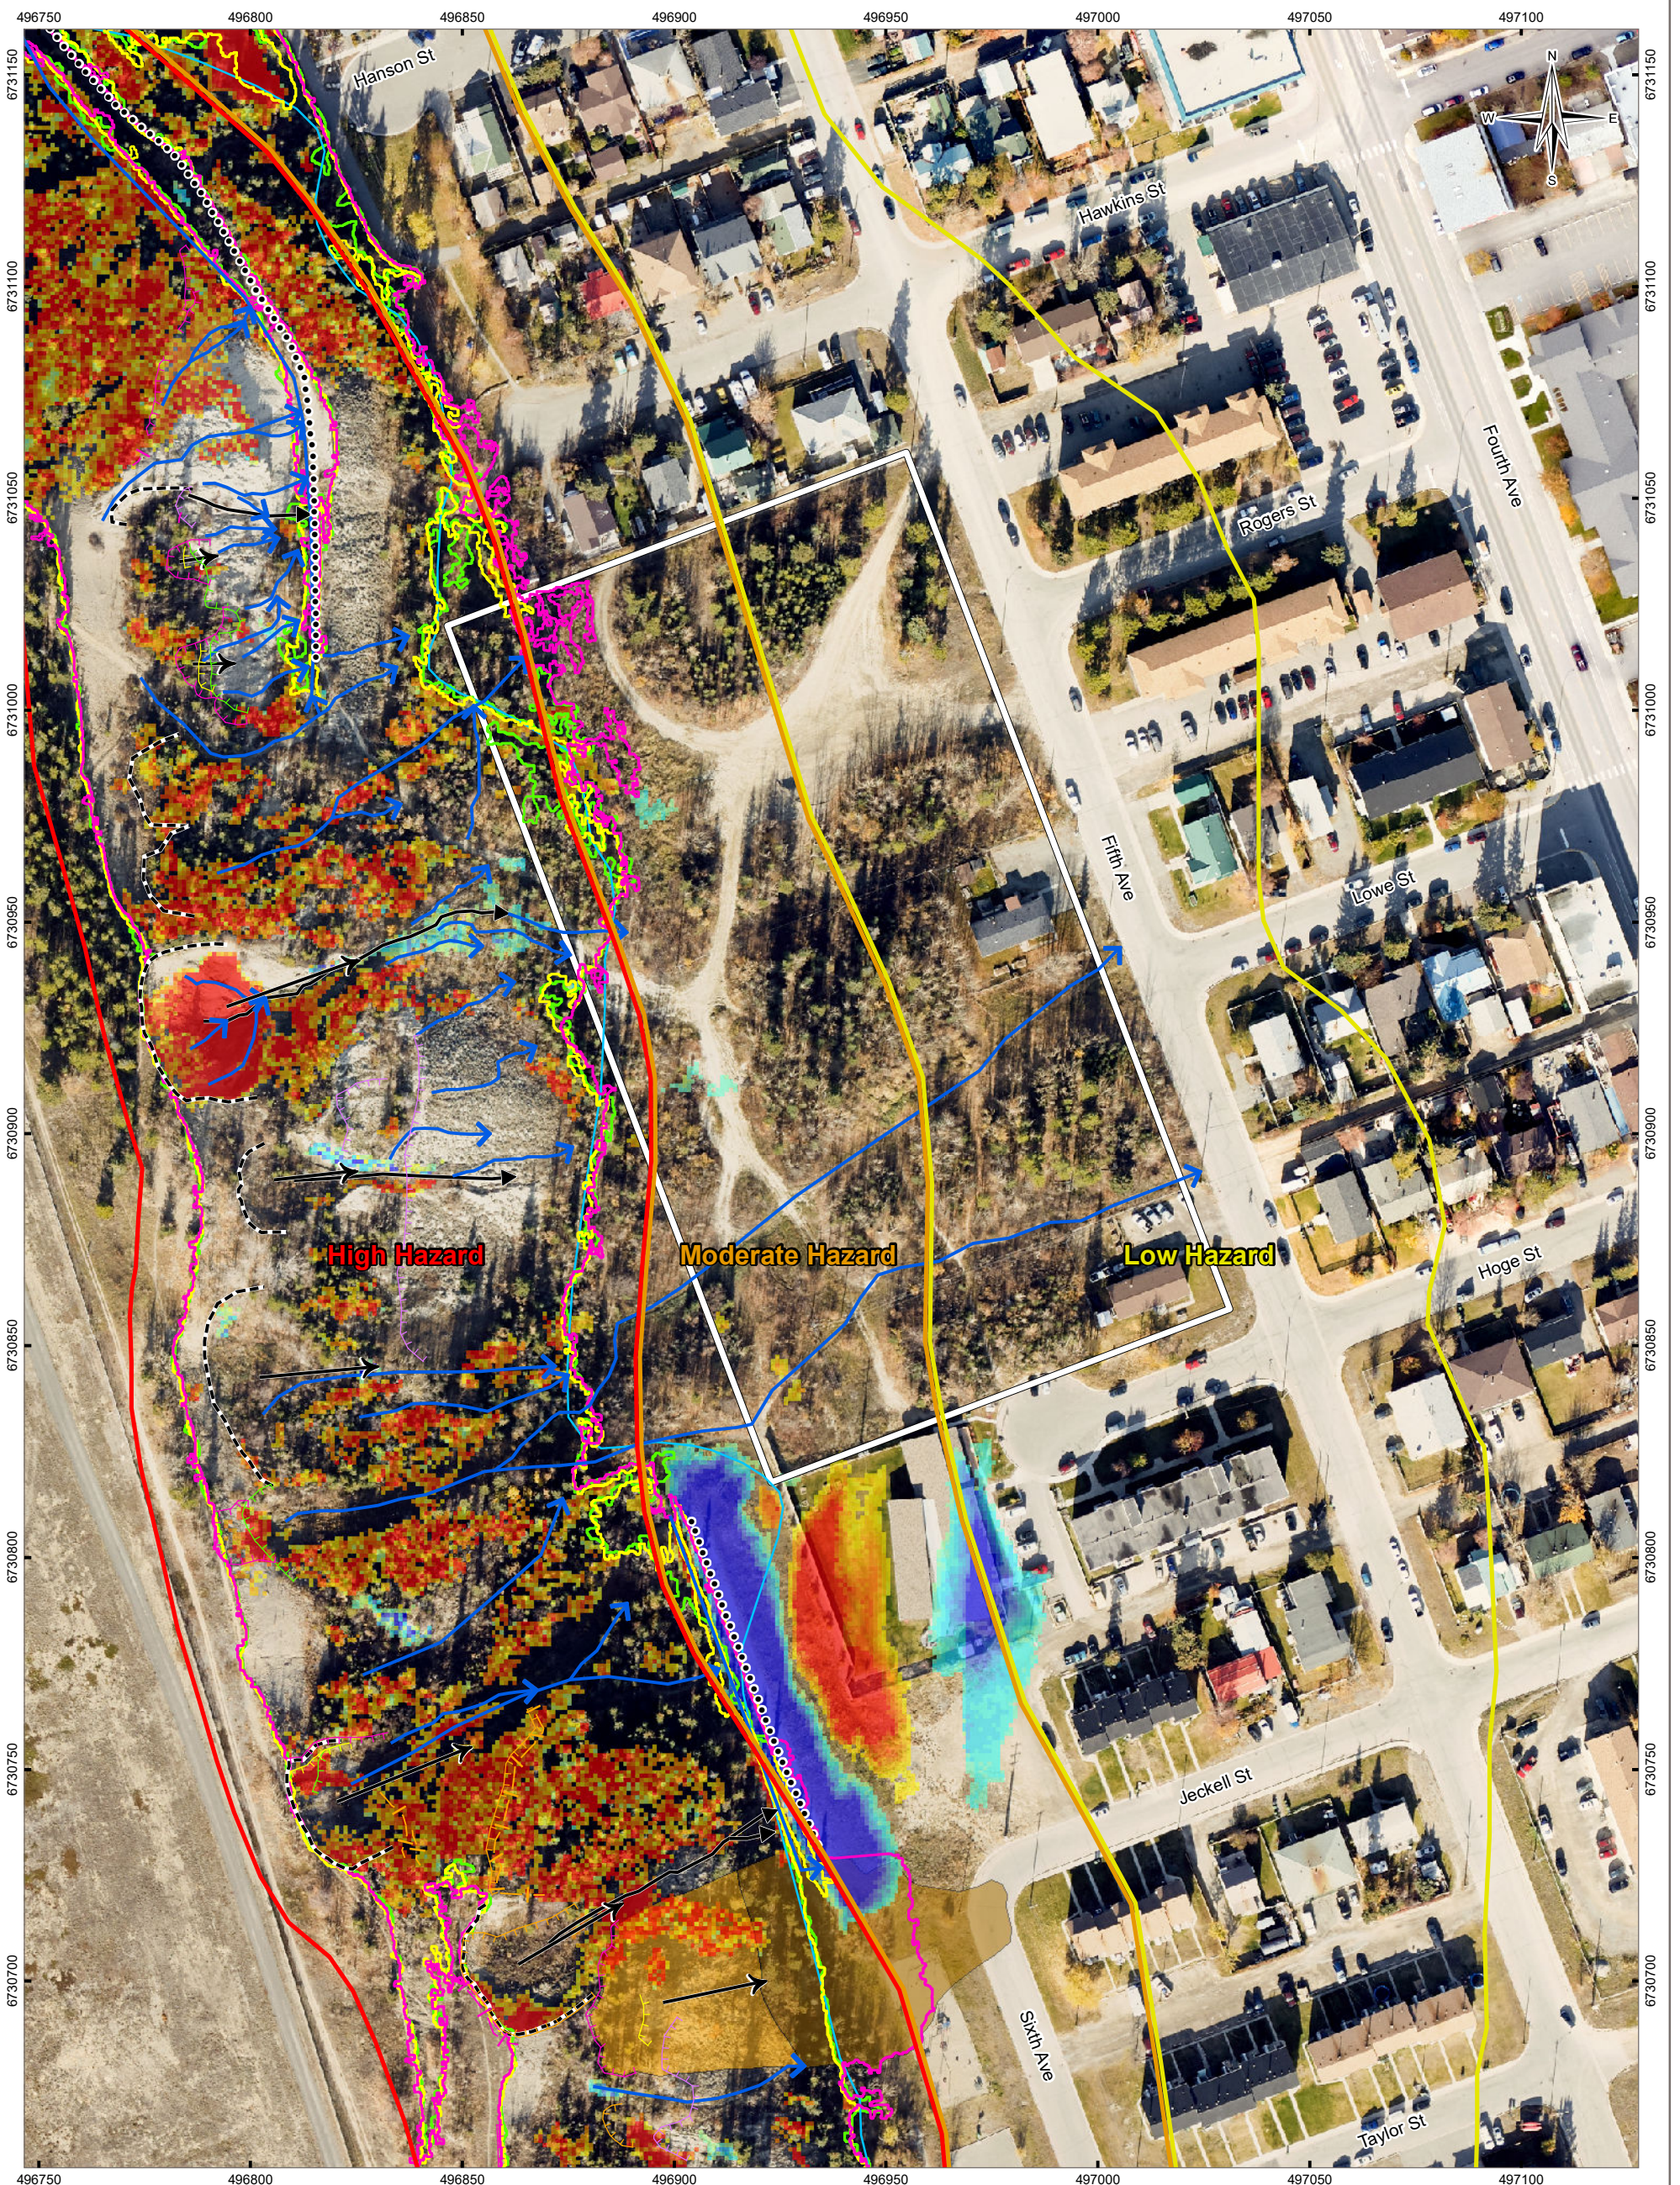
Figure 3

The results of the elevation change detection analysis between the 2013 and 2019, and 2019 and 2022 LiDAR-derived DEMs are illustrated in Figures 3 and 4, respectively. Regions of yellow to red represent apparent subsidence and are indicative of slumping/ erosion or backscarp face regression. Areas of green to blue indicate

apparent accumulation of the surficial material. Some anomalous results of the elevation change detection analysis can be attributed to misclassification or slightly different classification of LiDAR data results by third parties. The elevation change detection analysis generally corresponds with the expected mass movement activities and helped refine and confirm the mapped instability features and how they have been altered. Elevation changes due to cut (red) and fill (blue) of the ground for the construction of the St. Elias adult group home and fill placement (blue) for the interception berm west of the home were detected by the analysis and are clearly visible on Figure 3.

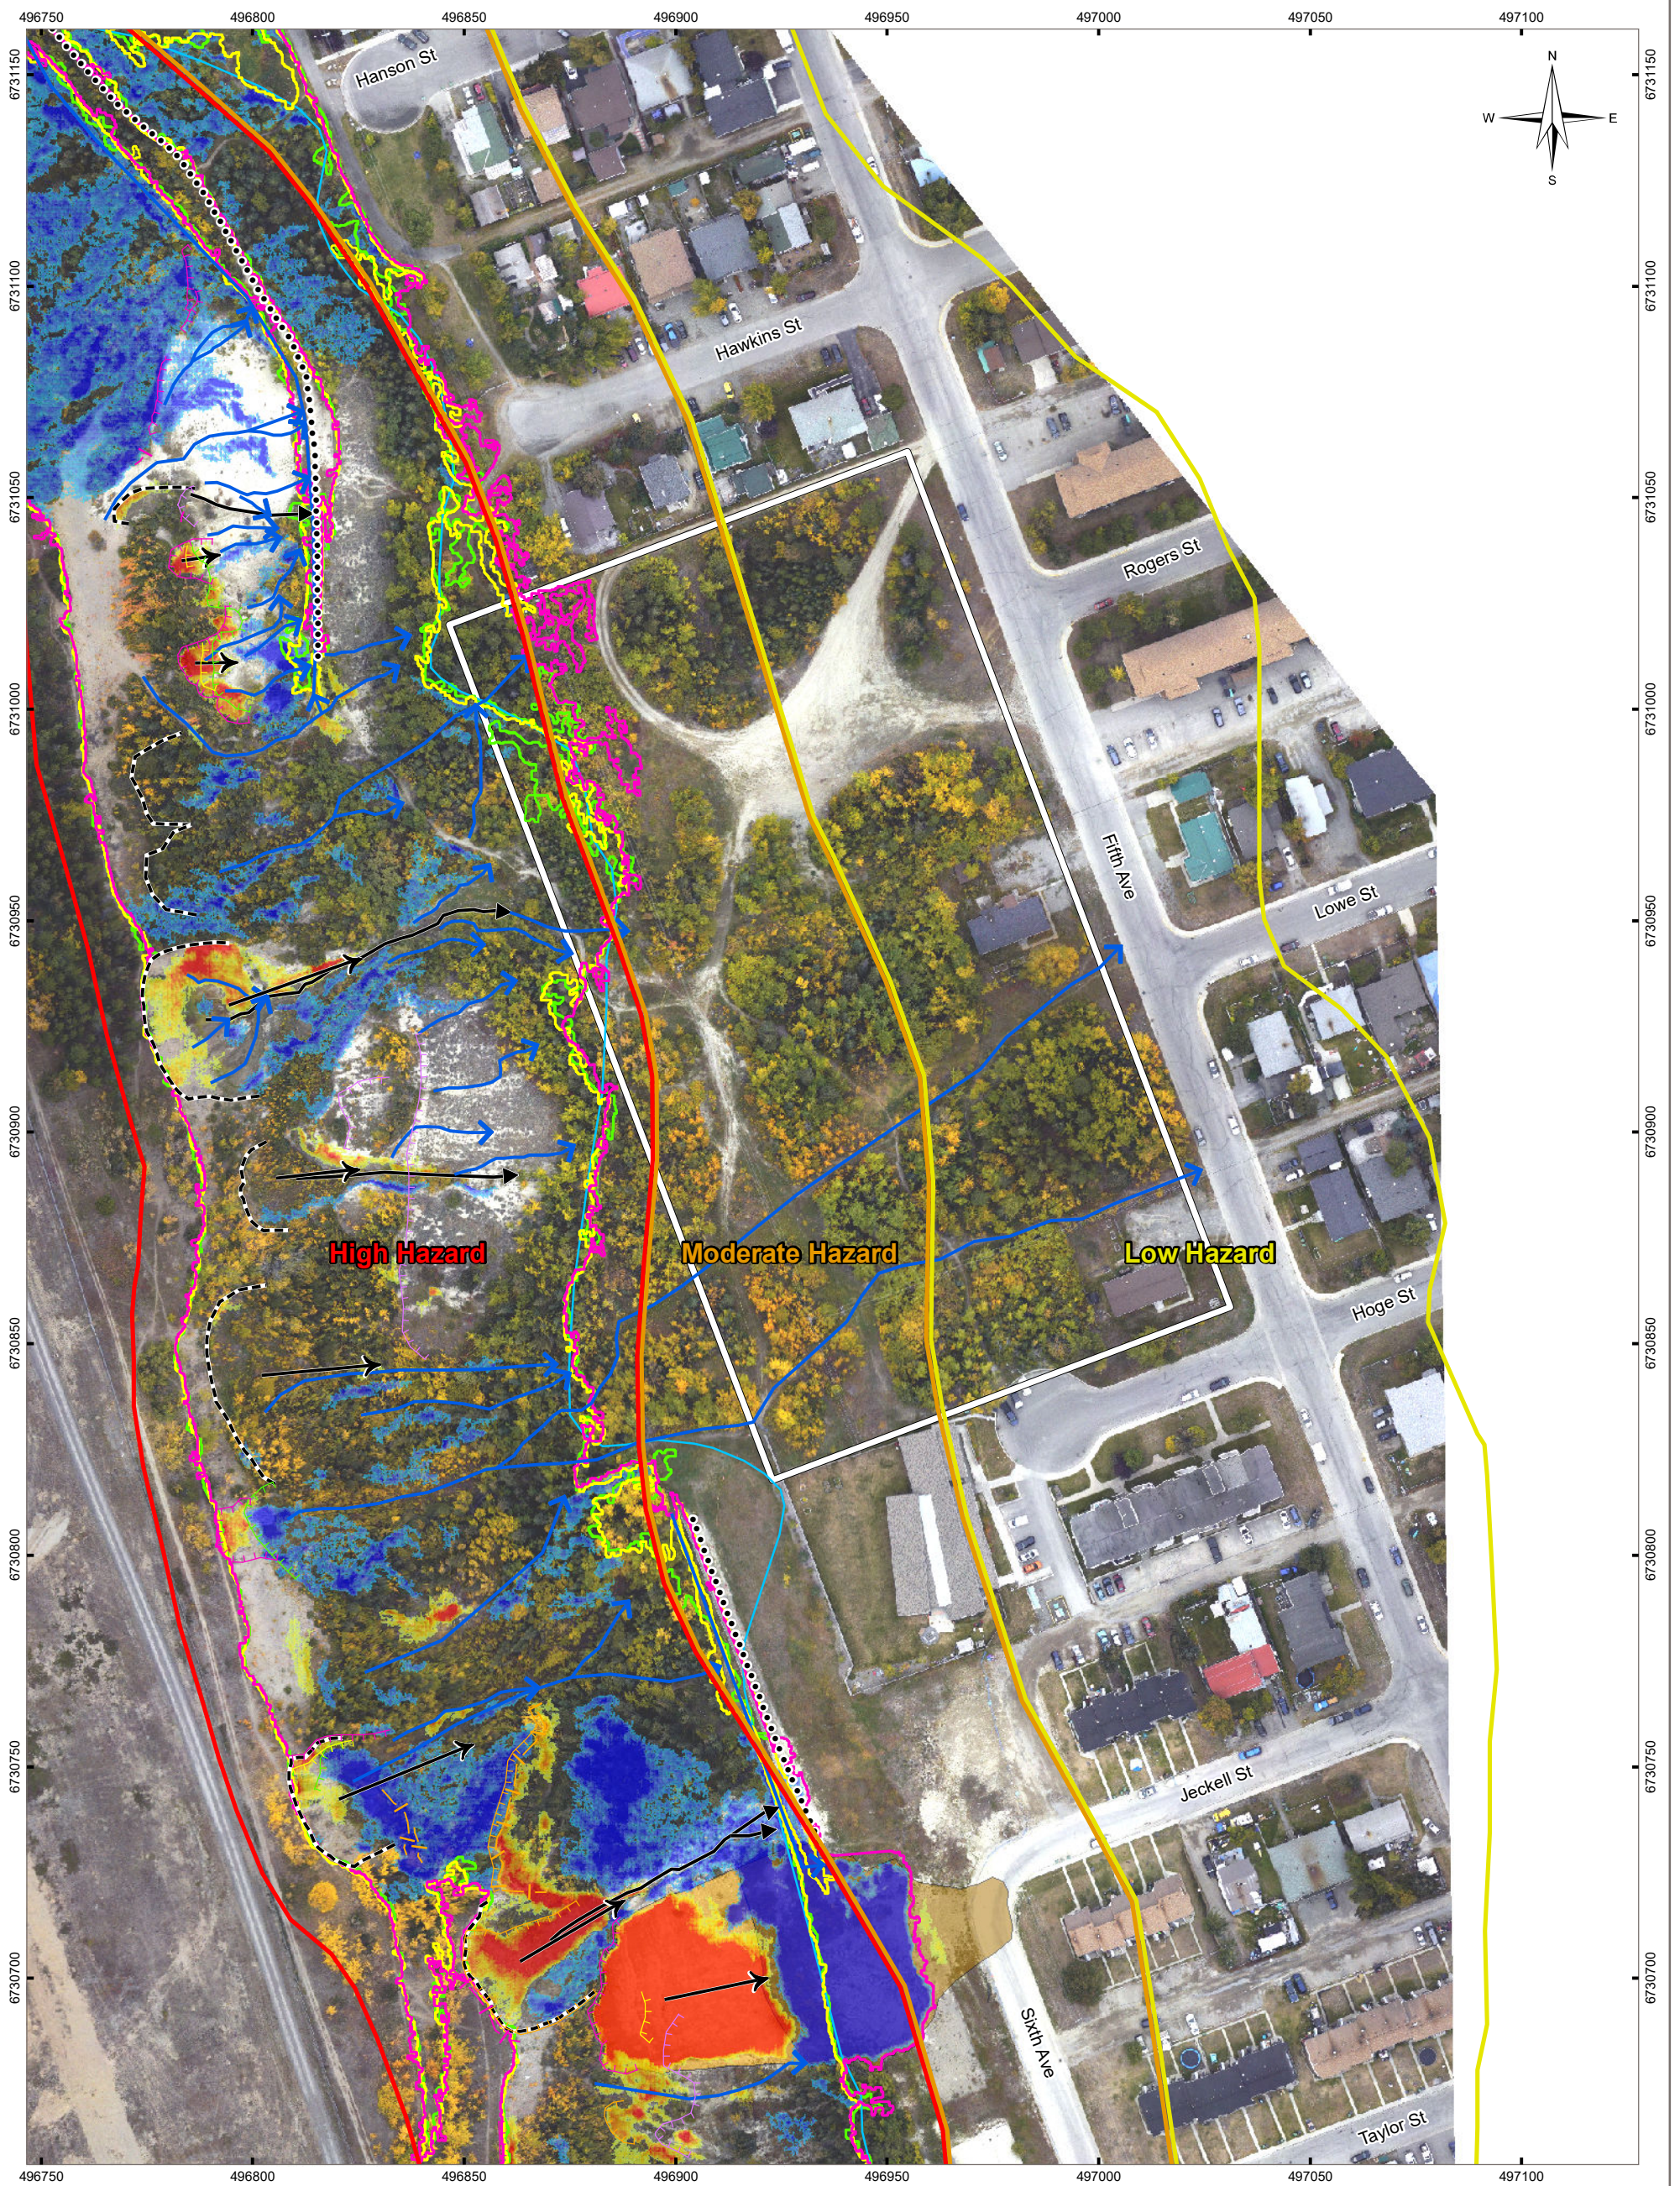
Figure 4 2022 Imagery 2019-2022 Surface Elevation Change Detection 5th and Rogers

In general, much of the Escarpment slope above the 5th and Rogers parcel has not experienced much elevation change between 2013 and 2022. The majority of material movement is seen at the headscarp located at the top of the Escarpment immediately west of the area between Rogers and Lowe Streets. The average thickness of material loss from the headscarp erosion is approximately 0.93 m between 2013 and 2019 and 0.68 m between 2019 and 2022. Given the size of the area (approximately 900 m²) this loss represents volumes of 840 m³ and 610 m³, respectively. The material flows down the gully and drainage paths and accumulates at the toe of the Escarpment. Accumulation of material averaging 0.5 m in thickness was identified at this location. Saturated ground surface conditions are evident at the Escarpment toe in this location throughout the spring and summer months.
