2013 ANNUAL QUARTZ MINING LICENCE REPORT

Carmacks Copper Project, Yukon Territory

**ANNUAL INSPECTION, JULY 16, 2013
CARMACKS COPPER PROJECT, CARMACKS, YUKON**

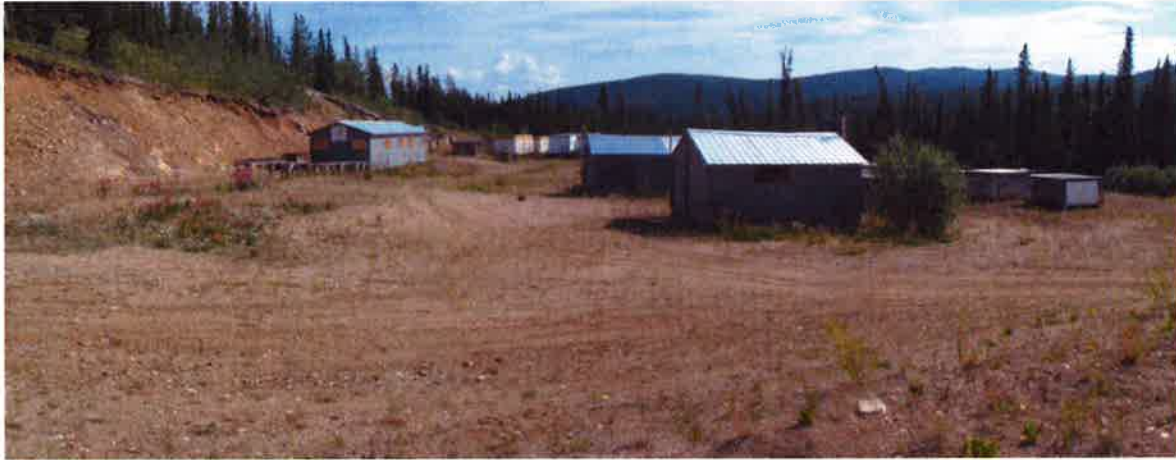
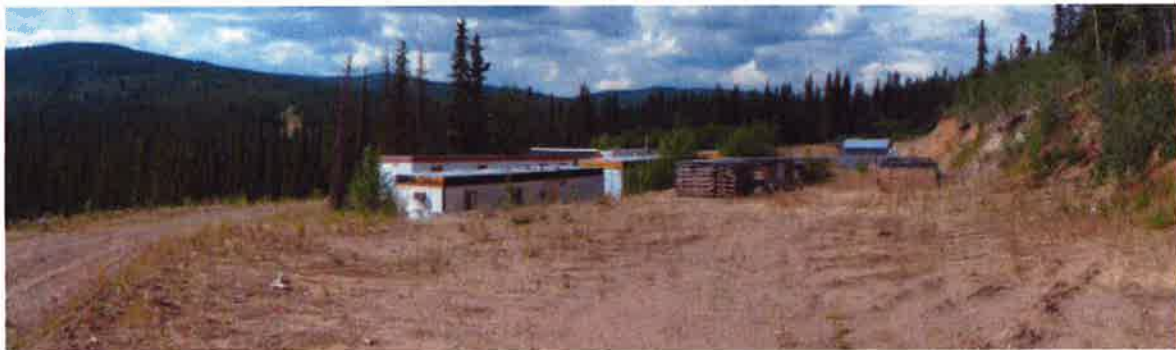
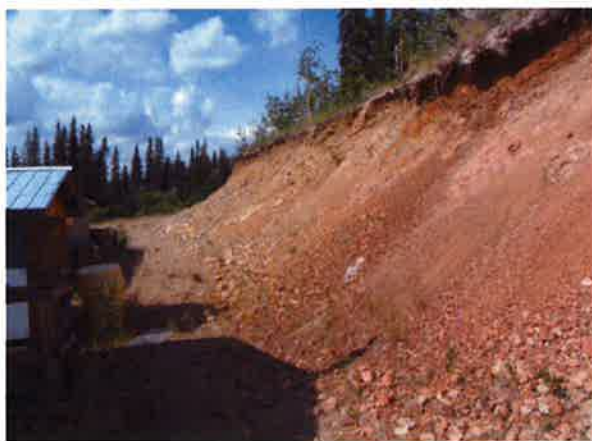
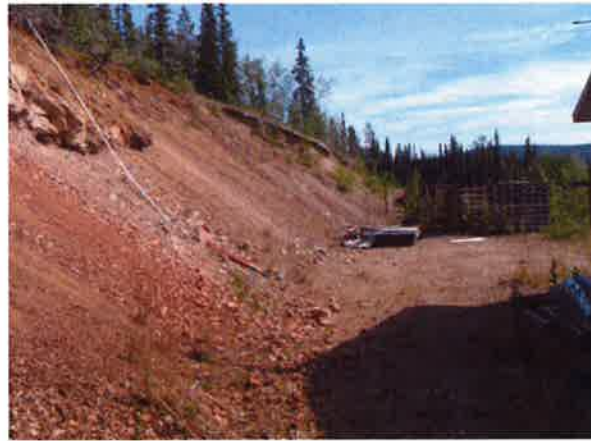
The inspection of the camp area indicated there is no erosion of sediments from the pad area into the surrounding natural area. The slope behind the camp is stable and is not impacting or causing any safety issues with the camp structures or operations. There is minor slumping and ravelling of small sections of the slope, but these are not impacting camp safety nor would they represent an issue to workers on the project. Some re-growth of vegetation was observed in the camp area. In addition, there was some cracking observed along the south edge of the pad (lower limit of pad), some 3 to 4 m from the pad edge.

Photographs 1 - 5: Carmacks exploration camp – views looking east to camp (top), looking west to camp (middle), slope immediately north of camp looking west (bottom left) and east (bottom right)

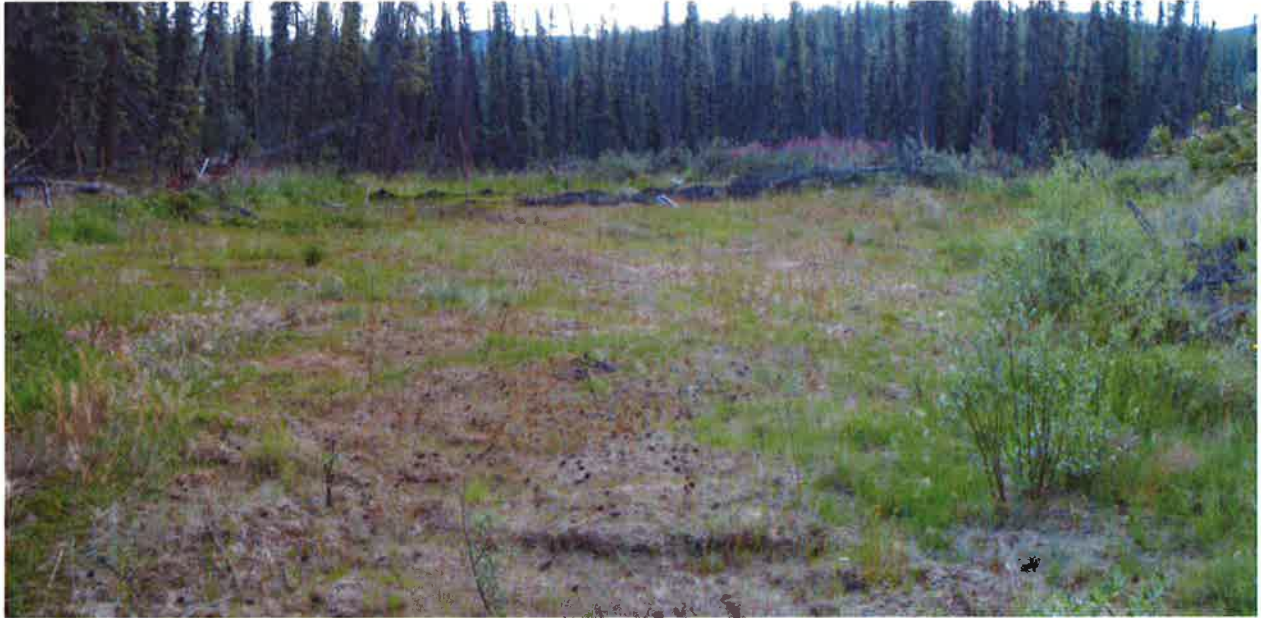
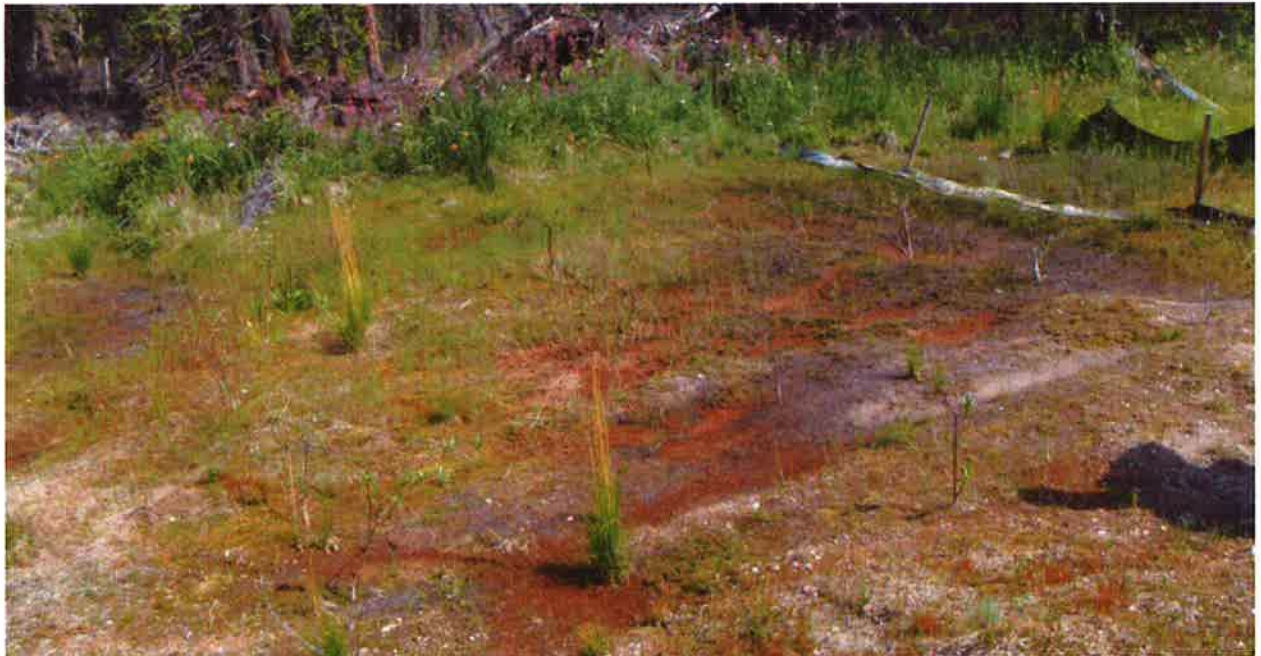
Further down slope of the proposed Heap Leach Facility Sediment Pond, and within the floodplain of Williams Creek, a series of silt fences have been installed and the area seeded where sediment from previous site erosion has accumulated. At the time of the inspection, it was observed that the silt fencing surrounding these areas is working effectively and there is no evidence of recent sediment movement. Grass seed was used in 2009 to promote the re-establishment of vegetation and further stabilize the sediment. The approach was noted to be generally effective in 2011 and 2012, but with limited re-growth attributed to periodic pooling of water. The area was re-vegetated with woody plants (willow cuttings), and plants appear to be tolerating saturated soil conditions. Conditions in 2013 were similar to 2012, with limited growth of the willow cuttings. No movement of sediment beyond the existing silt fences was observed, nor does it appear that sediment has entered Williams Creek. These erosion control measures are of a temporary nature that should be inspected annually and ongoing minor maintenance activities should be anticipated.

Photographs 6 - 7: Silt fences located between the area of the proposed Heap Leach Facility Sediment Pond and Williams Creek and re-vegetated area. Re-establishment of grass vegetation in this area appears to be hampered by the periodic pooling of water. Willow cuttings planted in 2011 had taken hold with limited new growth visible in 2013.

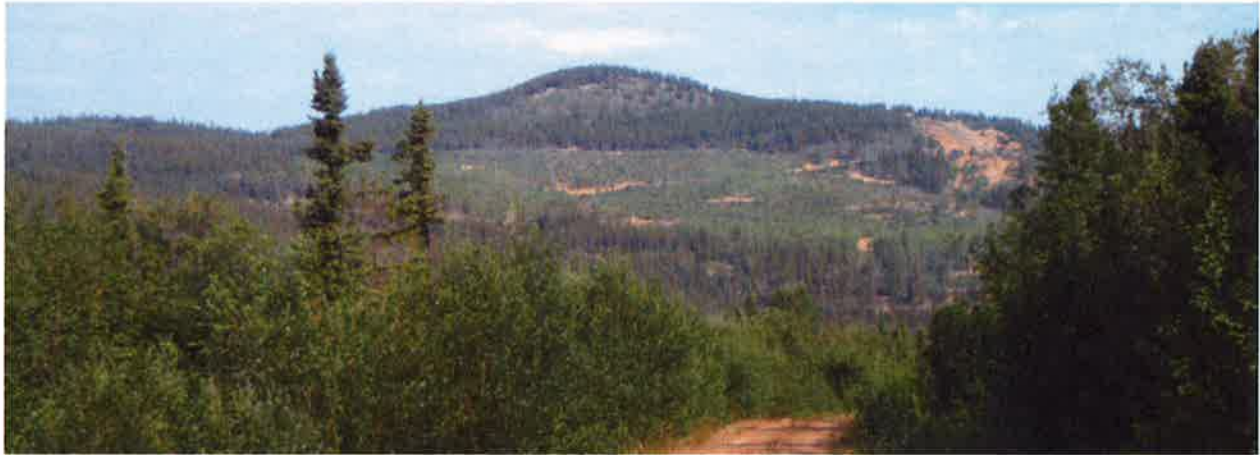
Photograph 8: View of proposed Heap Leach Facility and open pit areas (far slope) from site access road, looking north.

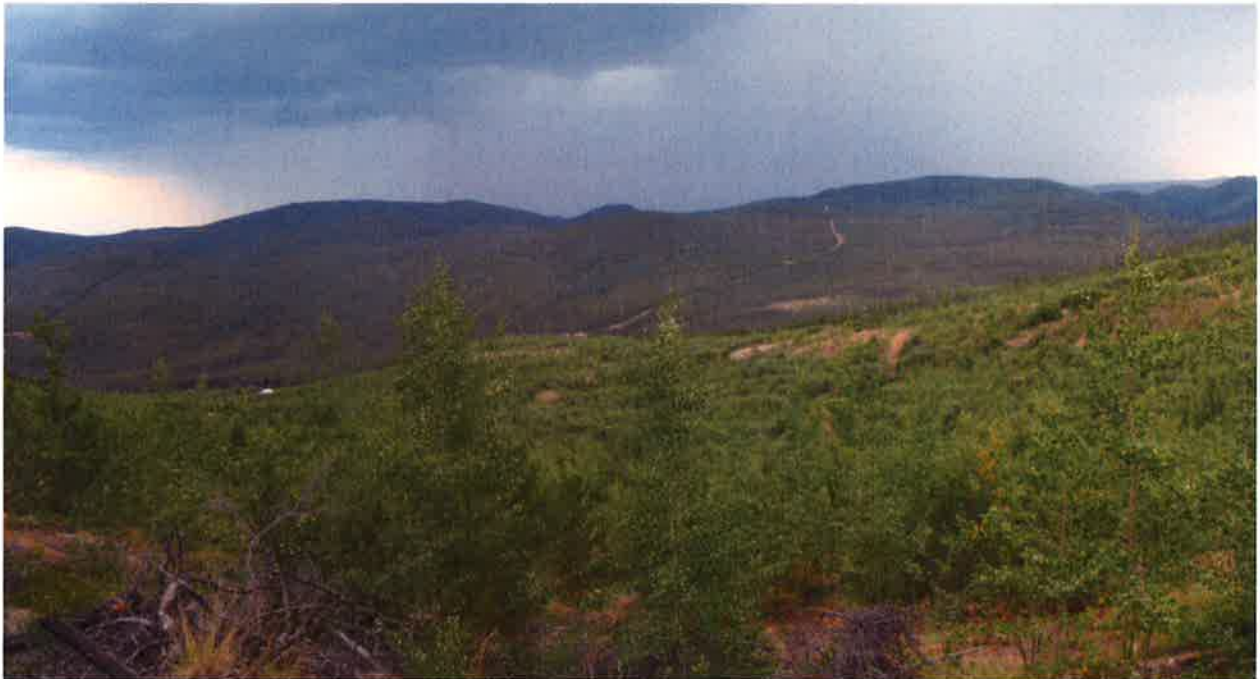
It is recommended that vegetation in the lower footprint area of the Heap Leach Facility and Confining Embankment be re-cleared of vegetation in 2013 or 2014 to promote thaw of permafrost ground prior to development of the area. Vegetation may allow re-establishment of permafrost and ground ice and should therefore the vegetation should be cleared to allow the ground to thaw over the warmer months.

Photograph 9: View of proposed Heap Leach Facility (foreground) looking south west.

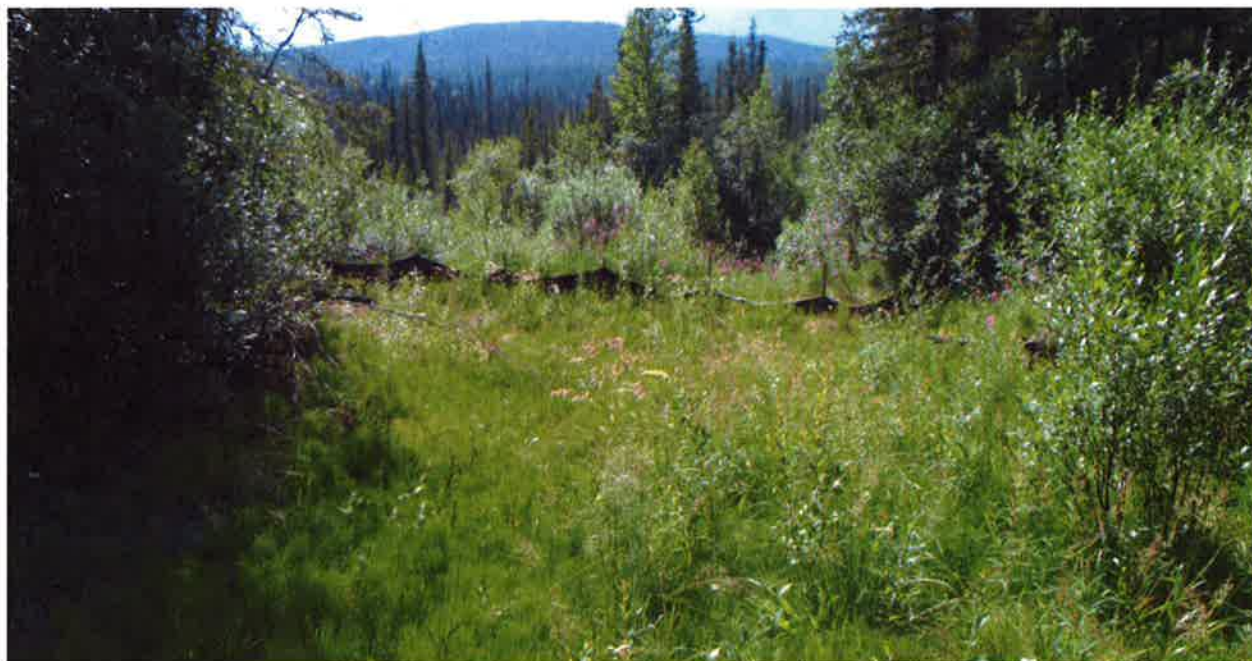
Photograph 10: Re-vegetation on drill access road in the Events Pond area.

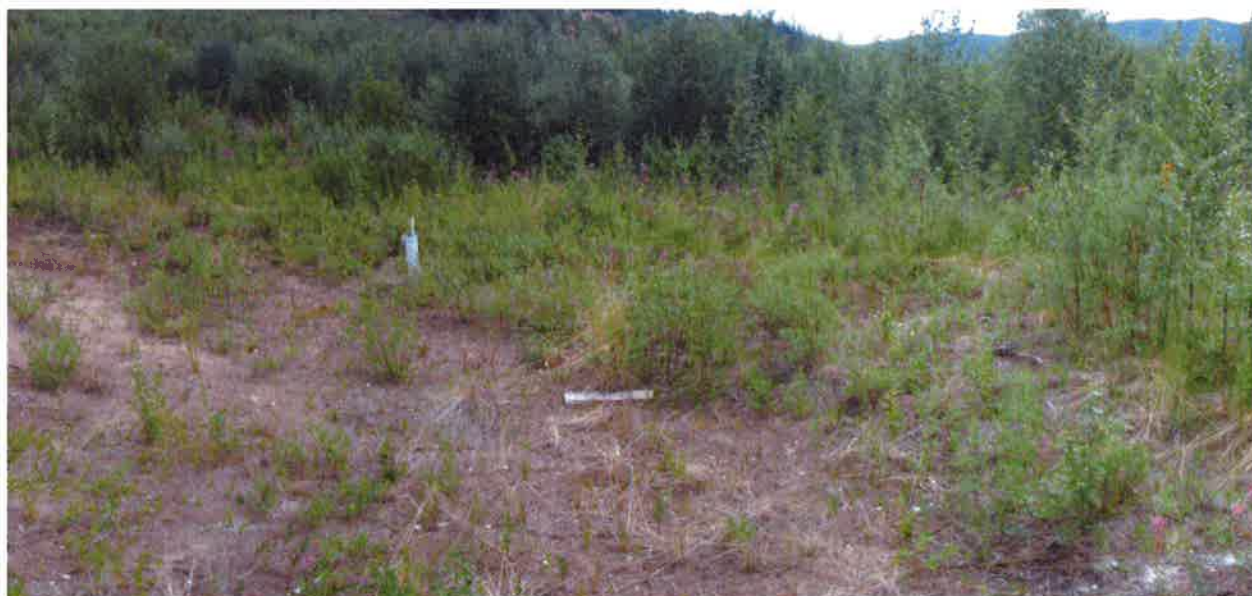
Photograph 11: Re-vegetation at BH17-07 drill pad in the Heap Leach Facility area.

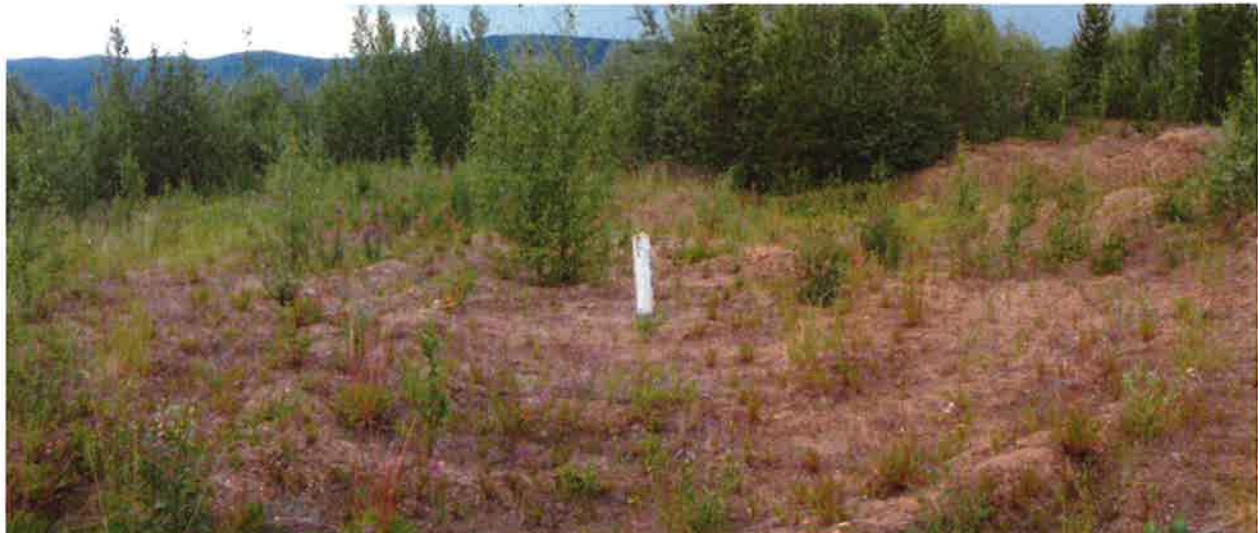
Photograph 12: Re-vegetation on BH-26-07 drill pad in the Heap Leach Facility area.

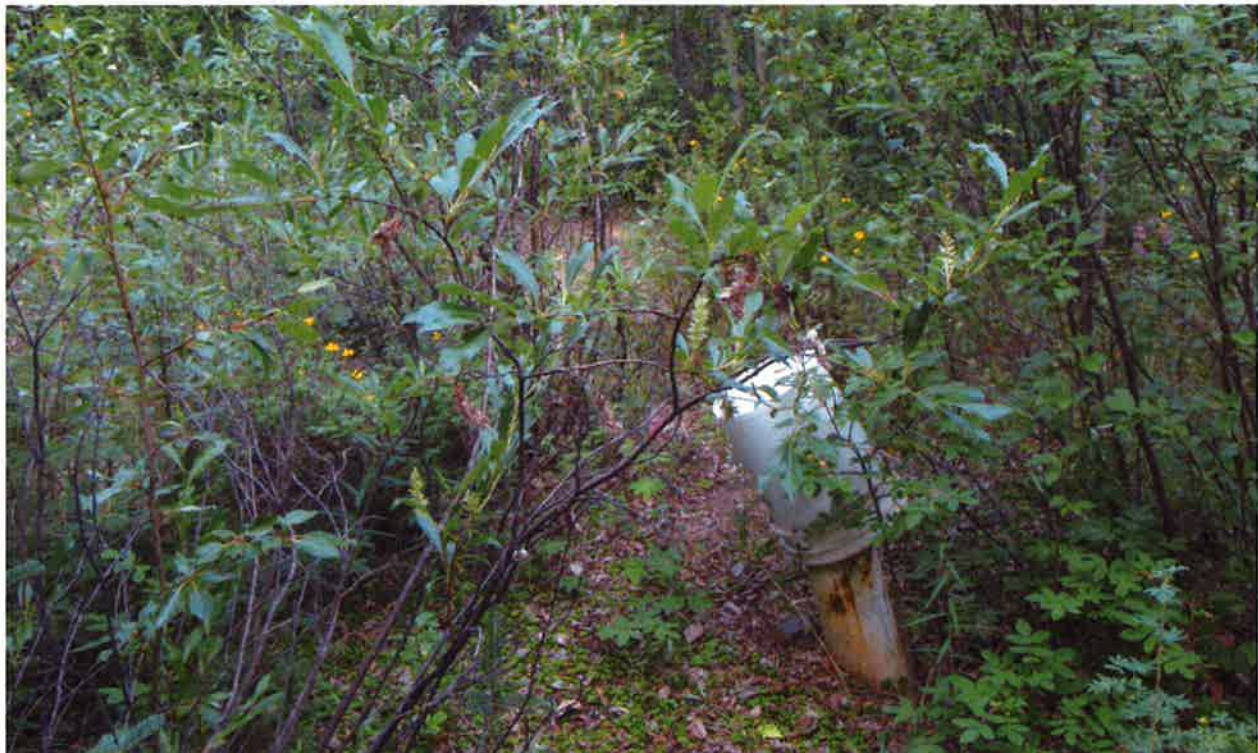
Photograph 13: Re-vegetation at DH95-H drill pad in the Heap Leach Facility area.

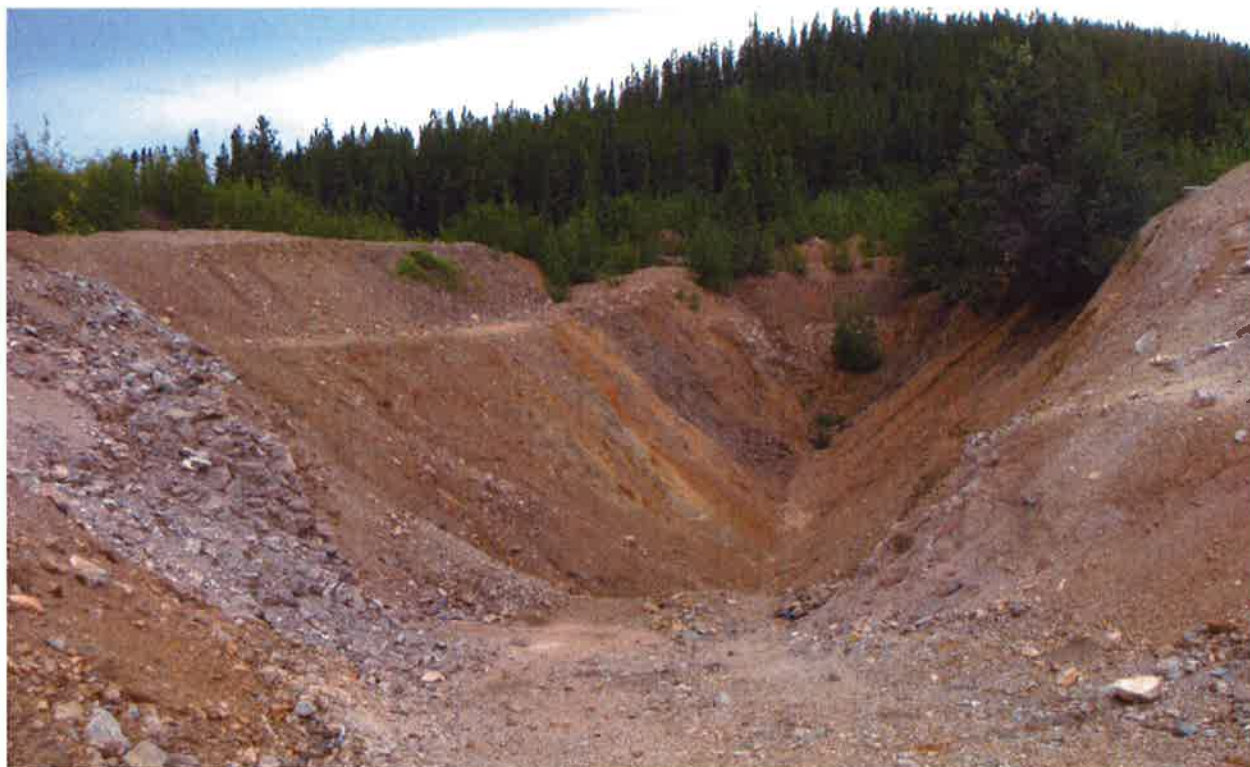
The area where the open pit is to be developed was inspected. The excavation slopes of the trenches developed as part of the effort to obtain bulk samples during exploration activities were observed to be in reasonable condition and there was no observed slumping or failures of these slopes. The leached ore pile from the off-site test pad adjacent the trench was observed to be stable and there was no erosion or slope movement of the material. Several of the closed drill pads were inspected and there did not appear to be any erosion noted from these areas that require attention.

Photograph 16: Bulk sample excavation site.

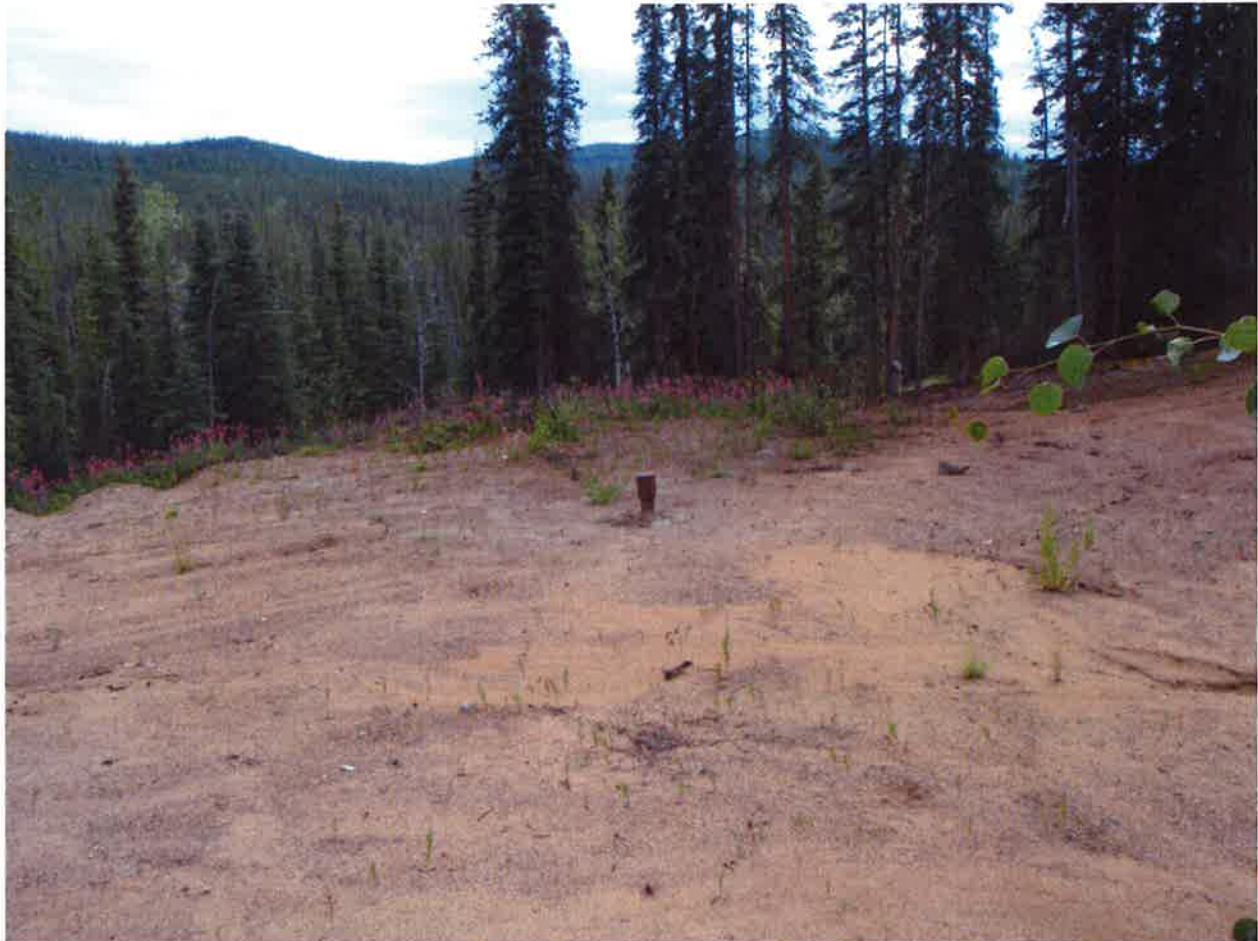
The proposed camp site was inspected and it is still tree covered. The site adjacent to the camp with two water wells was also inspected and there is no apparent movement of sediment beyond the work pads around the wells.

Photograph 17: Water supply well and pad near proposed camp site.

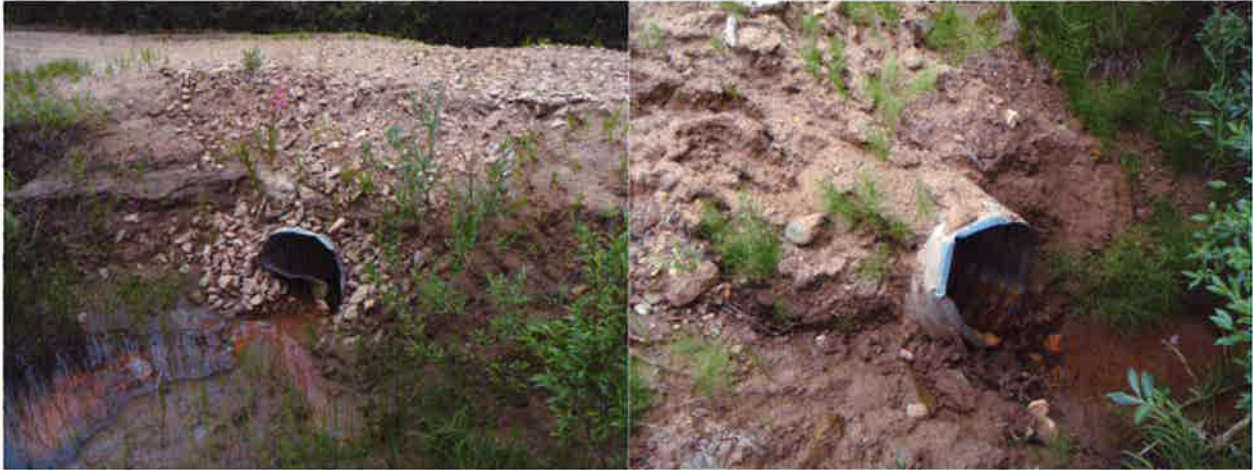
Photographs 18 and 19: Inlet (left) and outlet (right) of culvert on main access road crossing of North Williams Creek located north of the Waste Rock Storage Area.

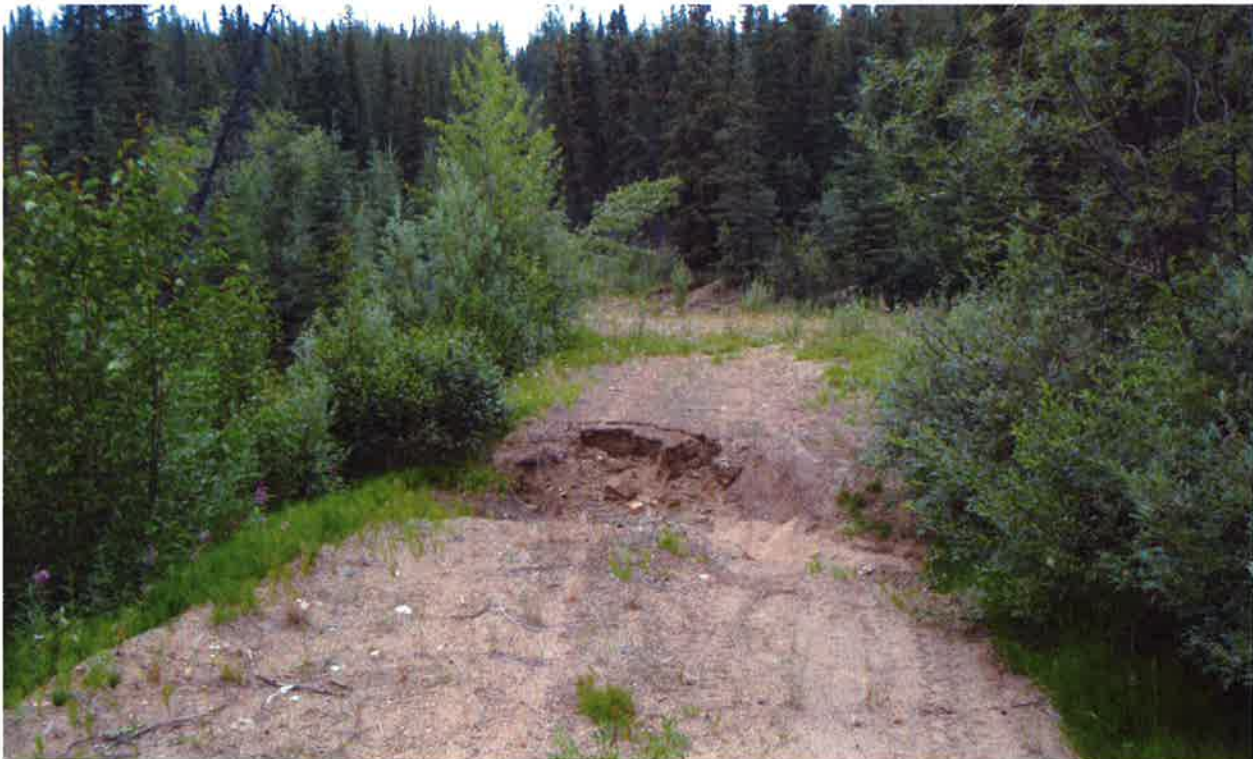
Local erosion on the main access road to the north of the Waste Rock Storage Area continues. The shoulders of the road at the culvert on North Williams Creek have eroded, reducing the road crest width at the culvert location. The road is washed out approximately 30 m past the culvert. A ponded area adjacent the road is anticipated to have temporarily flowed over and eroded the road fill due to reduced flow in the culvert near this location. The inlet of the culvert was observed to be bent. It is recommended that the culvert mouth be reshaped or opened to allow flow at capacity. The eroded area on the road should be filled with gravel to level the grade and re-establish the road.

Photograph 20: Erosion on road near North Williams Creek crossing.

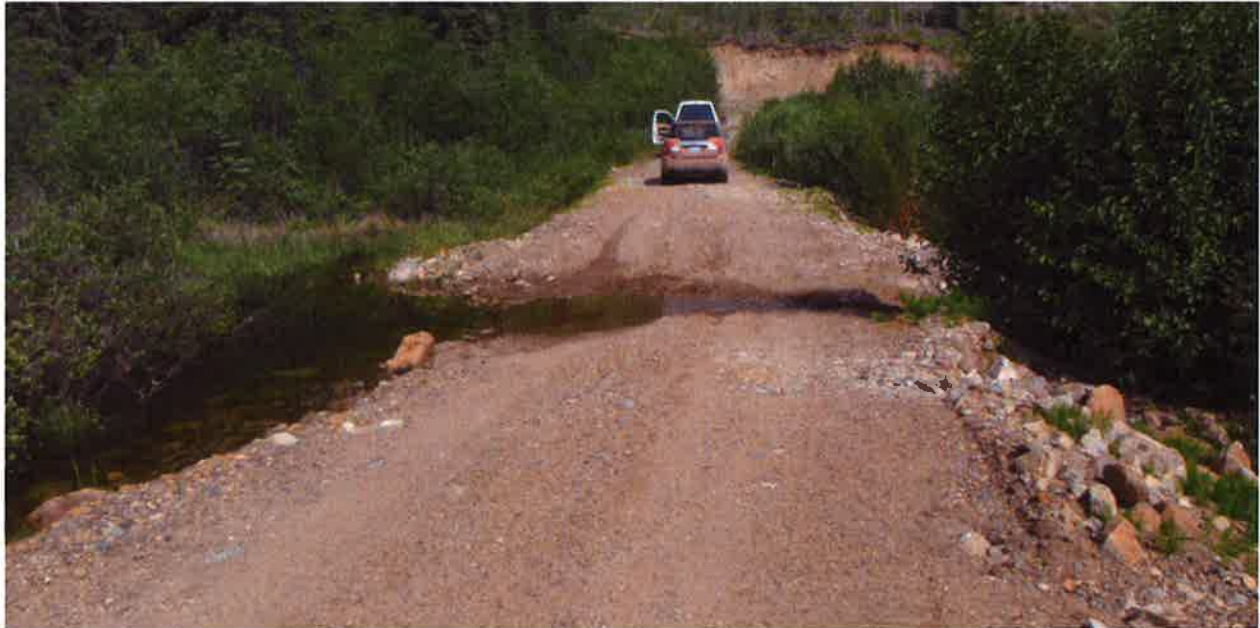
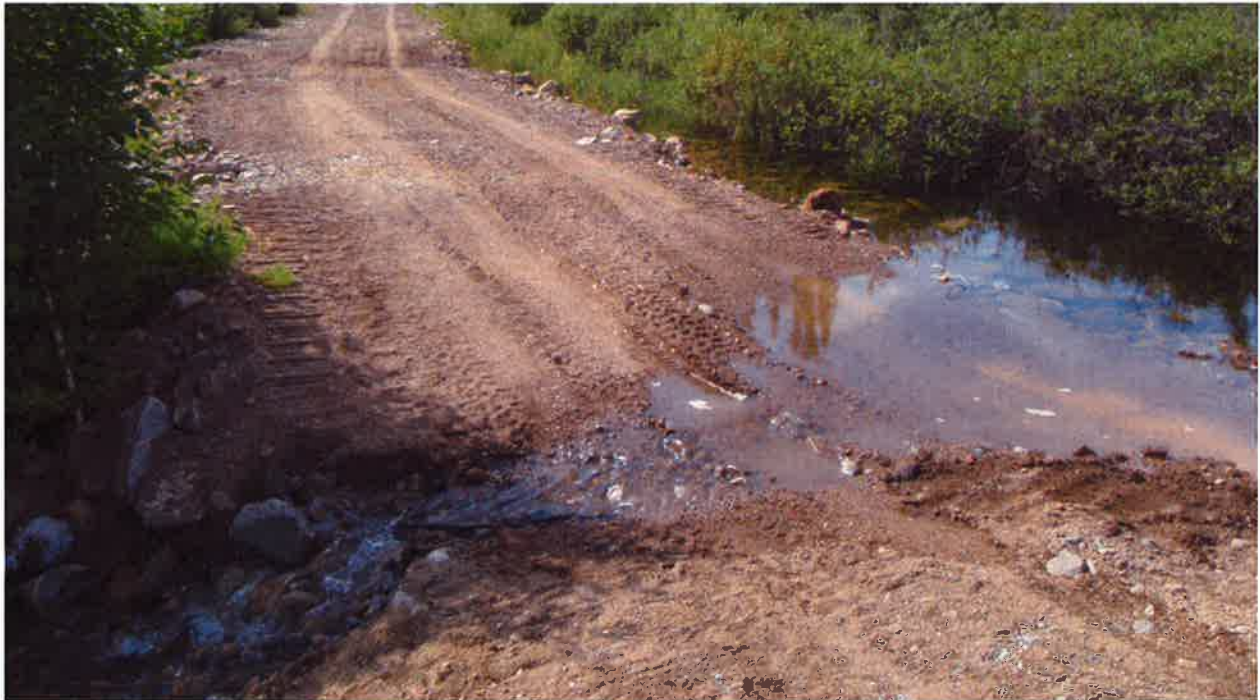
The culvert in the site access road which allowed Williams Creek to flow by the road was recently removed. The crossing is now a 'ford' with the road bed depressed over a length of 10 m to a maximum depth of 0.8 m below the adjacent road grade or crest elevation. Ponded water was observed on the upstream side of the road, with flow across the road. Scott Casselman reported that the culvert as angled upwards with the inlet in the air, and the culvert was therefore removed and the depression regarded as observed on July 10, 2013.

Without further erosion protection, it is anticipated that the general fill of the roadbed at Williams Creek will erode at the crossing location during high flow events. The culvert should therefore be replaced and armoured or the 'ford' should be upgraded to operate through next spring.

Photographs 21 - 22: *View of access road crossing of Williams Creek looking north (top) and south (bottom).*

- Clearing of vegetation in the footprint of the area of the lower Heap Leach Facility area and Confining Embankment to promote thaw of permafrost ground.
- Re-installation of the culvert on the site access road crossing of Williams Creek. The road embankment should be armored against erosion at the culvert location.
- Maintenance of the culvert on the main access road immediately north of the proposed Waste Rock Storage Facility.
- Filling and grading of the washouts on access roads in the Heap Leach Facility and Waste Rock Storage Facility areas.
- Clearing of the sediment trap on the access road to the lower re-vegetated area near Williams Creek east of the exploration camp, near the proposed Heap Leach Facility Sediment Pond location.

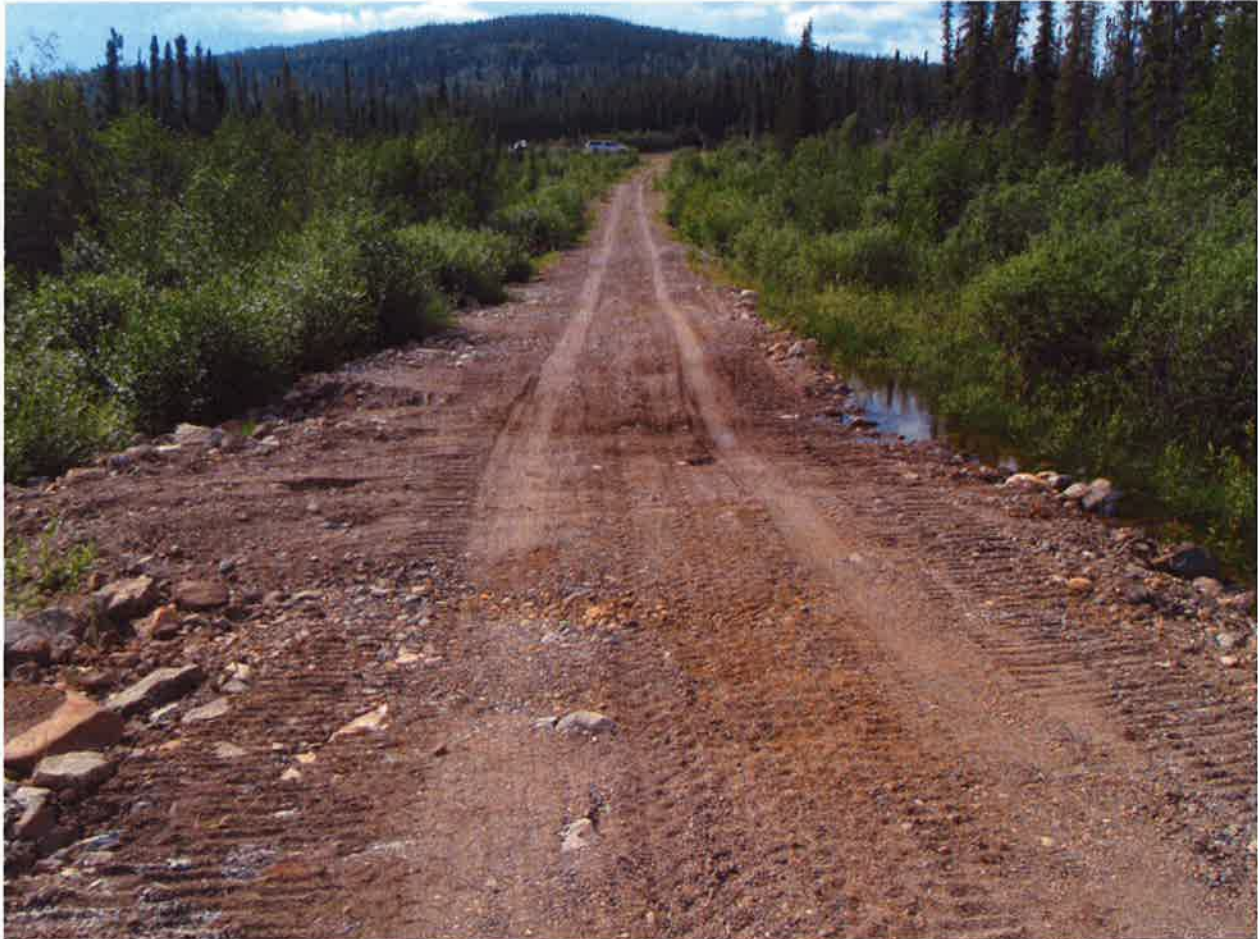
Some erosion noted during the 2012 inspection, indicated that flow had previously appeared to pass over an additional segment of the road near the Williams Creek crossing, eroding the road bed some 18 m south of the culvert location. It is anticipated that this was a temporary condition, which likely occurred at the beginning of the freshet, potentially when the culvert was still frozen/blocked by snow and ice. This southern eroded area was observed to have been repaired. Scott Casselman reported that the eroded area was repaired on July 10, 2013.

Photograph 23: View of access road repair just south of Williams Creek, looking south.

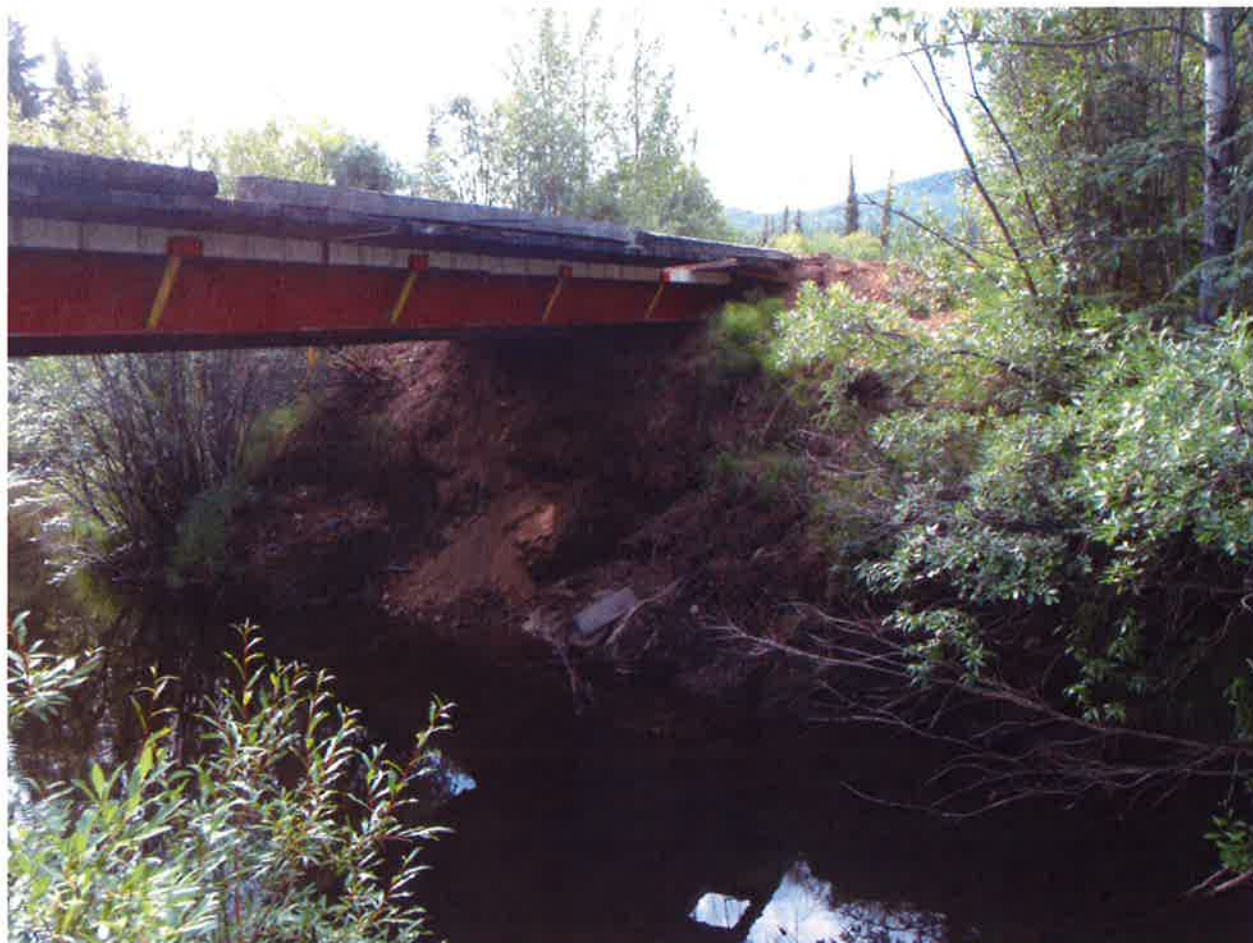
The access road crossing at Merrice Creek includes a single span bridge set on grade. No steelwork or abutment foundations were observed. In July 2012 the creek banks were being eroded and under cut at the crossing location. Scott Casselman reported that the bridge span was re-set on July 10, 2013, following recommendations in the July 2012 inspection memorandum. The abutment on the Village of Carmacks side of the bridge was reportedly leveled, or cut down, and then the span dragged back and re-set. During the July 2013 inspection the length of span seated on the Village side abutment was 0.5 to 0.75. The slope of the ground at the abutment immediately under the span at this location was observed to be over-steepened, approximately 1 horizontal to 2 vertical. The measures to stabilize the span therefore appear temporary and it is anticipated that the bridge will have to be re-set again in 2014 or in 2015.

Photograph 24: Site access road crossing of Merrice Creek, view of bridge abutment nearest to the Village of Carmacks.
Date Taken: July 16, 2013
